WINDOW SURVEY AT 1-2 & 3-4 LIVESEY STREET, TESTON, KENT

1. SWAT Archaeology Partnership has been instructed by the owners of the above properties to carry out a full investigation of all the windows and provide a detailed written condition report based on the survey findings.

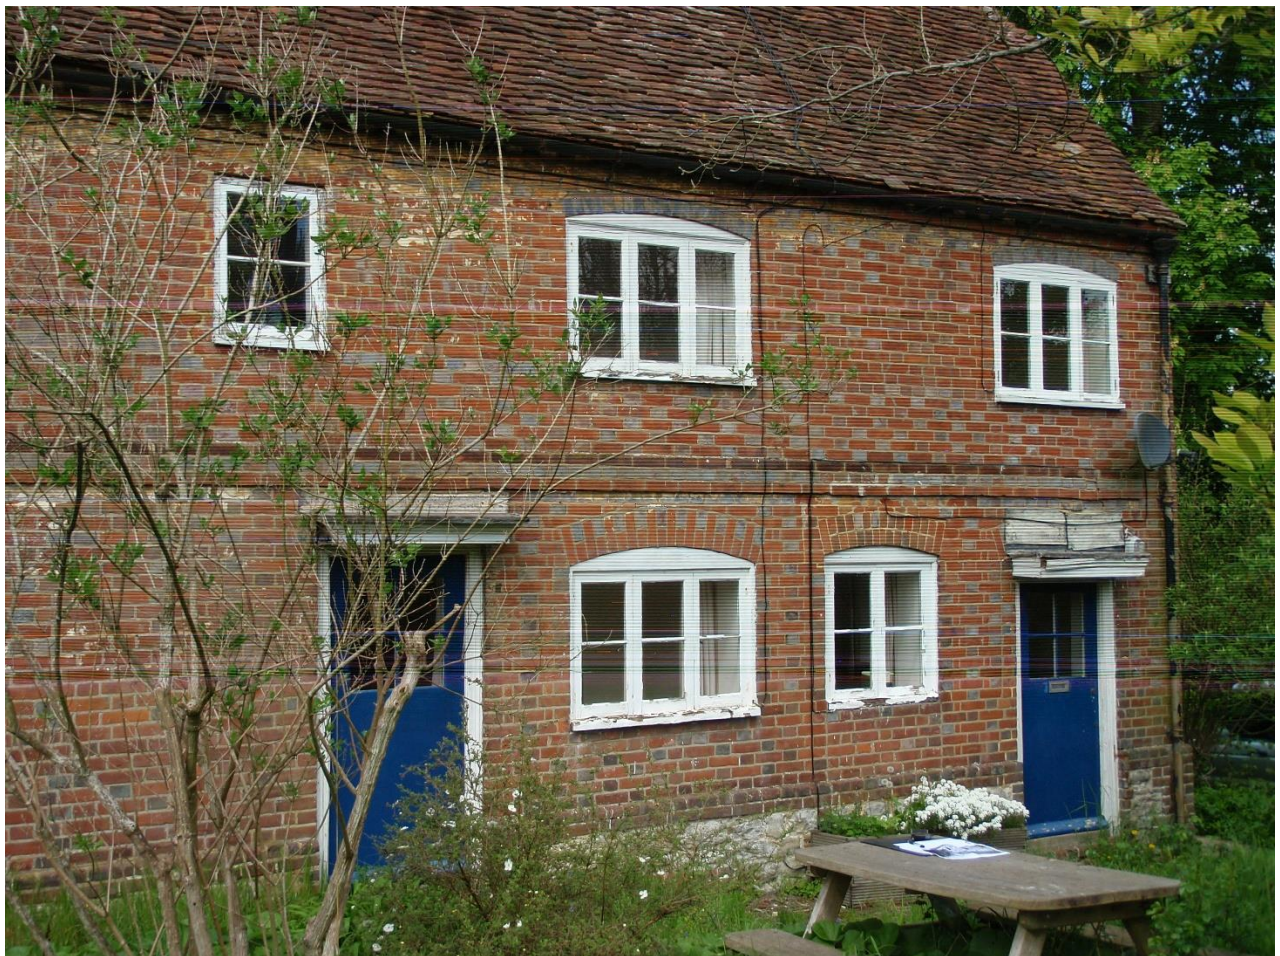
Plate 1. South elevation with Windows 5, 6, 7, 8, 9

ITEM	WINDOW CONDITION	REPAIR OR REPLACE
Window 1 (Plate 2)	Cill, bottom rail, left jamb rotted	Replace
Window 2 (Plate 2)	Cill, bottom rail, right and left jamb rotted	Replace
Window 3 (Plates 2, 4)	Cill rotted	Replace
Window 4 (Plates 2, 6)	Poor replacement cill, left mullion rotted	Replace
Window 5 (Plate 1)	Cill and right jamb rotted	Replace
Window 6 (Plate 1)	Cill rotted	Replace

Window 7 (Plate 1)	Cill rotted	Replace
Window 8 (Plates 1, 5)	Cill, right and left bottom rail rotted	Replace
Window 9 (Plate 3)	Cill, left and right bottom rotted	Replace

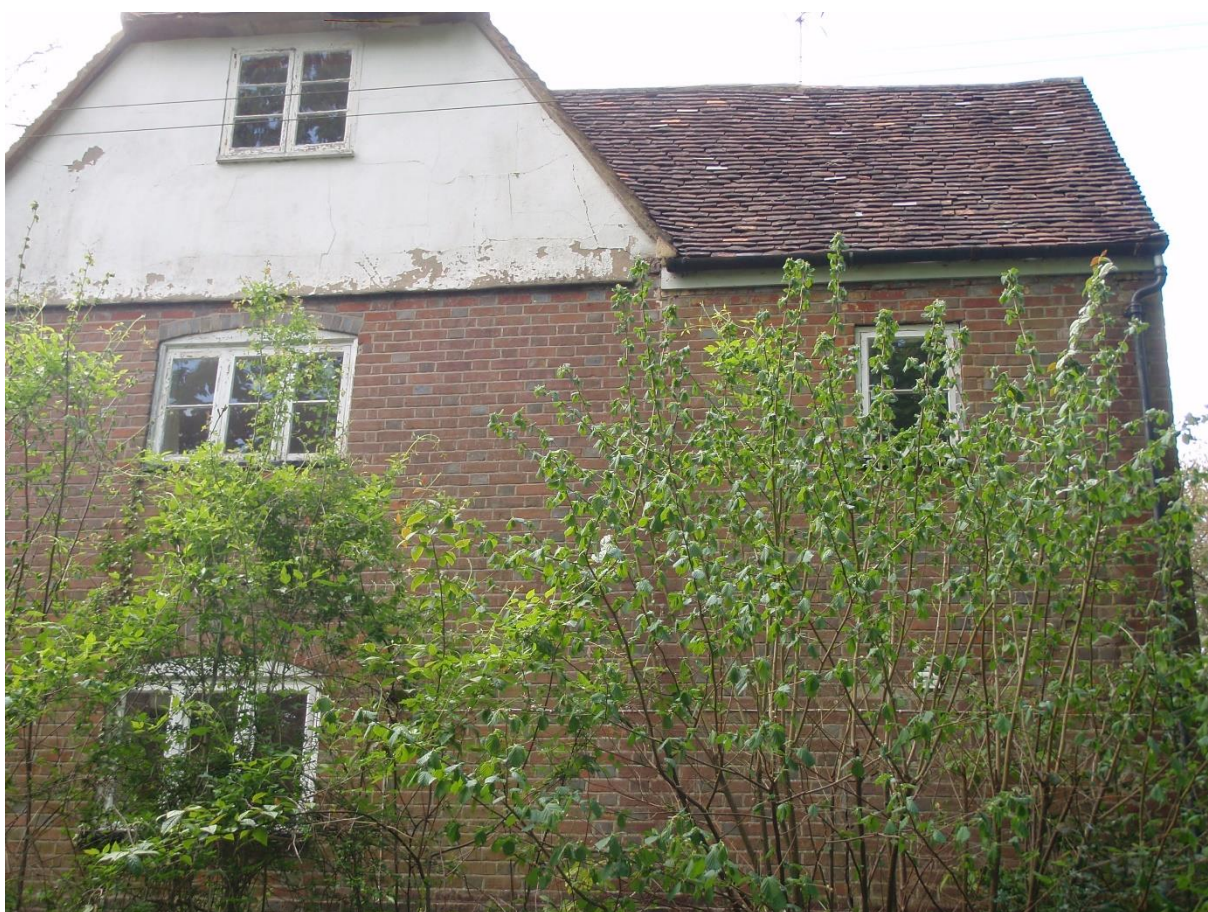
Plate 7. Windows east elevation

ITEM	WINDOW CONDITION	REPAIR OR REPLACE
Window 10 (Plate 7)	Cill, bottom rail, left jamb rotted	Replace
Window 11 (Plates 7, 9)	Cill and bottom rail rotted	Replace
Window 12 (Plate 7)	Cill, bottom rail, right and left jamb rotted	Replace
Window 13 (Plates 7, 8)	Bottom rail rotted	Replace

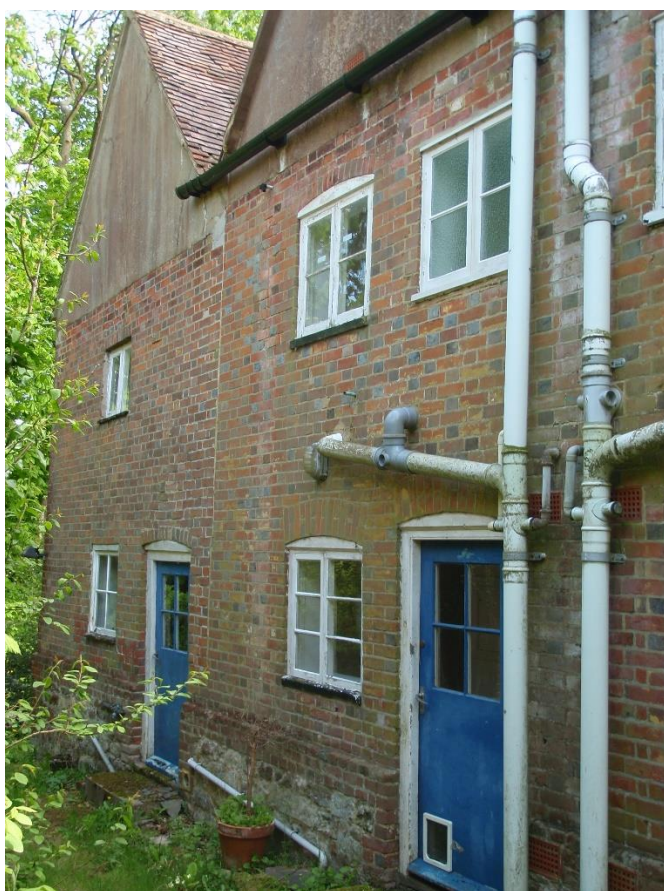
Plate 10. North elevation

ITEM	WINDOW CONDITION	REPAIR OR REPLACE
Window 14 (Plates 10, 15)	Cill, bottom rail, left jamb rotted	Replace
Window 15 (Plates 10, 12)	Cill, bottom rail, right and left frame rotted	Replace
Window 16 (Plate 10)	Cill, bottom rail, right and left jamb rotted	Replace
Window 17 (Plate 10)	Cill, bottom rail, right and left jamb rotted	Replace
Window 18 (Plates 10, 11)	Cill rotted	Replace

ITEM	WINDOW CONDITION	REPAIR OR REPLACE
Window 19 (Plates 10, 13)	Cill, bottom rail, left jamb rotted	Replace
Window 20 (Plates 10, 13)	Cill and bottom rail rotted	Replace
Window 21 (Plates 10, 13)	Cill rotted	Replace
Window 22 (Plates 10, 14)	Cill, right jamb rotted	Replace
Window 23 (Plates 10, 14)	Cill rotted	Replace

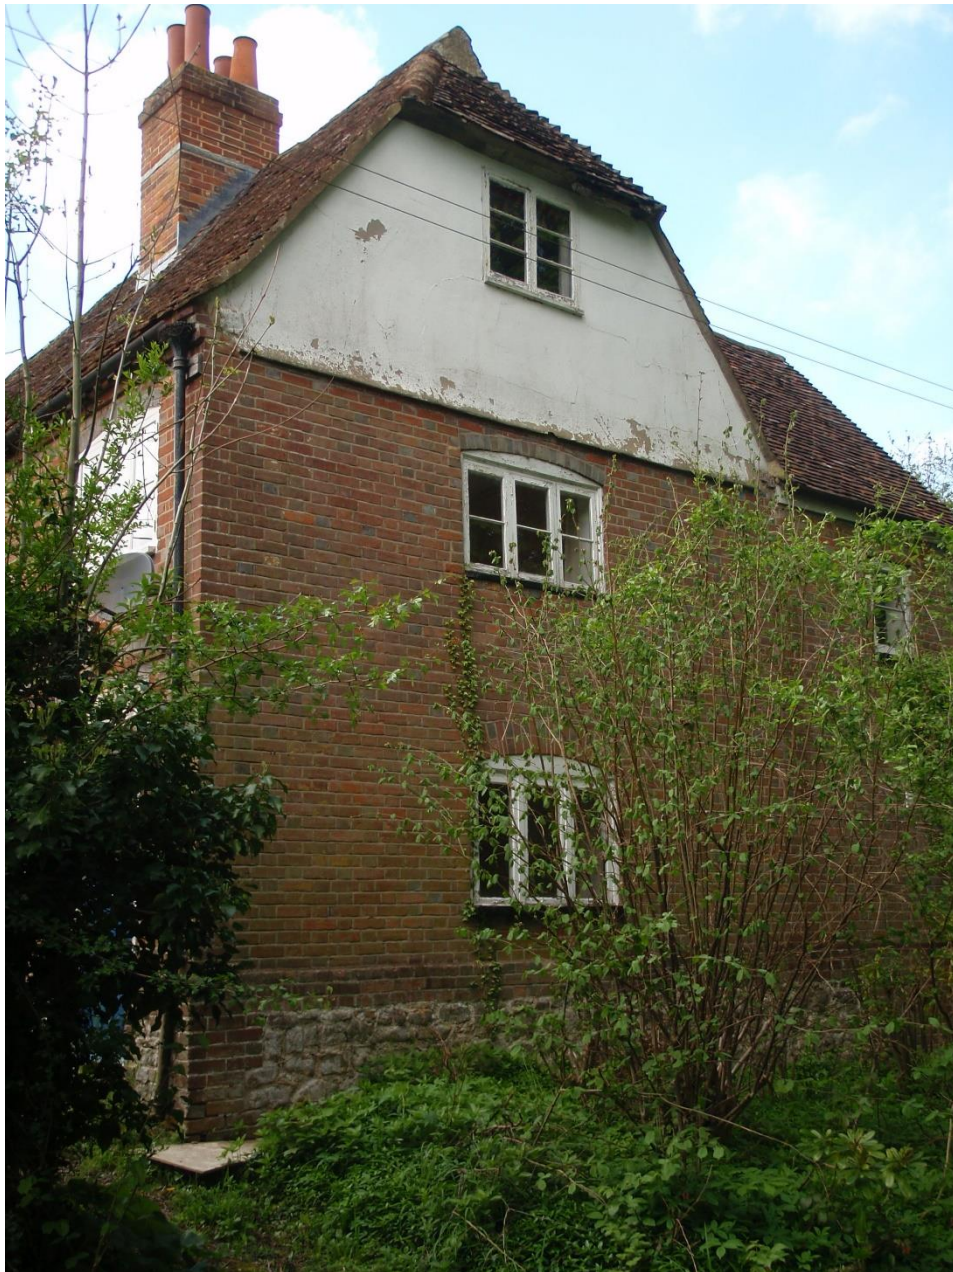
Plate 16. West elevation windows 24, 25, 26

ITEM	WINDOW CONDITION	REPAIR OR REPLACE
Window 24 (Plate 16)	Cill, bottom rail, left jamb rotted	Replace
Window 25 (Plate 16)	Cill, bottom rail, right and left jamb rotted	Replace
Window 26 (Plate 16)	Cill, bottom rail, right and left frame rotted	Replace
