HISTORIC BUILDING RECORDING AT CLAYDENE FARM, HARTFIELD ROAD, COWDEN, KENT

Date of report 11^{th} June 2021

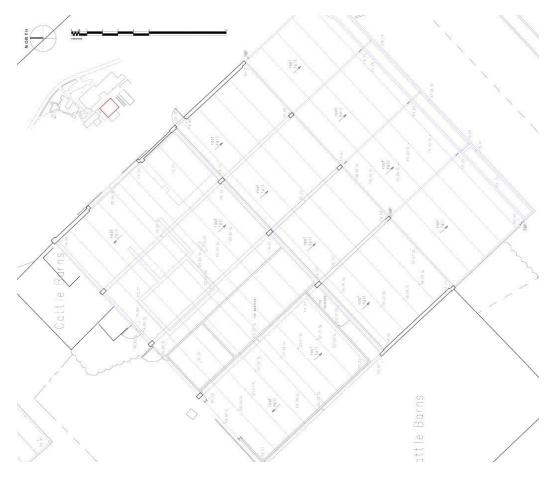
Figure 4. Barn 1 plan

3.1 Barn 1 The building is located in the centre of the group of farm buildings and faces northeast. It is a ATCOST Building with the main building measuring 11m x 19.75m and the additional building to the south-east 13m in width (Plate 7. Figure 4). The main building has a brick facade with two large sliding double doors of corrugated metal painted black whilst the attached building is faced with concrete blocks and accessed through a single timber door (Plate 8). The roof is corrugated asbestos sheets as is the upper storey of the building (Plate 9). The interior has a concrete floor and a number of concrete settling tanks whilst the four roof spans are of ATCOST concrete with concrete purlins (Plate10).

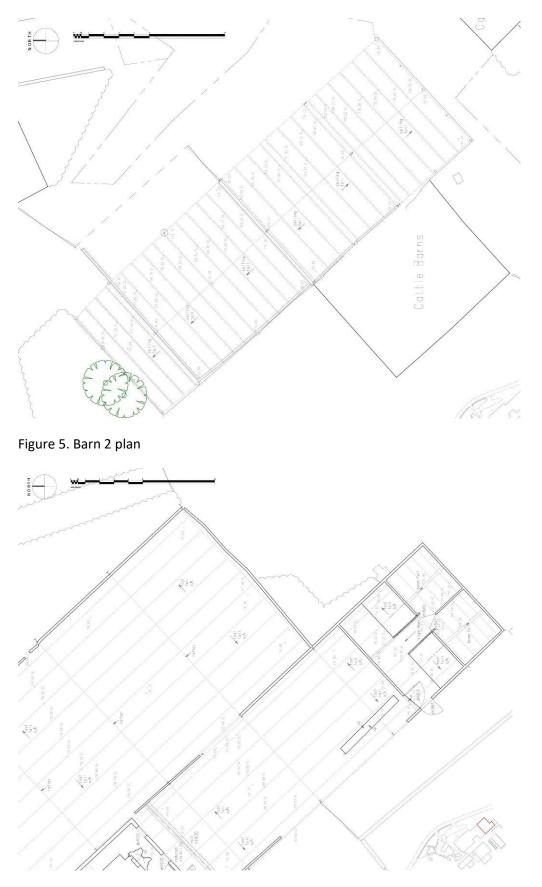
Figure 6. Barn 4 plan

3.4 Barn 4 The building (Figure 6) is a three bay Dutch barn with two additional extensions with sloping roofs (Plate 11) and is the largest building on the site (Plates 1, 2). Early barn types in the UK, such as aisled barns, were primarily used for the processing and temporary storage of grain. Processing comprised of hand-threshing (or later, machine threshing) the grain before removal to a granary for more permanent storage. The hay barn was developed

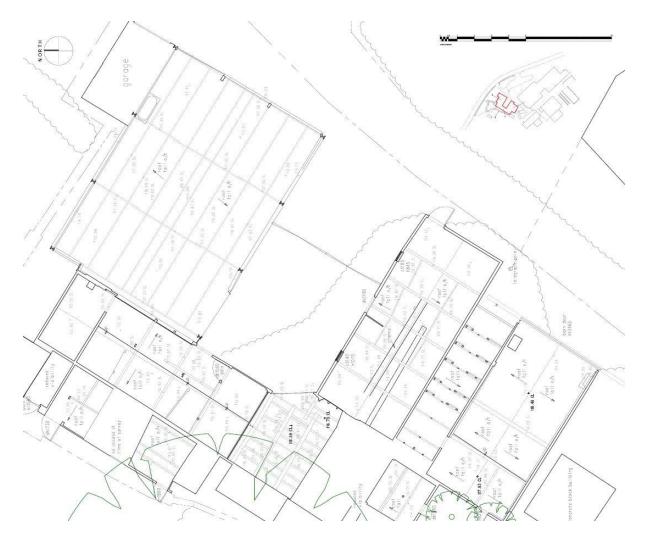
Figure 7. Barns 5, 6 plans

3.5 Barn 5 The building (Figure 7) is a double height barn built of vertical corrugated sheets of asbestos cement secured to a metal frame with a large sliding double door faced with vertical corrugated metal sheets painted black (Plate 18). The building measures 14m x 22m including the extension with a sloping roof built of timber (Plate 19). The interior of the main barn shows the central pitched roof built of metal struts sat on vertical metal beams with the three side extensions divided by vertical railway sleepers. The internal floor surface is of tarmac road scrapes (Plate 20).

3.6 Barn 6 The building (Figure 7) is a prefabricated building of slotted concrete external posts with walls constructed of slotted concrete slabs and repaired with sheets of corrugated metal (Plate 21). Roof was of asbestos corrugated sheeting. The front elevation (Plate 22) shows access on the right and repairs to the wall on the left. The internal floor is concrete.

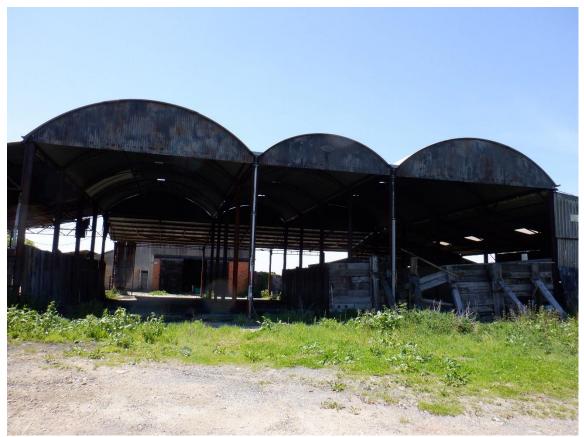
Plate 1. View of Barn 4 (looking SW)

3.4.1 Different types of hay barns evolved, over time they came to share certain common characteristics that they would generally have a roof but no walls (Plate 1). Dutch barns, as they became to be called, were often constructed with a rounded or arched corrugated metal roof and with metal uprights (Plate 3). Due to their ease of construction these open framework barns are often considered temporary with their existence determined by the life of the metal uprights or the corrugated metal roof (Plates 4, 5). Internal partitions are of vertical railway sleepers (Plates 3) and the internal floor surface is of concrete (Plate 4).

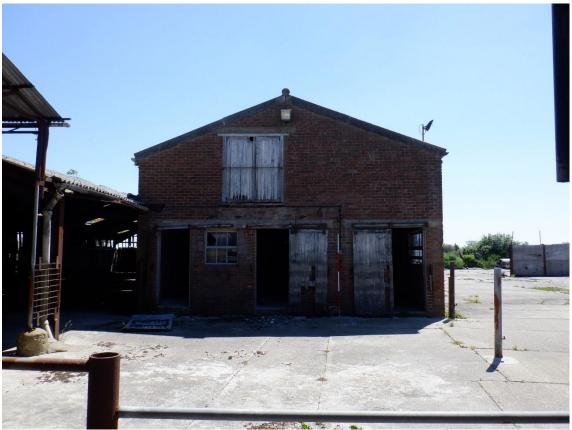
Plate 12. Front elevation of Barn 3 (looking SE)

3.3 Barn 3 The building is located in the south-east area of the site and the frontage (Plate 12) is orientated to the north-west. The main building measures 22m x 30m and the extension to the south measures 12.30m x 9.50m. The main facade is brick built with three single door entrances on the ground floor closed by wooden sliding doors and the upper storey has a double door entrance with two wooden hinged doors. The pitched roof is of corrugated asbestos sheets on the main building. To the rear the building continues as a part brick built single storey structure (Plate 15) and part built with external walls of vertical railway sleepers with a pitched roof of corrugated asbestos sheeting (Plate 14). The interior is floored with concrete.
