# HISTORIC BUILDING ASSESSMENT OF THE DIRTY HABIT PUBLIC HOUSE, UPPER STREET, HOLLINGBOURNE, KENT

Date of report 10<sup>th</sup> March 2023

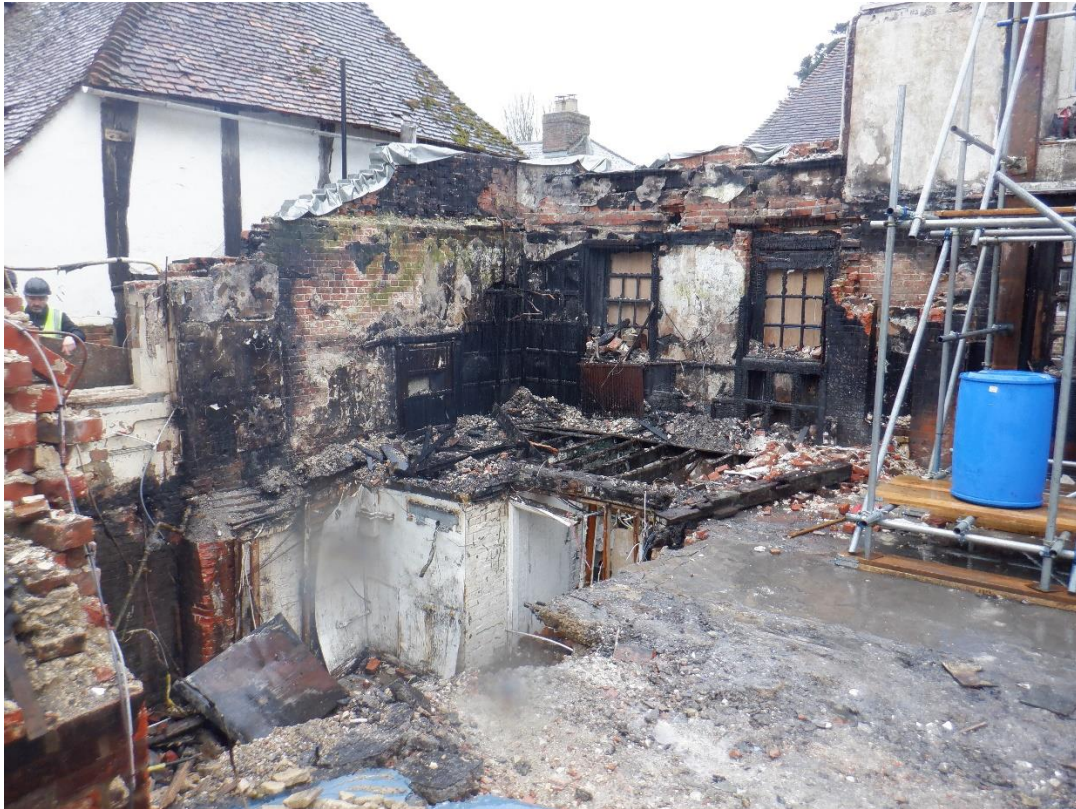
Plate 11. Interior (looking East)

5.1 The basement was examined and the chalk sections are original bedrock and not loose infill. The cellar ceilings and ground floor beams are fire damaged and are a 19<sup>th</sup> century build with 19<sup>th</sup> century machined joists and reused earlier hand cut main beams (Plates 11, 12).

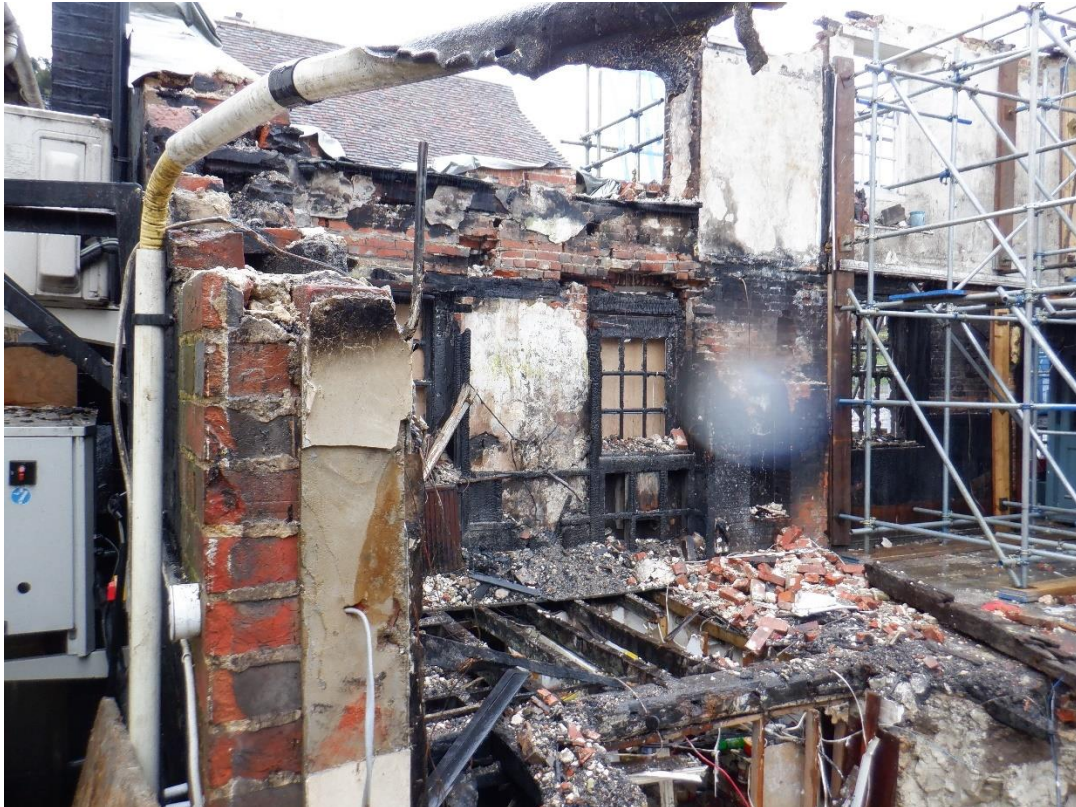
Plate 12. Interior (looking North)

5.3 The NE internal frontage walls are also of early 19<sup>th</sup> century date pierced with two late 19<sup>th</sup> century badly fire damaged sash windows and the internal ground floor walls finished with timber panelling constructed with plywood panels and dating no earlier than the mid 19<sup>th</sup> century (Plates 12-13).

5.4 It is planned to demolish the NE walls of which are of no historical significance and part of the frontage as are in a dangerous condition and this proposal is acceptable. However, the exterior bricks, both red and grey should be cleaned and retained and used if possible in the proposed cavity wall rebuild.

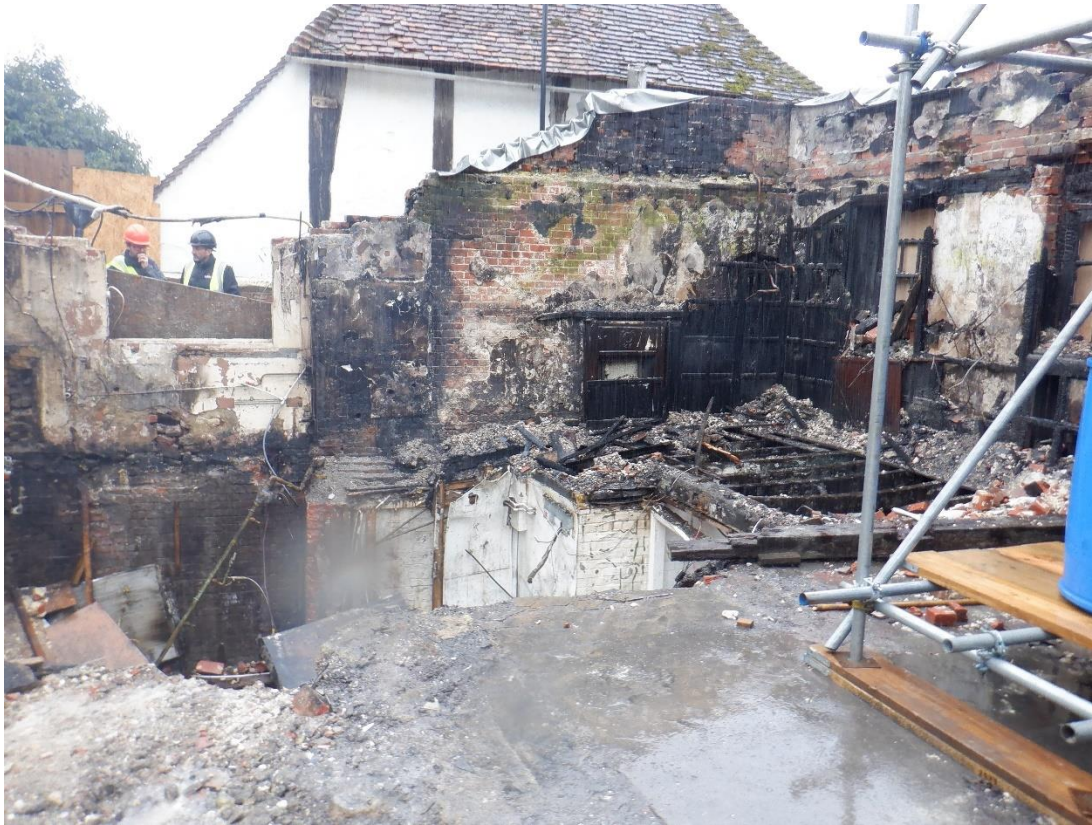
Plate 14. Interior (looking SW)

5.2 The brick walls of the cellars are red bricks of early 19<sup>th</sup> century date laid in a Flemish Bond with lime mortar (Plate 14).
