HISTORIC BUILDING RECORDING OF EXISTING COMMERCIAL BUILDINGS AT SCAMMELL LODGE, DETLING, KENT

Site code: SLD-BR-24

Date of Report: 18th March 2024

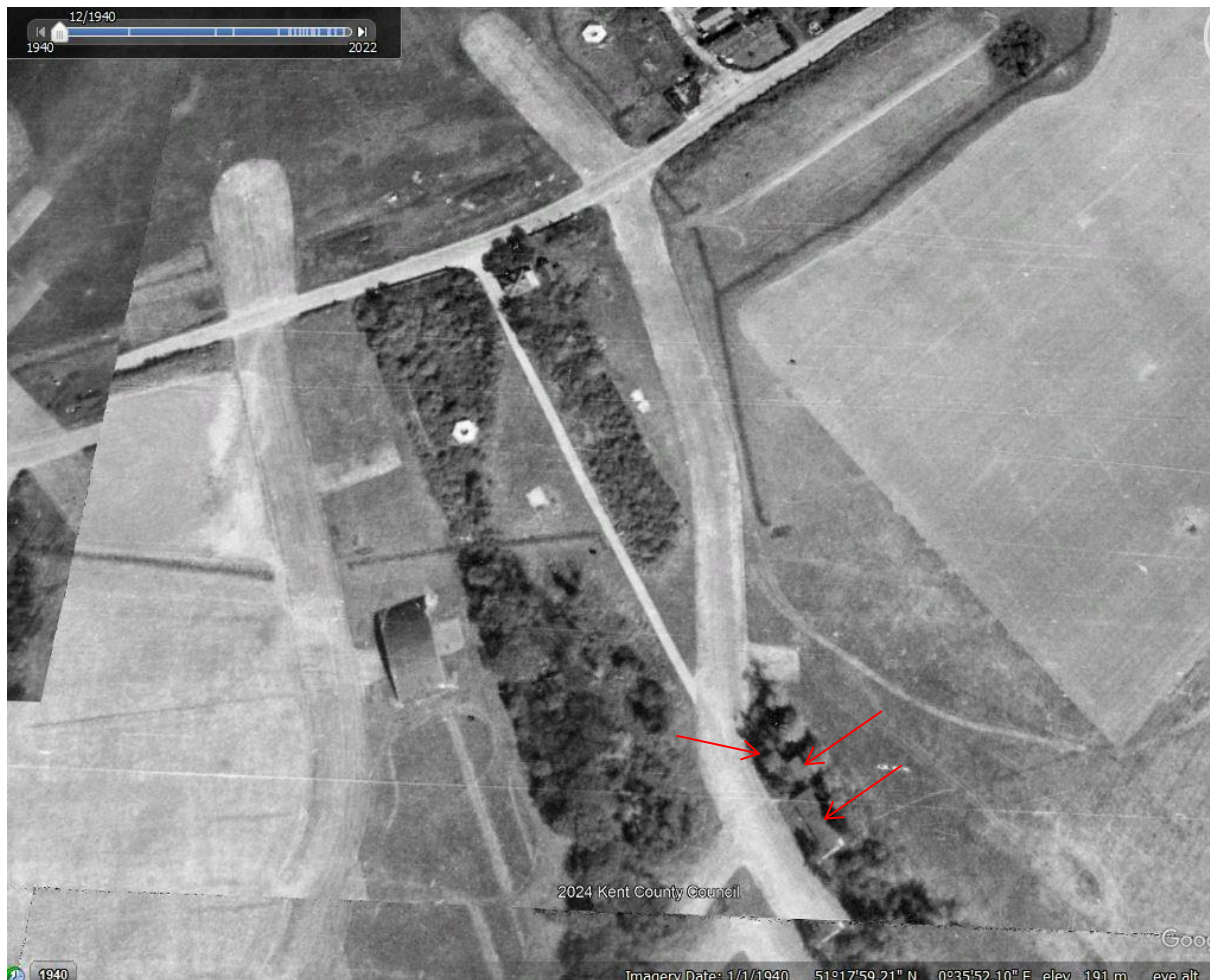
5.2. However, the search of available aerial photographs show that the earliest aerial photograph dated 1940 shows three building on site (Plate 1, red arrow) as well as a number of hexagonal pill boxes.

Plate 1. AP dated 1940- red arrow points out building on site

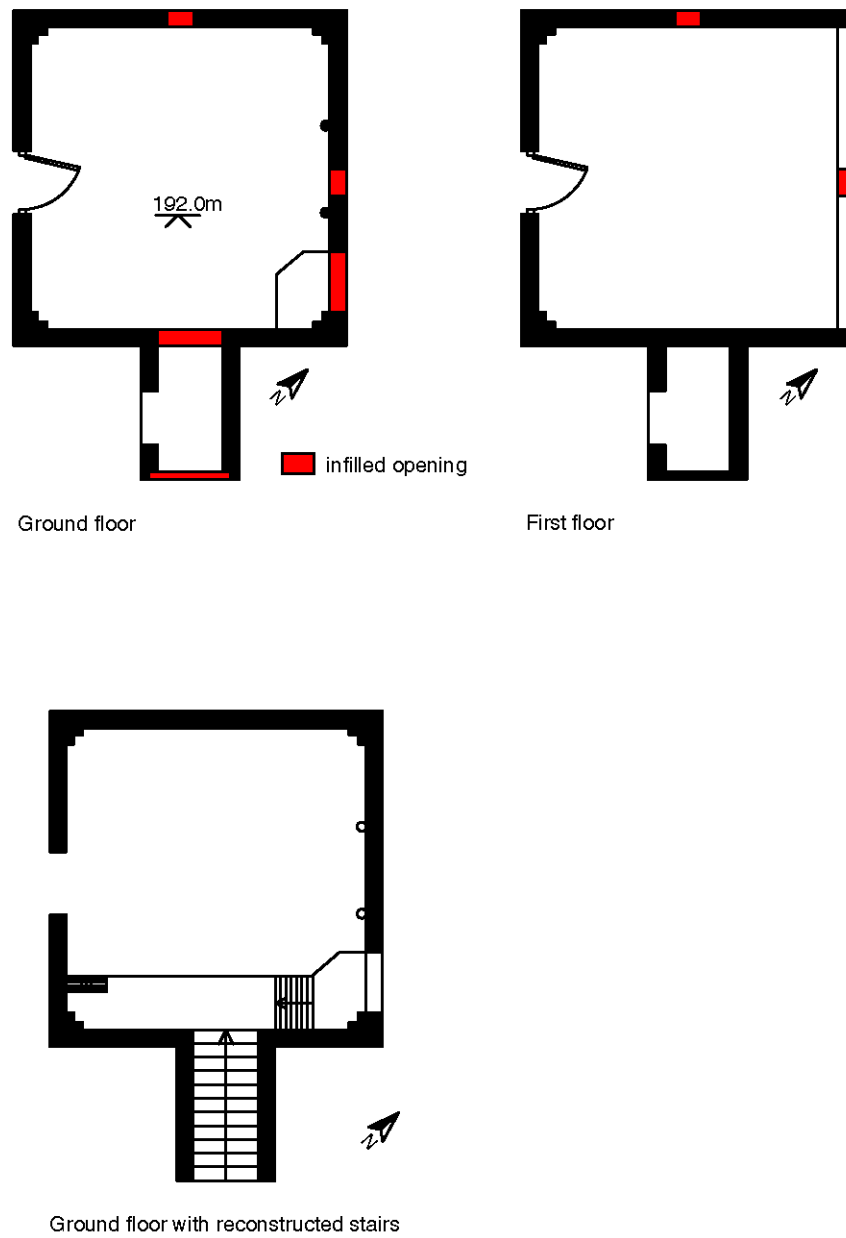
Figure 3: Floor plans of building 2

6.1 The building layout (Figure 3) was square measuring 4.4m in length with small rectangular extension in the middle of southern wall measuring 1.77m by 1.3m. The building was 6.35m high. The building and extension featured two floors that were not connected. In extension part there was a toilet cubicle on each floor with doorways on the west wall. There was no passage between extension and main building.

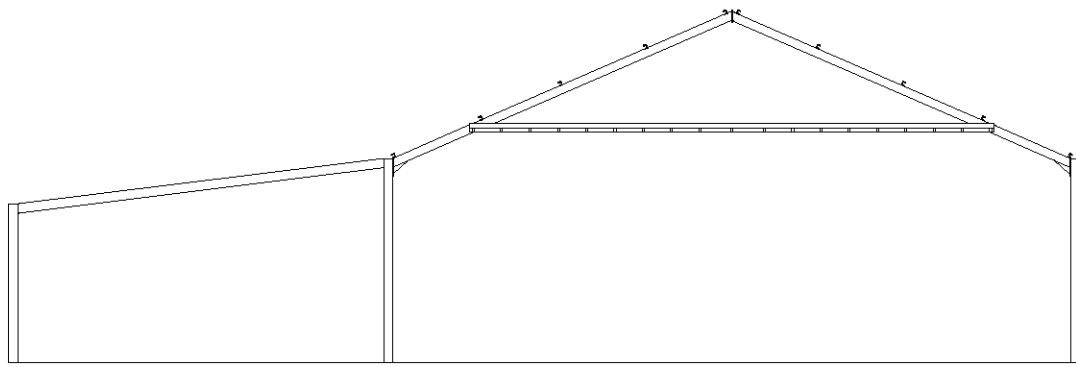
Figure 5: Building 1 plan and cross section

6.10 Frame of Building 1 (Figure 5) was also recorded as its layout is matching the extent of the building visible in 1940 photograph. It seems that the steel frame of the building is the remains of the original building and walls built of concrete blocks are a later addition. Building was rectangular in plan measuring 18.35m by 14.16m and it is 4.65m high. It comprised of 5 trusses placed 4.56m apart. The frame was constructed from H profile steel beams joined together with screws. At the front northern wall it featured sliding doors consisting of wooden frame and corrugated metal sheet.

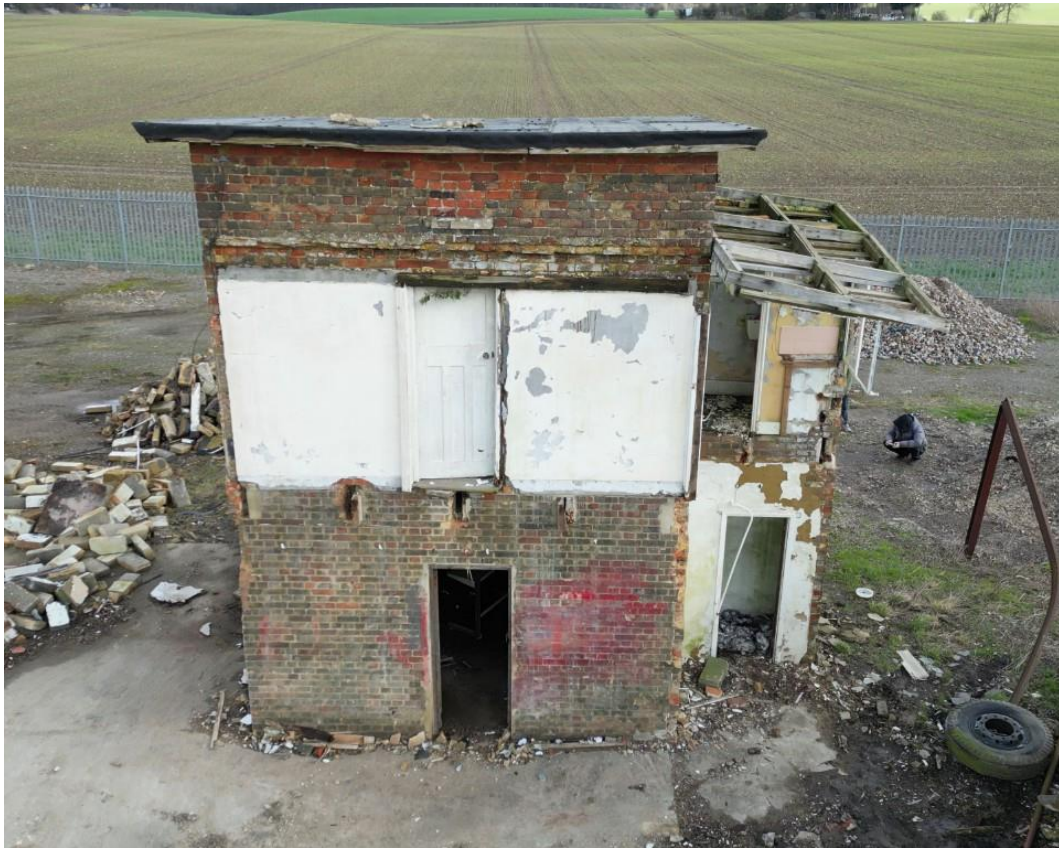
6.3 South West elevation (Figure 4, Plate 18 and 24) consist a wall built in English Bond with a doorway in the middle on both floor levels. The wall on the level of upper floor is rendered white. Just below rendered wall there are rectangular cavities that were previously accommodating flooring beams and cut beams. The top two courses and in the middle three bricks wide additional six courses are built of relatively uniform red brick indicating different phase of construction. This is visible on each elevation. Above the rendered wall there is a horizontal groove indicating position of now removed roof.

Plate 18. Exterior of Building 2 - south west elevation

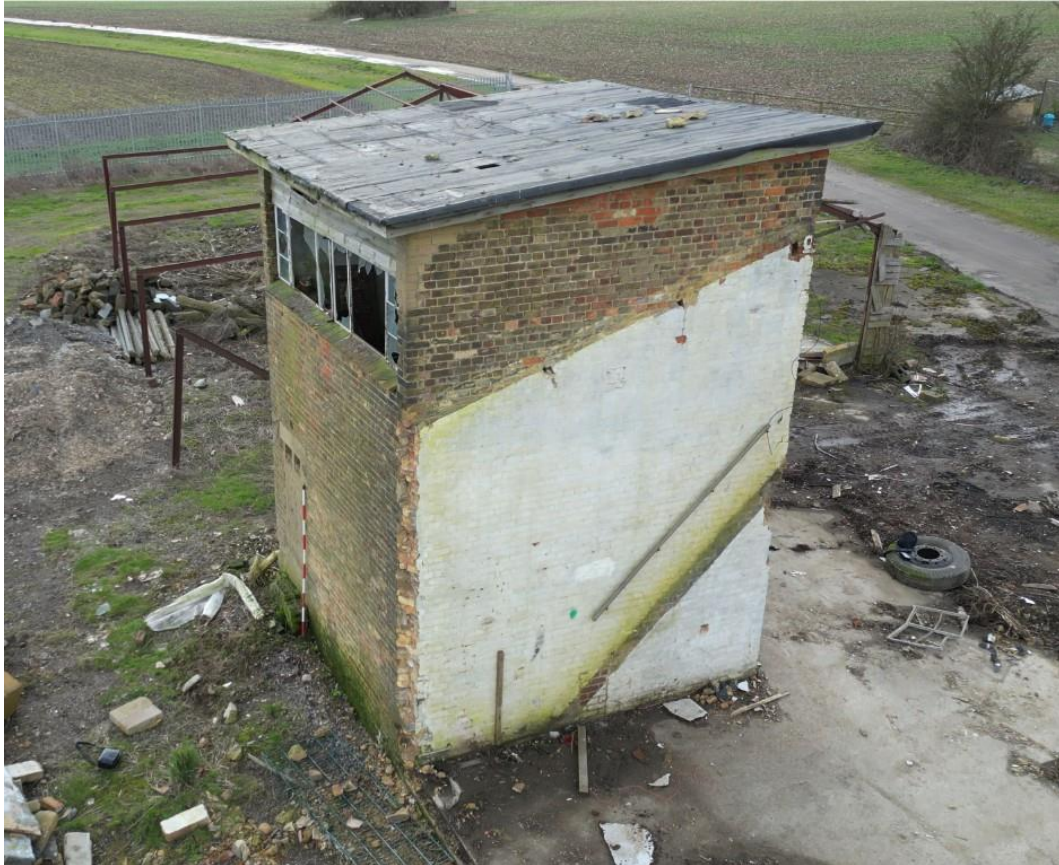
6.5 North west elevation (Figure 4, Plate 20 and 25) consist partially white rendered brick wall built in English Bond. There is imprint of the stairs and gable end rafter. There were also stair rail mounted to the wall and rectangular cavities that were accommodating purlins of the removed roof. Those features are not the subject of interest. The top of the wall is gently descending to the east and top two courses and additional six in the middle feature red brick while left top corner featuring orange bricks are indicating later phase of construction. There are two small infilled rectangular openings measuring 0.35m by 0.66m. They are positioned near the middle of the wall at the level of each floor just above the floor level and are vertically aligned.

Plate 20. Exterior of Building 2 (looking S)

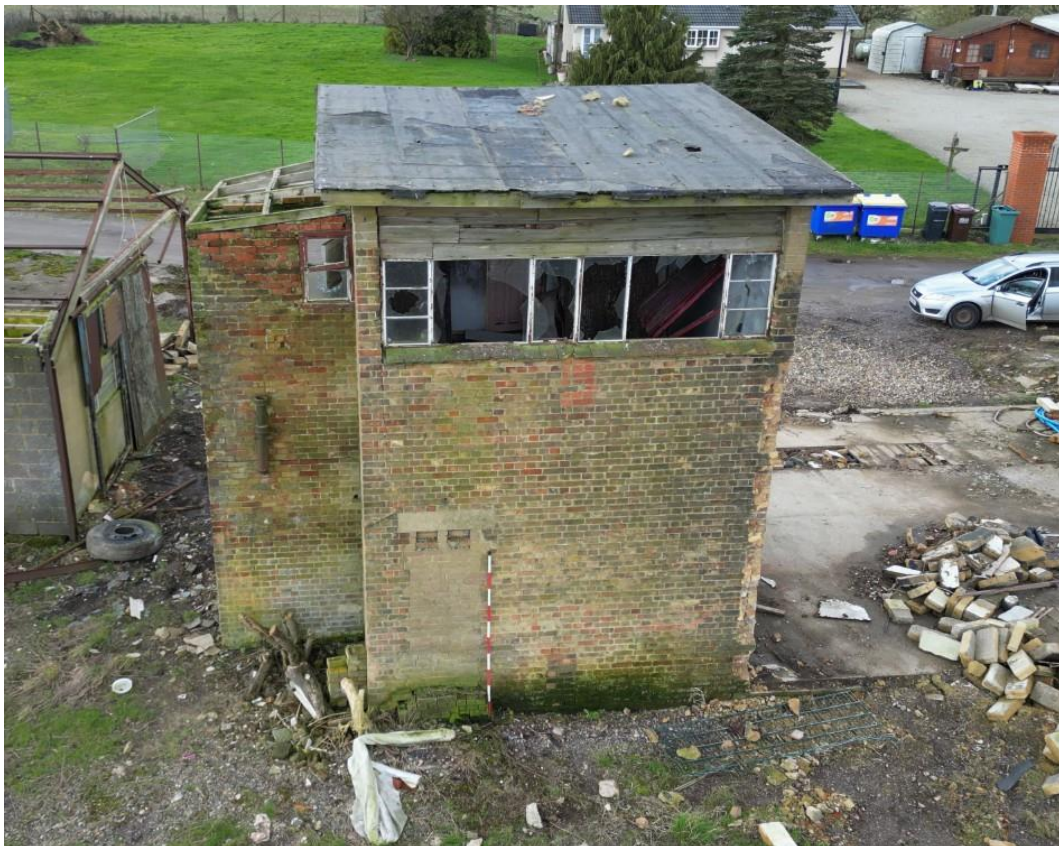
6.6 North east elevation (Figure 4, Plate 21 and 26) features brick wall built in English Bond with a window at the upper floor. The window spanned the width of the room. Above the window there is wooden wall. There are two small infilled openings in the middle of the wall, one underneath the window and other one at the ground floor level. There is infilled doorway on the ground floor level and on the left extent of the wall.

Plate 21. Exterior of Building 2 – north east elevation

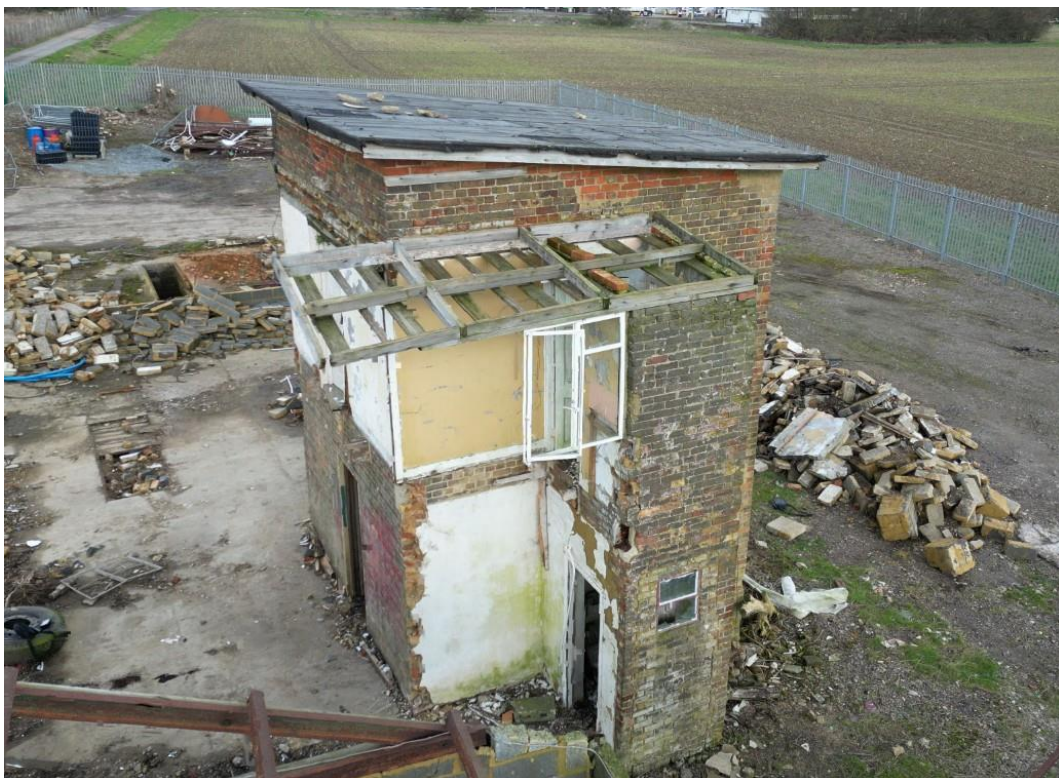
6.8 South east elevation (Figure 4, Plate 23 and 27) consists of face of the wall of extension building located in the middle of the wall of the main building which wall is built in English Bond that is obscured by render on the left side of the extension. The top courses are built of red brick and top right corner of orange brick indicating a different phase of construction.

Plate 23. Exterior of Building 2 (looking N)

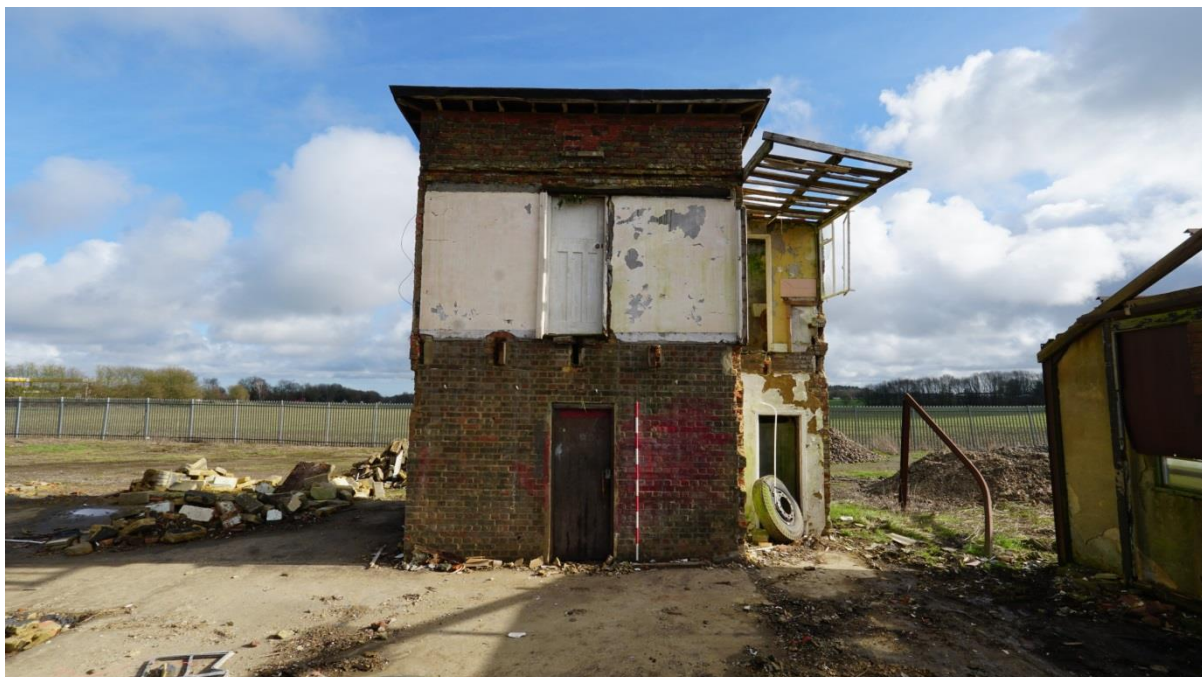
Plate 24. Exterior of Building 2 – south west elevation

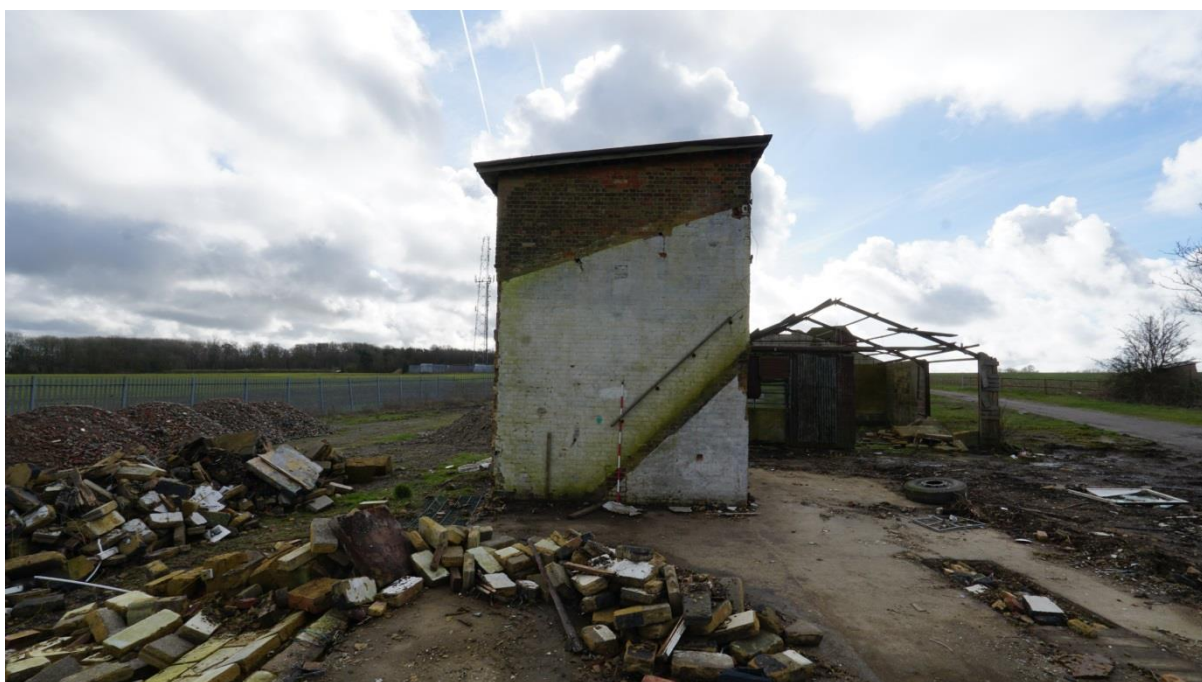
Plate 25. Exterior of Building 2 – north west elevation

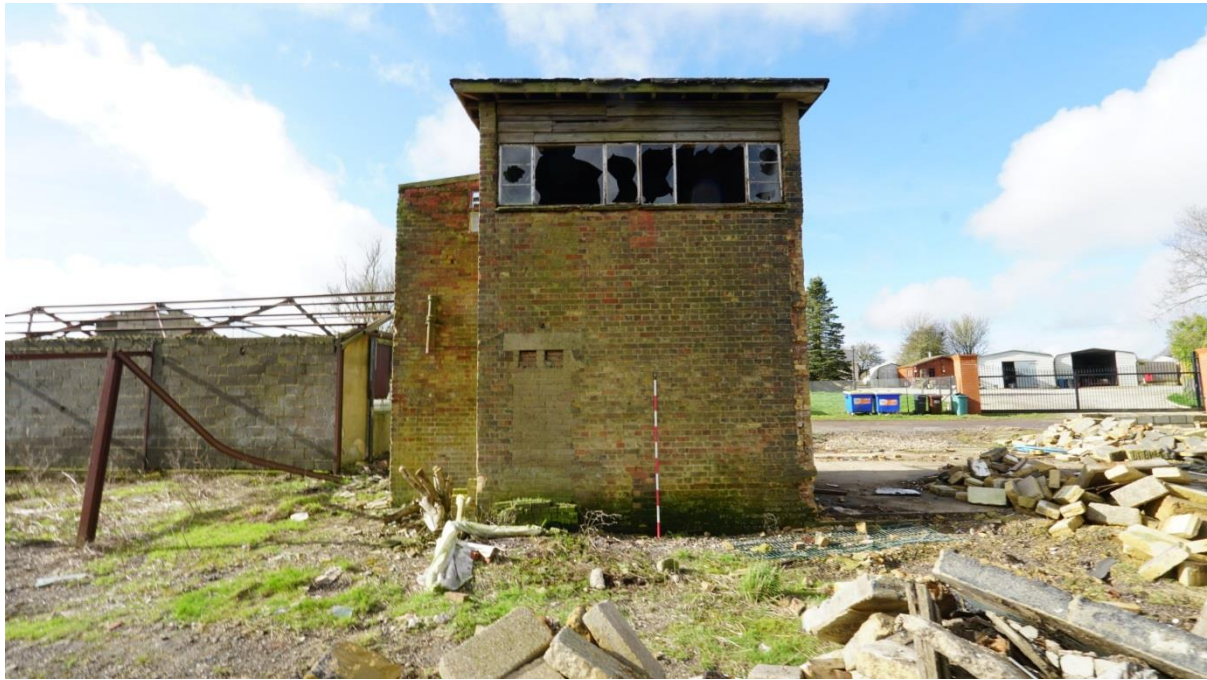
Plate 26. Exterior of Building 2 – north east elevation

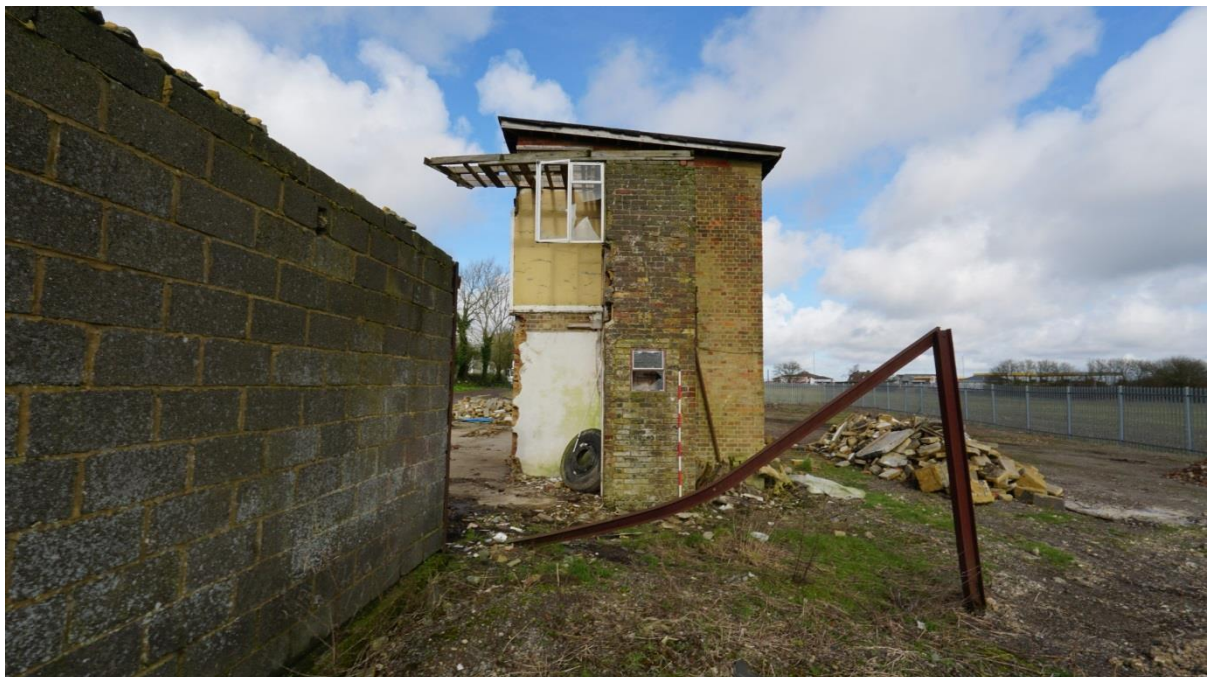
Plate 27. Exterior of Building 2 – south east elevation

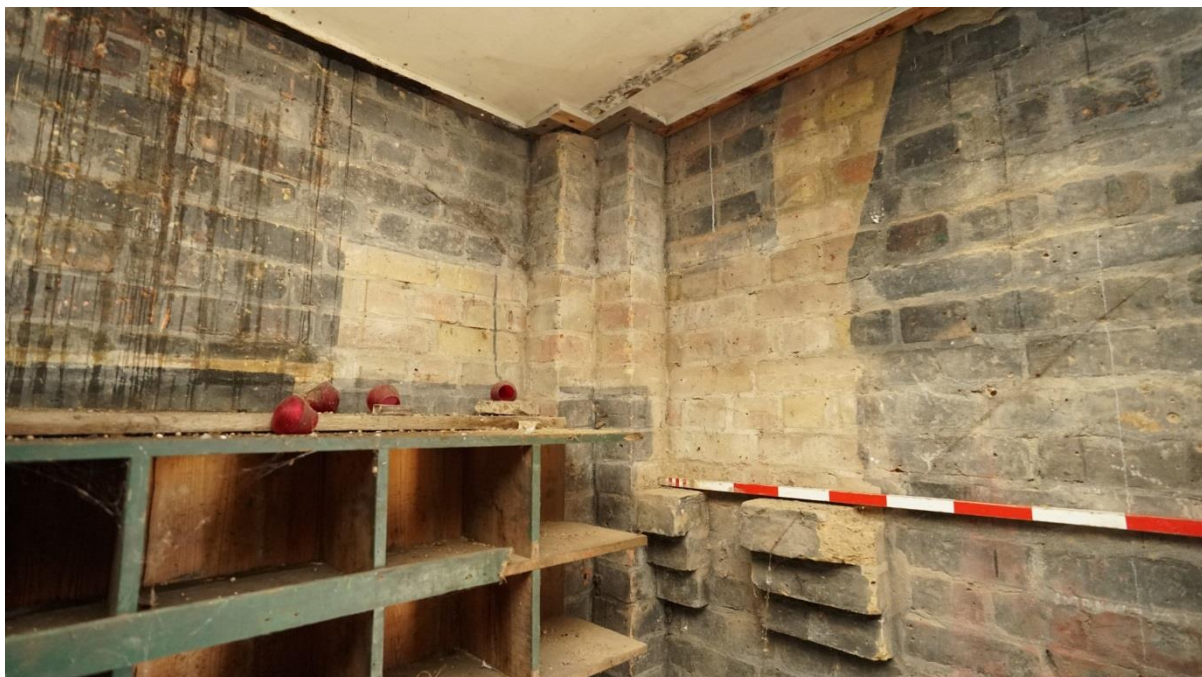
Plate 33. Interior of Building 2 – southern corner of the room with imprints of the half floor and ladder

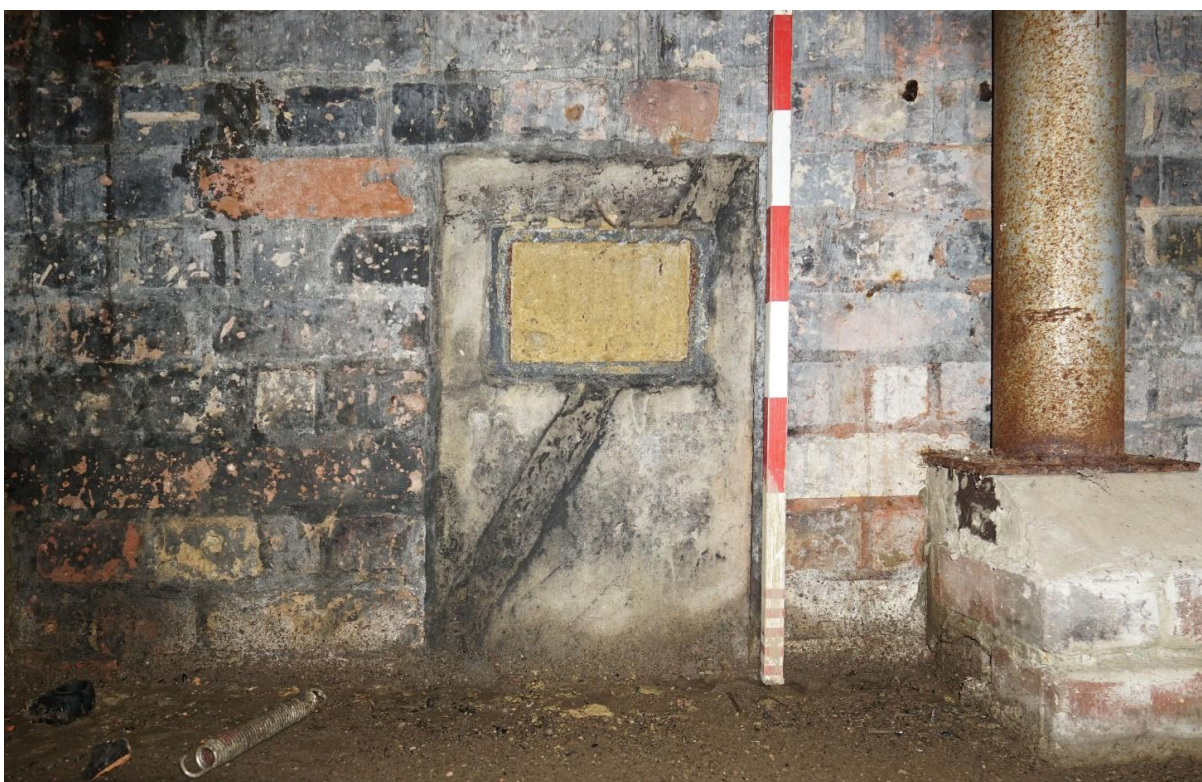
Plate 34. Interior of Building 2 – north east wall – Infilled opening

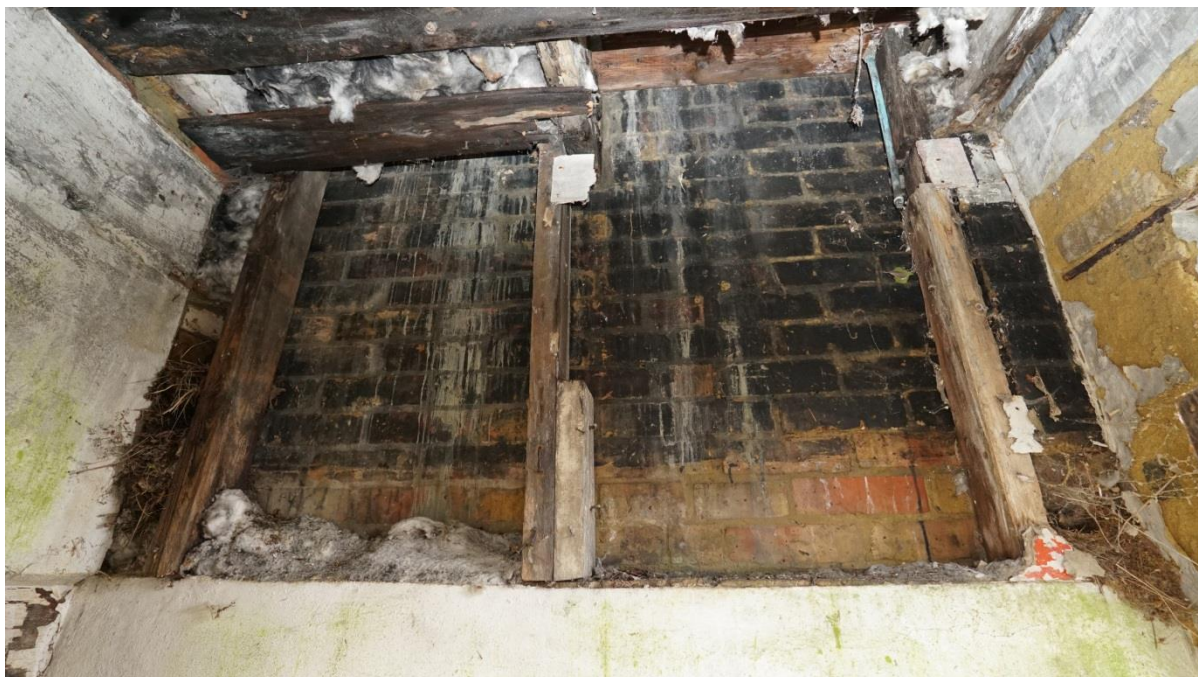
8.5 Charred walls might indicate that it harboured engine, most likely steam engine. Charred beam located alongside north east wall indicate that the original building caught fire that was relatively quick extinguished.

Plate 38. Interior of extension of Building 2, soothed brick wall (looking NE)

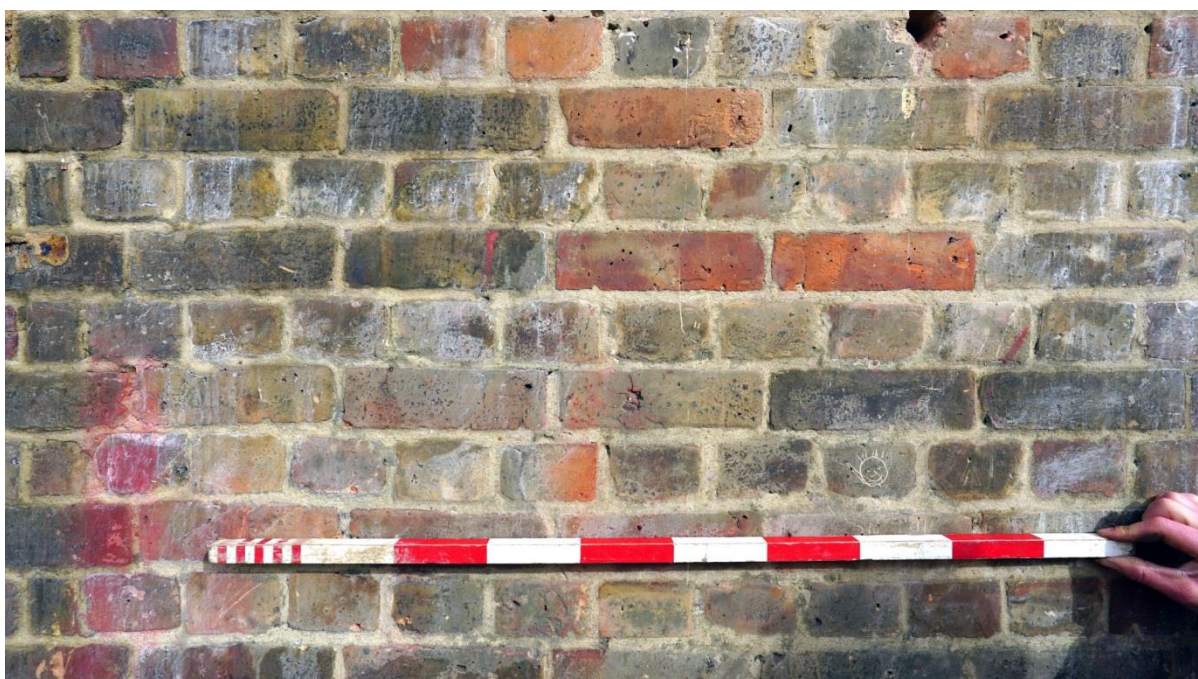
6.2 The building was built of handmade stock brick in English Bond (Plate 39-40). The bricks had colour range from yellow to dark red. The bricks are quite porous with abundant impurities comprising small stones, chalk and coal slag. Also bricks were easily peeling off indicating low content of the clay. The brick were bonded with mid grey mineral mortar that was 10-13mm thick.

Plate 39. Exterior of Building 2, sample of brickwork pattern at south west elevation (looking NE)

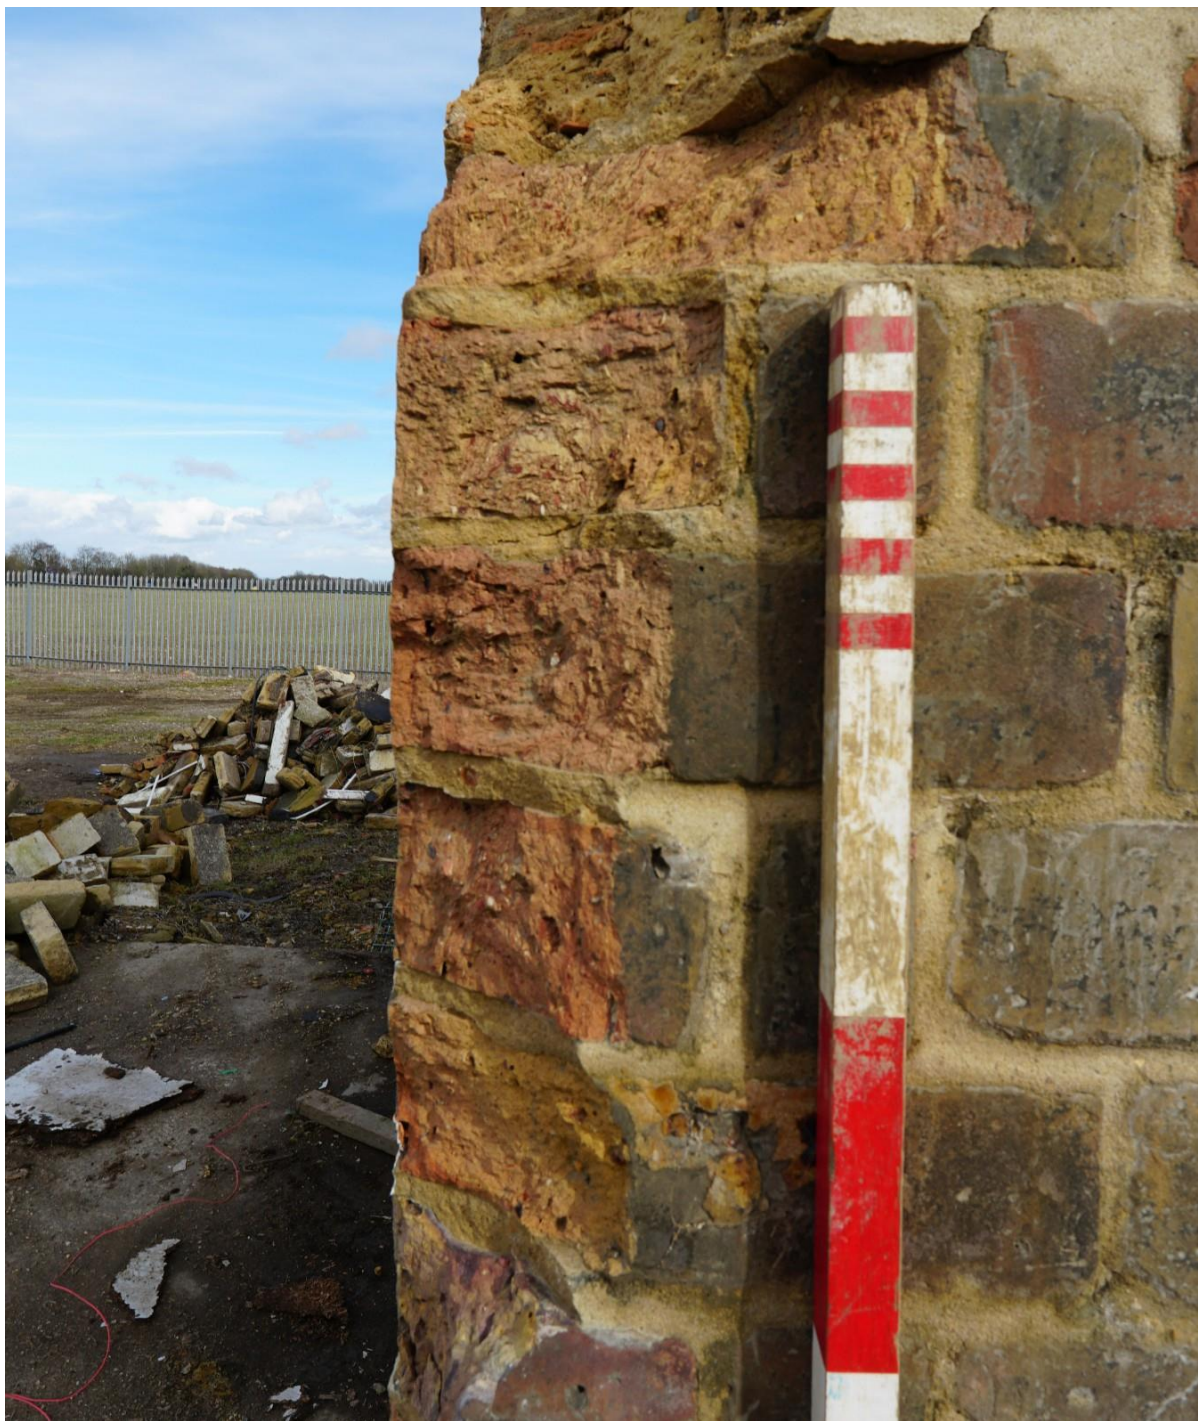
Plate 40. Exterior of Building 2, bricks at south west elevation (looking NE)

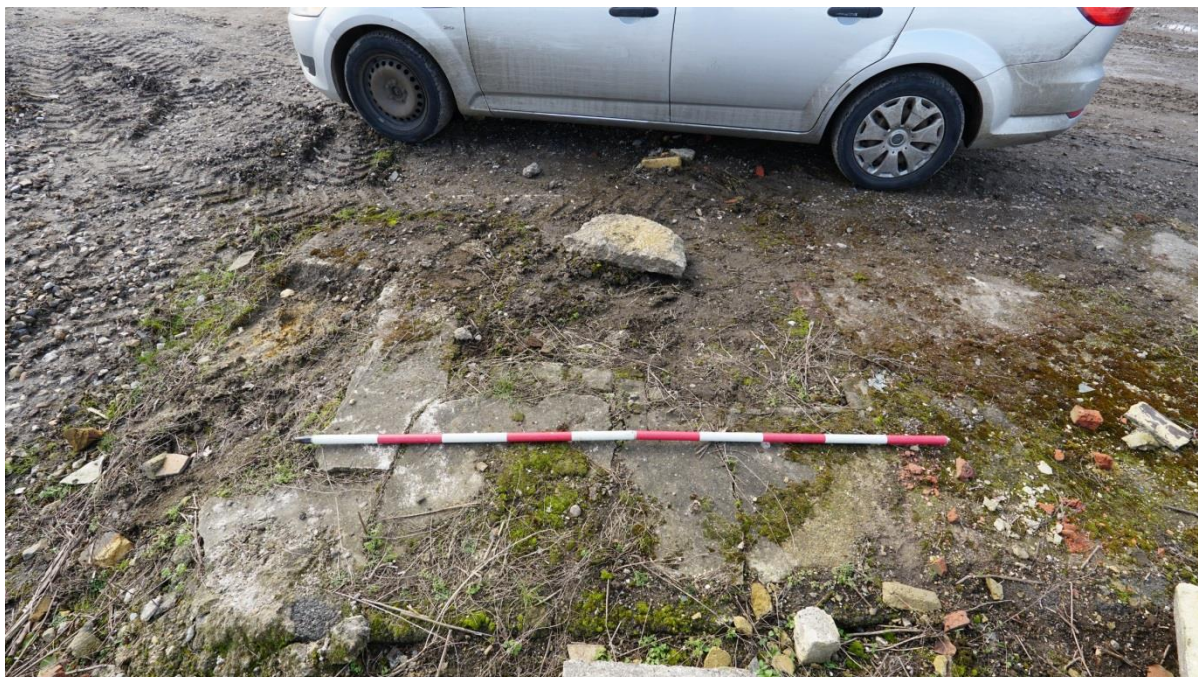
6.11 Two infilled openings in the ground located on the west side of demolished workshop were surveyed and labelled MH 1 and 2, and their location can be seen in Figure 2. The full extent of the openings wasn't exposed MH1 was 1.38m long and visible width was 0.7m. MH2 was 0.8m long and visible width was 0.42m.

Plate 41. Man hole 1 (looking SW)

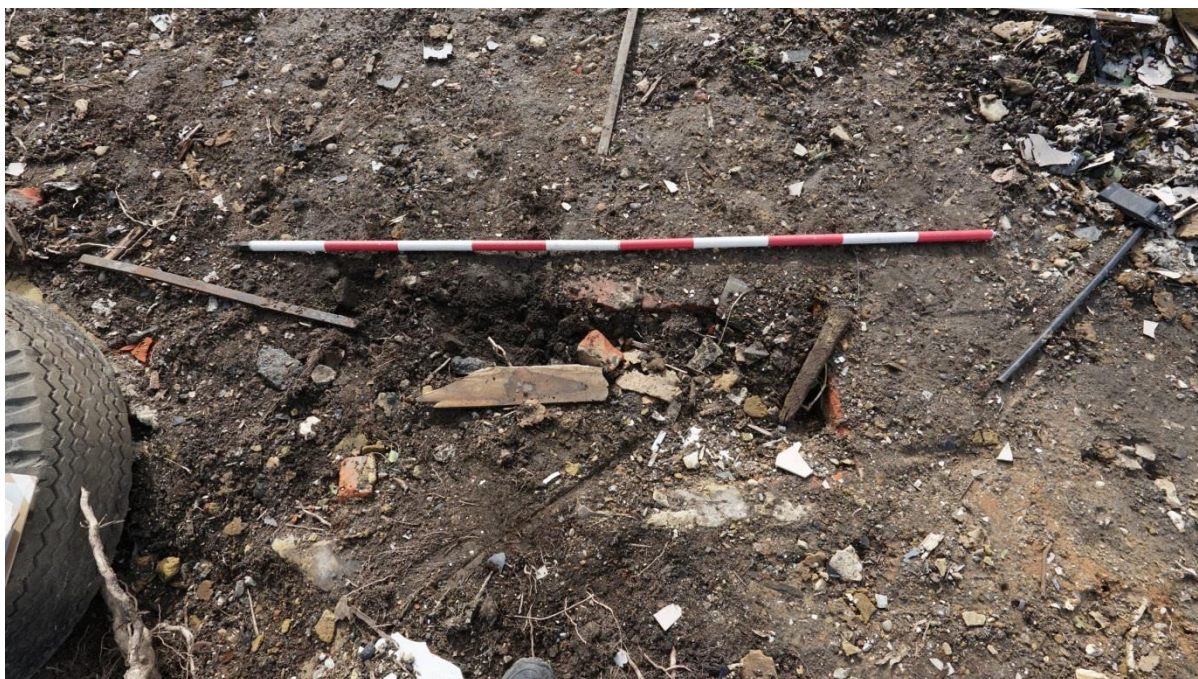
Plate 42. Man hole 2 (looking SW)
