HISTORIC BUILDING RECORDING AT HILL GREEN

FARMHOUSE, STOCKBURY, MAIDSTONE,

KENT

Date of report: 30th June 2023

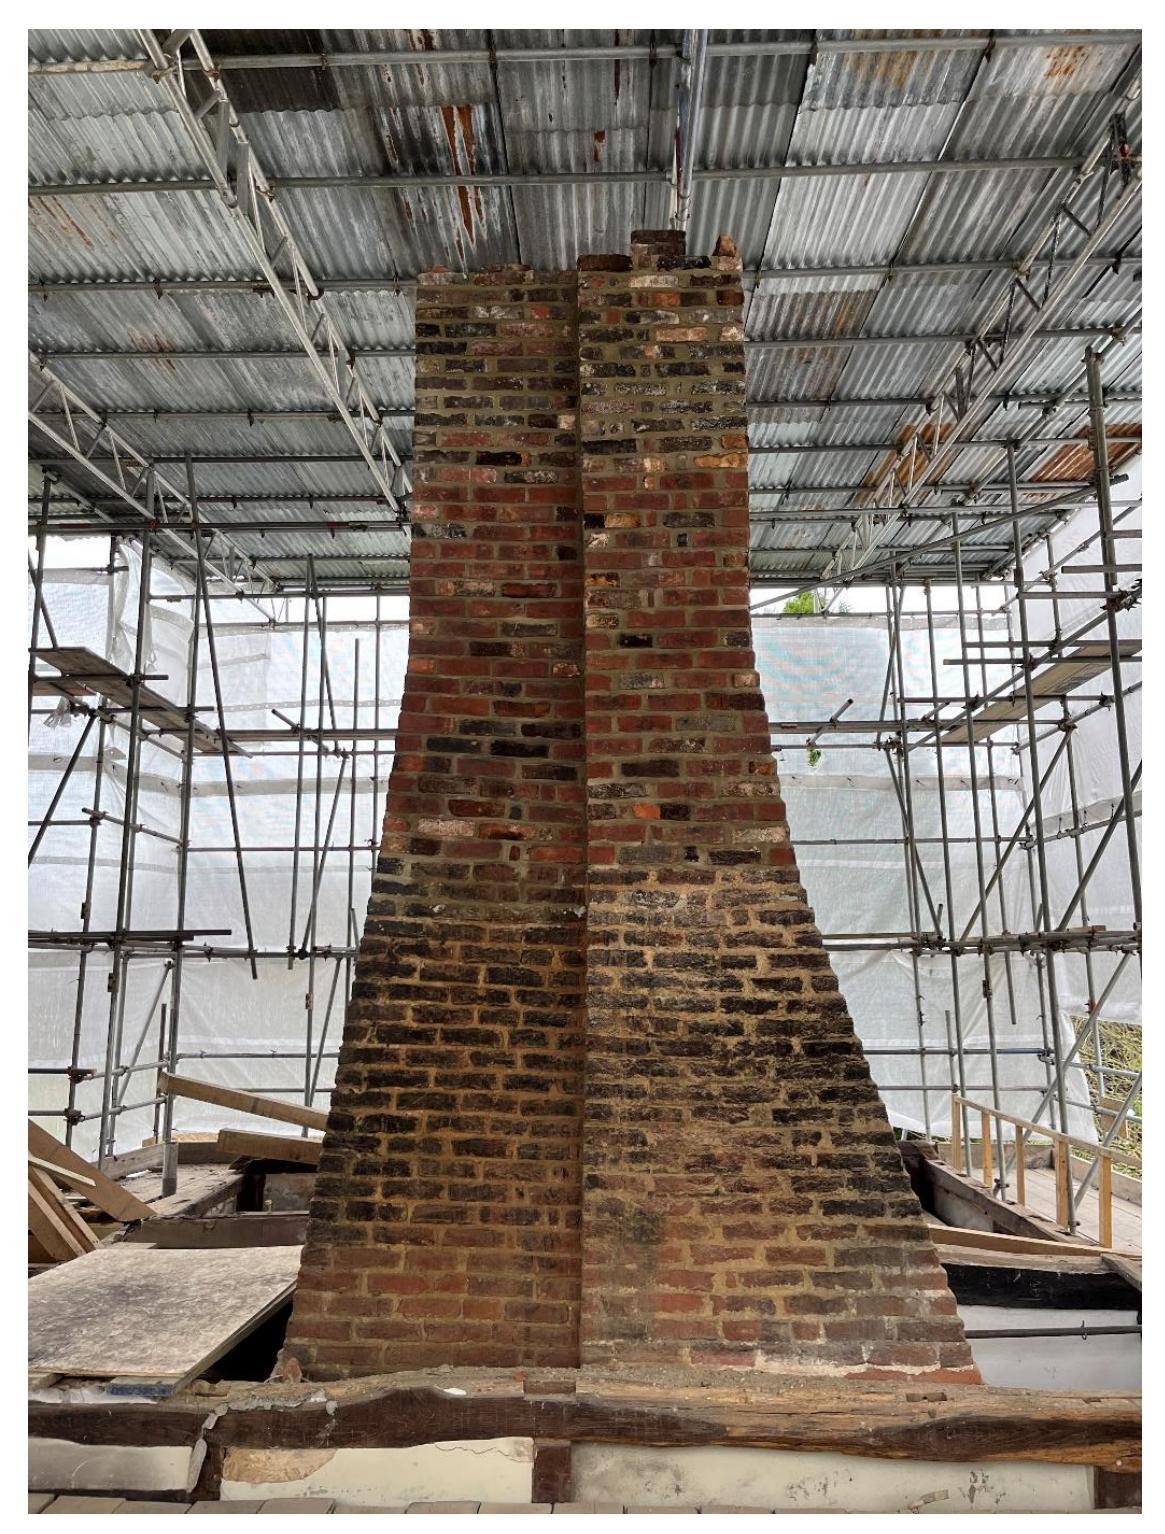
The entire roof structure was consumed by the fire. The chimneys survived and at the time of the survey had been cleaned from the smoke damage (Site Photo 2). The chimney at the northern end of the property is the larger of the two and is likely the earliest. Both chimneys suffered structural issues and has been partial rebuilt following works to maintain its stability.

Site Photo 2. Northern Chimney Stack

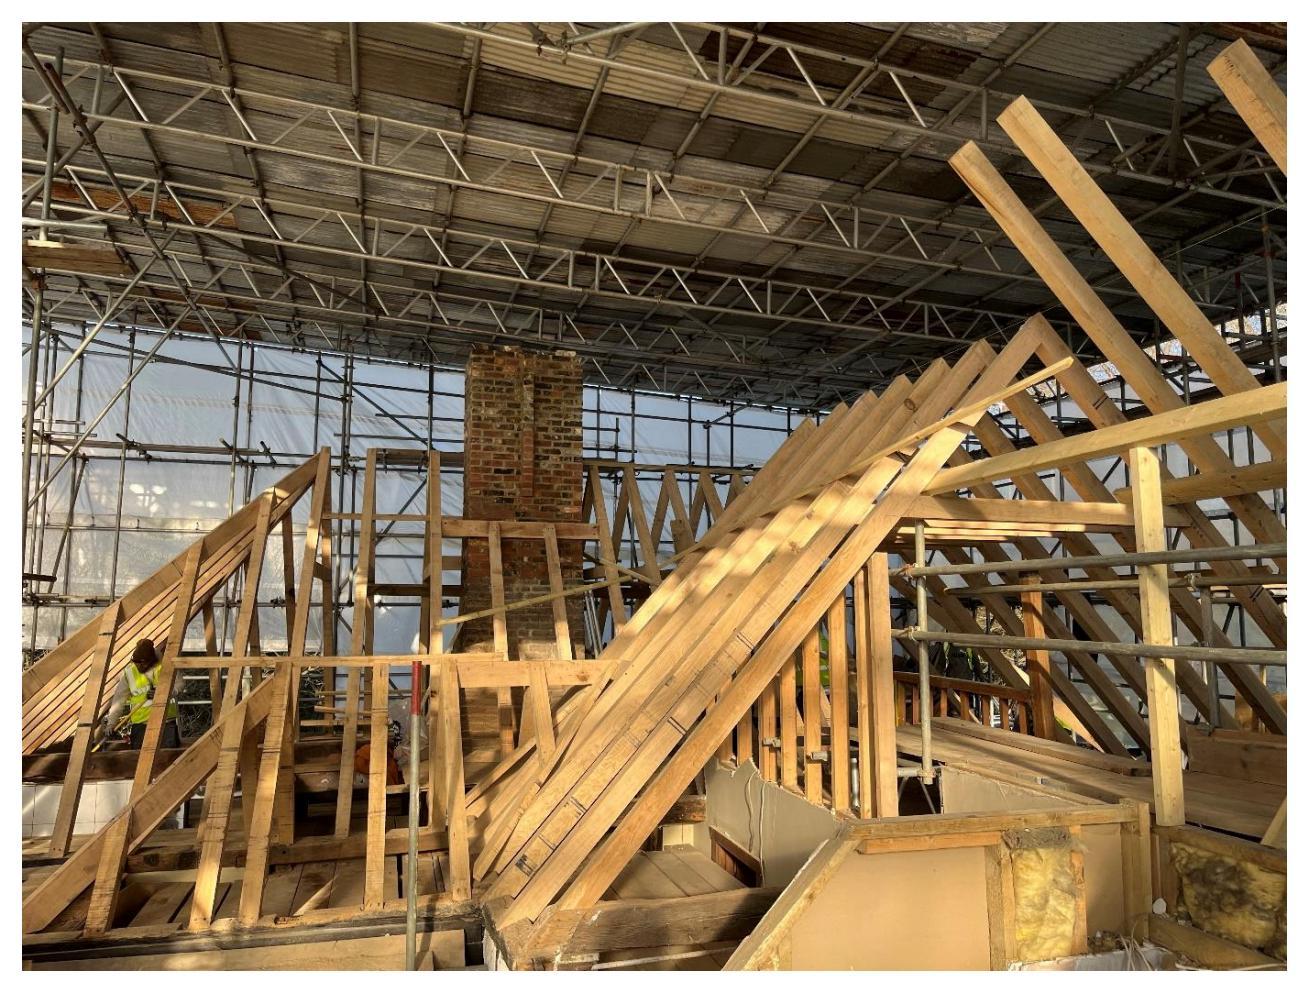
Site Photo 3. Rafters, Looking north

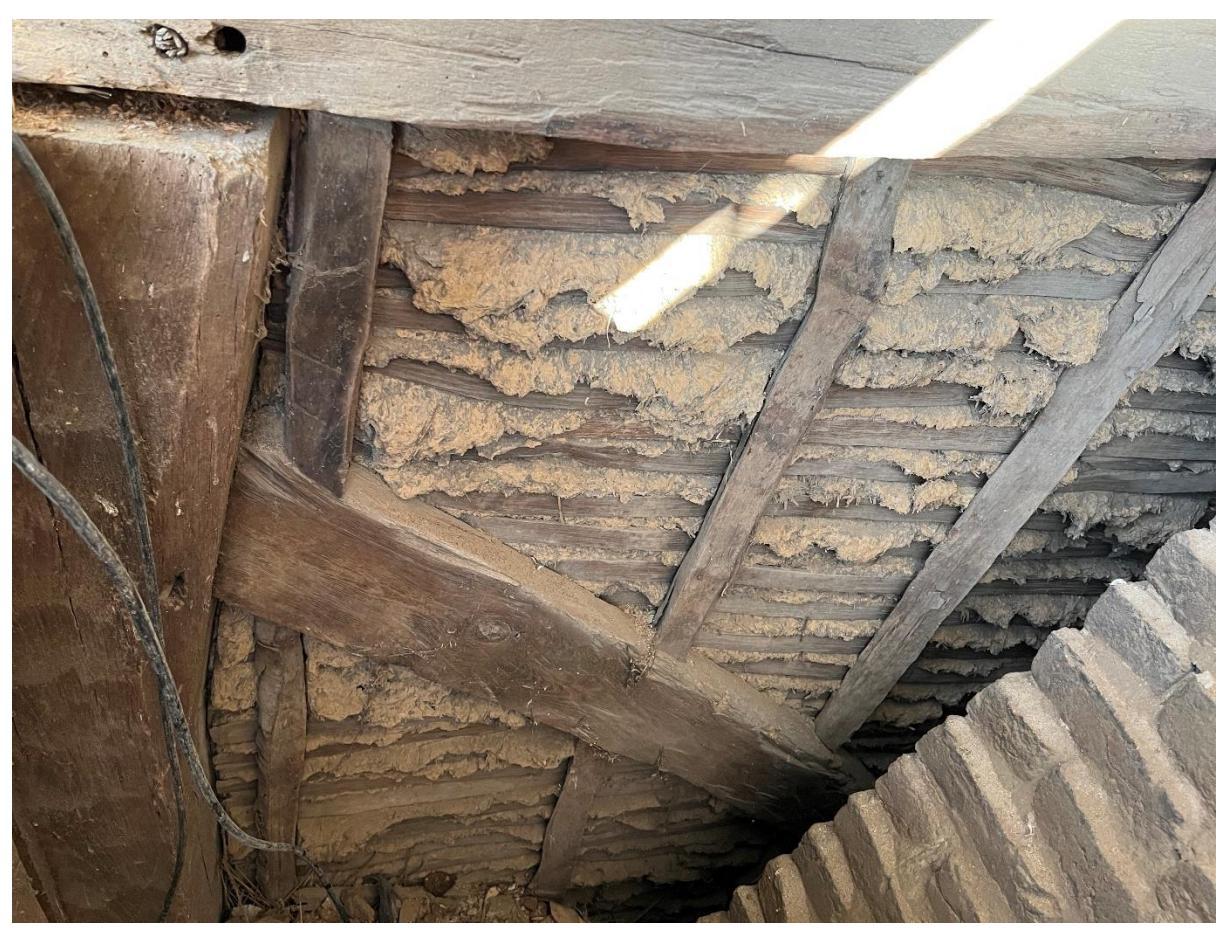
Site Photo 5. Evidence by chimney of lathe and plaster.

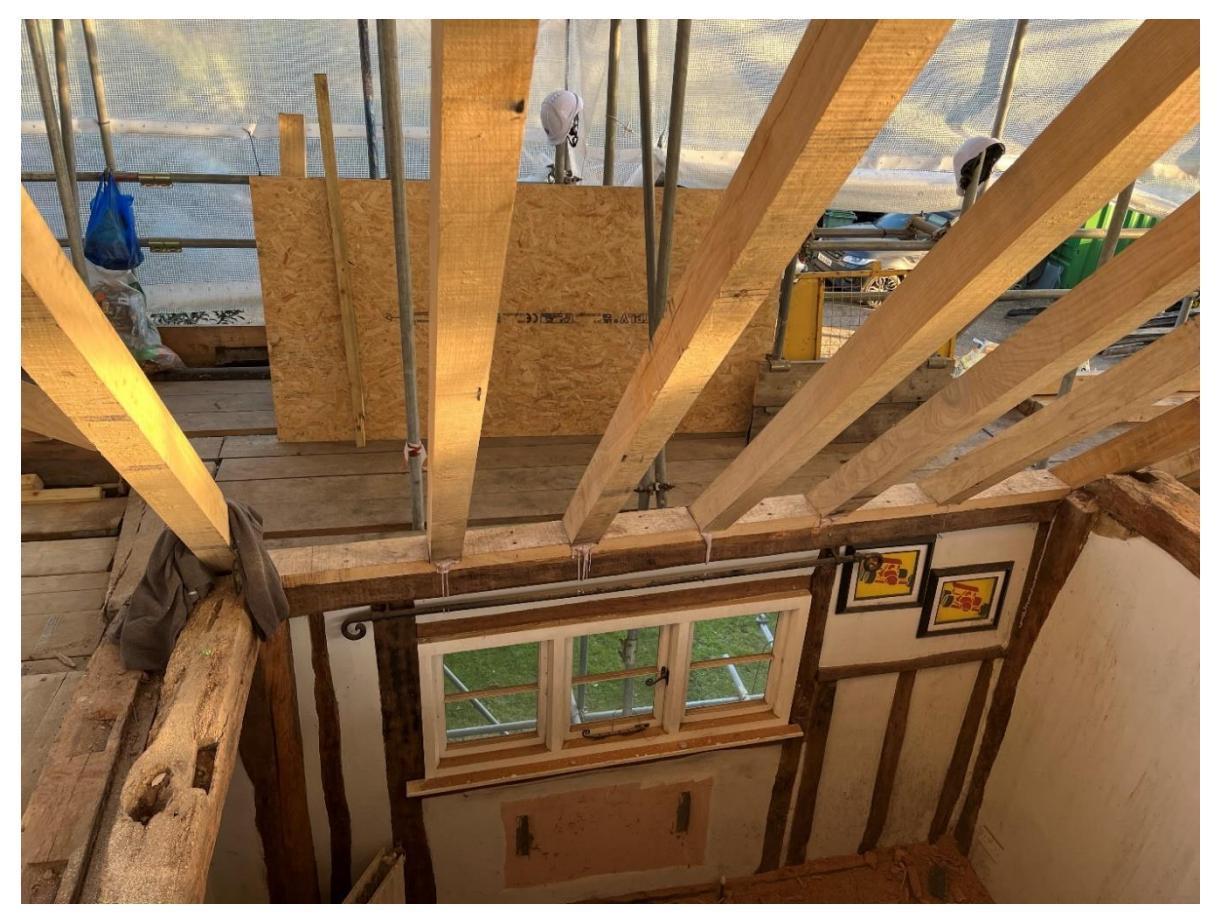
Site Photo 6. View across roof floor

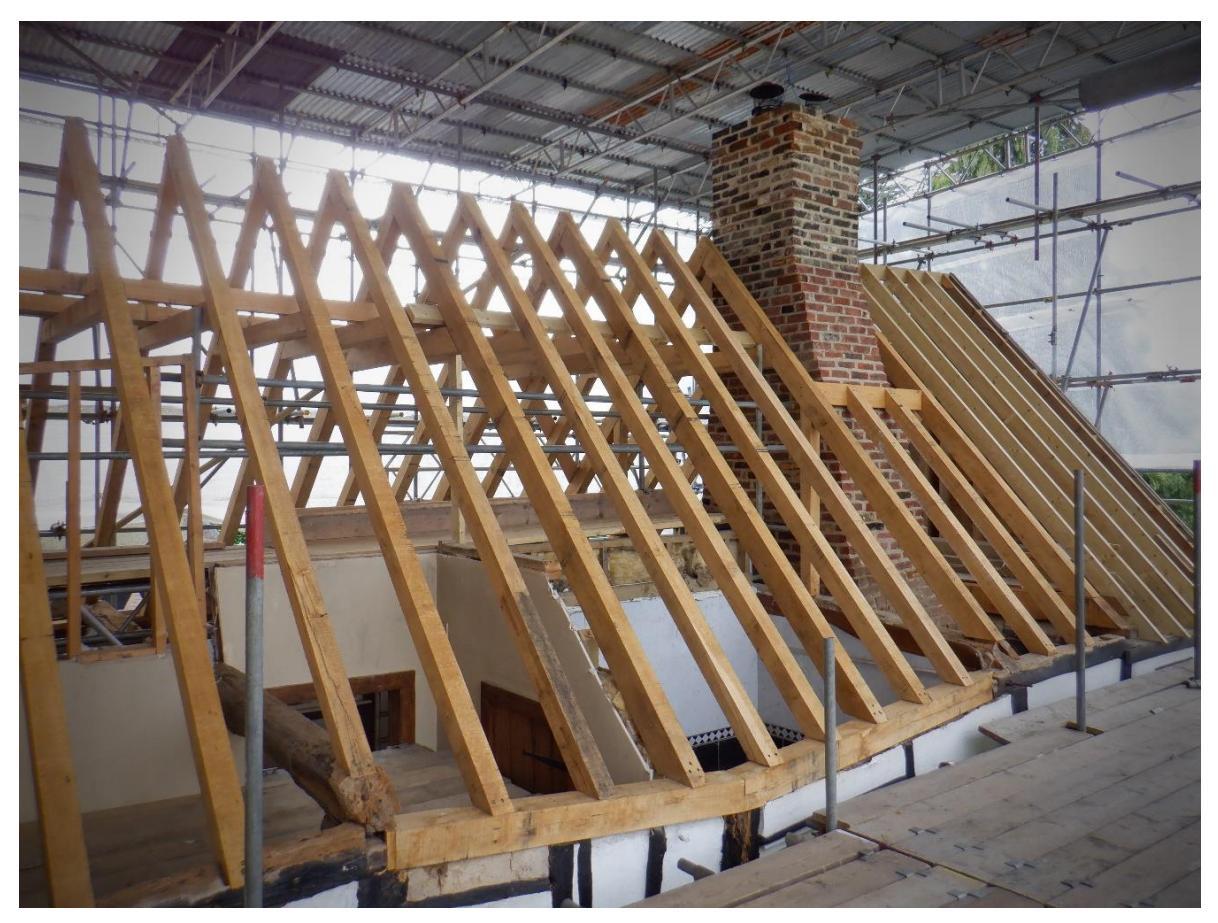
Site Photo 7. New roof on rear extension showing rear chimney

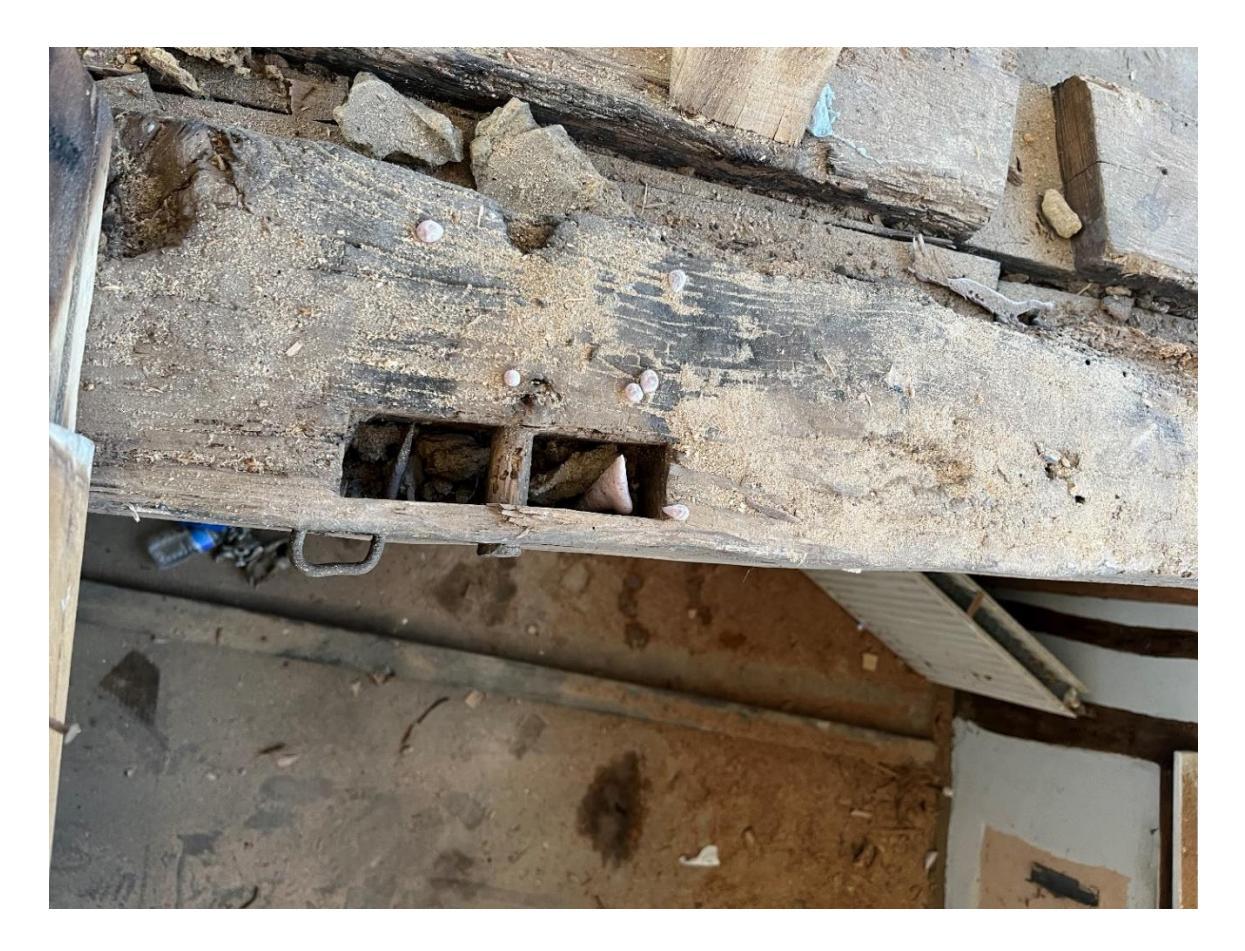
It was observed that a number of steel tie rods had previously been installed across the property at wall plate level above the first floor (Photo 8), with the tie rods fixed to longitudinal steel angles which were installed across the feet of the rafters. These suggest that the property has had some issues with roof spread / lateral displacement of walls in the past, and that remedial measures were undertaken to try and rectify this.

Site Photo 8. Showing historical staples

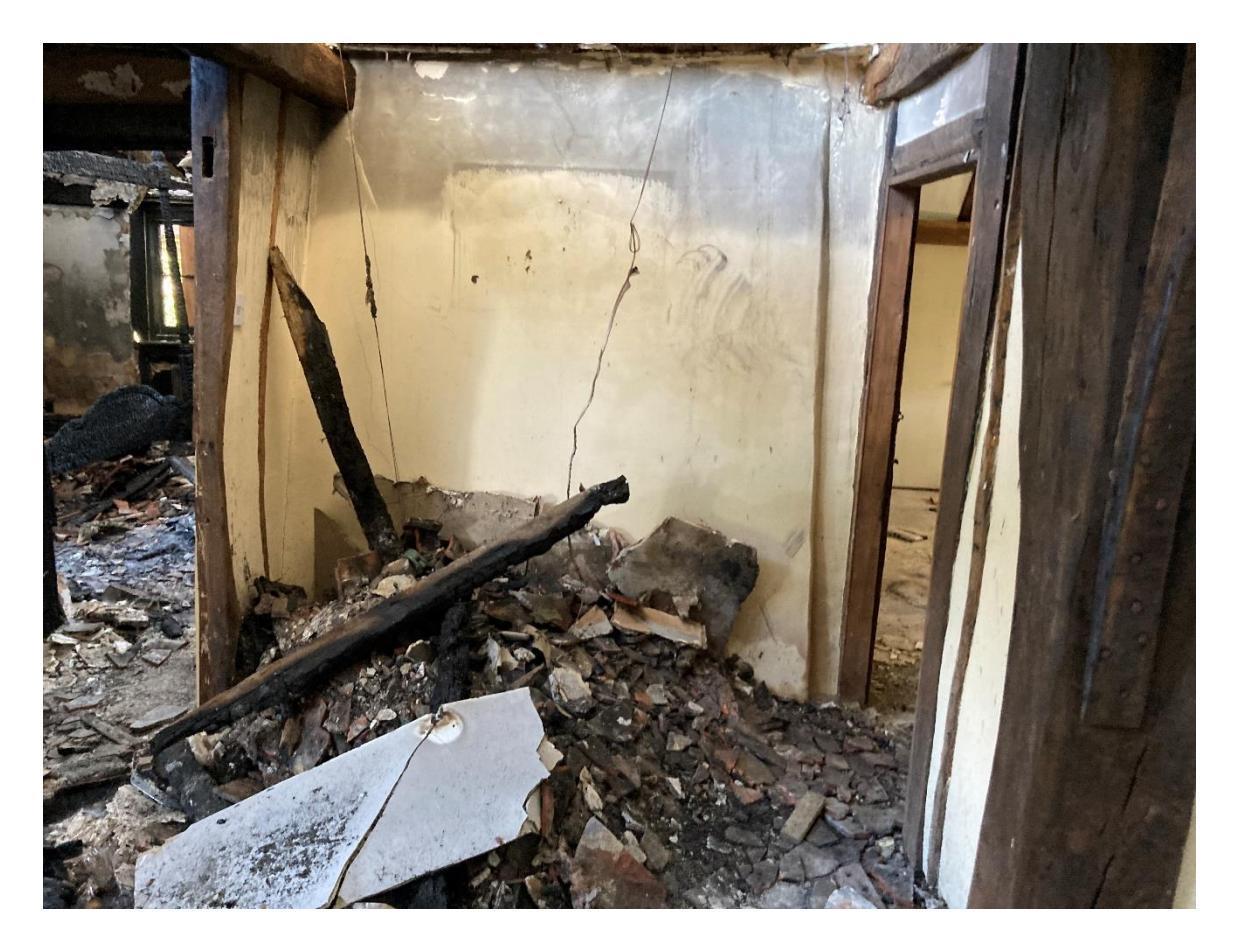
Site photo 15. Area of ground floor with fire damage (Looking west)
