Archaeological Evaluation of Land at Larkey Woods Farm, Cockering Road, Chartham, Kent

Site Code: LARK/EV/16

(Planning Application: C/15/00683/FUL)

SWAT Archaeology

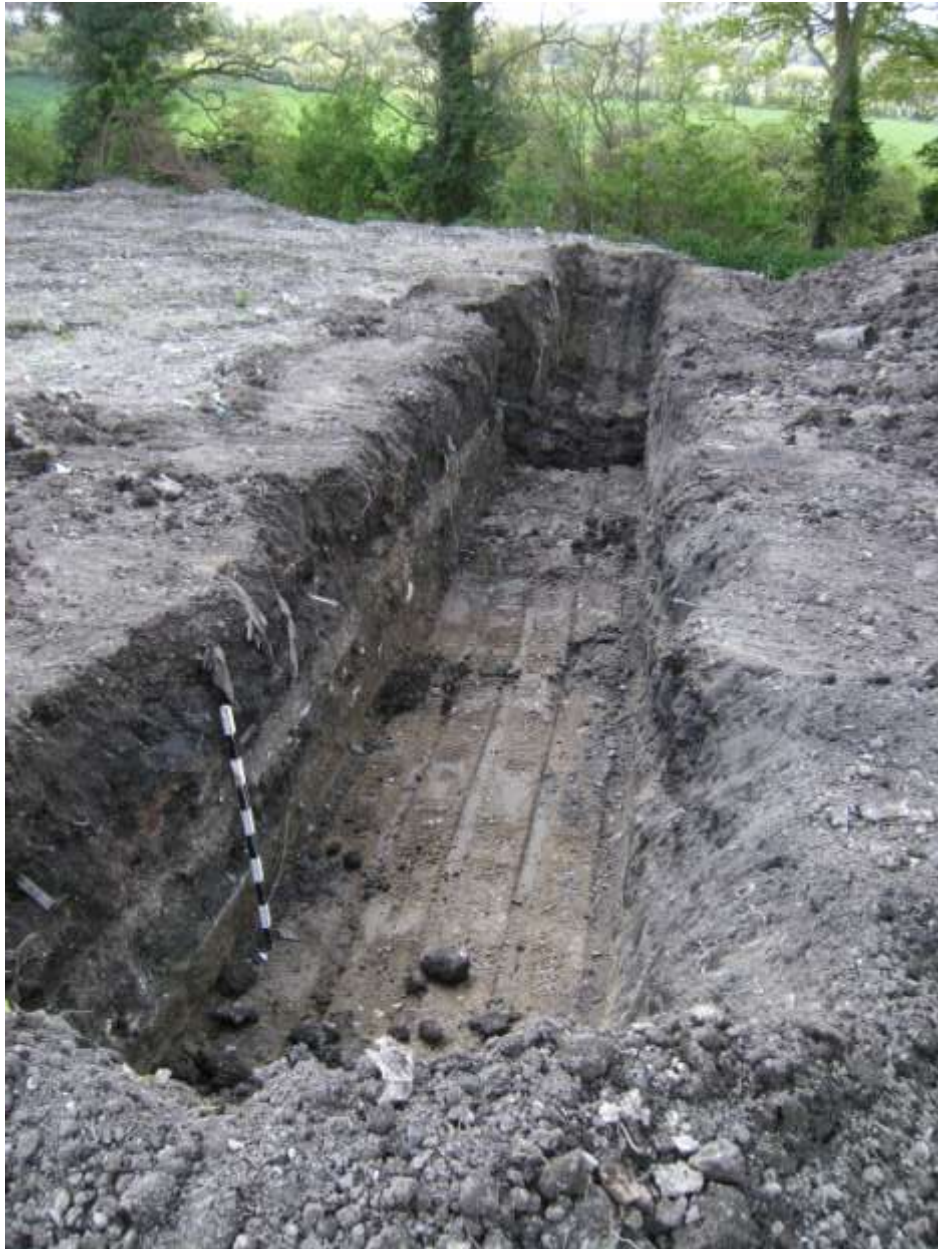
The plan is recorded in Figure 1 (see also Plate 1). The trench lay on south-east to north-west alignment and measured approximately 25m by 1.80m.

Undisturbed natural geology **(102)** was identified across the trench as light brown chalky silt at a depth of approximately 1.45m (80.55mOD) below the present ground surface at 82m OD at the NW end of the trench.

The natural geology was sealed by a layer of dumped material **(101)** 1.45m thick, mid brown in colour overlaid by a thin layer of topsoil **(100)**.

Plate 1. Trench 1 from the northwest, one-metre scale

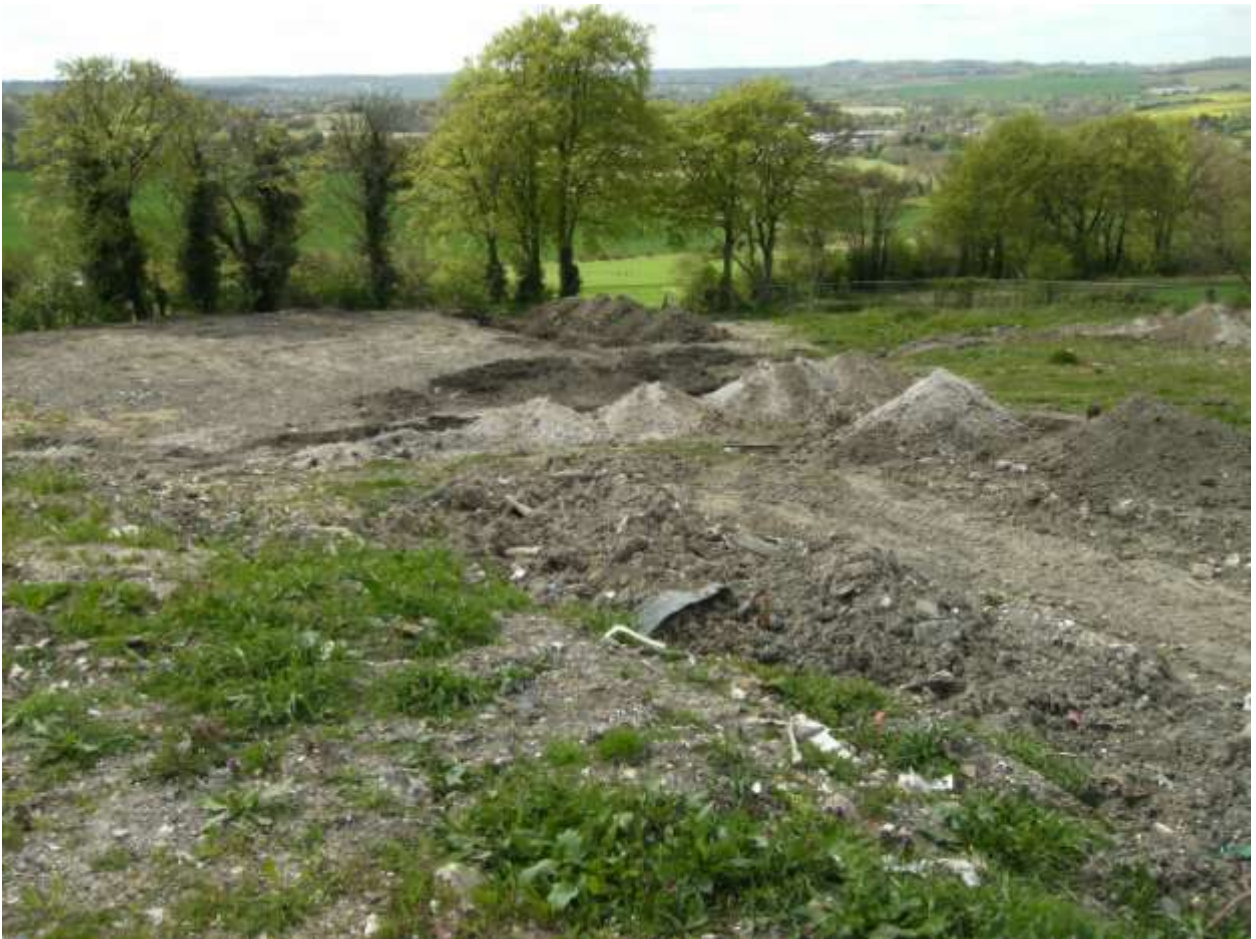
Plate 2. Trenches 1, 2 and 3 looking northwest

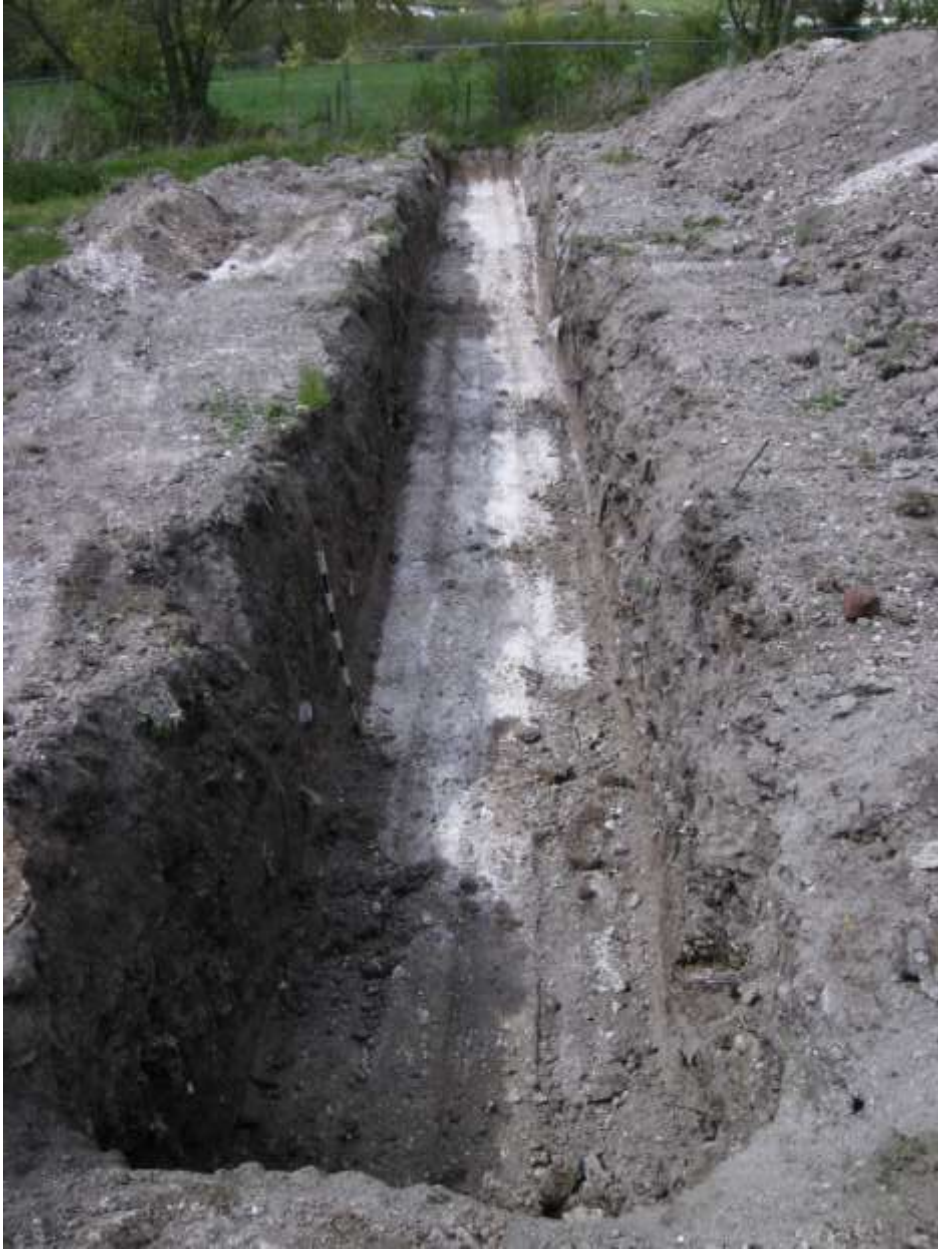
The plan is recorded in Figure 1 (see also Plate 3, 4). The trench lay on north-east to south-west alignment and measured approximately 25m by 1.80m.

Undisturbed natural geology **(202)** was identified across the trench as chalk at a depth of approximately 1.45m (80.55mOD) below the present ground surface at 82m OD at the SW end of the trench.

The natural geology was sealed by a layer of dumped material **(201)** 1.45m thick, mid brown in colour overlaid by a thin layer of topsoil **(200)**.

Plate 3. Trench 2 from the southeast, one-metre scale

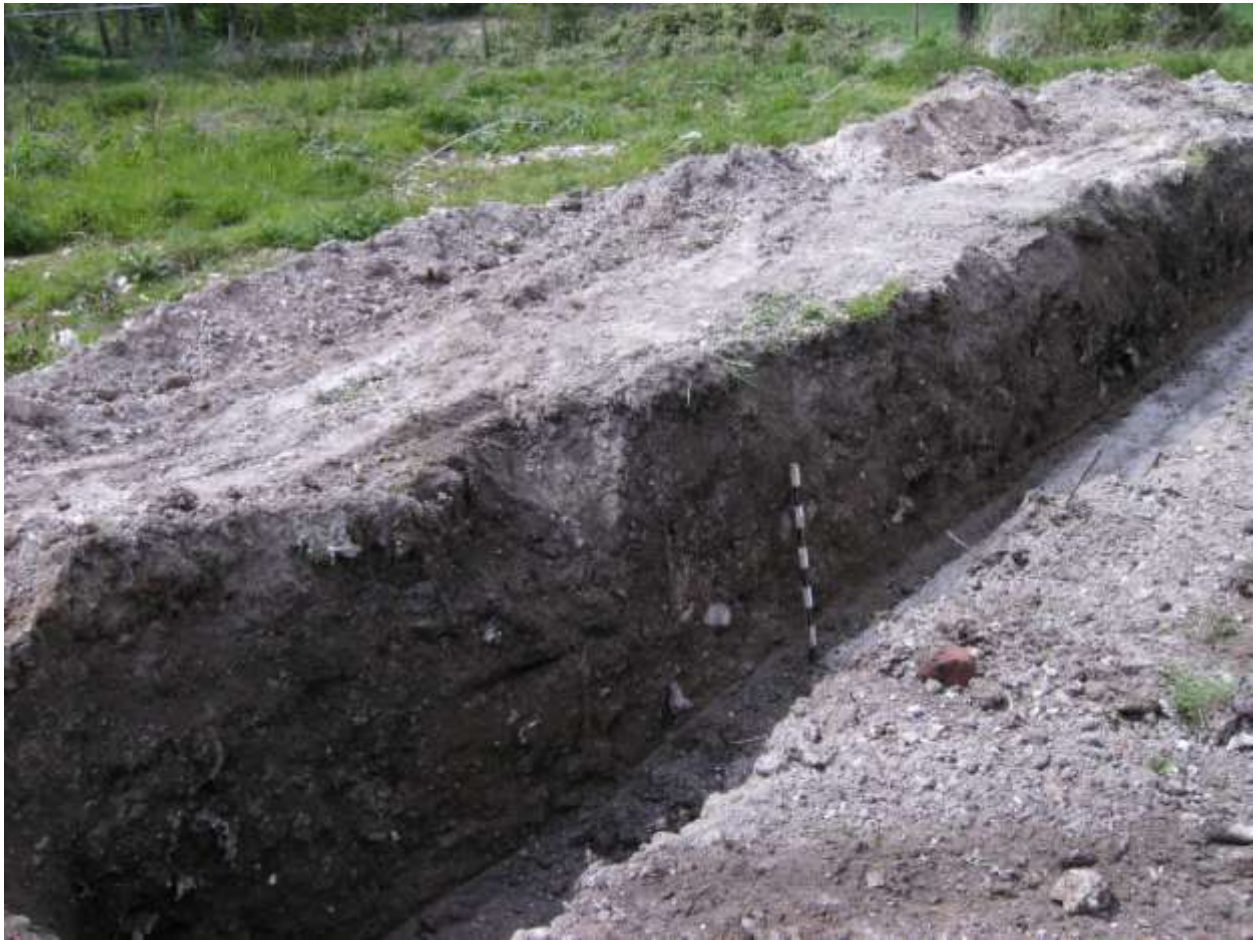
Plate 4. Trench 2 section from the east, one-metre scale

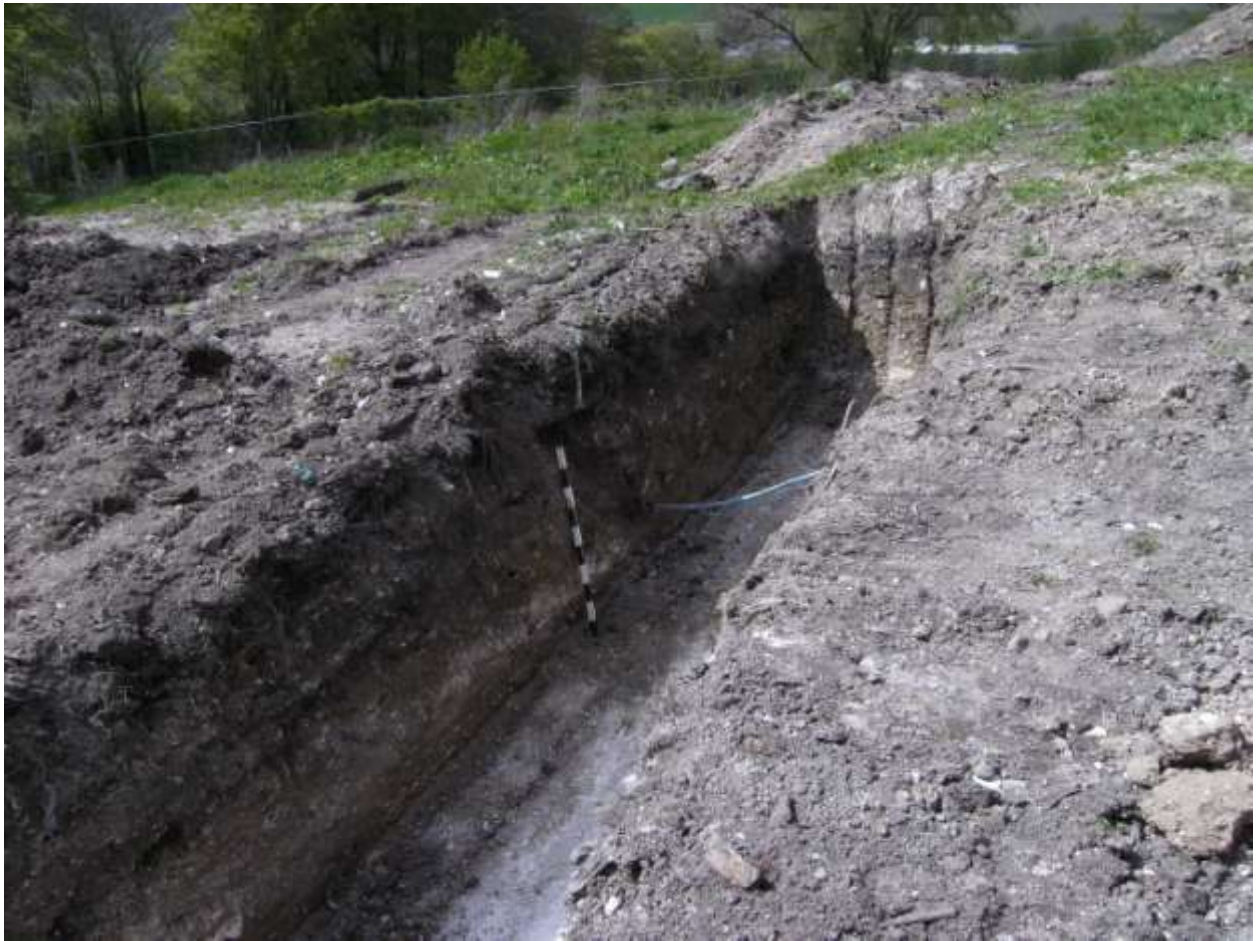
The plan is recorded in Figure 1 (see also Plate 5, 6). The trench lay on south-east to north-west alignment and measured approximately 25m by 1.80m.

Undisturbed natural geology **(302)** was identified across the trench as light brown chalky silt at a depth of approximately 1.45m (80.55mOD) below the present ground surface at 82m OD at the NW end of the trench.

The natural geology was sealed by a layer of dumped material **(301)** 1.45m thick, mid brown in colour overlaid by a thin layer of topsoil **(300)**.

Plate 5. Trench 3, northwest end, one-metre scale

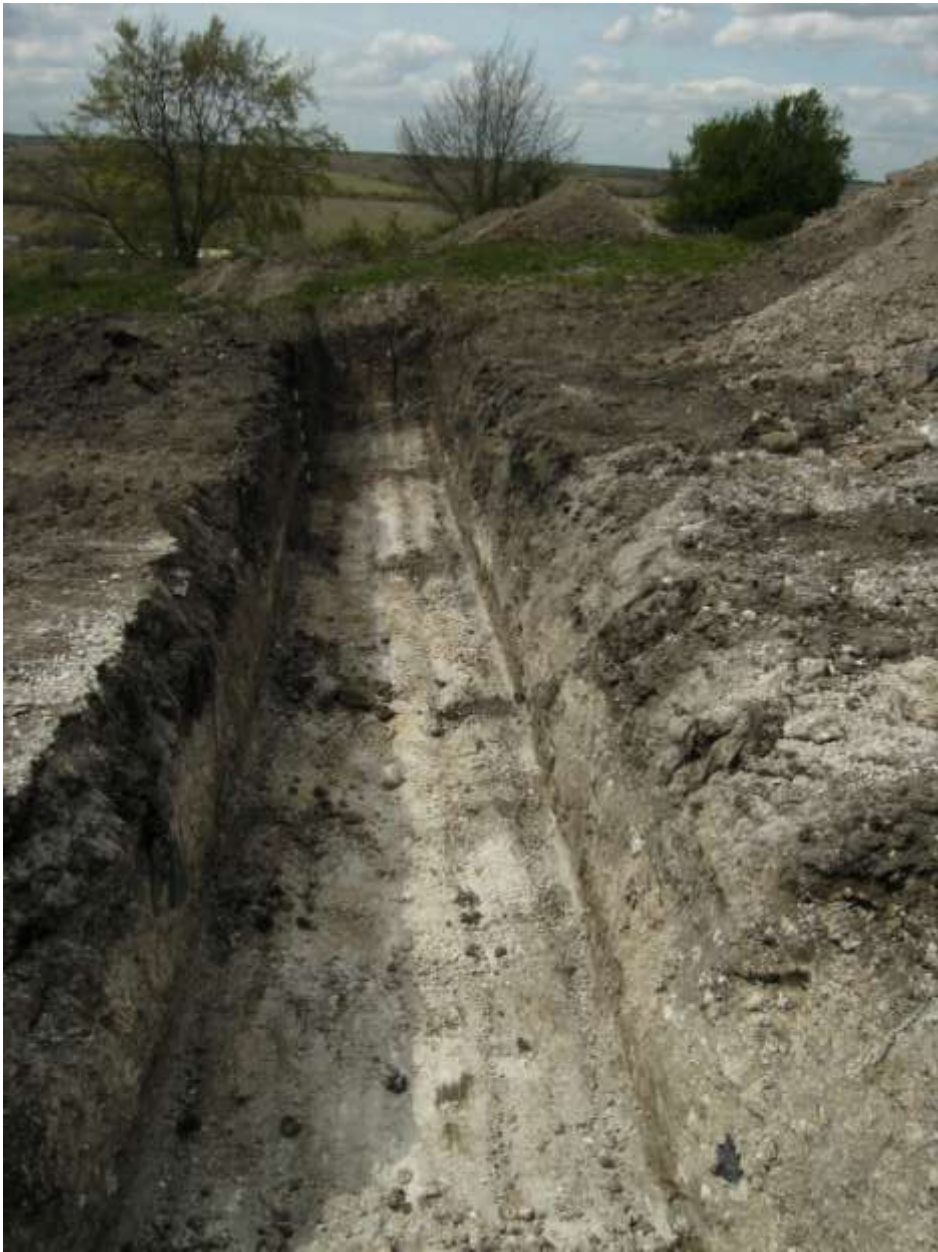
Plate 6. Trench 3 from the southeast

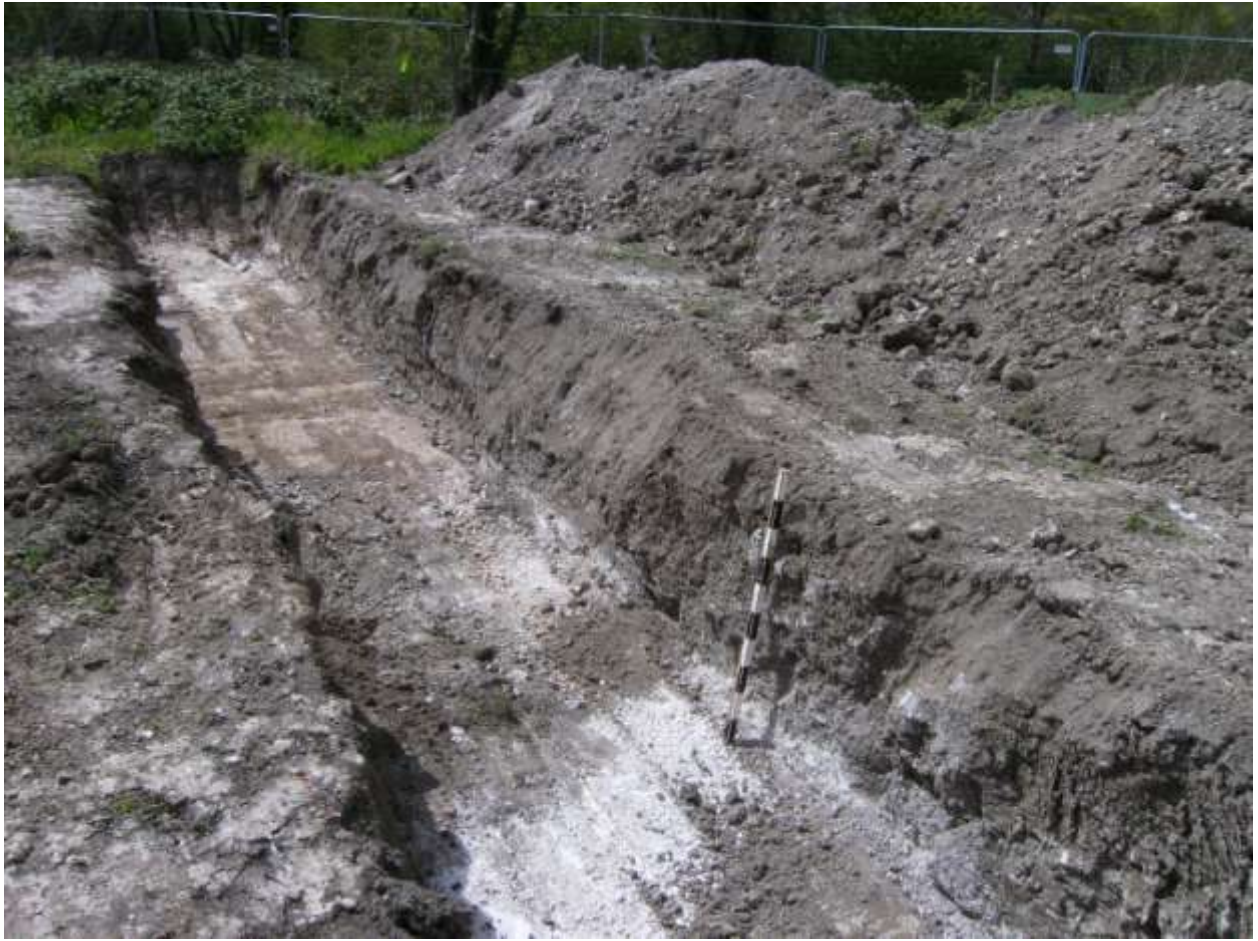
The plan is recorded in Figure 1 (see also Plate 7, 8). The trench lay on south-east to north-west alignment and measured approximately 25m by 1.80m.

Undisturbed natural geology **(402)** was identified across the trench as chalk at a depth of approximately 1.00m (81.mOD) below the present ground surface at 82m OD at the NW end of the trench.

The natural geology was sealed by a layer of dumped material **(401)** 1.00m thick, mid brown in colour overlaid by a thin layer of topsoil **(400)**.

Plate 7. Trench 4 from the southeast, one-metre scale

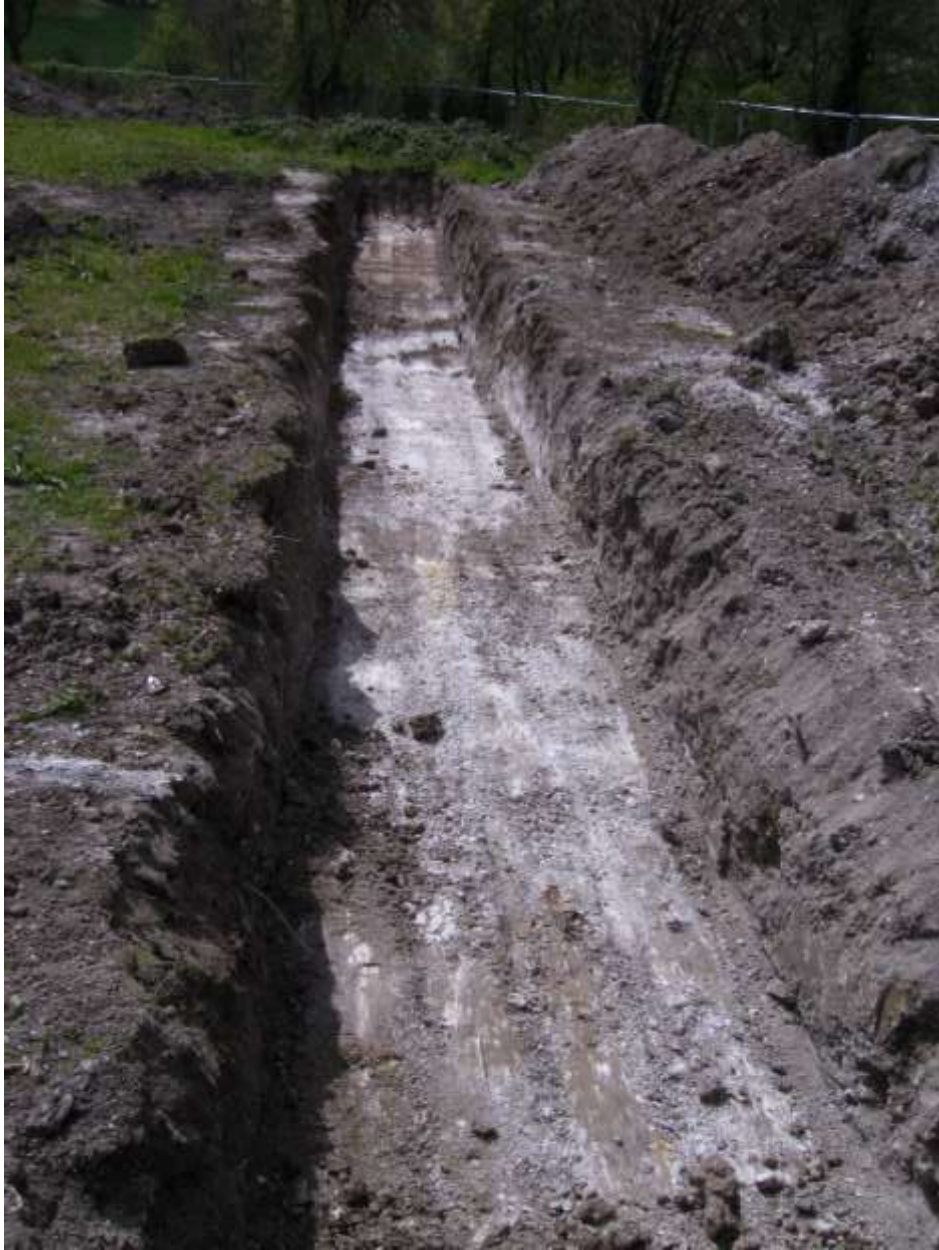
Plate 8. Trench 4 from the east, one-metre scale

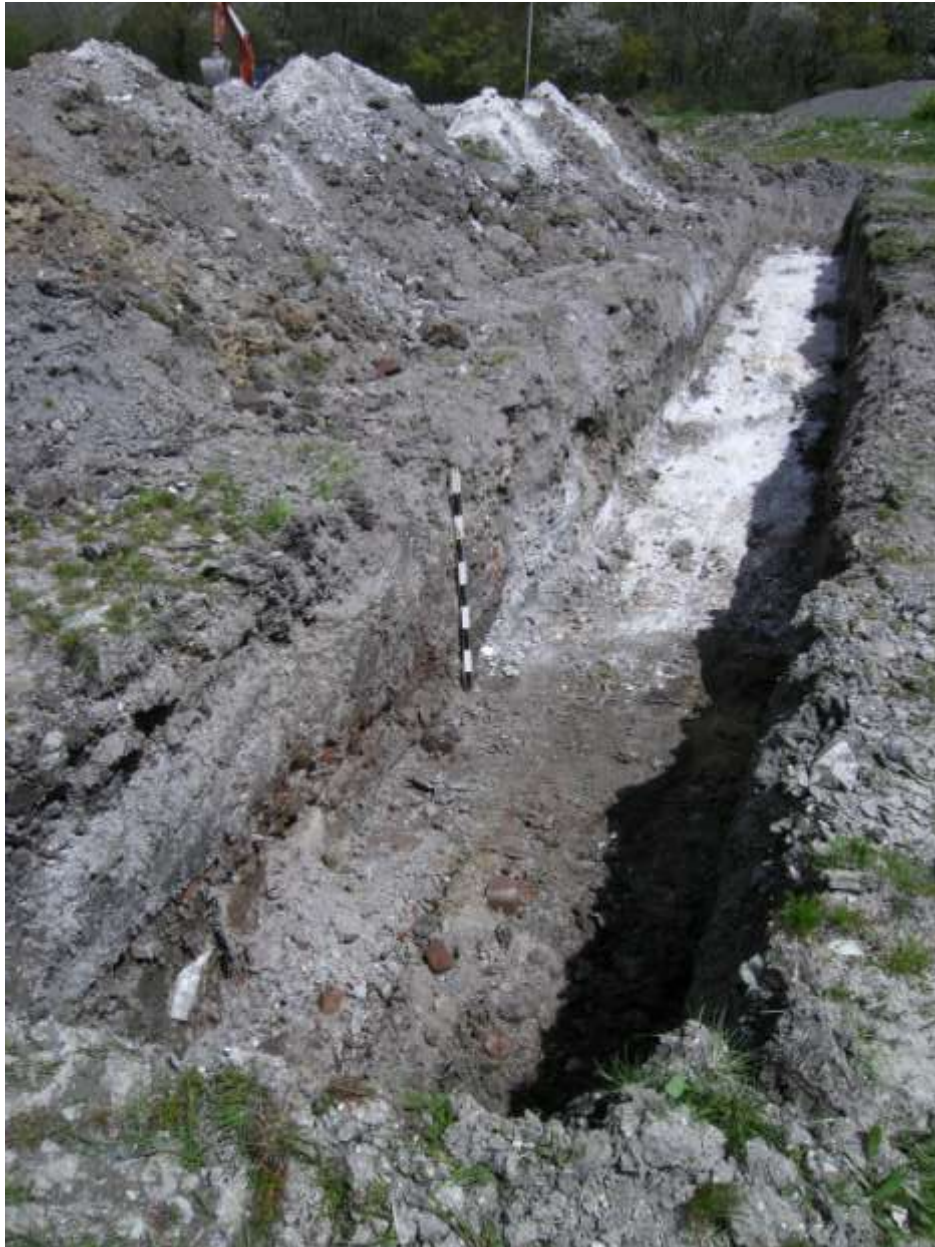
The plan is recorded in Figure 1 (see also Plate 9, 10, 11). The trench lay on south-west to north-east alignment and measured approximately 25m by 1.80m.

Undisturbed natural geology **(502)** was identified across the trench as chalk at a depth of approximately 1.30m (80.70mOD) below the present ground surface at 82m OD at the NE end of the trench.

Plate 9. Trench 5 from the northwest, one-metre scale

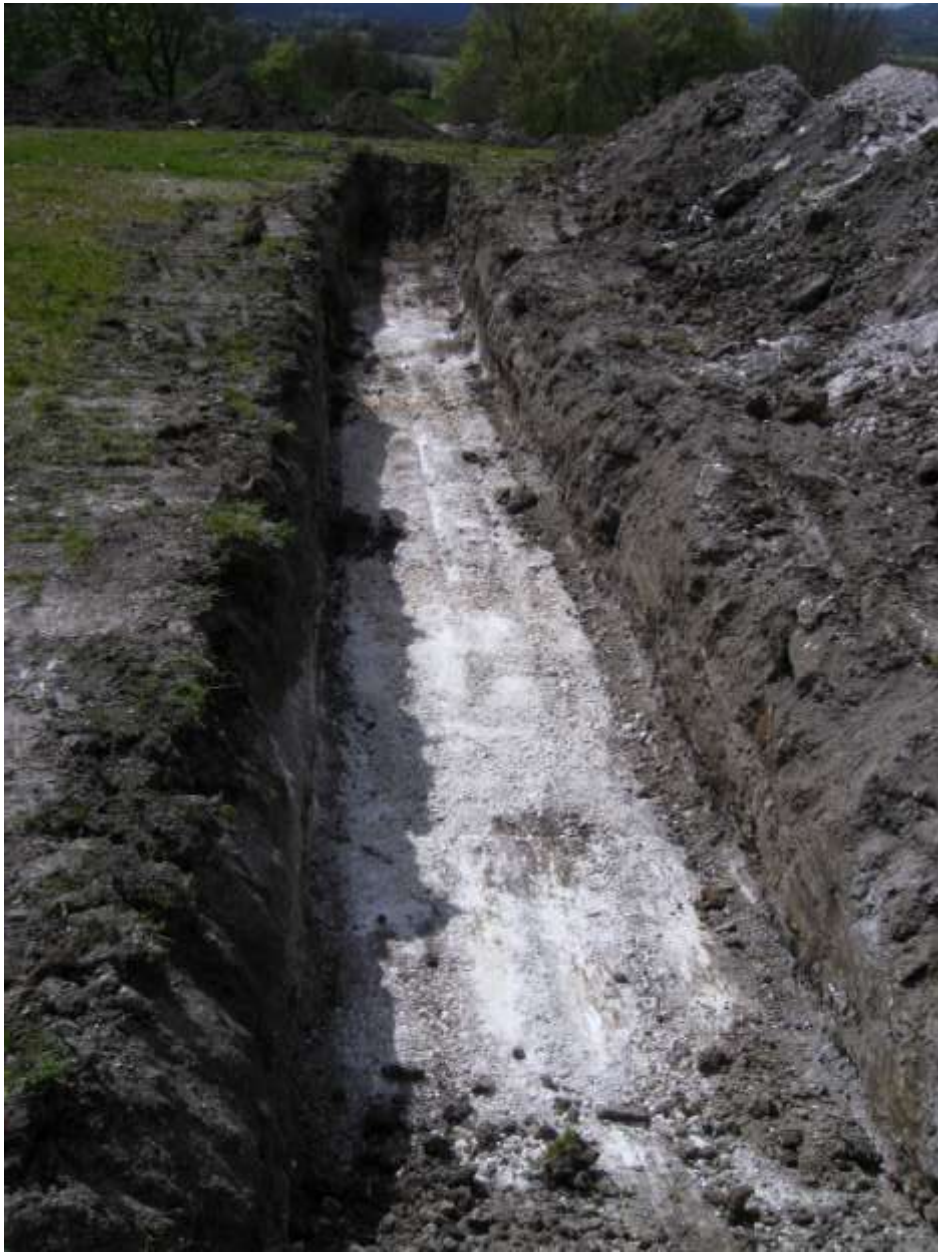
Plate 10. Trench 5 from the southeast, one-metre scale

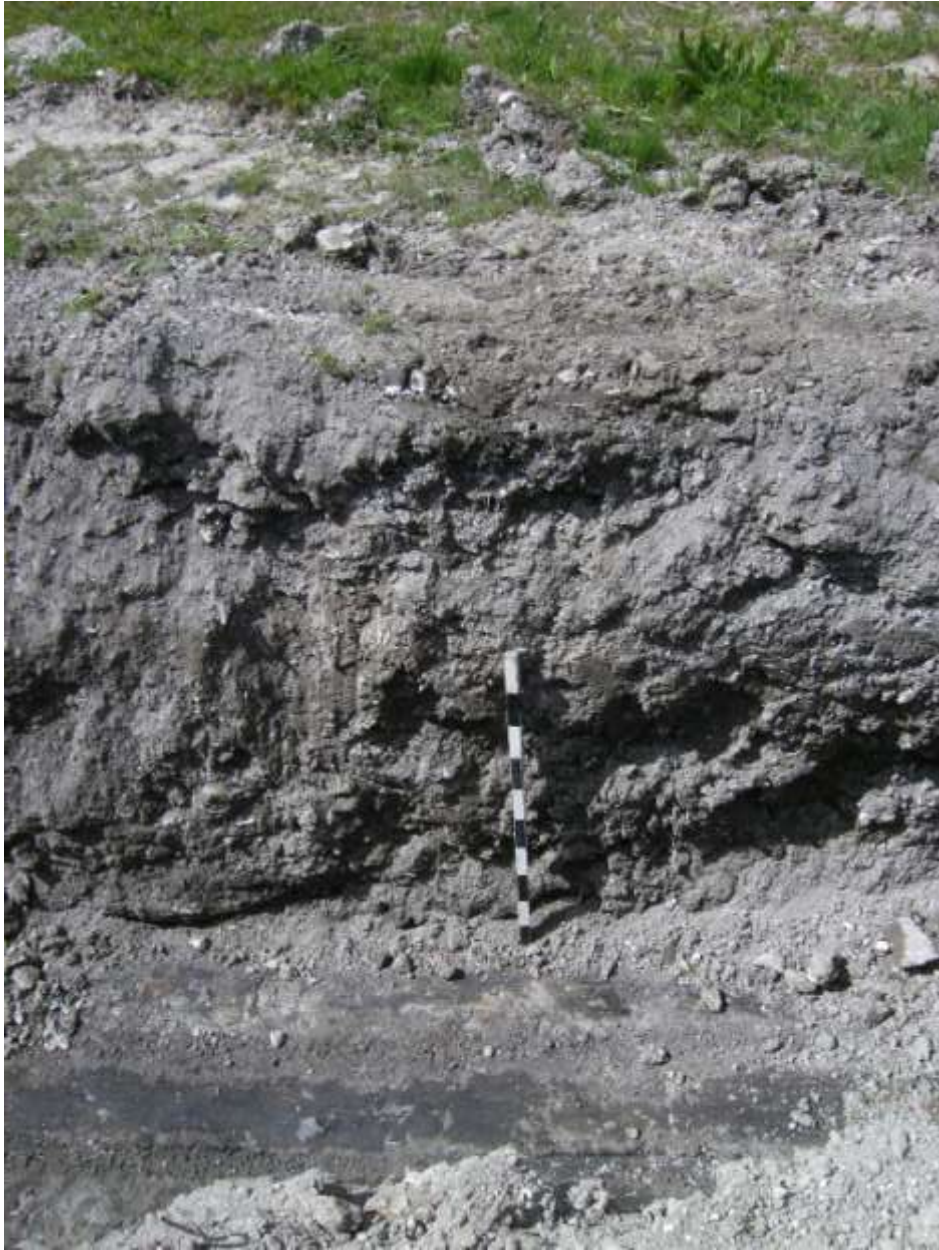
The natural geology was sealed by a layer of dumped material **(501)** 1.30m thick, mid brown grey in colour overlaid by a thin layer of topsoil **(500)**.

Plate 11. Section of Trench 5 looking west, one-metre scale

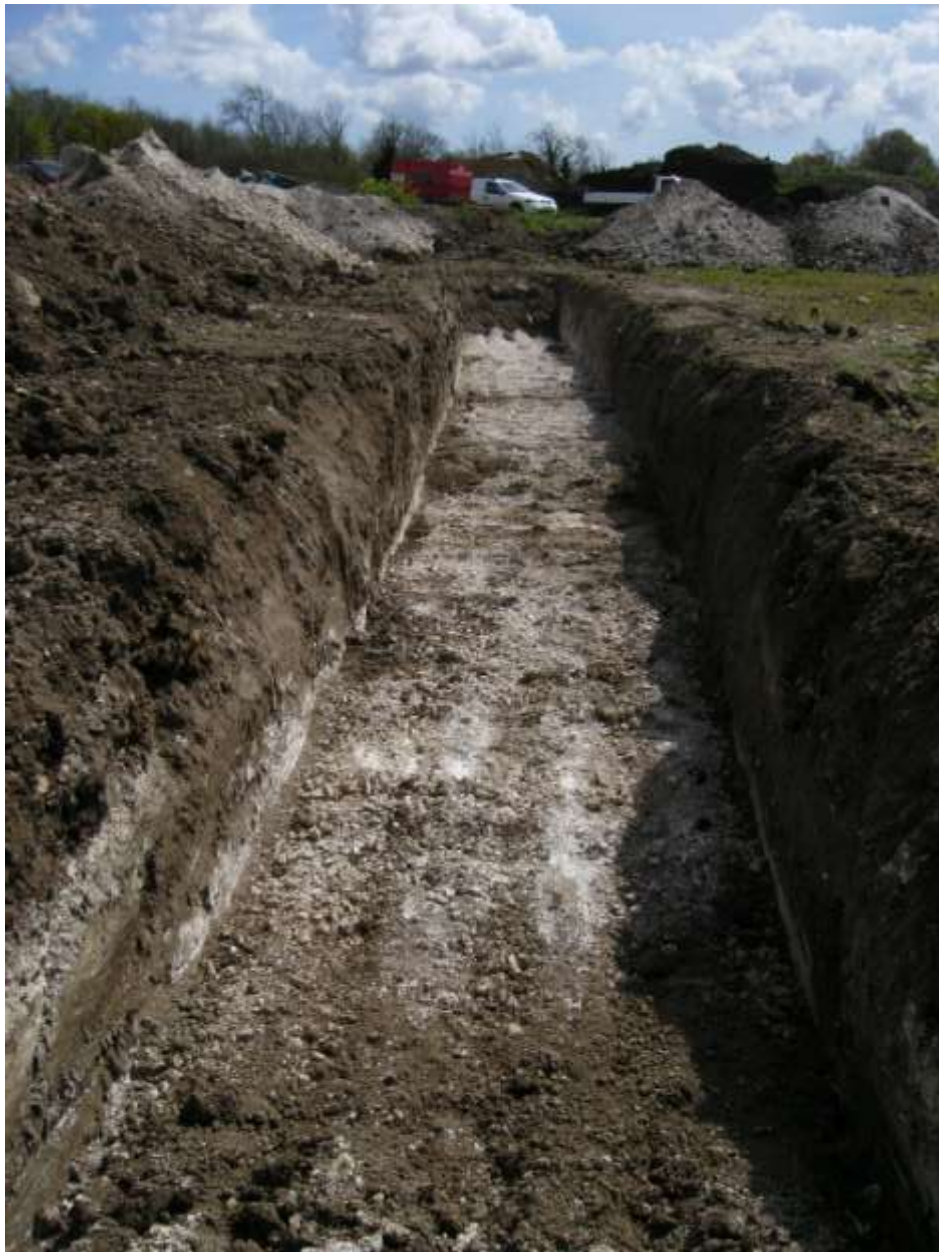
The plan is recorded in Figure 1 (see also Plate 12). The trench lay on south-west to north-east alignment and measured approximately 25m by 1.80m.

Undisturbed natural geology **(602)** was identified across the trench as chalk at a depth of approximately 1.30m (80.70mOD) below the present ground surface at 82m OD at the NE end of the trench.

The natural geology was sealed by a layer of dumped material **(601)** 1.30m thick, mid brown grey in colour overlaid by a thin layer of topsoil **(600)**.

Plate 12. Trench 6 from the southwest

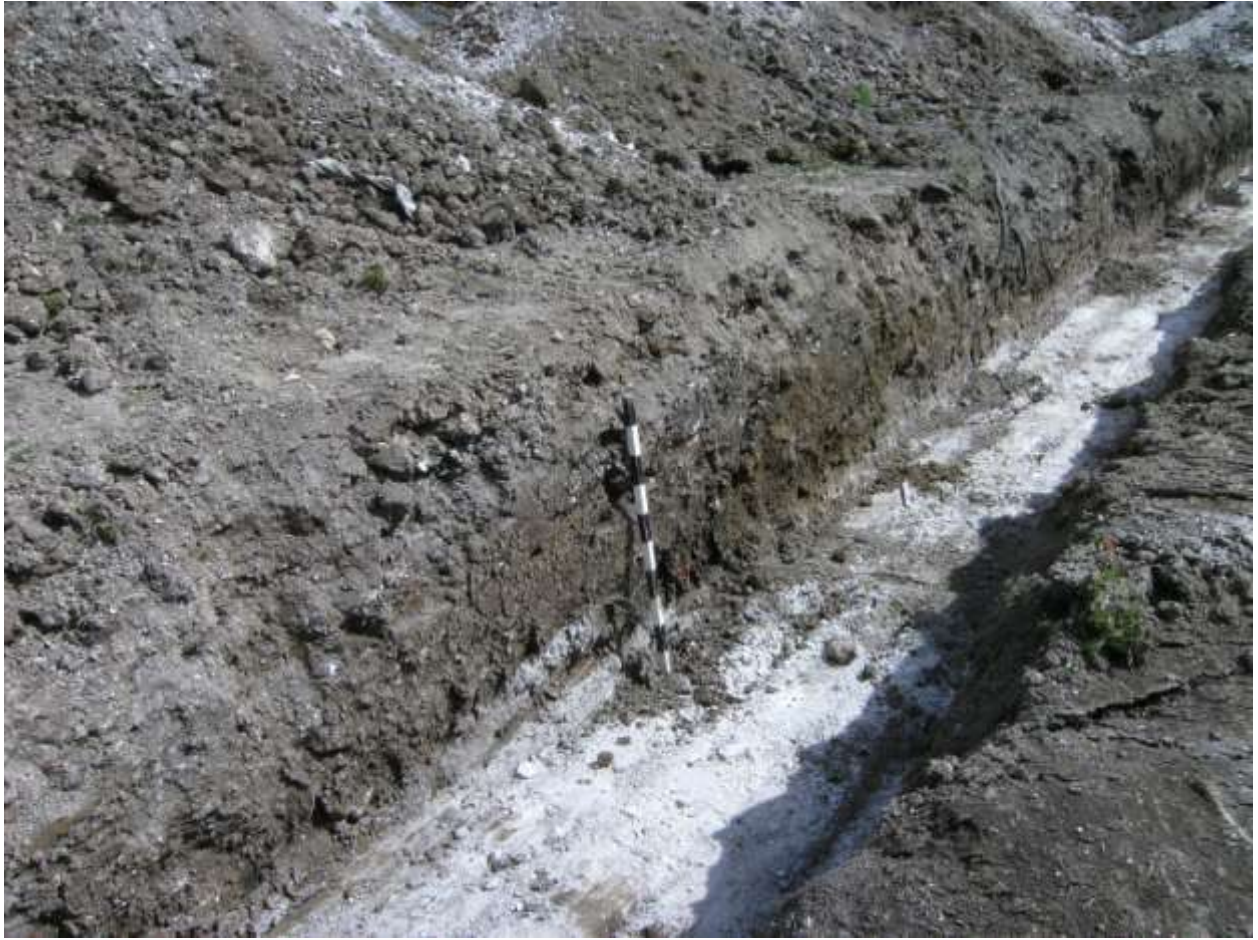
The plan is recorded in Figure 1 (see also Plate 13). The trench lay on north-west to south-east alignment and measured approximately 25m by 1.80m.

Undisturbed natural geology **(702)** was identified across the trench as chalk at a depth of approximately 1.30m (79.70mOD) below the present ground surface at 81m OD at the NW end of the trench.

The natural geology was sealed by a layer of dumped material **(701)** 1.30m thick, mid brown grey in colour overlaid by a thin layer of topsoil **(700)**.

Plate 13. Trench 7 looking northeast, one-metre scale

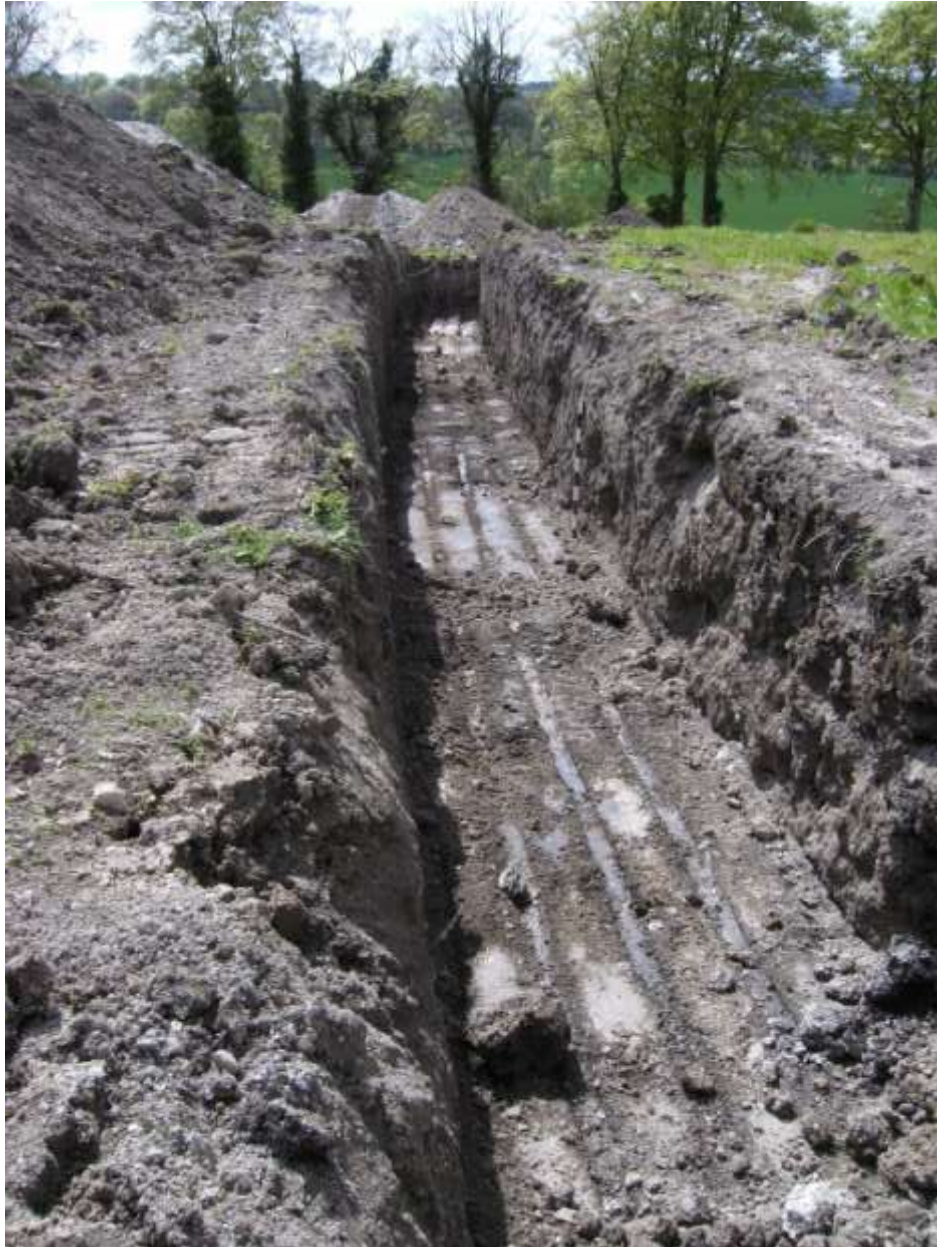
The plan is recorded in Figure 1 (see also Plate 14,15). The trench lay on north-west to south-east alignment and measured approximately 15m by 1.80m.

Undisturbed natural geology **(802)** was identified across the trench as chalk at a depth of approximately 1.30m (80.70mOD) below the present ground surface at 82m OD at the NW end of the trench.

Plate 14. Trench 8 looking northwest, one-metre scale

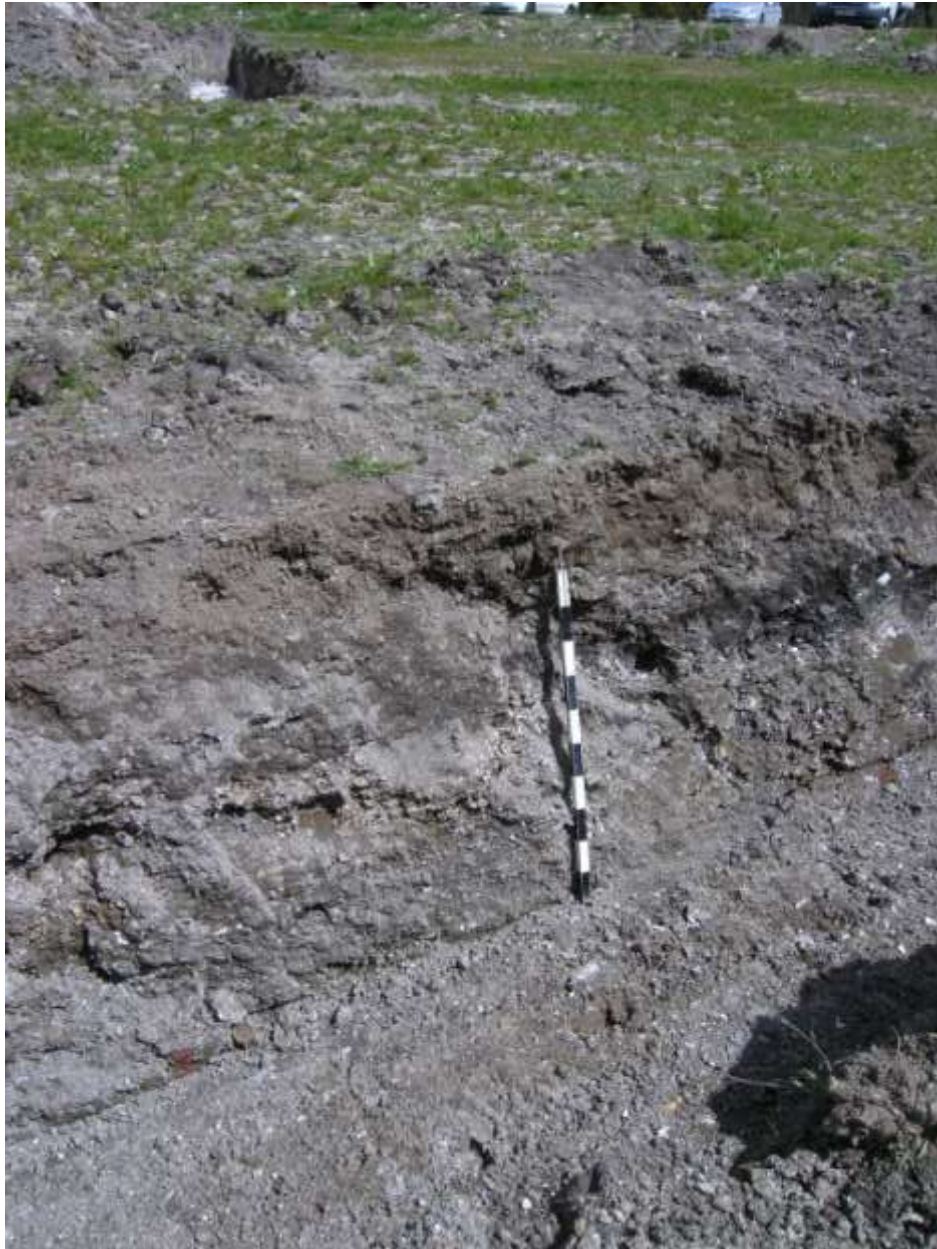
The natural geology was sealed by a layer of dumped material **(801)** 1.30m thick, mid brown grey in colour overlaid by a thin layer of topsoil **(800)**.

Plate 15. Section of Trench 8, looking north, one-metre scale

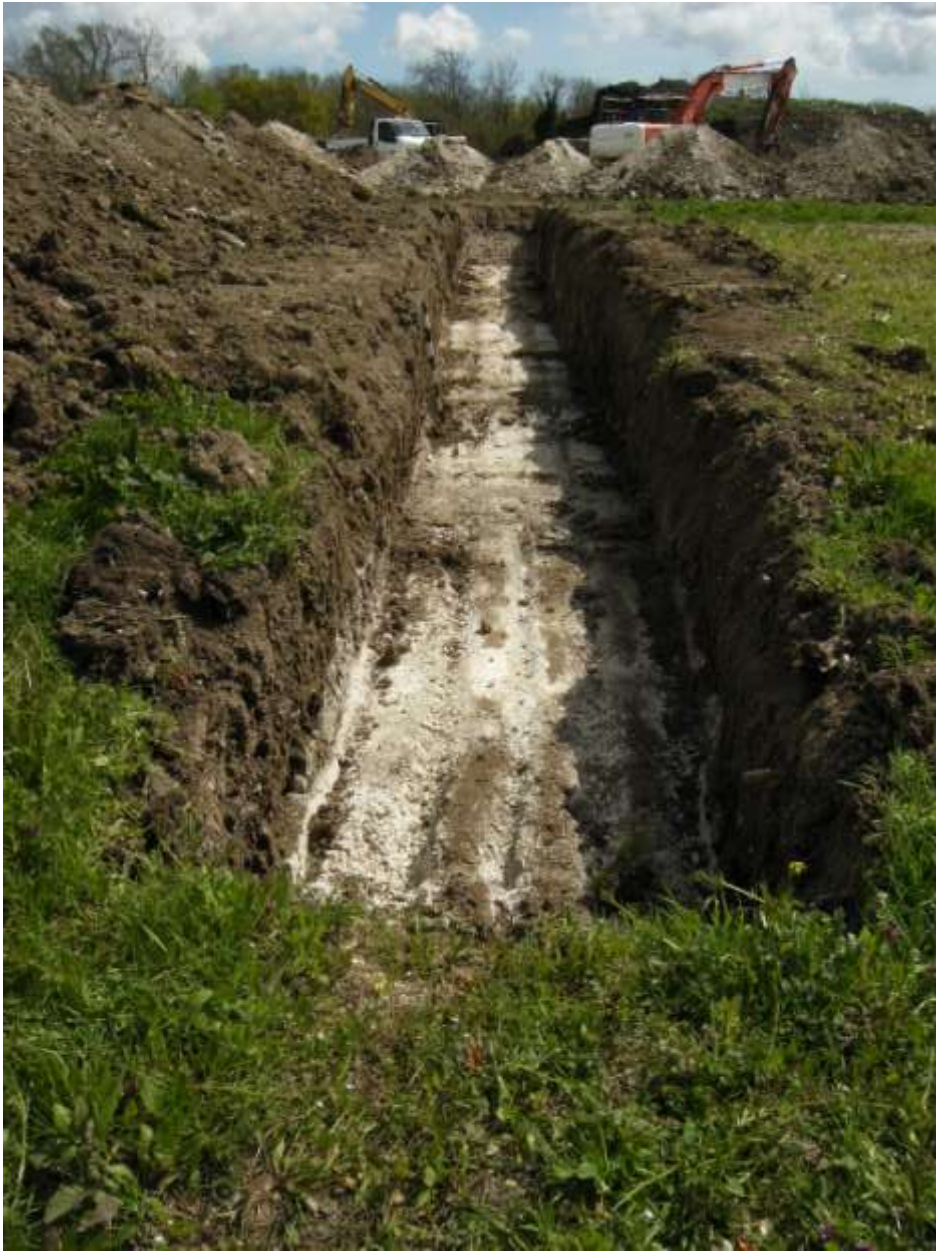
The plan is recorded in Figure 1 (see also Plate 16). The trench lay on south-west to north-east alignment and measured approximately 25m by 1.80m.

Undisturbed natural geology **(902)** was identified across the trench as chalk at a depth of approximately 1.30m (80.70mOD) below the present ground surface at 82m OD at the NE end of the trench.

The natural geology was sealed by a layer of dumped material **(901)** 1.30m thick, mid brown grey in colour overlaid by a thin layer of topsoil **(900)**.

Plate 16. Trench 9 looking southeast

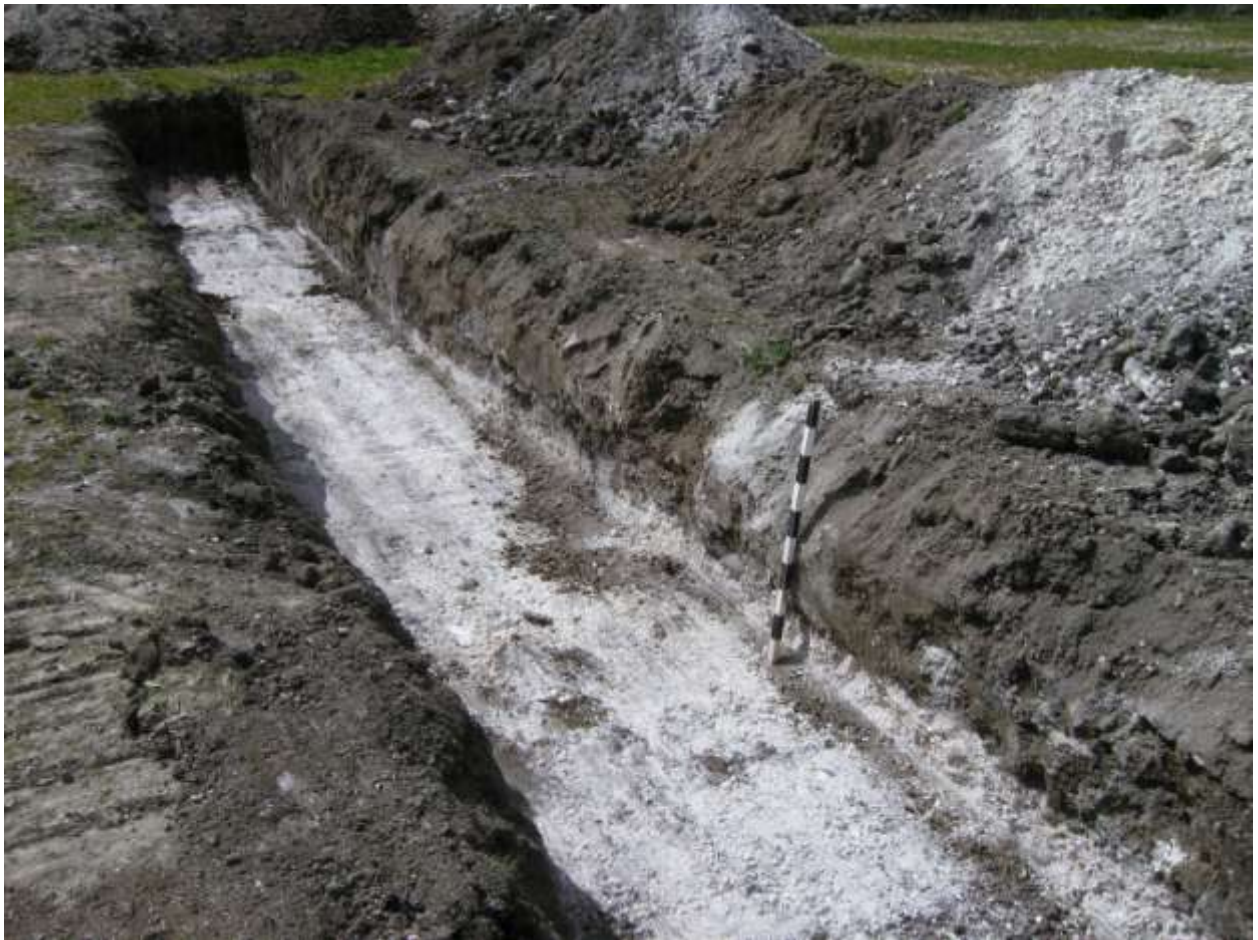
The plan is recorded in Figure 1 (see also Plate 17, 18). The trench lay on south-west to north-east alignment and measured approximately 25m by 1.80m.

Undisturbed natural geology **(1002)** was identified across the trench as chalk at a depth of approximately 1.00m (81m OD) below the present ground surface at 82m OD at the NE end of the trench.

Plate 17. Trench 10 from the southeast, one-metre scale

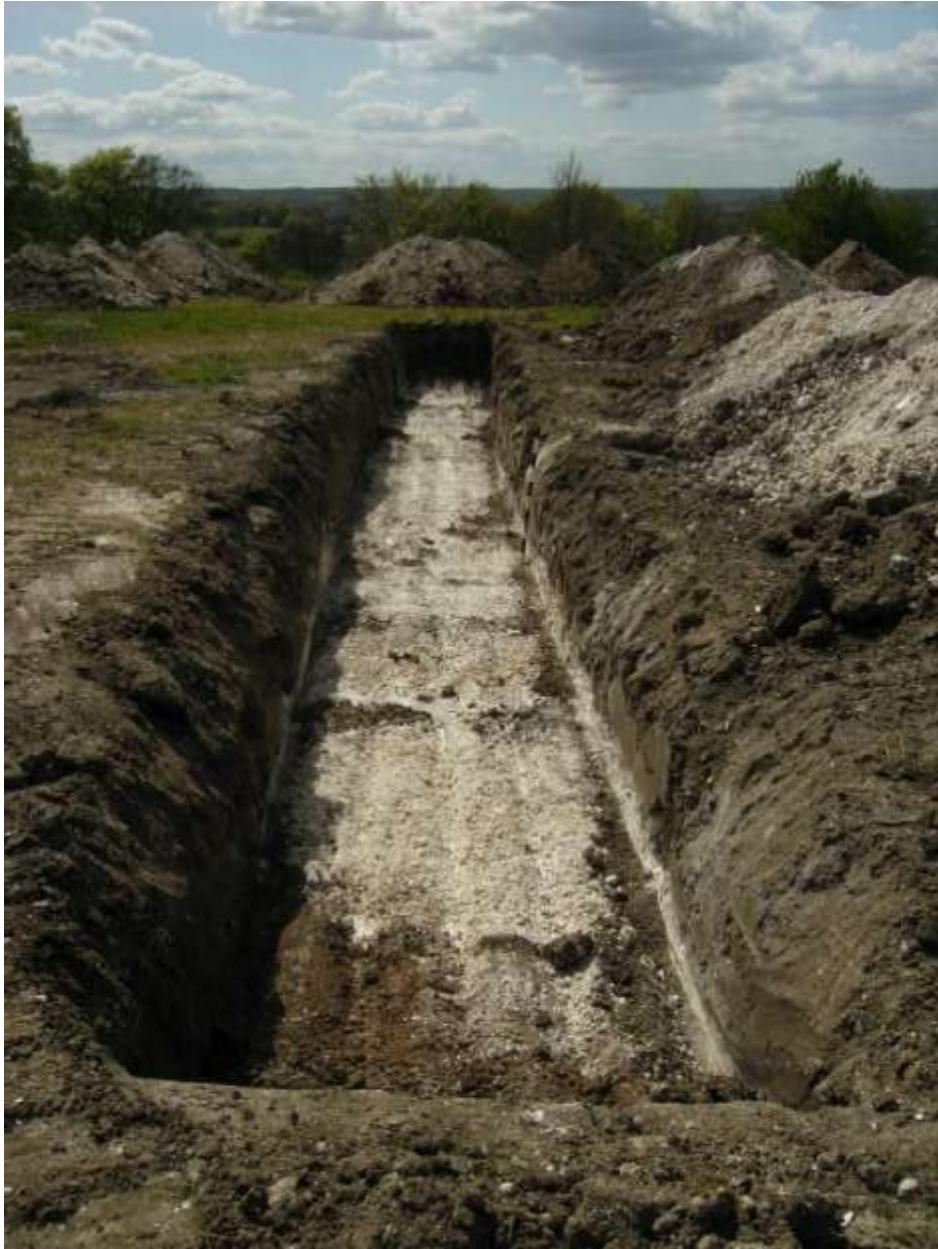
The natural geology was sealed by a layer of dumped material **(1001)** 1.00m thick, mid brown grey in colour overlaid by a thin layer of topsoil **(1000)**.

Plate 18. Trench 10 from the east
