Archaeological Evaluation of Land at Larkey Woods Farm, Cockering Road, Chartham, Kent

Site Code: LARK/EV/16

(Planning Application: C/15/00683/FUL)

SWAT Archaeology

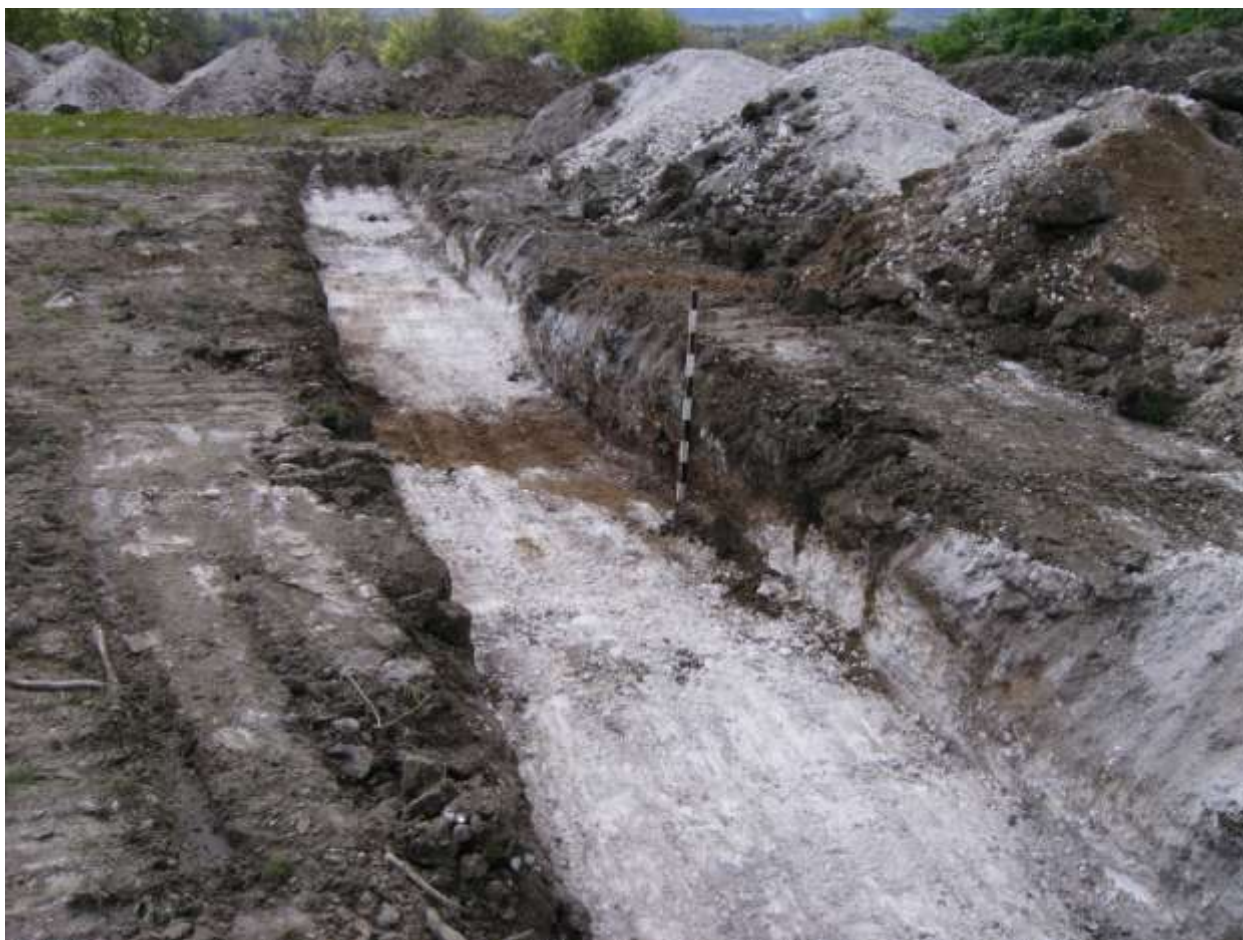
The plan is recorded in Figure 1 (see also Plate 19). The trench lay on south-west to north-east alignment and measured approximately 20m by 1.80m.

Undisturbed natural geology **(1102)** was identified across the trench as chalk at a depth of approximately 0.70m (81.30m OD) below the present ground surface at 82m OD at the NE end of the trench.

Plate 19. Trench 11 from the south, one-metre scale

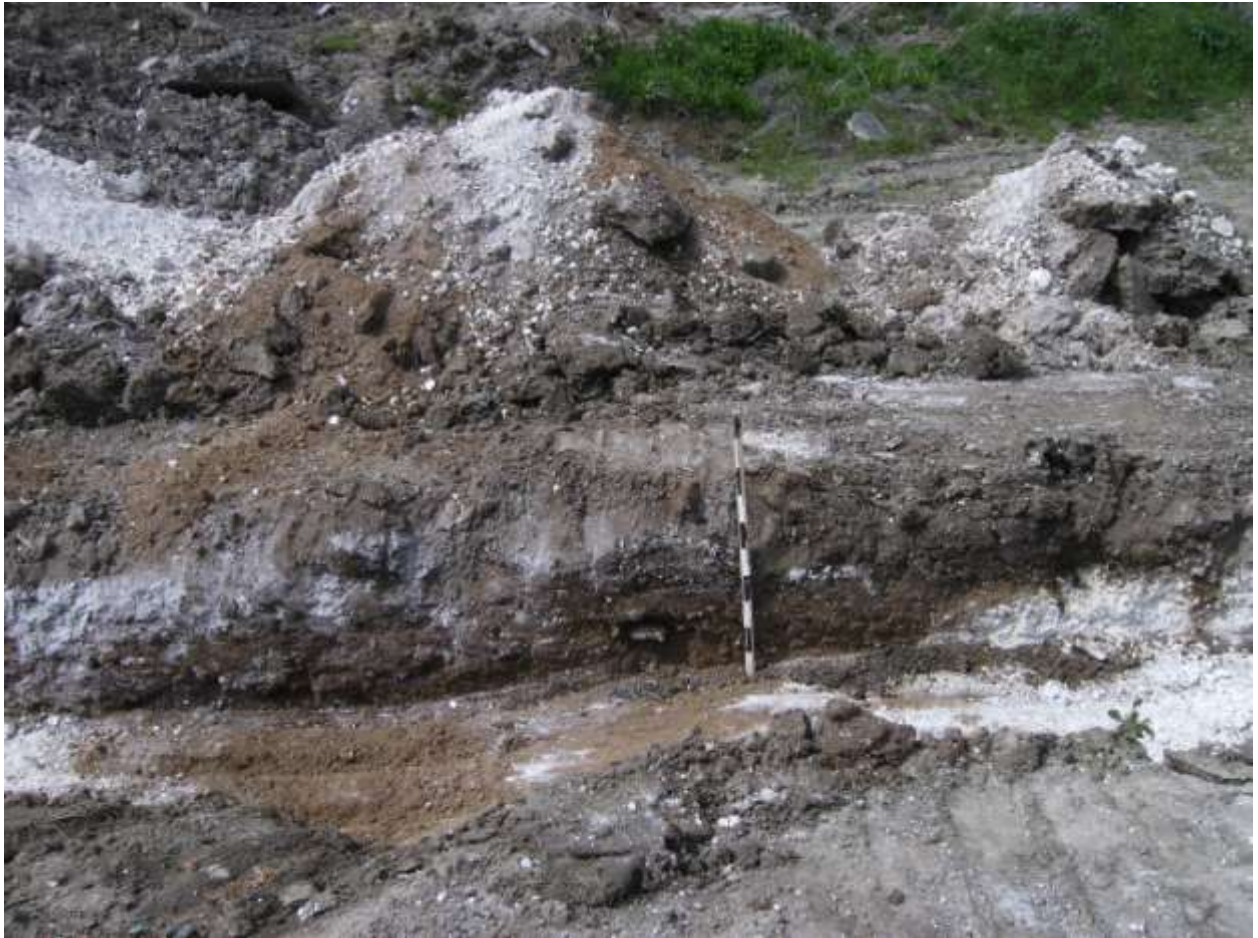
The natural geology was sealed by a layer of dumped material **(1101)** 0.70m thick, mid brown grey in colour overlaid by a thin layer of topsoil **(1100)**.

Plate 20. Trench 11 section, looking east, one-metre scale

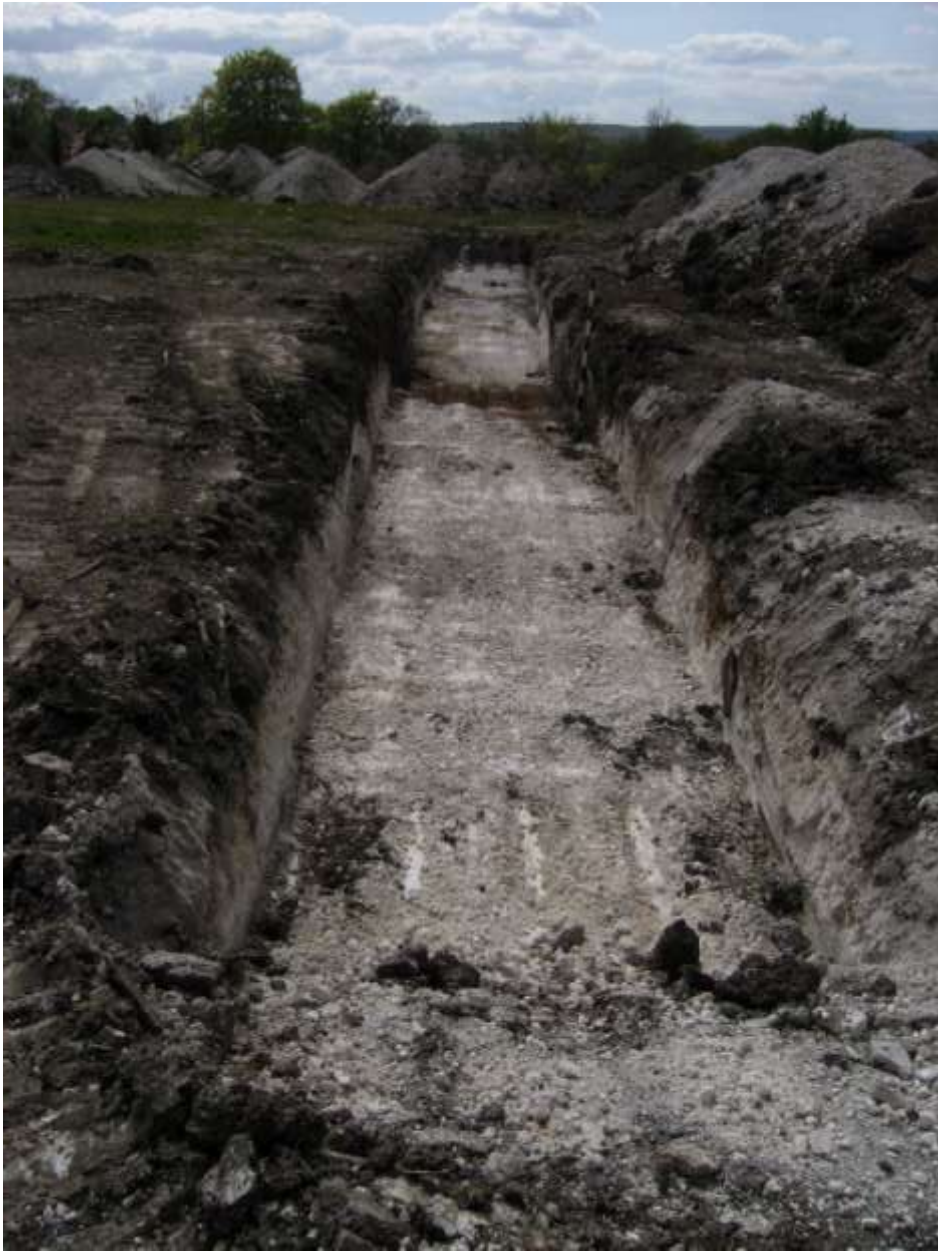
Plate 21. Trench 11 from the north

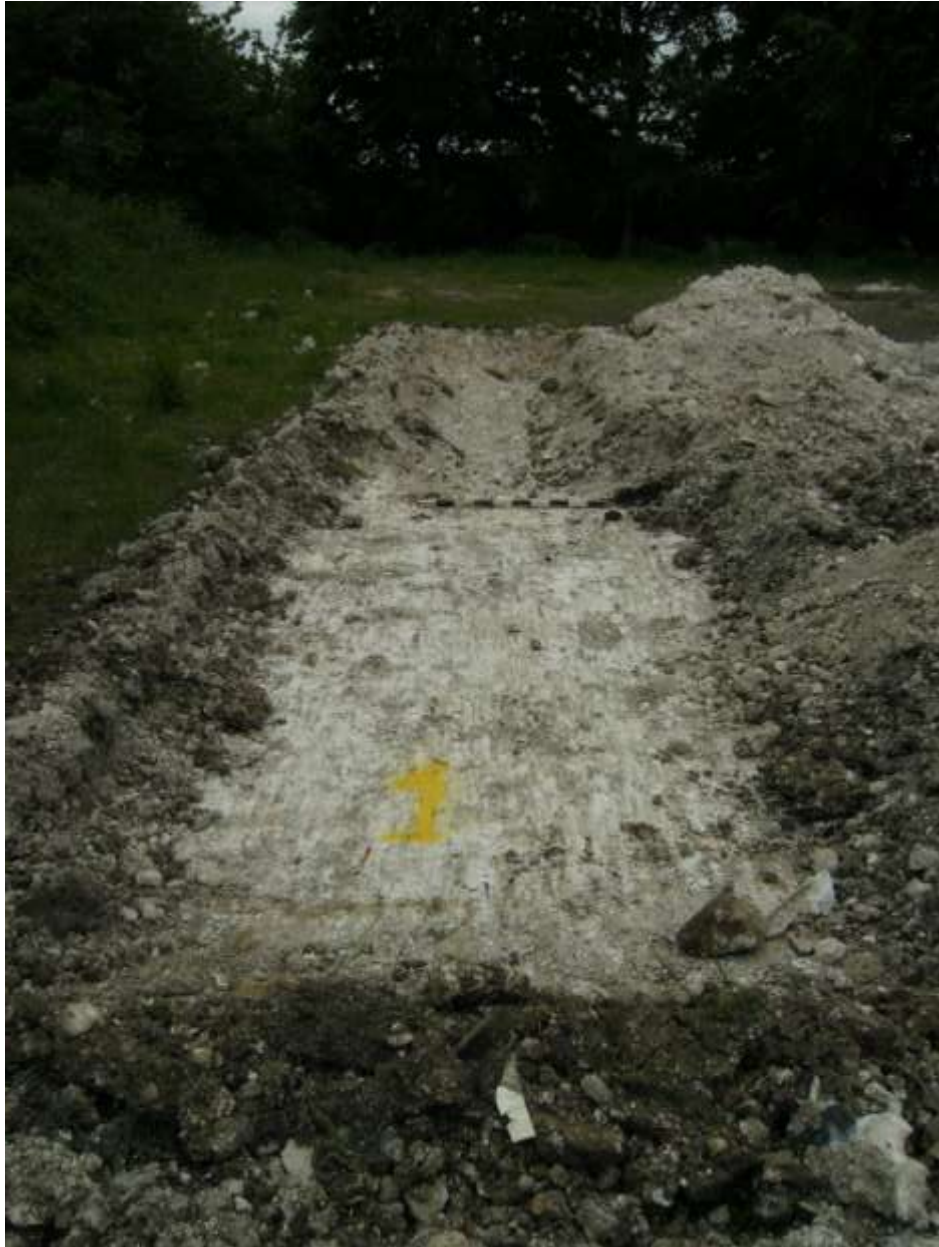
The plan is recorded in Figure 1 (see also Plate 22). The trench lay on north-west to south-east alignment and measured approximately 10m by 1.80m.

Undisturbed natural geology (**1502**) was identified across the trench as chalk at a depth of approximately 0.30m (81.70mOD) below the present ground surface at 82m OD at the NW end of the trench.

The natural geology was sealed by a layer of dumped material (**1501**) 0.30m thick, mid brown grey in colour overlaid by a thin layer of topsoil (**1500**).

Plate 22. Trench 15 (second phase), looking west, one-metre scale

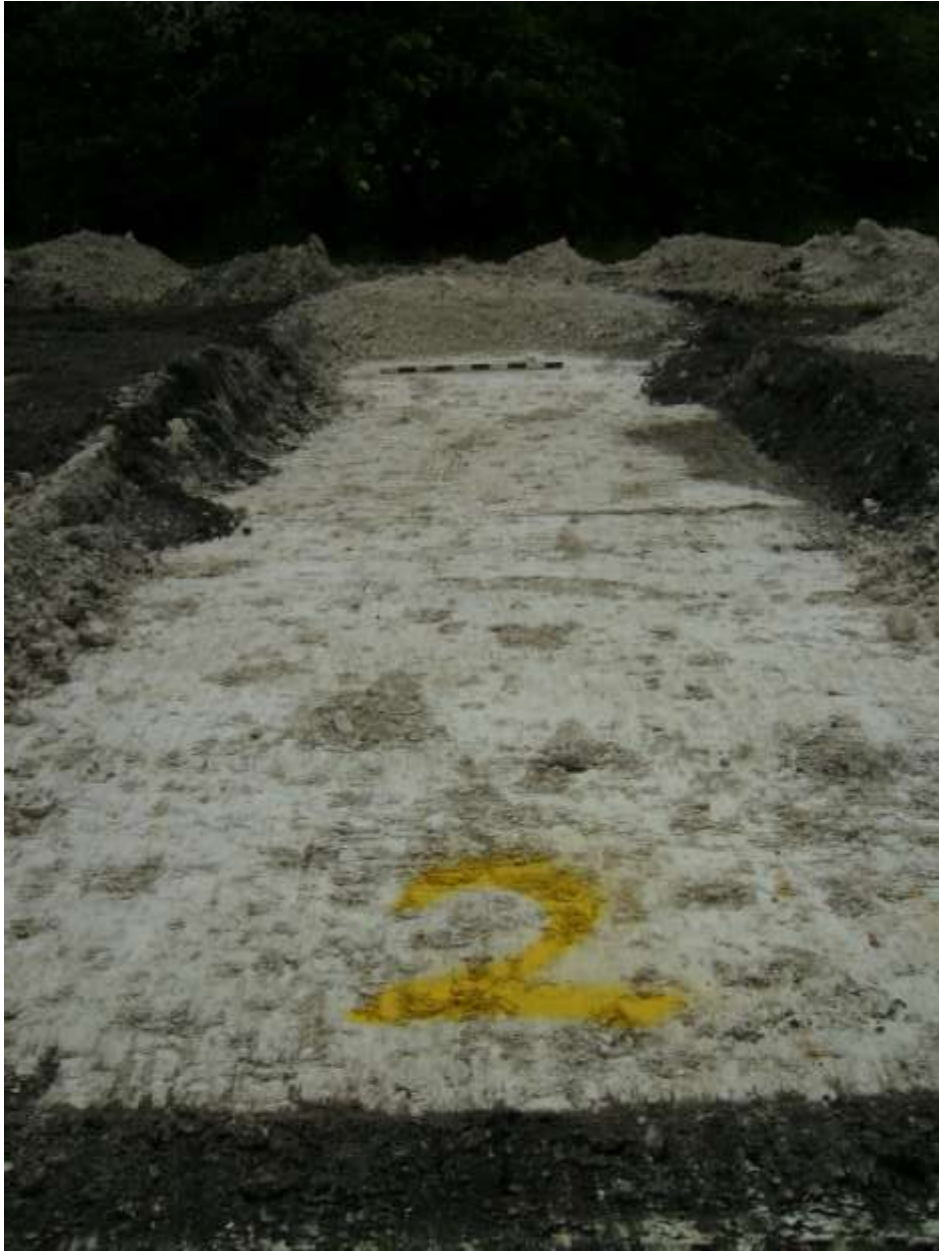
The plan is recorded in Figure 1 (see also Plate 23). The trench lay on NNE to SSW alignment and measured approximately 12m by 1.80m.

Undisturbed natural geology (**1402**) was identified across the trench as chalk at a depth of approximately 0.40m (81.60mOD) below the present ground surface at 82m OD at the NNE end of the trench.

The natural geology was sealed by a layer of dumped material (**1401**) 0.40m thick, mid brown grey in colour overlaid by a thin layer of topsoil (**1400**).

Plate 23. Trench 14 (second phase), looking south, one-metre scale

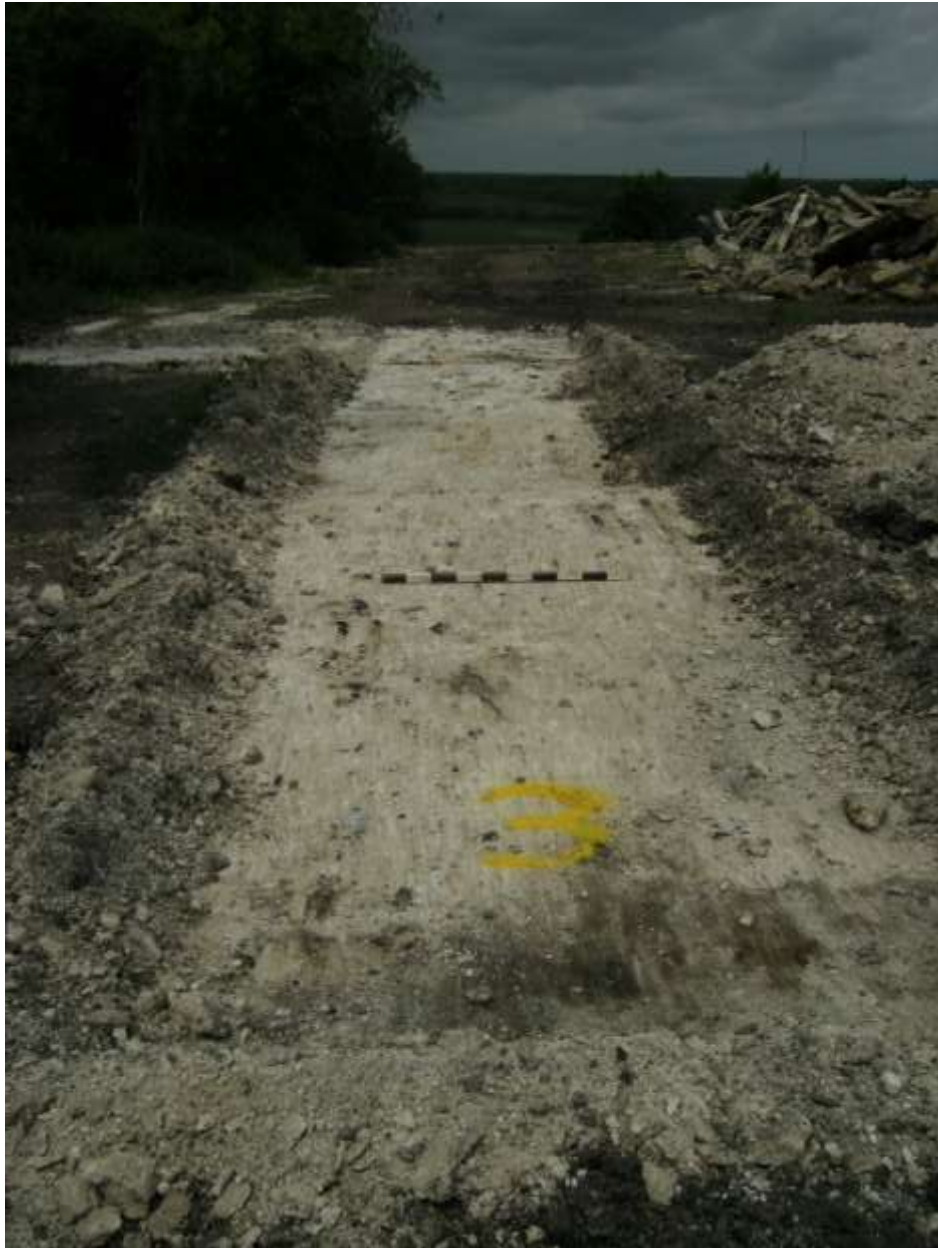
The plan is recorded in Figure 1 (see also Plate 24). The trench lay on south-west to north-east alignment and measured approximately 15m by 1.80m.

Undisturbed natural geology (**1602**) was identified across the trench as chalk at a depth of approximately 0.20m (84.80mOD) below the present ground surface at 85m OD at the NE end of the trench.

The natural geology was sealed by a layer of dumped material (**1601**) 0.20m thick, mid brown grey in colour overlaid by a thin layer of topsoil (**1600**).

Plate 24. Trench 16 (second phase), looking west, one-metre scale

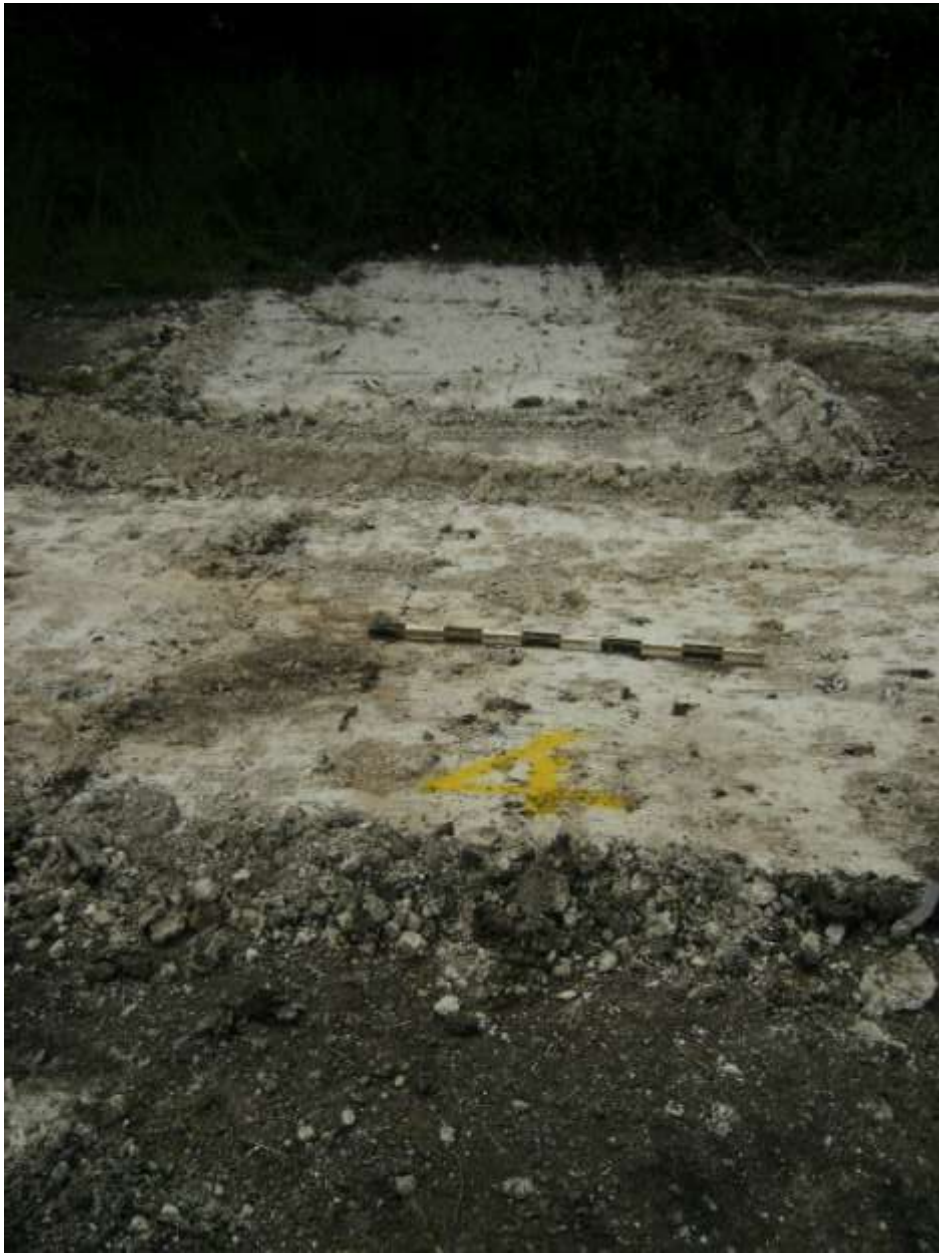
The plan is recorded in Figure 1 (see also Plate 25). The trench lay on north-west to south-east alignment and measured approximately 10m by 1.80m.

Undisturbed natural geology (**1702**) was identified across the trench as chalk at a depth of approximately 0.20m (84.80mOD) below the present ground surface at 85m OD at the NW end of the trench.

The natural geology was sealed by a layer of dumped material **(1701)** 0.20m thick, mid brown grey in colour overlaid by a thin layer of topsoil **(1700)**.

Plate 25. Trench 17 (second phase), looking south, one-metre scale

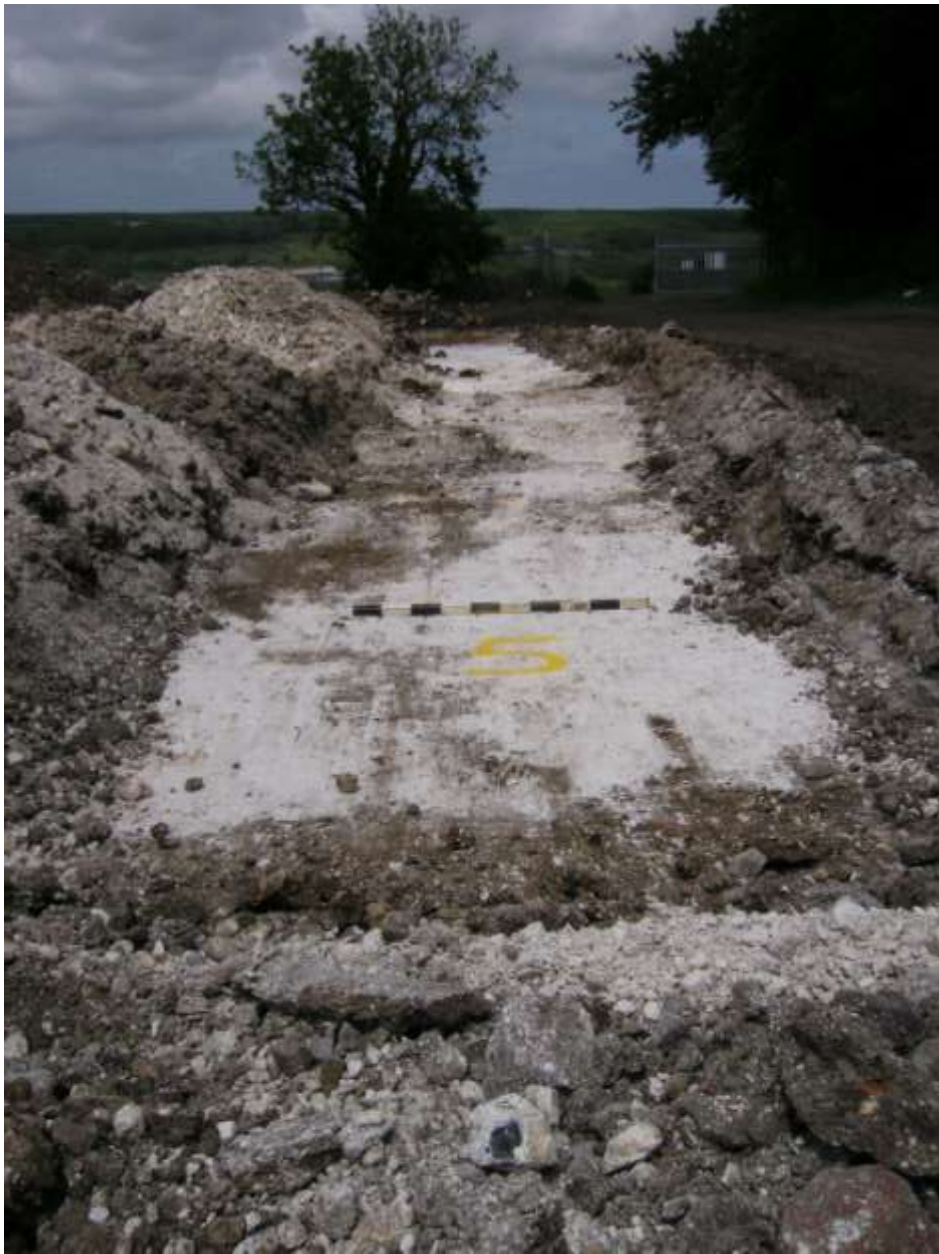
Plate 26. Trench 18 (second phase), looking north, one-metre scale

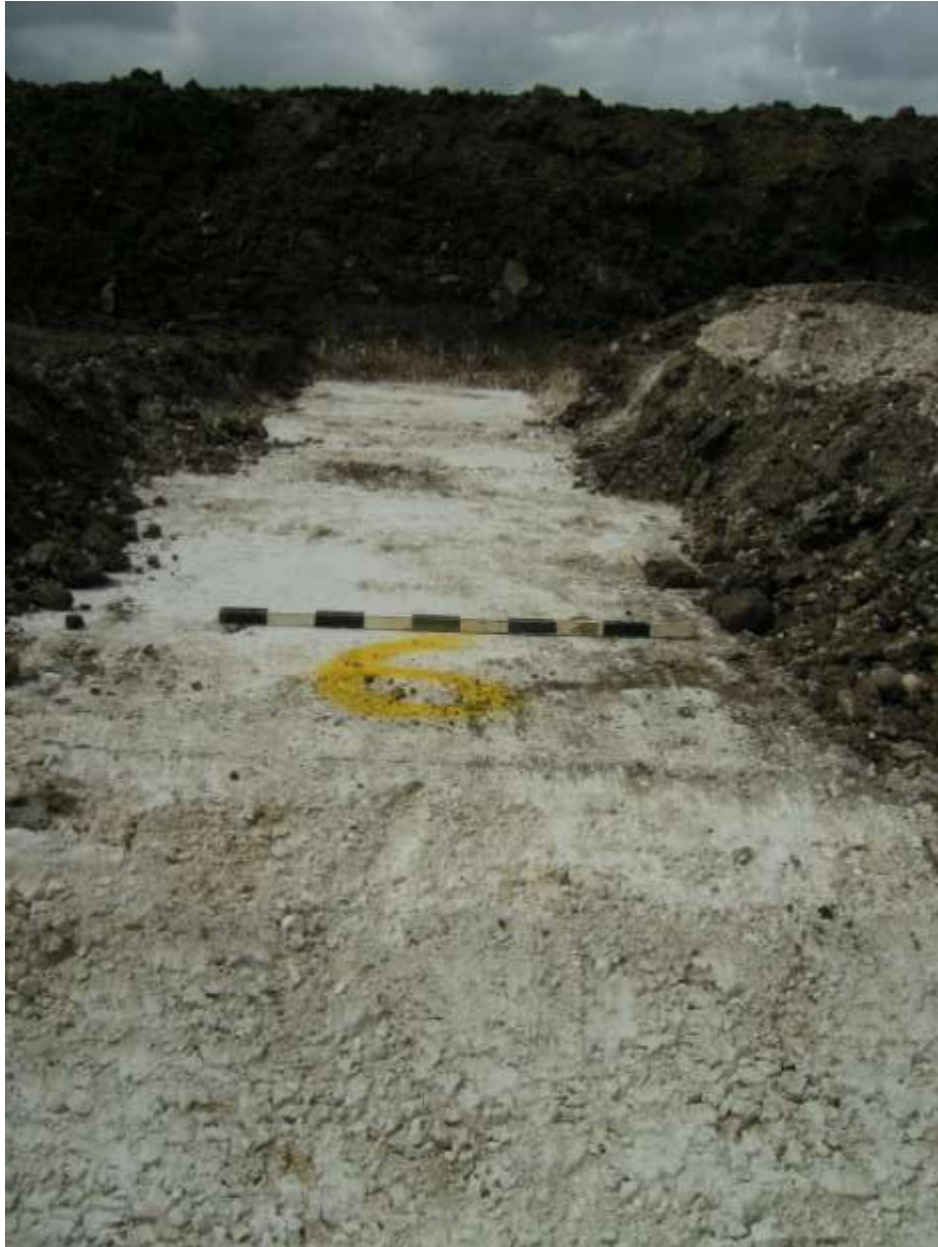
Plate 27. Trench 19 (second phase), from the west, one-metre scale

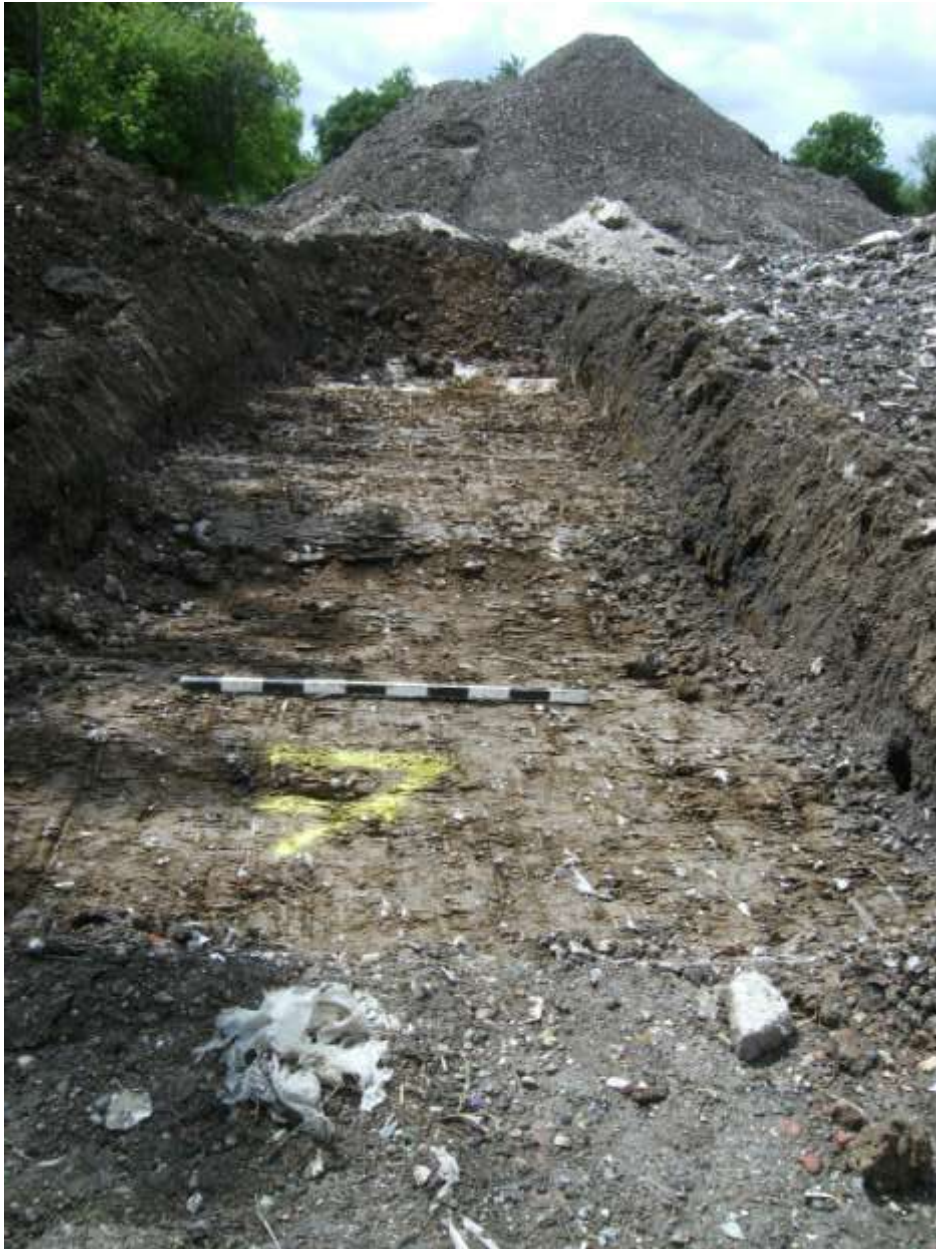
The plan is recorded in Figure 1 (see also Plate 28). The trench lay on south to north alignment and measured approximately 18m by 1.80m.

Undisturbed natural geology **(1302)** was identified across the trench as chalk at a depth of approximately 0.60m (76.40mOD) below the present ground surface at 77m OD at the NE end of the trench.

The natural geology was sealed by a layer of dumped material **(1301)** 0.60m thick, mid brown grey in colour overlaid by a thin layer of topsoil **(1300)**.

Plate 28. Trench 13 (second phase), looking southeast, one-metre scale
