# HISTORIC BUILDING RECORDING OF ST JOHN'S BOARD SCHOOL, ST JOHN'S PLACE, CANTERBURY, KENT

1.1 In December 2016 Dr Paul Wilkinson MCIfA of SWAT Archaeology carried out a historic building recording of the St John's Board School, St John's Place, Canterbury, Kent (Figures 11-14). The building is presently unoccupied and is undergoing conversion.

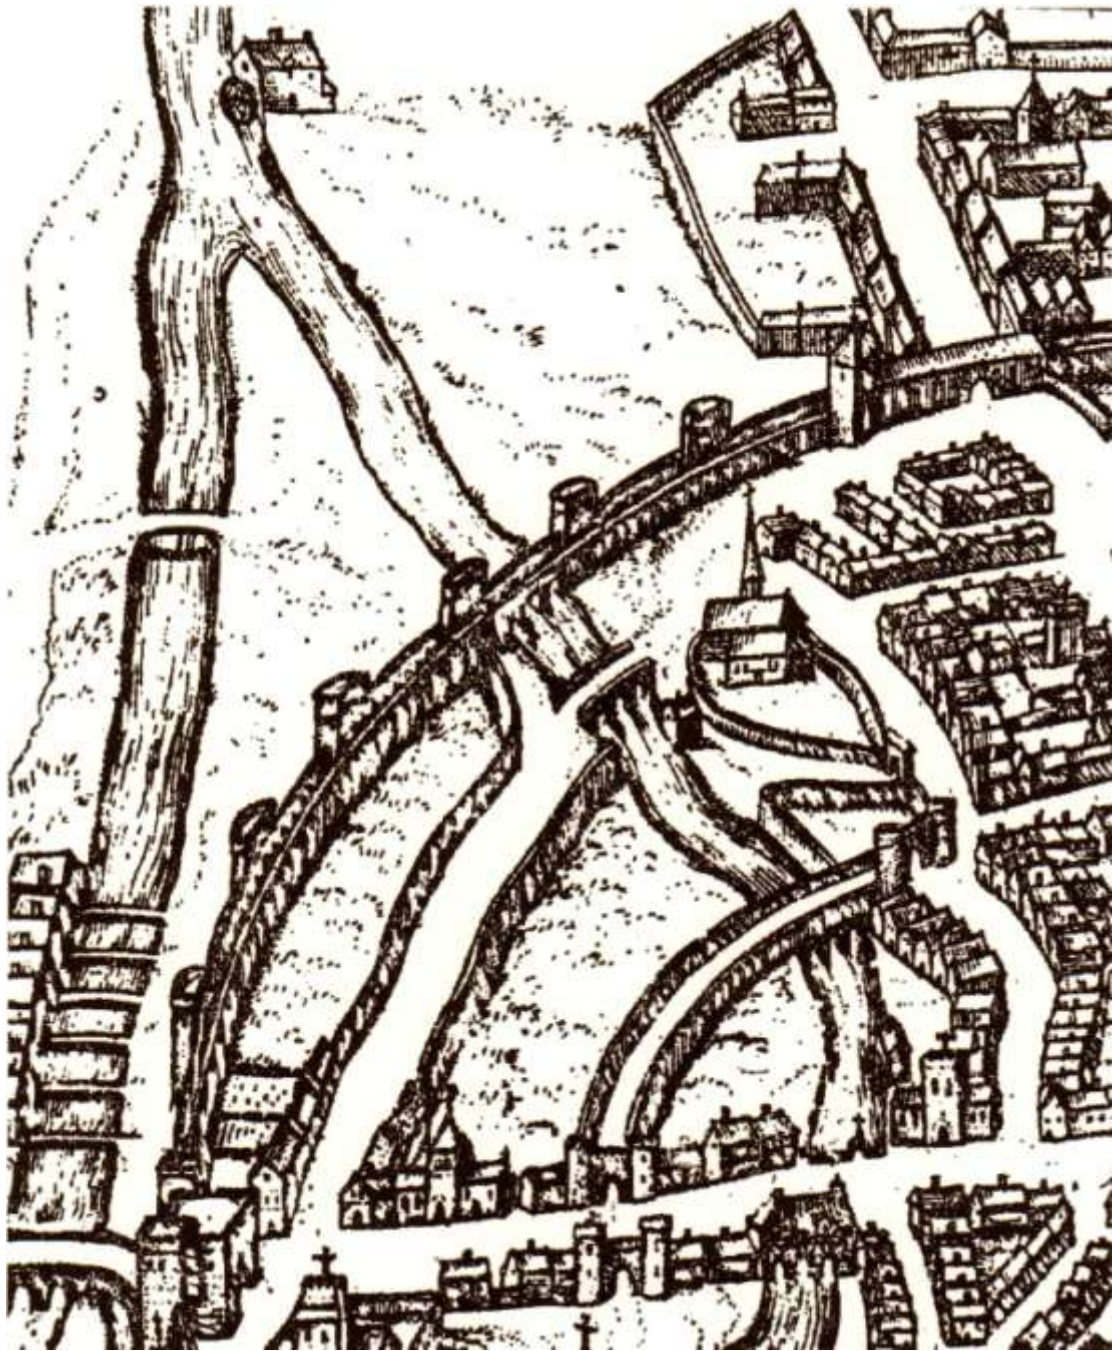
Figure 1. Braun map of 1688

2.2.3 A limited map regression exercise on large scale Ordnance Survey maps has been carried out on the proposed development area. In addition earlier historical maps have been viewed and have shown that the site in 1588 was probably open fields. This map, the William Smith's Canterbury survey of c.1588 for Braun and Hogenberg's *Civitates Orbis Terrarum* is not terribly good on detail but does show the religious houses of St John and Gregory north of the Roman city walls (Figure 1).

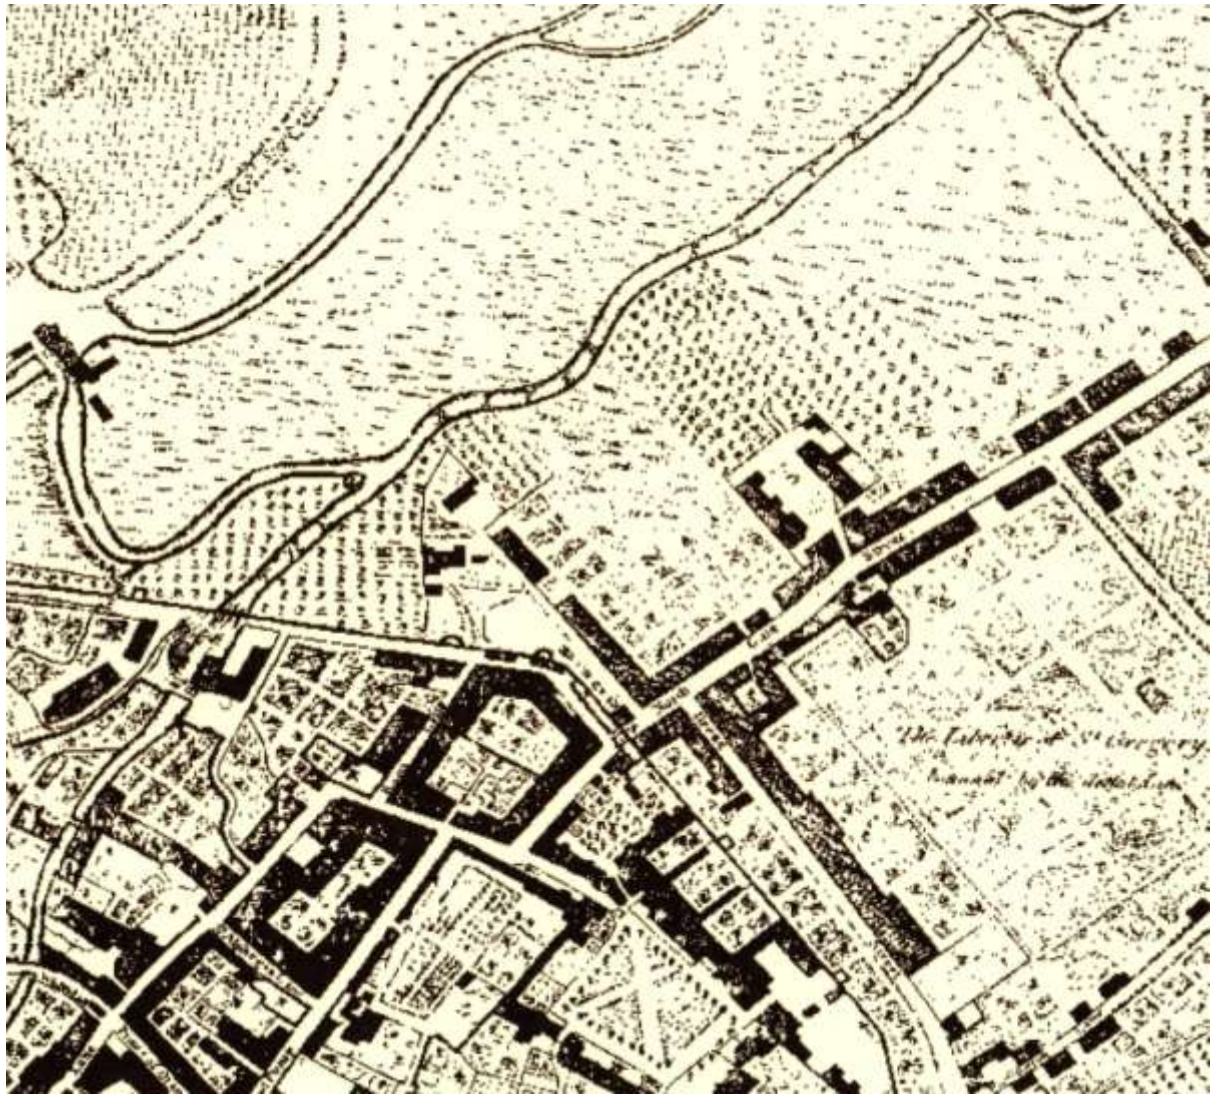
Figure 2. John Speed map of 1611

The maps of John Speed (1611) and Wenceslas Hollar (1670) seem to be based on an earlier survey, now lost but a detail show St John's Hospital to the west of Northgate with what appears to be a formal garden that is in later maps, a portion of which seems to be part of the PDA (Figure 2).

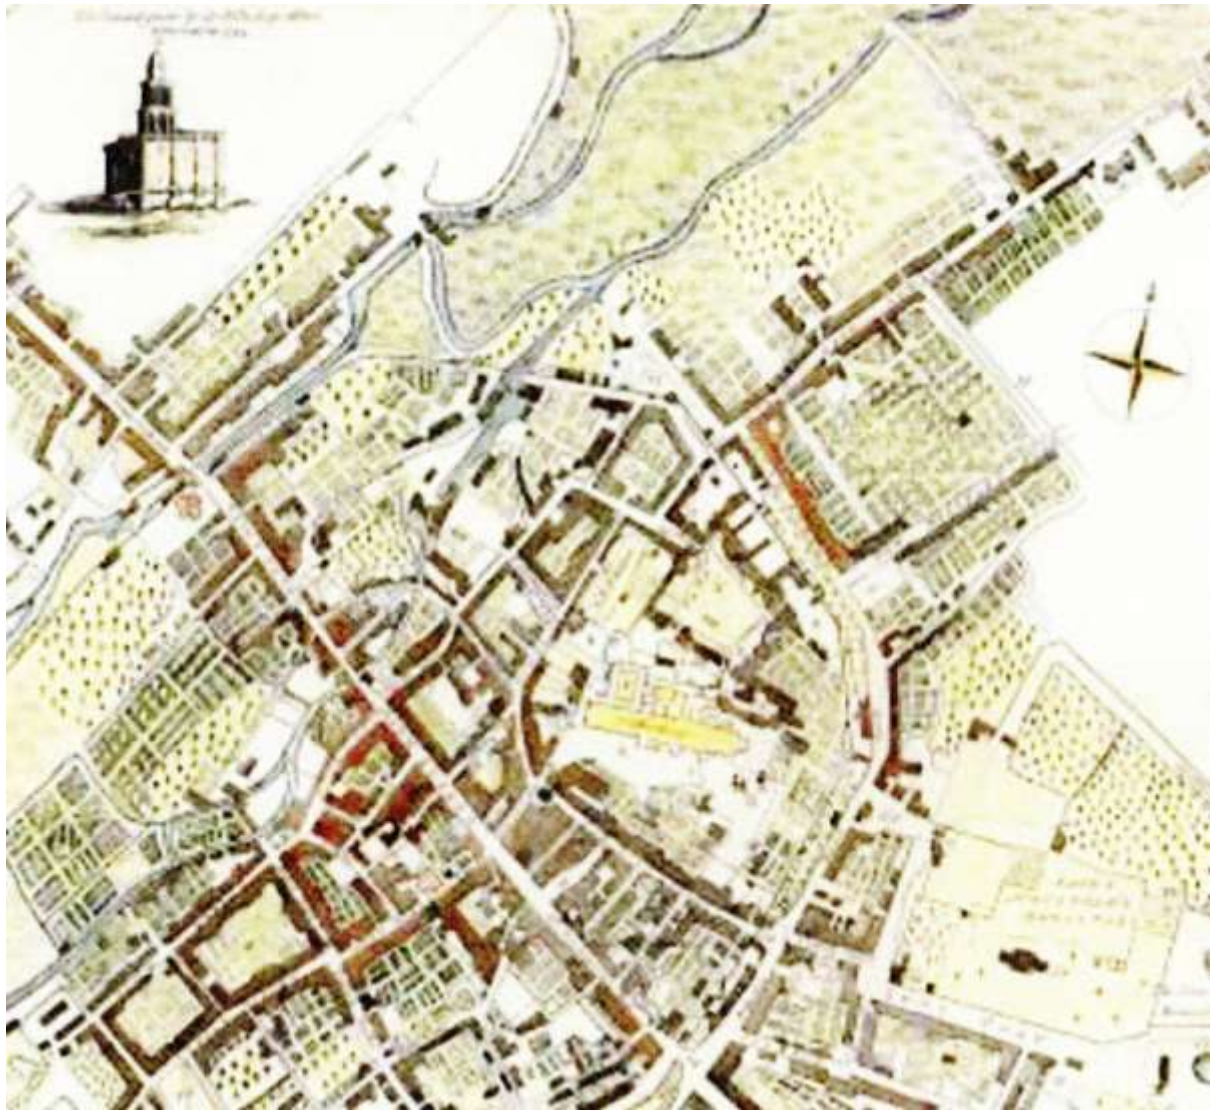
Figure 4. Fennar map of 1825

By 1825 the coloured map of Canterbury by Fenner shows the same layout of garden around the buildings of St John/s Hospital (Figure 3).

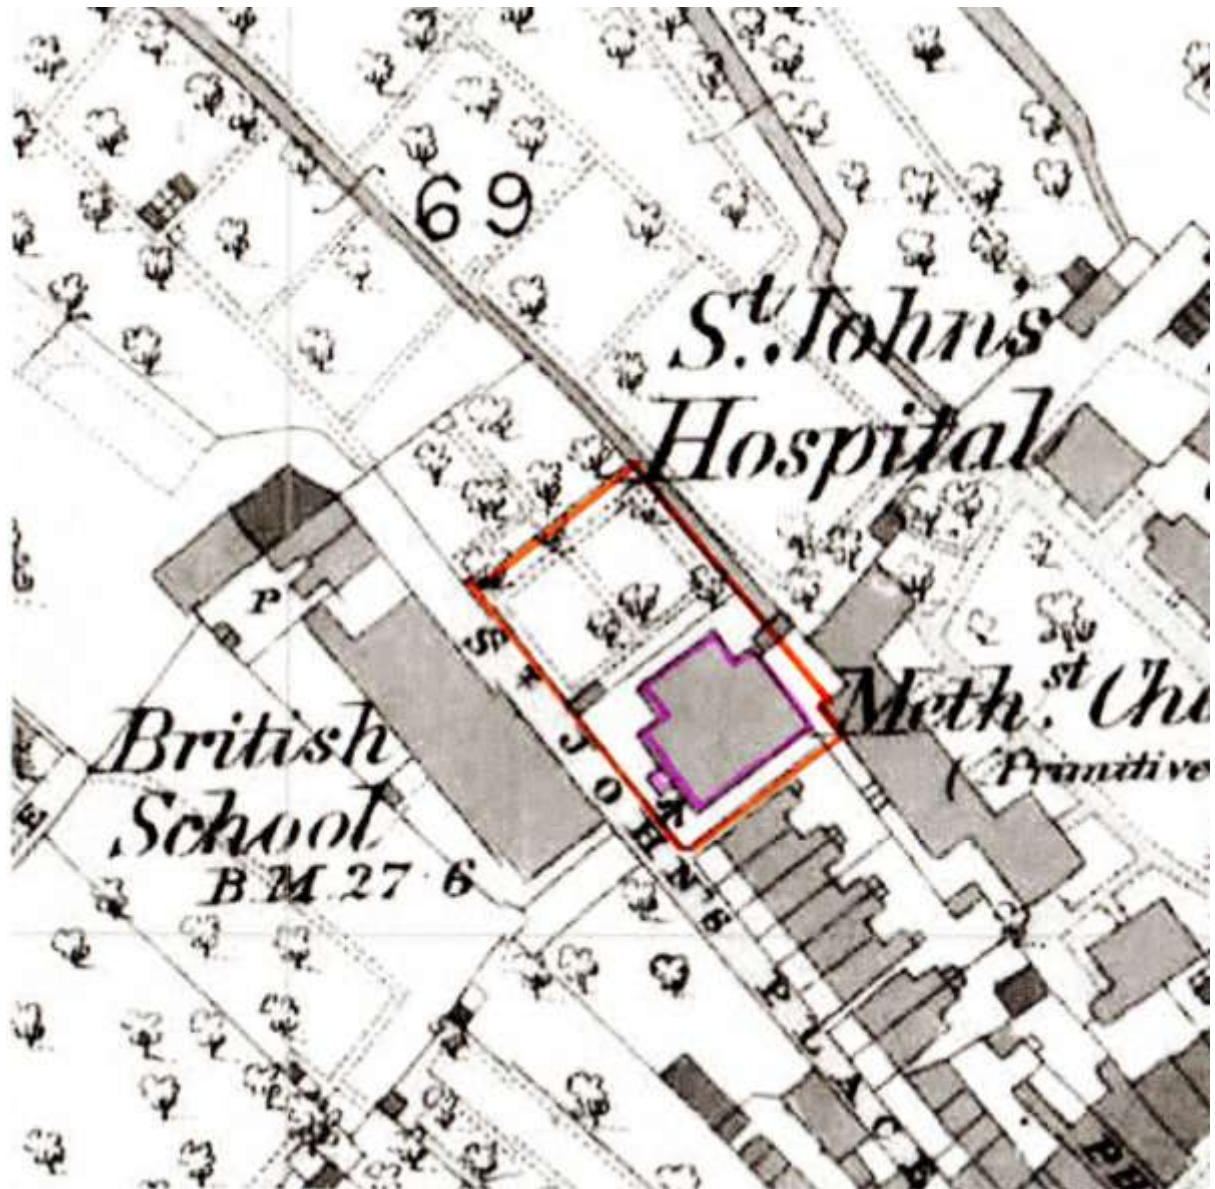
Figure 5. OS map of 1873

The Ordnance Survey map of 1873 shows for the first time buildings on the PDA, the Methodist (Primitive) Chapel, the British School opposite and terraced housing running along St John's Place (Figure 4).

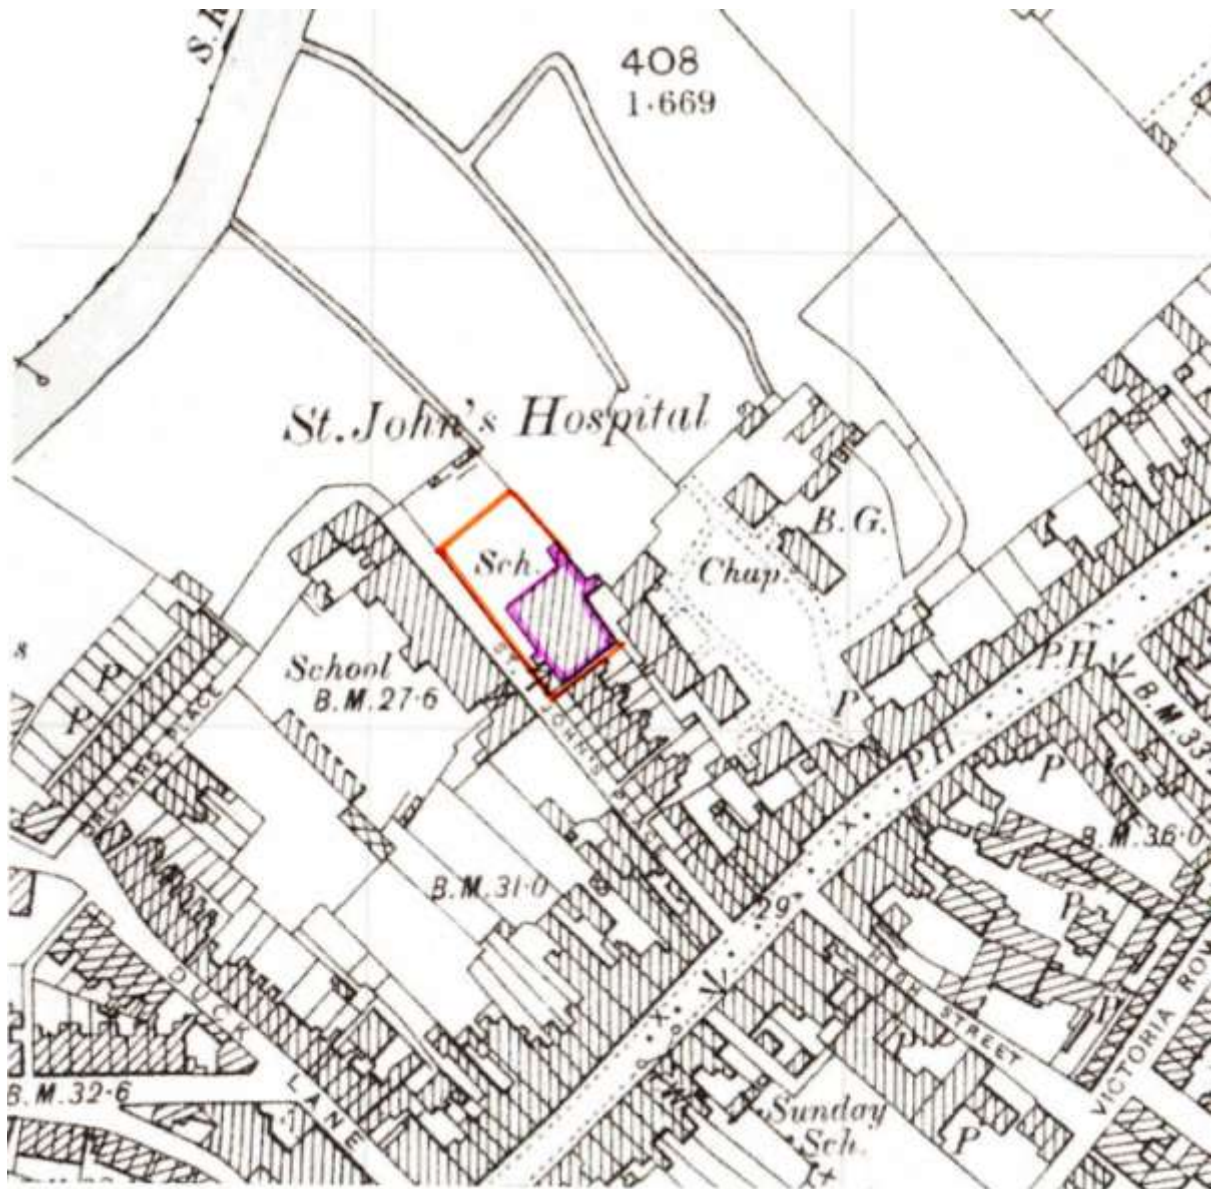
Figure 6. OS map of 1898

By 1898 the OS map shows the Methodist Chapel is now a school and the north-west facade has been rebuilt and the school opposite extended (Figure 5).

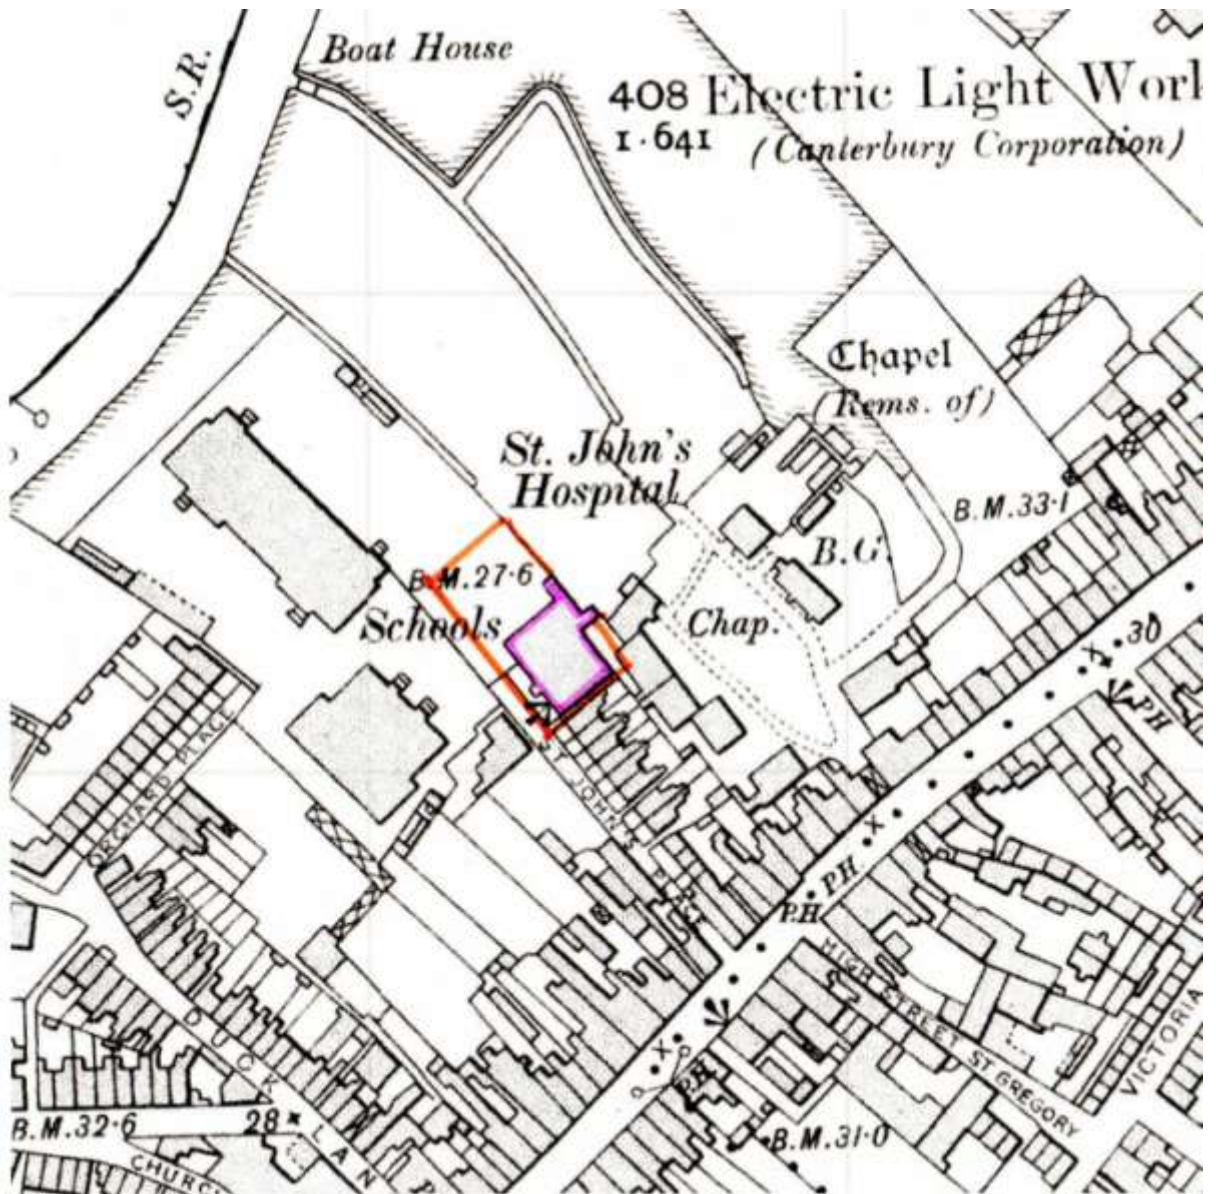
Figure 7. OS map of 1907

The 1907 OS map shows no change on the PDA but the school opposite has been demolished and rebuilt as two schools, one set back from St John's Place (Figure 6).

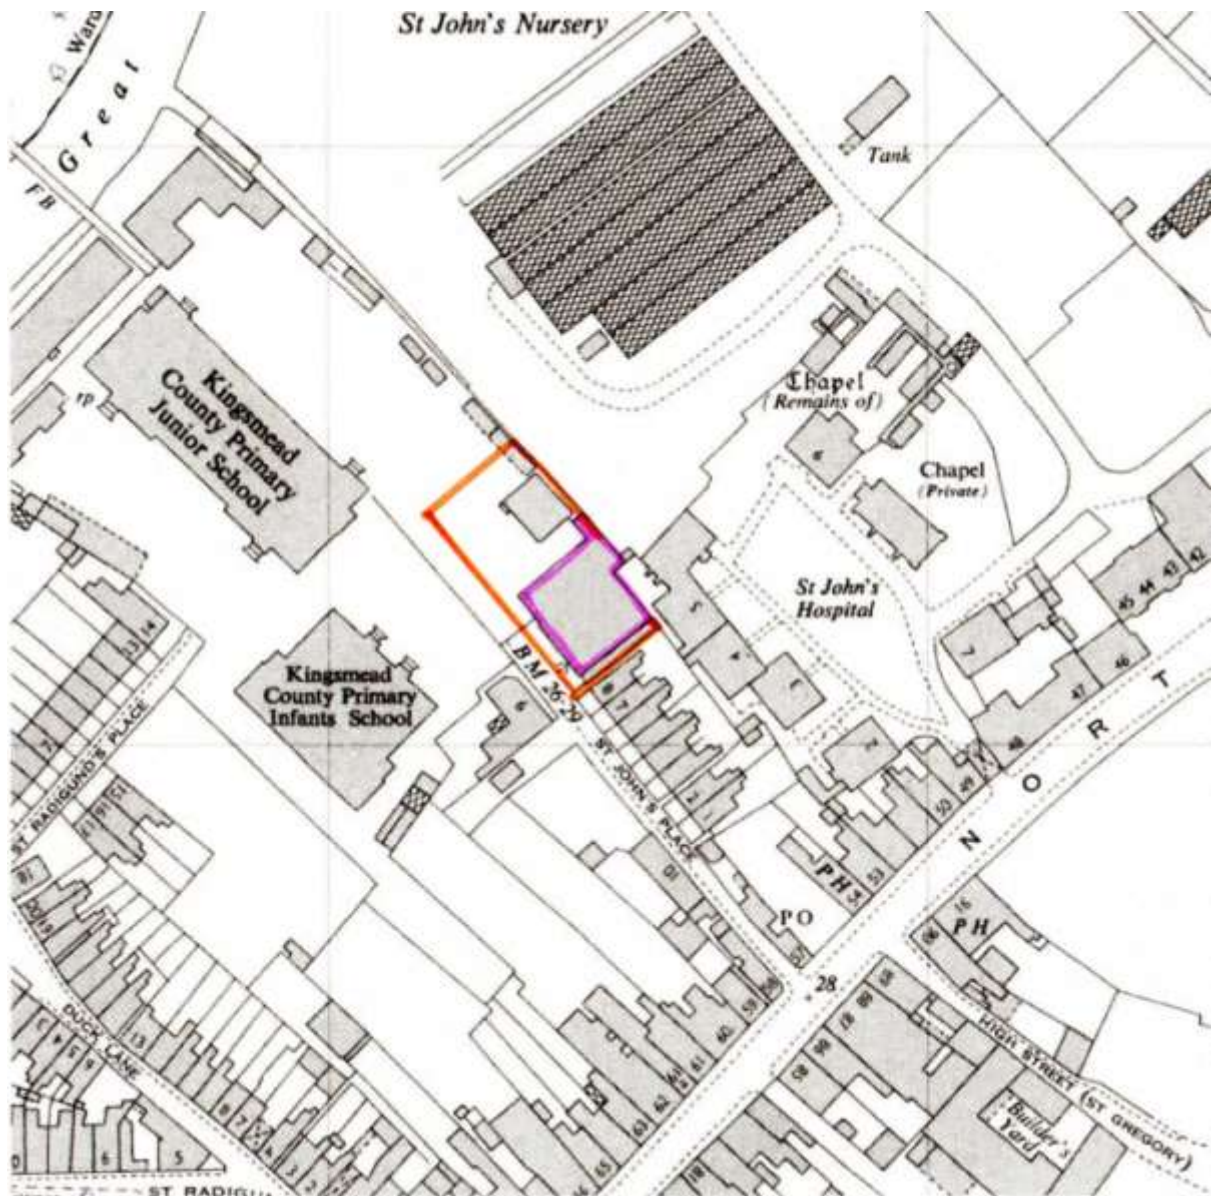
Figure 8. OS map of 1955

By 1955 the gardens of St John's Hospital have given way to large rectangular greenhouses-St John's Nursery. The strip of land running down from the PDA to the River Stour has now a number of buildings on it including one inside the PDA. The schools opposite are now named- Kingsmead County Primary Infants School and Kingsmead County Primary Junior School (Figure 7).

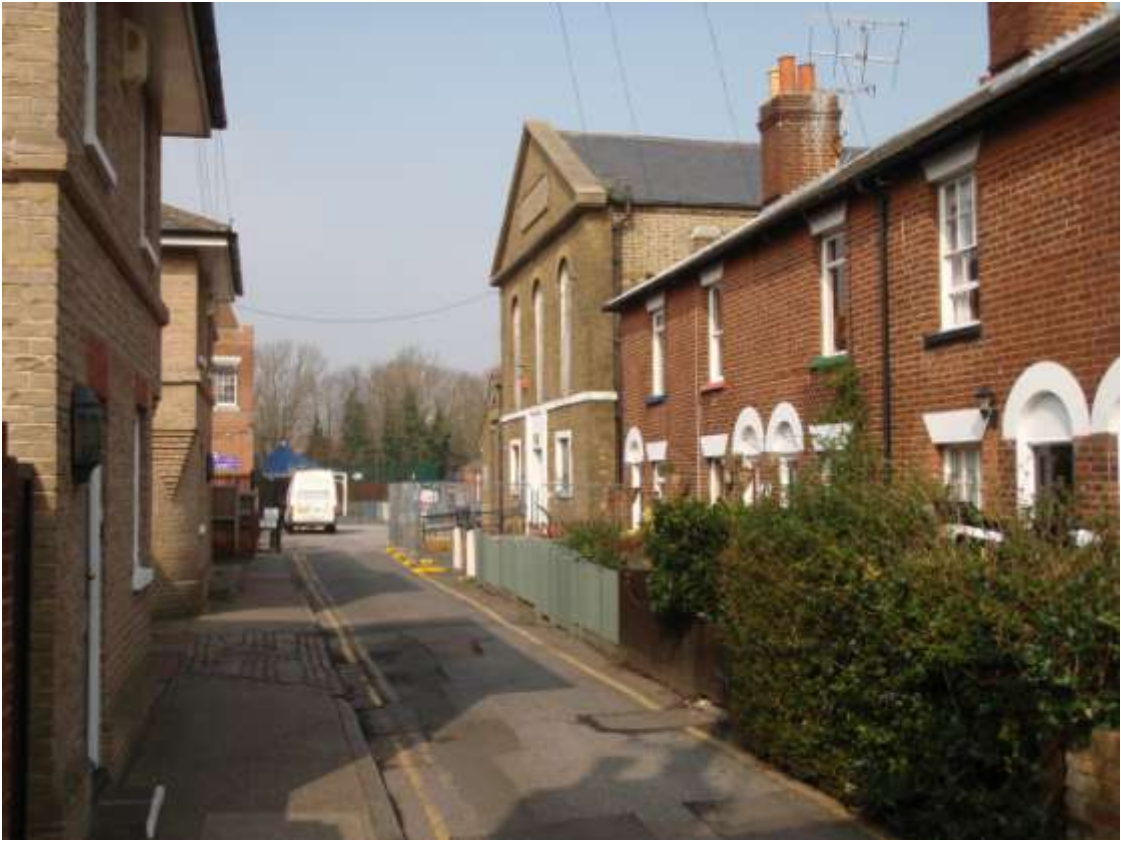
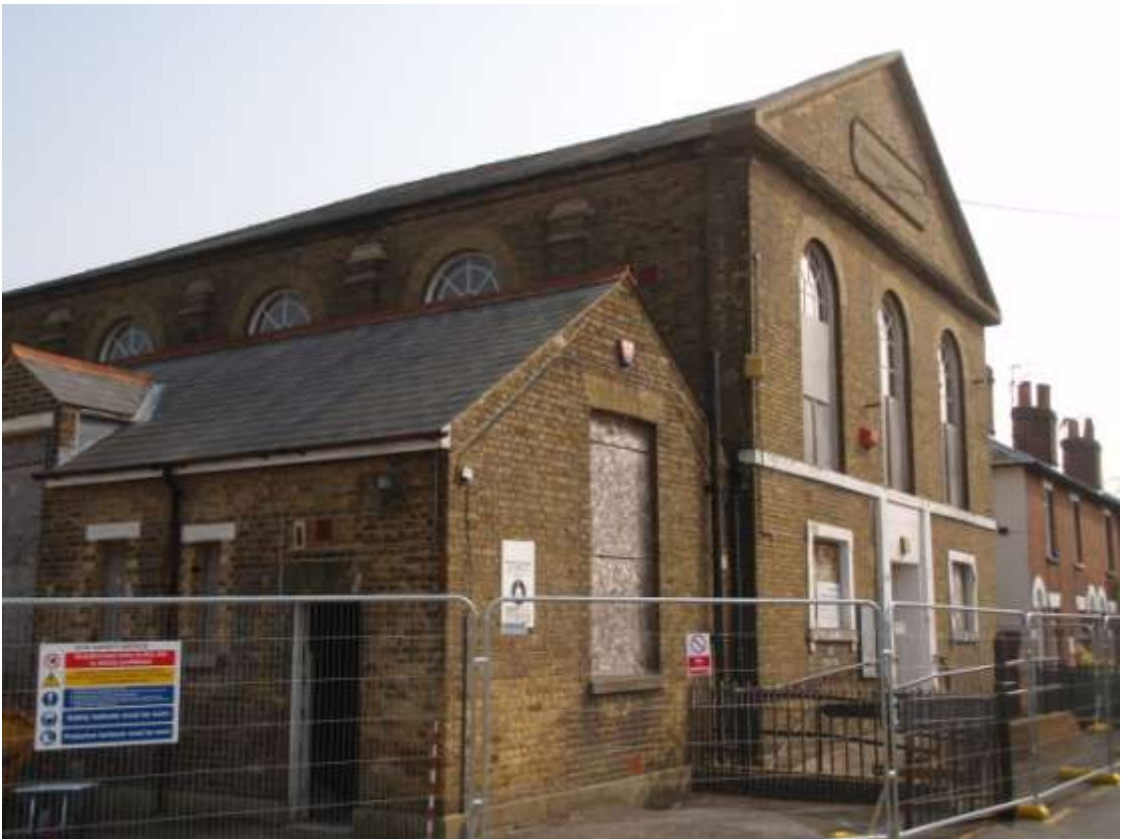
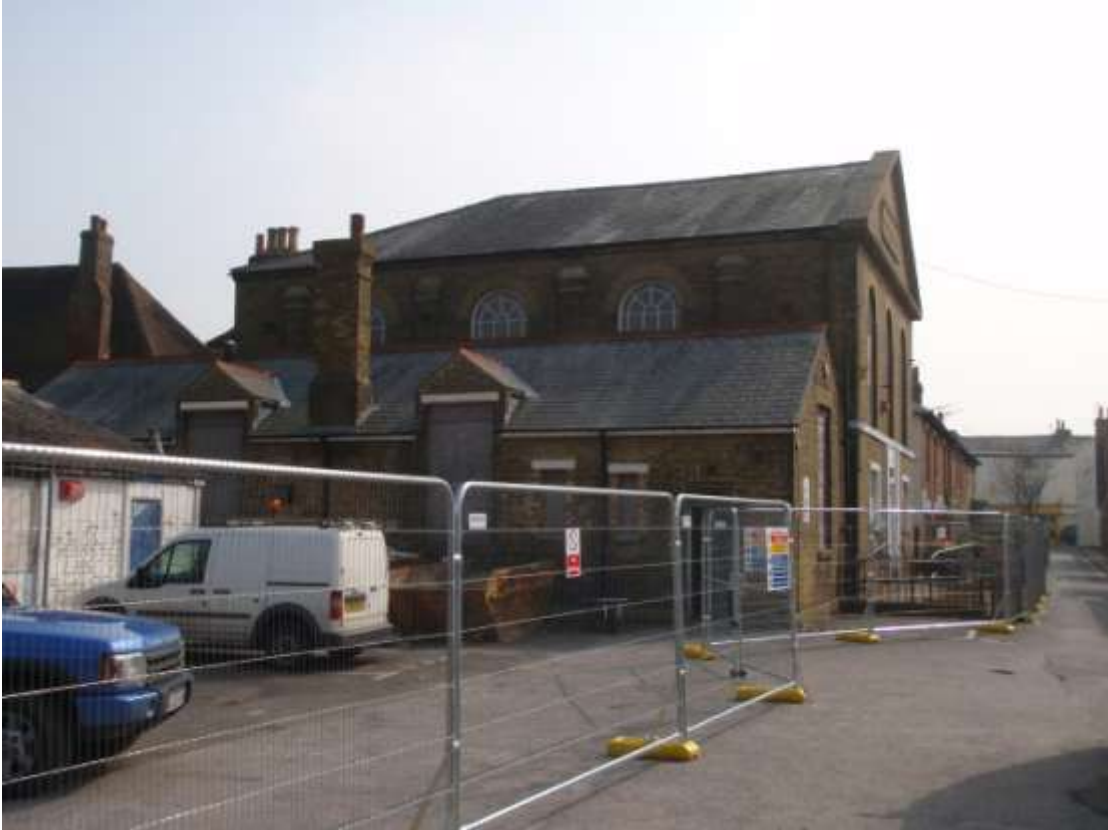
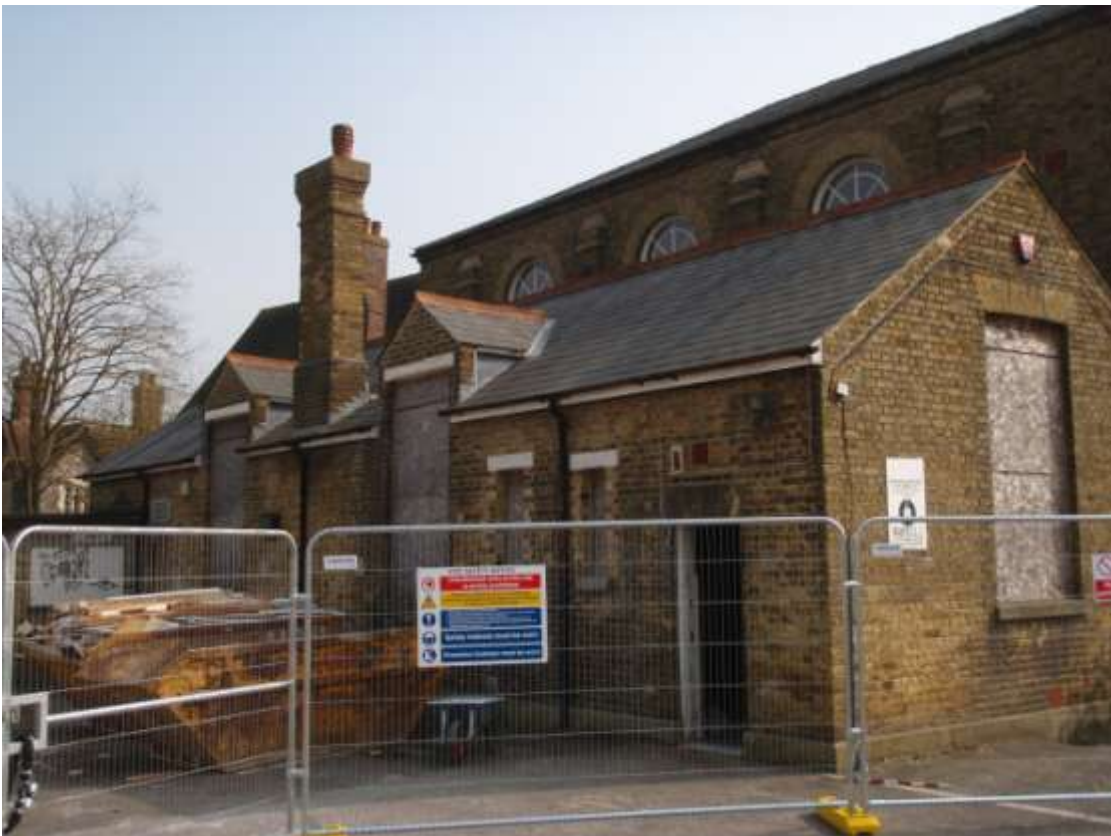
3.2.4 The sides of the building are built of Flemish bond brick with the upper storey defined by the stone stringer course with the same number of courses as seen on the frontage and bayed by four double height external brick-built buttresses about 0.60m wide and 7.25m high topped by a stone stringer course set three courses down and the top of the buttress flanchued by concrete render.

3.2.5 Both sides of the building are pierced in the upper storey by three recessed rounded original six over six sliding sash windows which measure 3.25m high and 1.55m wide and are topped by an arched soldier course of rubbed buff bricks.

The lower storey is somewhat restricted in the recording by the Victorian building adjacent to the school but seemed to have six rectangular windows about 1.60m square with a stone cill and rubbed brick segmental arch.

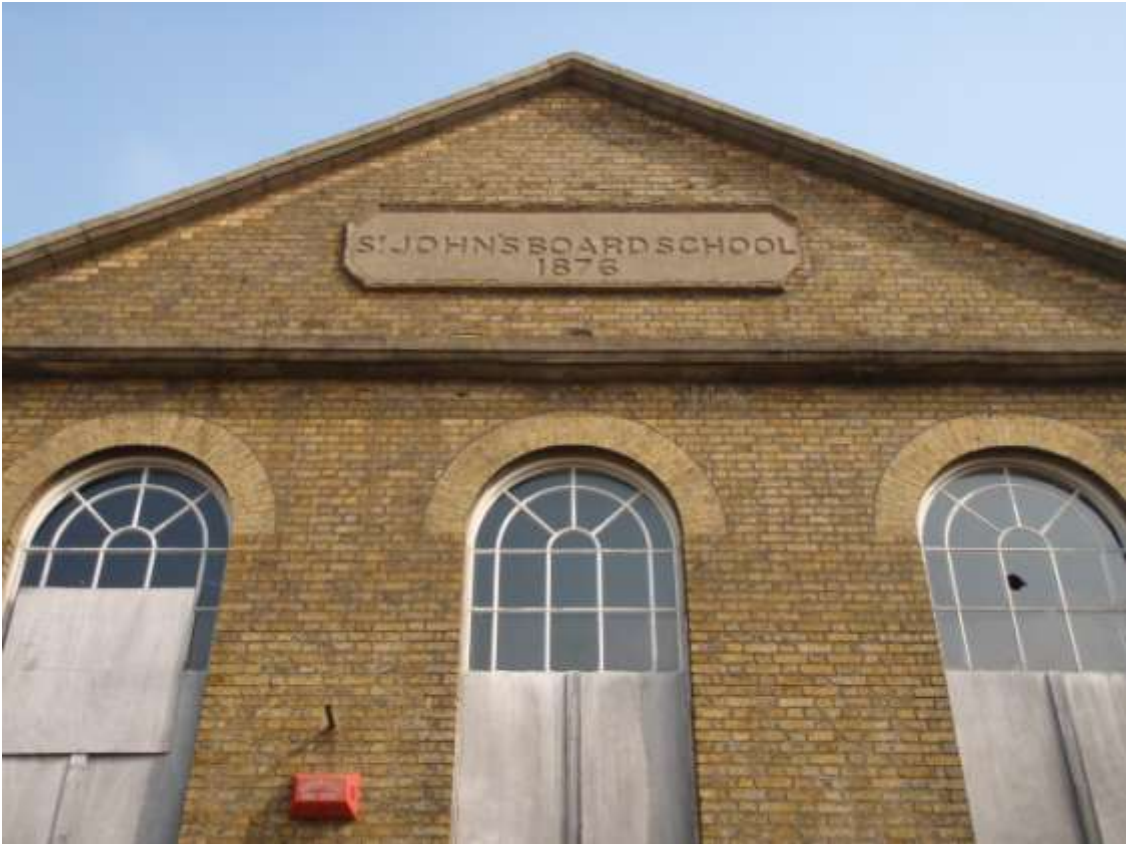
Plate 5. View of façade

The building is a two storied rectangular shaped building with a slate pitched roof and hipped to the rear is fronted by a classical facade topped by a brick built triangular pediment framed by a moulded stone raking cornice embellished on the pediment with a stone rectangular plaque carved with an inscription in capital letters ' St. JOHN'S BOARD SCHOOL 1876'.

The dimensions of the facade are 11.40m wide, 3.80m to the stringer course and 4.00m to the lower pediment course. The pediment is 3.20m high and 12.00m wide with the stone plaque 3.70m wide and 0.80m high.

3.1.2 The frontage is built with buff bricks laid in a Flemish bond pattern with 46 courses to the white painted stone string course and 52 courses above. The facade is pierced in the upper storey by three recessed rounded original six over six sliding sash windows which measure 3.25m high and 1.55m wide and are topped by a arched soldier course of rubbed buff bricks.

The windows seem to have the original glass and the glazing bars are of ovolo moulded pine painted white. The lower two rectangular windows set either side of the main double-leafed door are 1.60m wide and 1.60m high. The windows are boarded up but the white painted stone architrave and cill can still be seen.

3.2.3 The doorway is described in the EH listing as 'door case is set within a wide moulded architrave' which unfortunately has not survived the test of time and is now a blue painted double timber door set into a white painted stone door case framed by two rectangular stone engaged columns without any carved decoration. The entrance is 2.30m wide centre to centre on the columns and 2.30m high whilst the two doors are 1.50m wide.

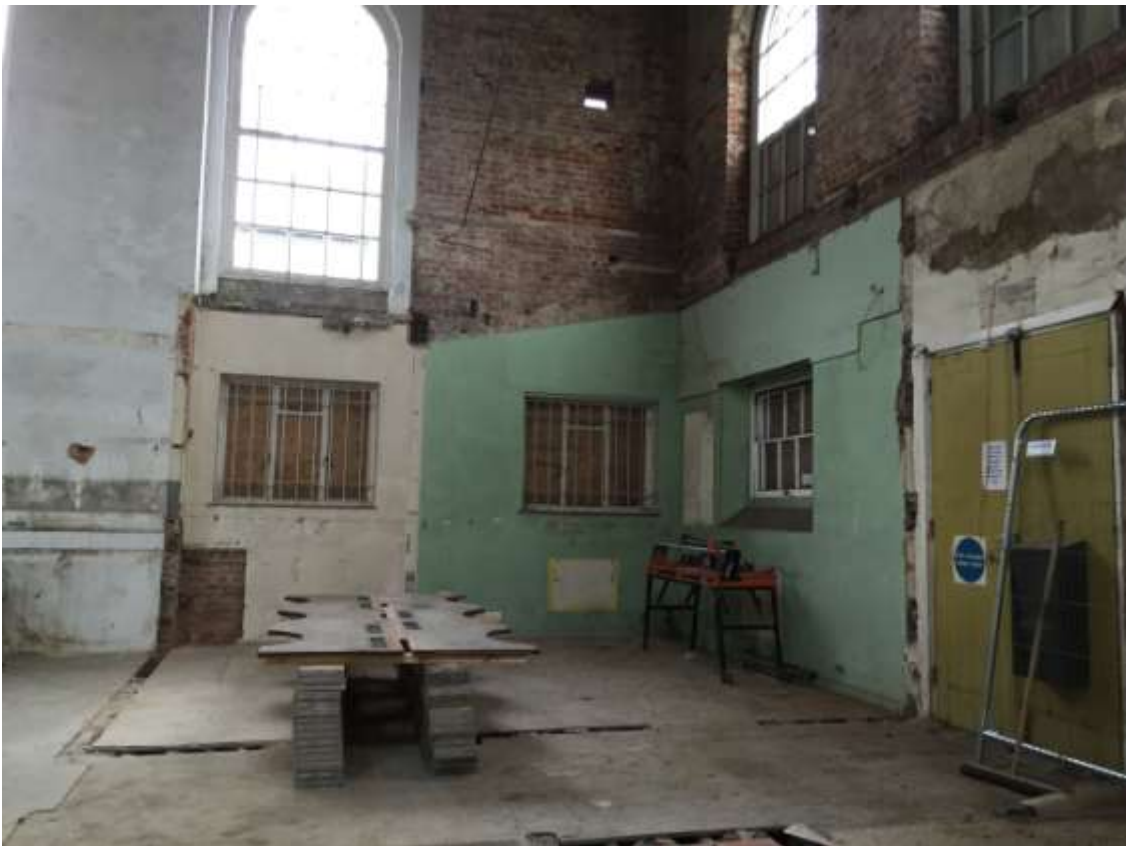
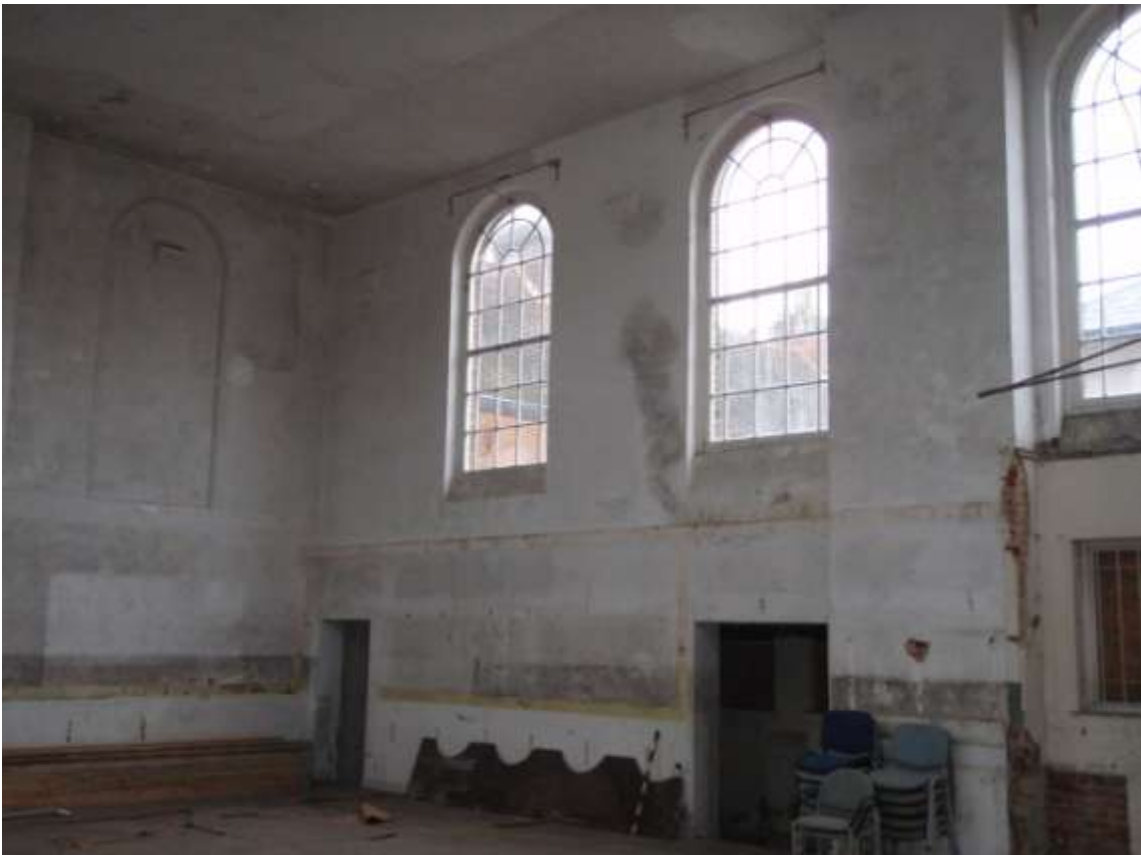
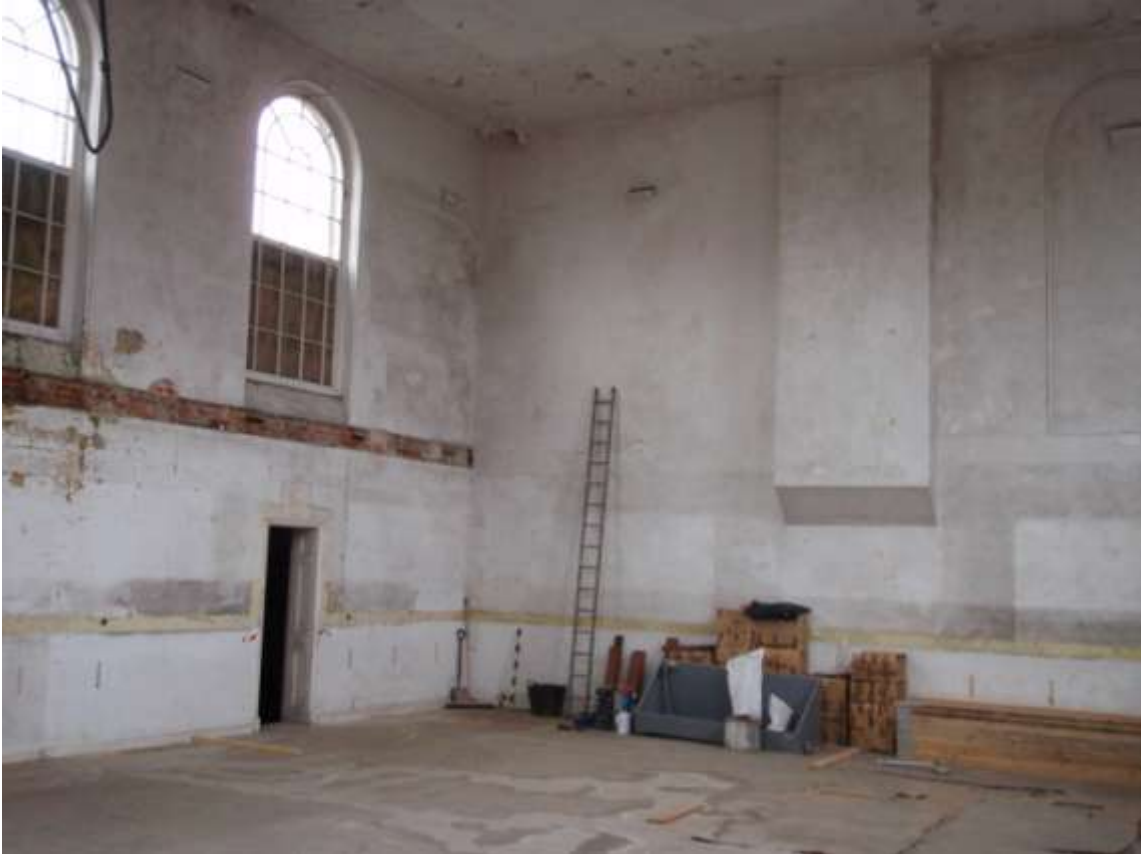
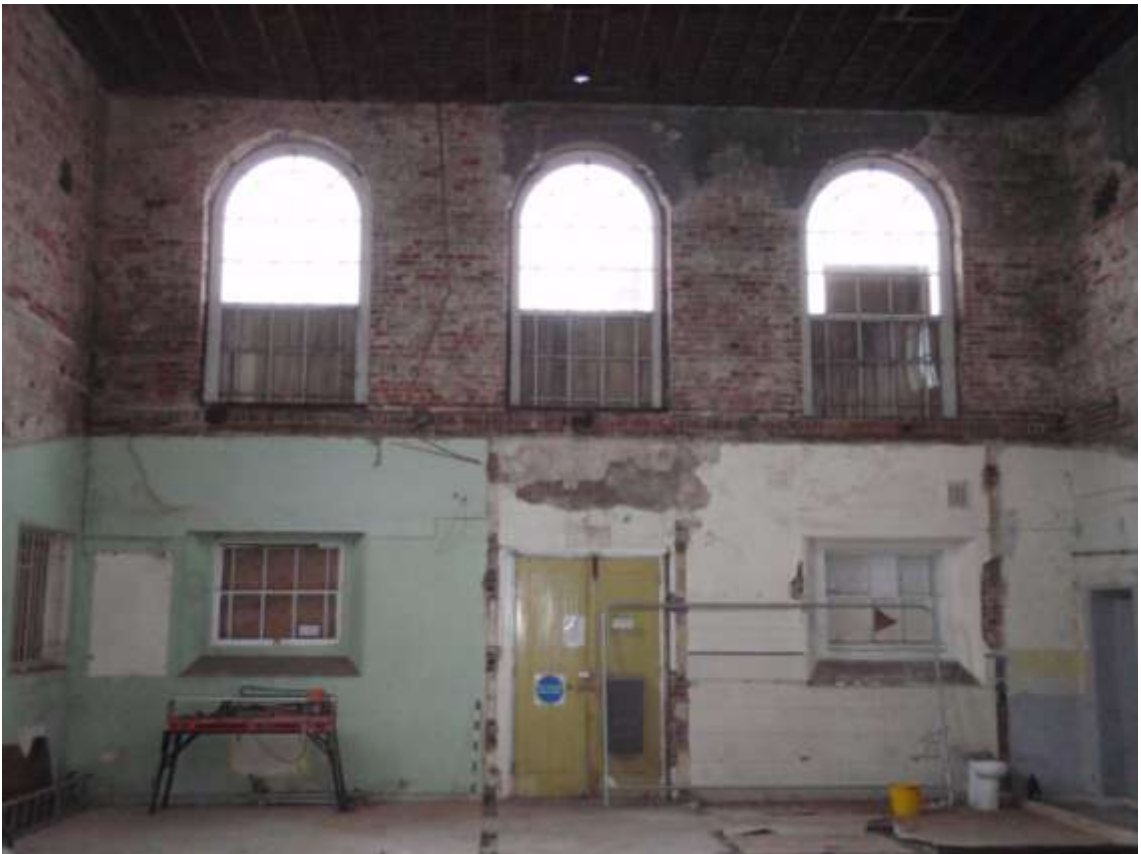
4.1 The main hall has lost all of its internal fittings and what is left is a large double height space that is filled with light from the nine rounded sliding sash windows.

4.2 Removal of the internal fittings and some demolition had already taken place at the time of the survey but photographs are useful for the interior layout (Plates 6, 8-10).
