Archaeological Evaluation of Land adjoining Sunhallow, Gore Lane, Eastry, near Sandwich, Kent

Site Code: SHE/EV/17

Planning Application: DOV/17/00267

August 2017

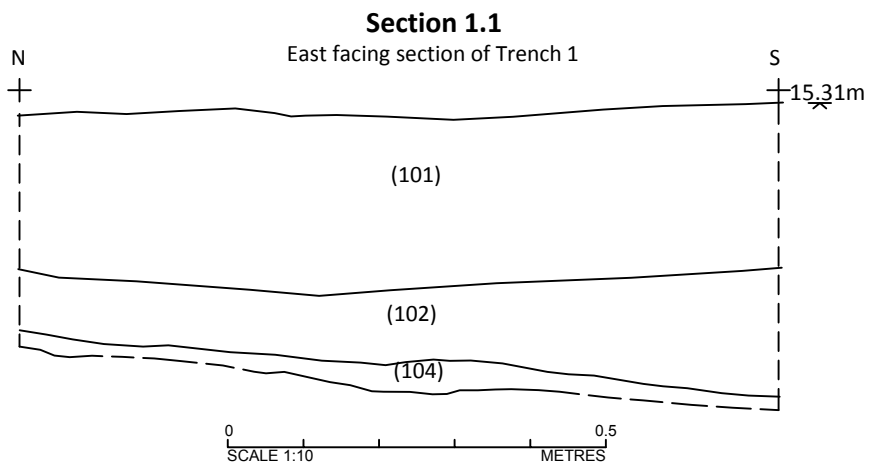
Figure 3: Trench 1 - plan and sections

Trench 1 (Figure 3, Plates 8-10 inclusive)

The trench measured 1.6x17.8m. Trench 1 exposed the Margate Chalk geology intersected by several features which on investigation turned out to be periglacial. No archaeology was revealed.

(101) Top-soil

(102) Sub-soil

(103) Rolling chalk/ head – Pale orange brickearth

(104) Solid chalk geology

[105] Cut of natural geological feature (periglacial)

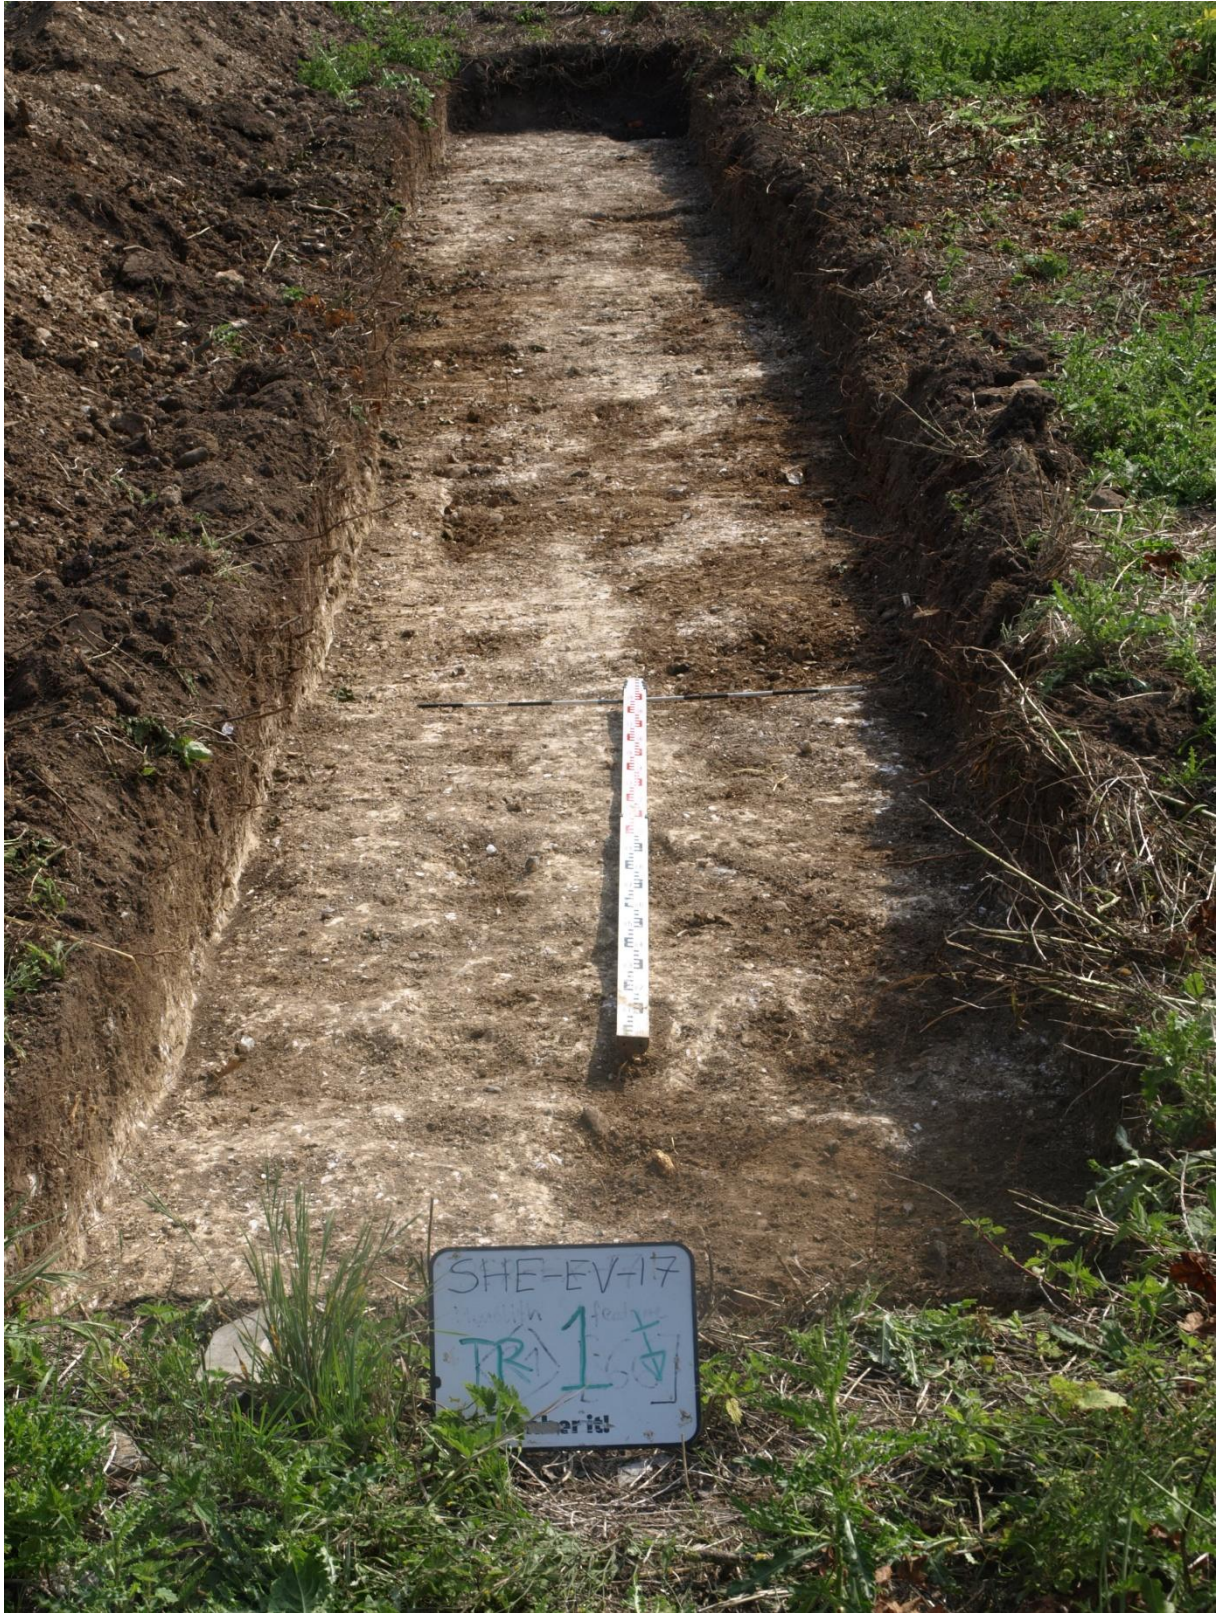
Plate 8: Showing Evaluation Trench 1. Looking south, one and two-metre scales.

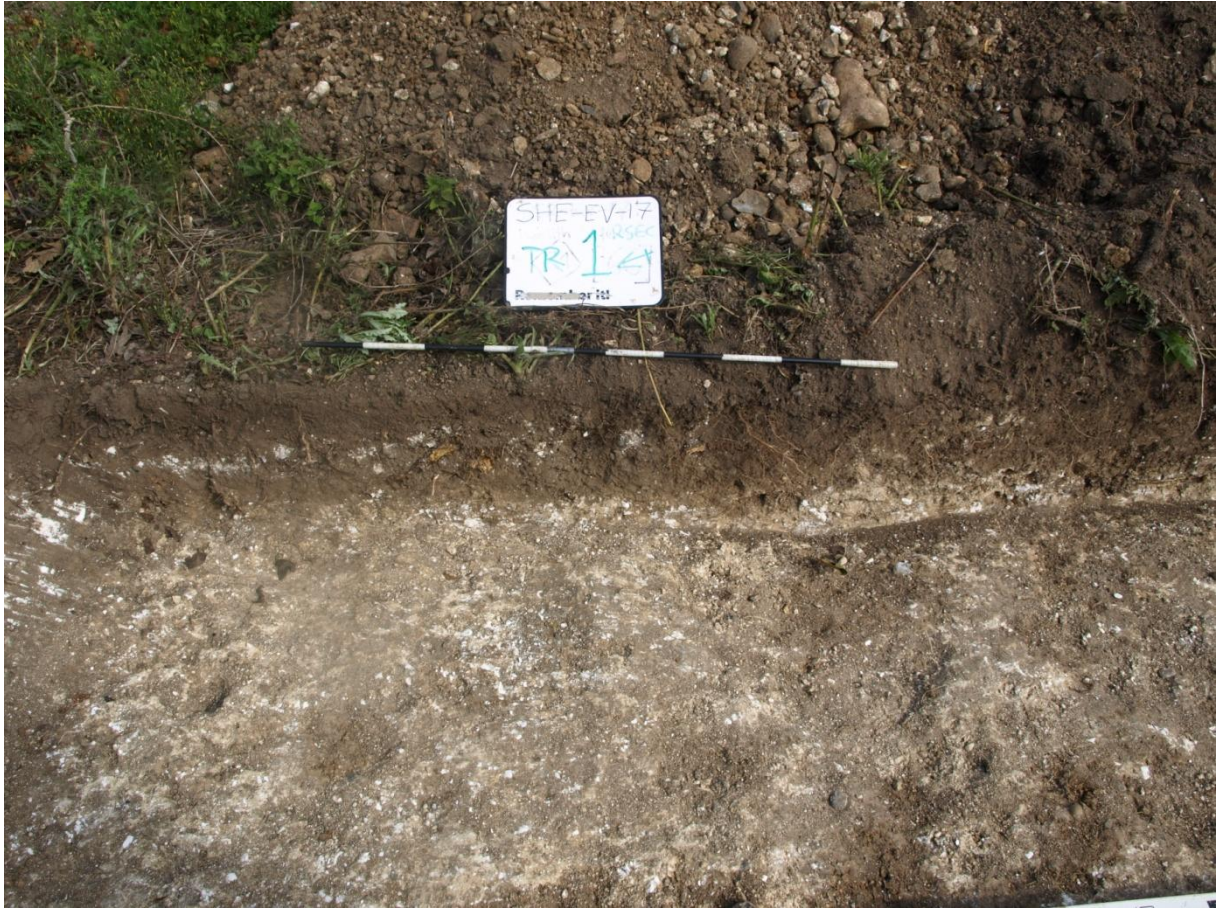
Plate 9: Showing representative section 1.1 in Trench 1. Looking east, one metre scale.

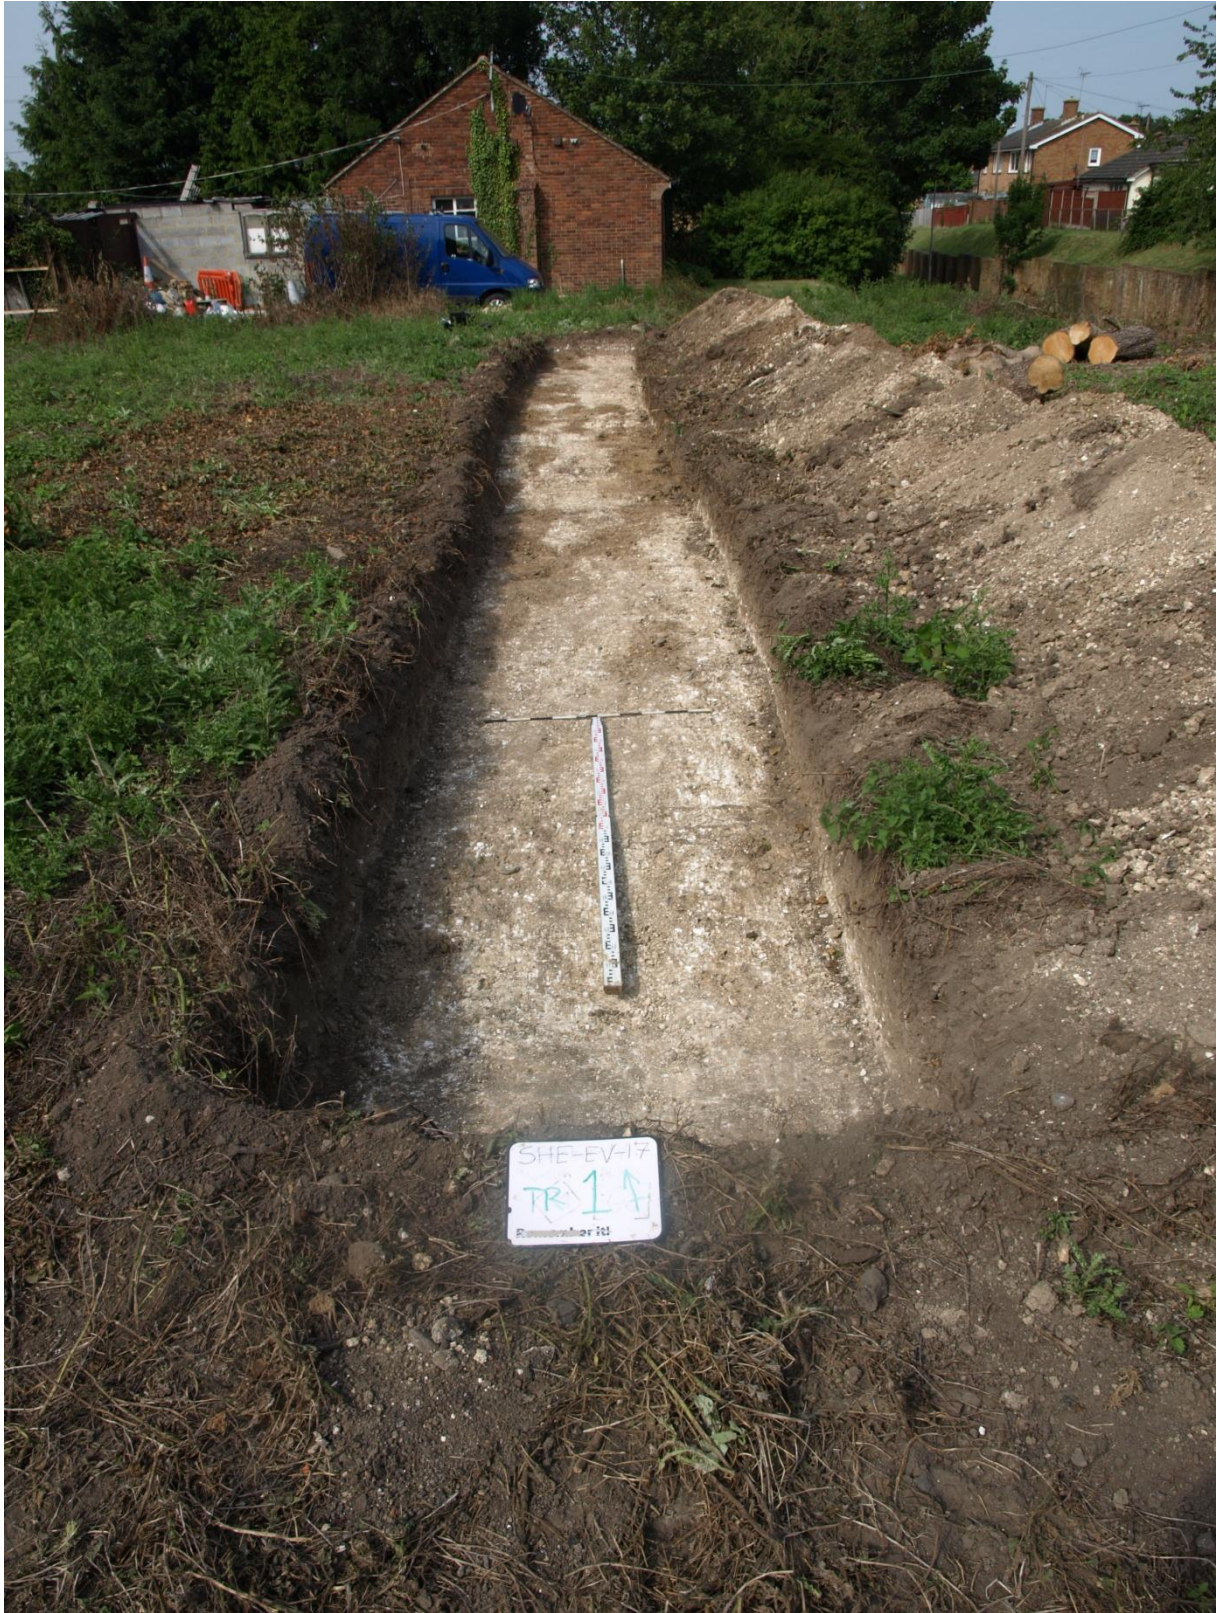
Plate 10: Showing Evaluation Trench 1. Looking North, one and two-metre scales.

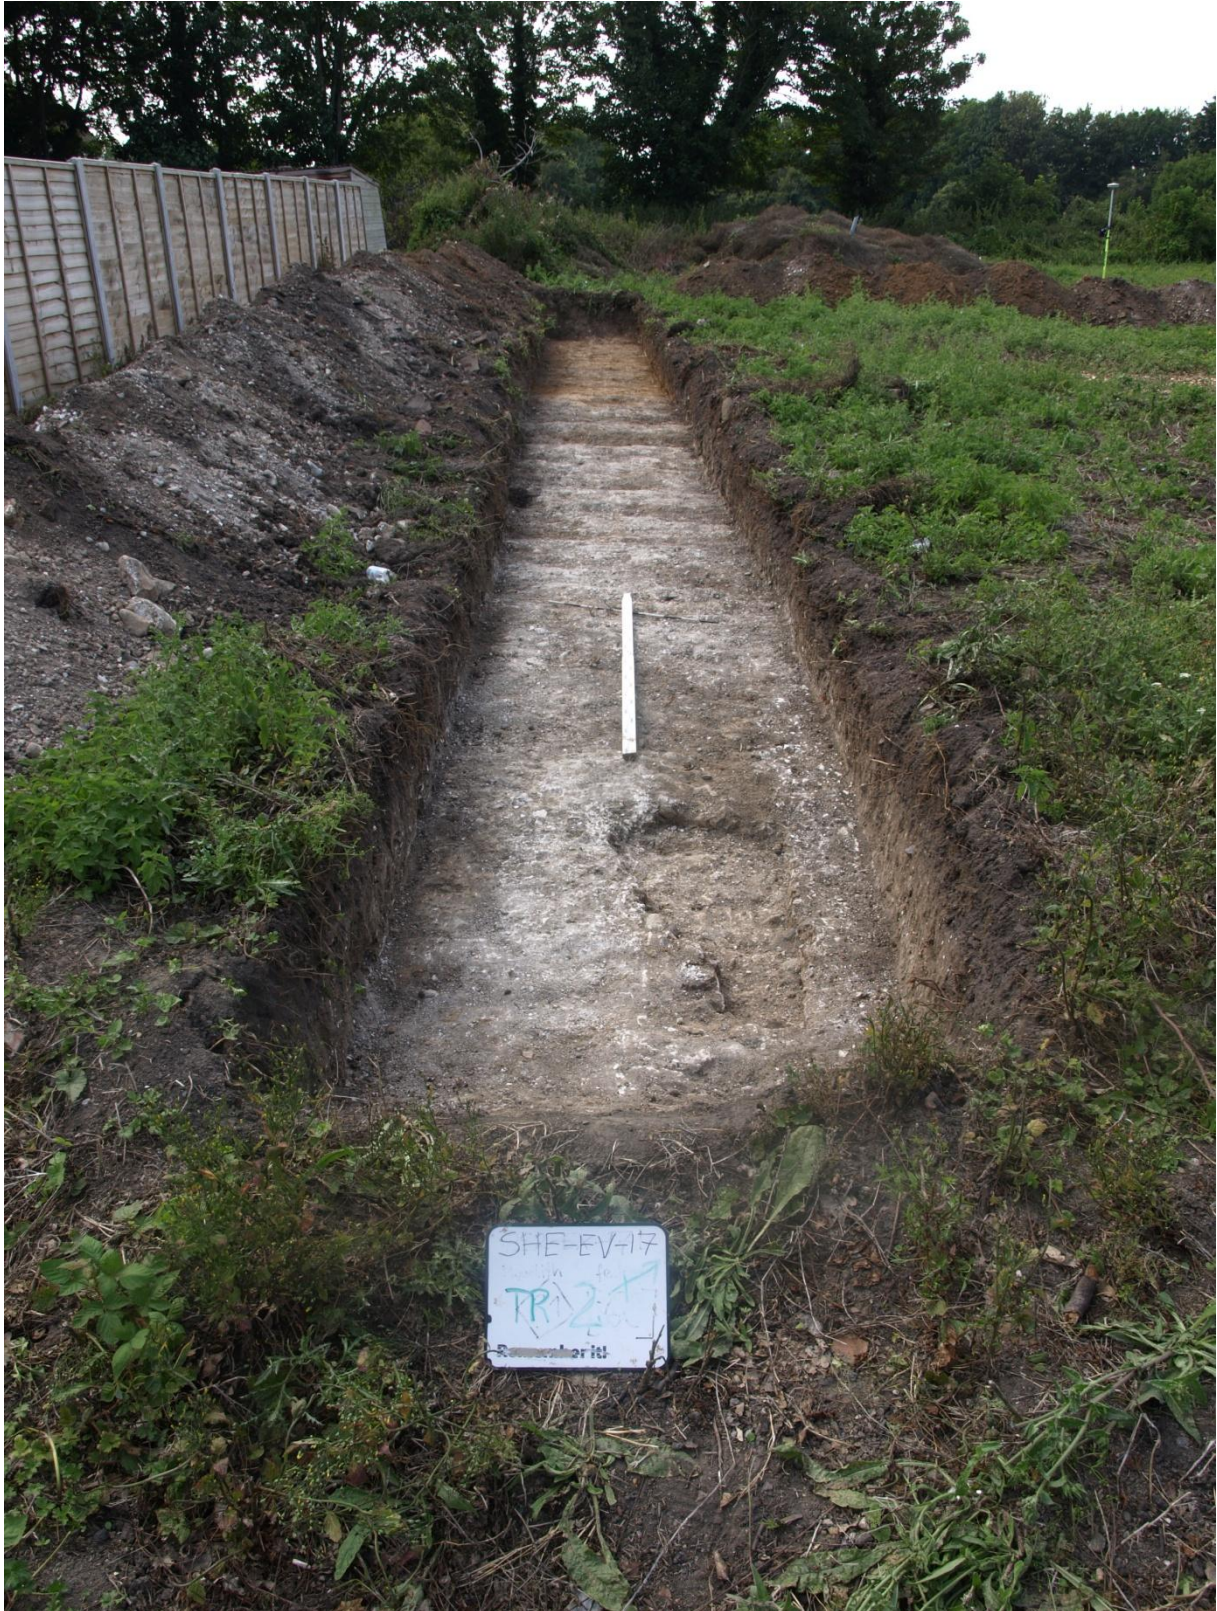
Trench 2 exposed solid chalk geology (204) capped by head deposit (203). Within the eastern extent of the trench a disintegrated chalk wall (207) was present (Figure 4) accommodated within construction cut [205]. The foundation trench was partially back-filled by context (206), comprising moderately compacted, dark-grey, clay-silt with moderate flint cobbles. Remaining areas of the evaluation trench exposed a modern water main and several shallow modern intrusions.

Plate 11: Showing Trench 2, looking west. Almost entirely robbed-out wall (207) visible in foreground. One and two-metre scales.

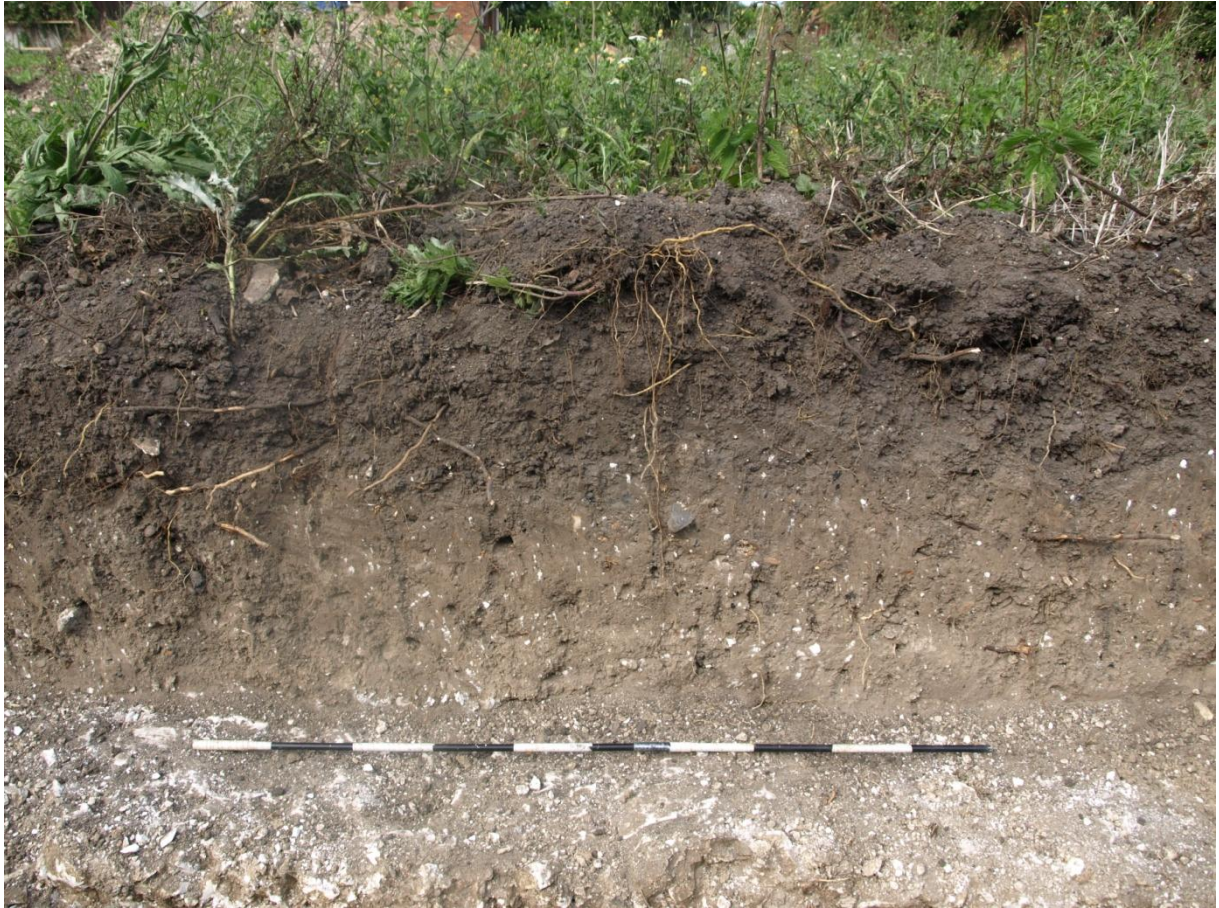
Plate 12: Showing representative section 2.1 in Trench 2. Looking north-east, one-metre scale.

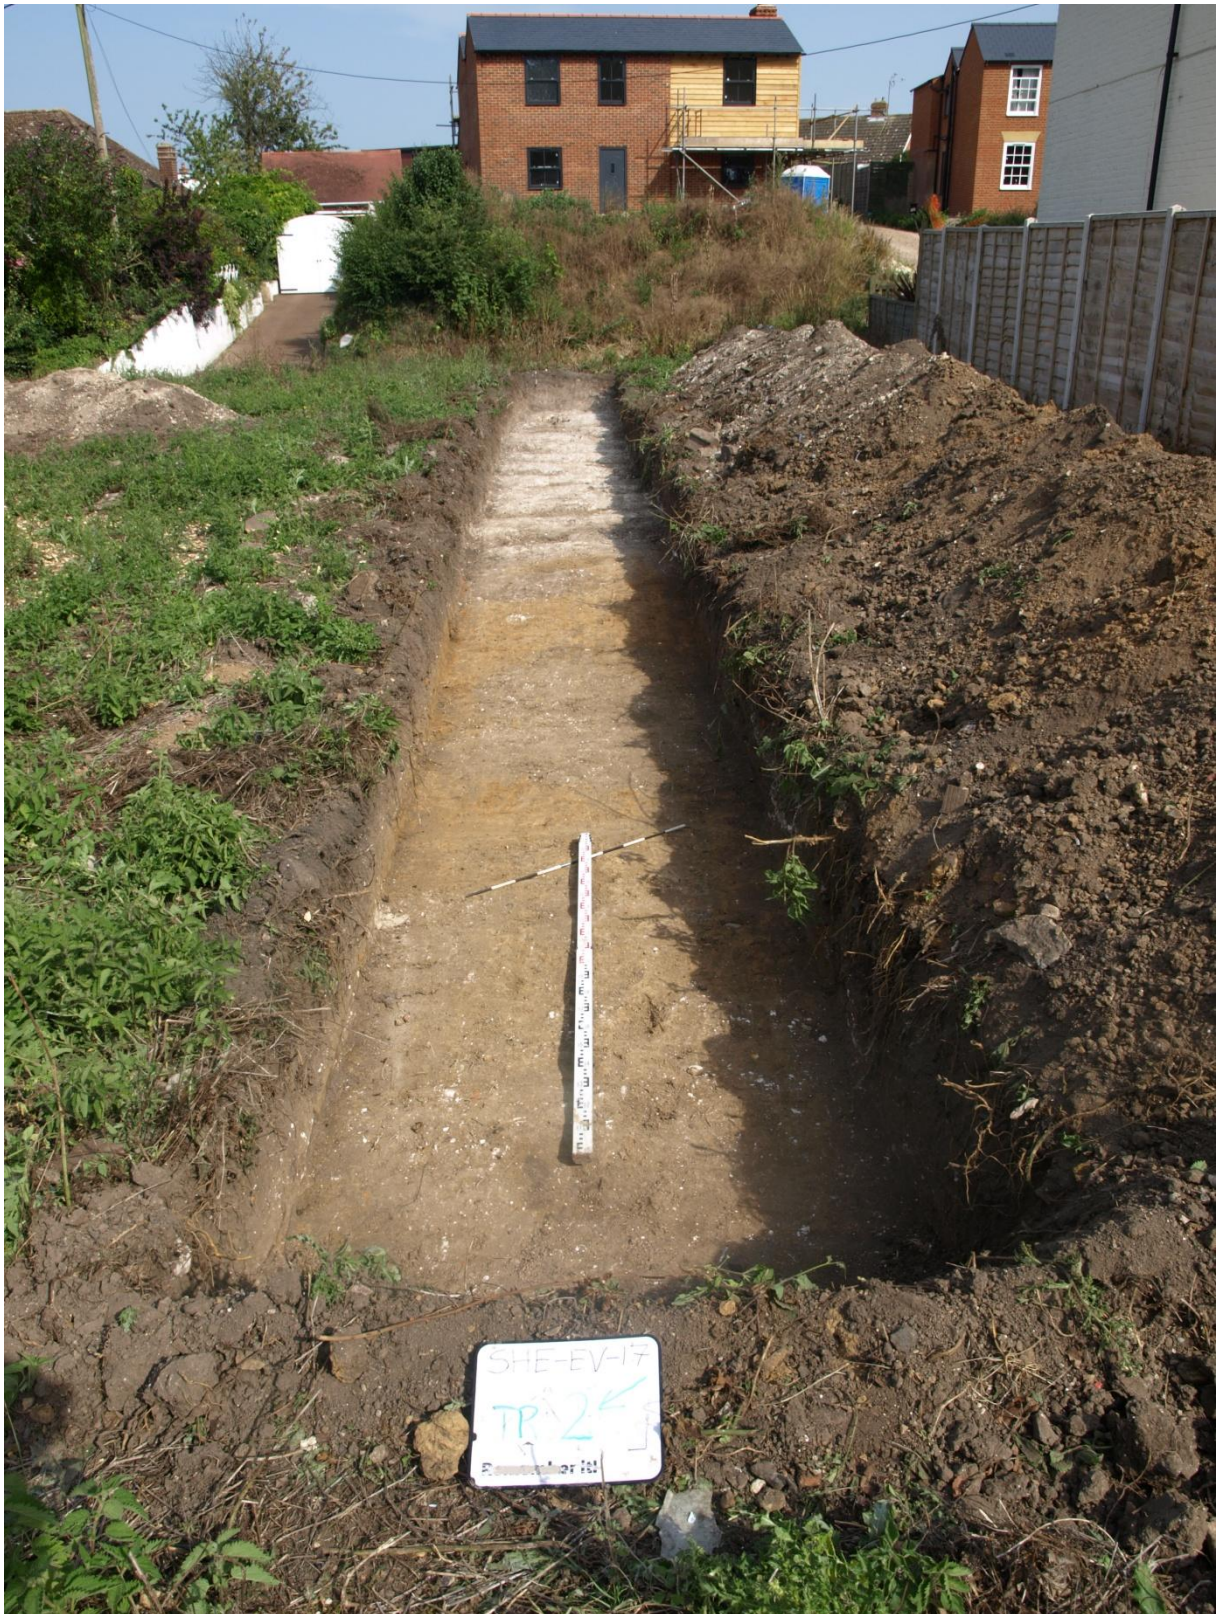
Plate 13: Showing Evaluation Trench 2. Looking east, one and two-metre scales. Modern intrusions visible in foreground.

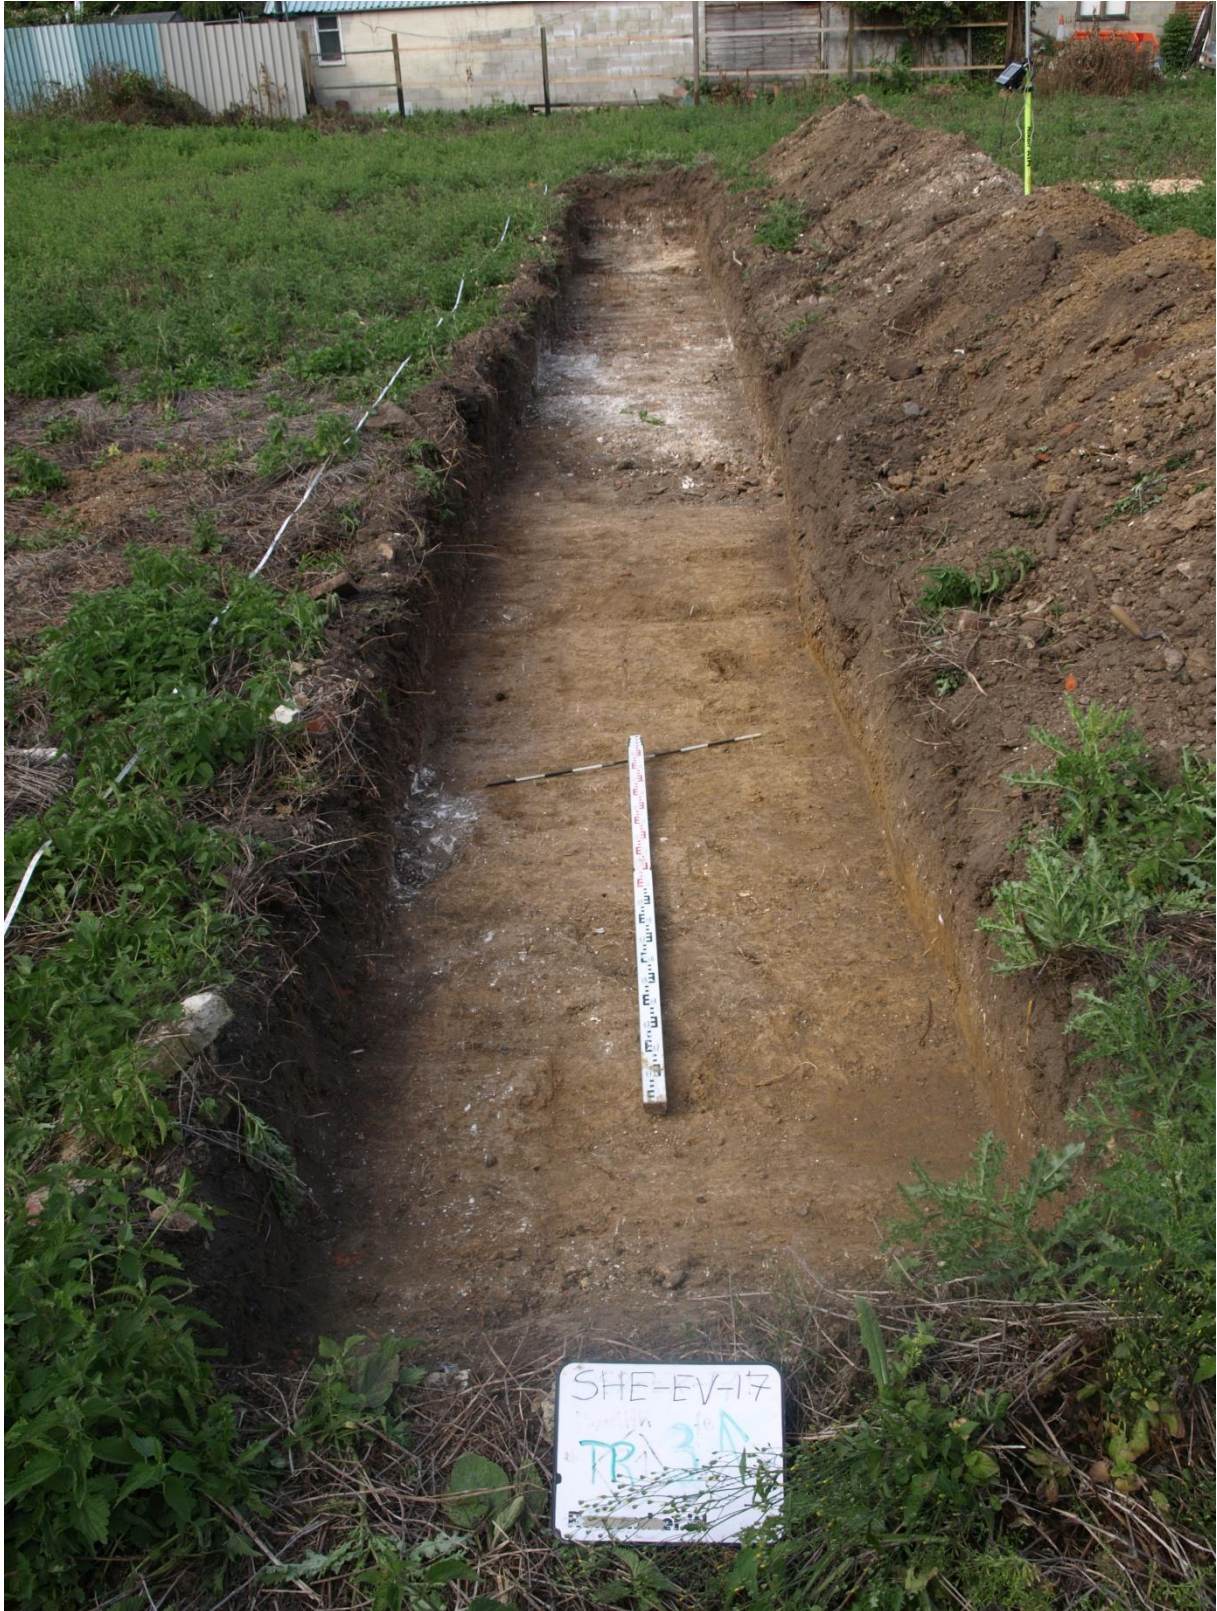
Plate 14: Showing Evaluation Trench 3. Looking north, one and two-metre scales. Natural chalk outcrop visible to the left, modern refuse pits [305] and [307] in background.

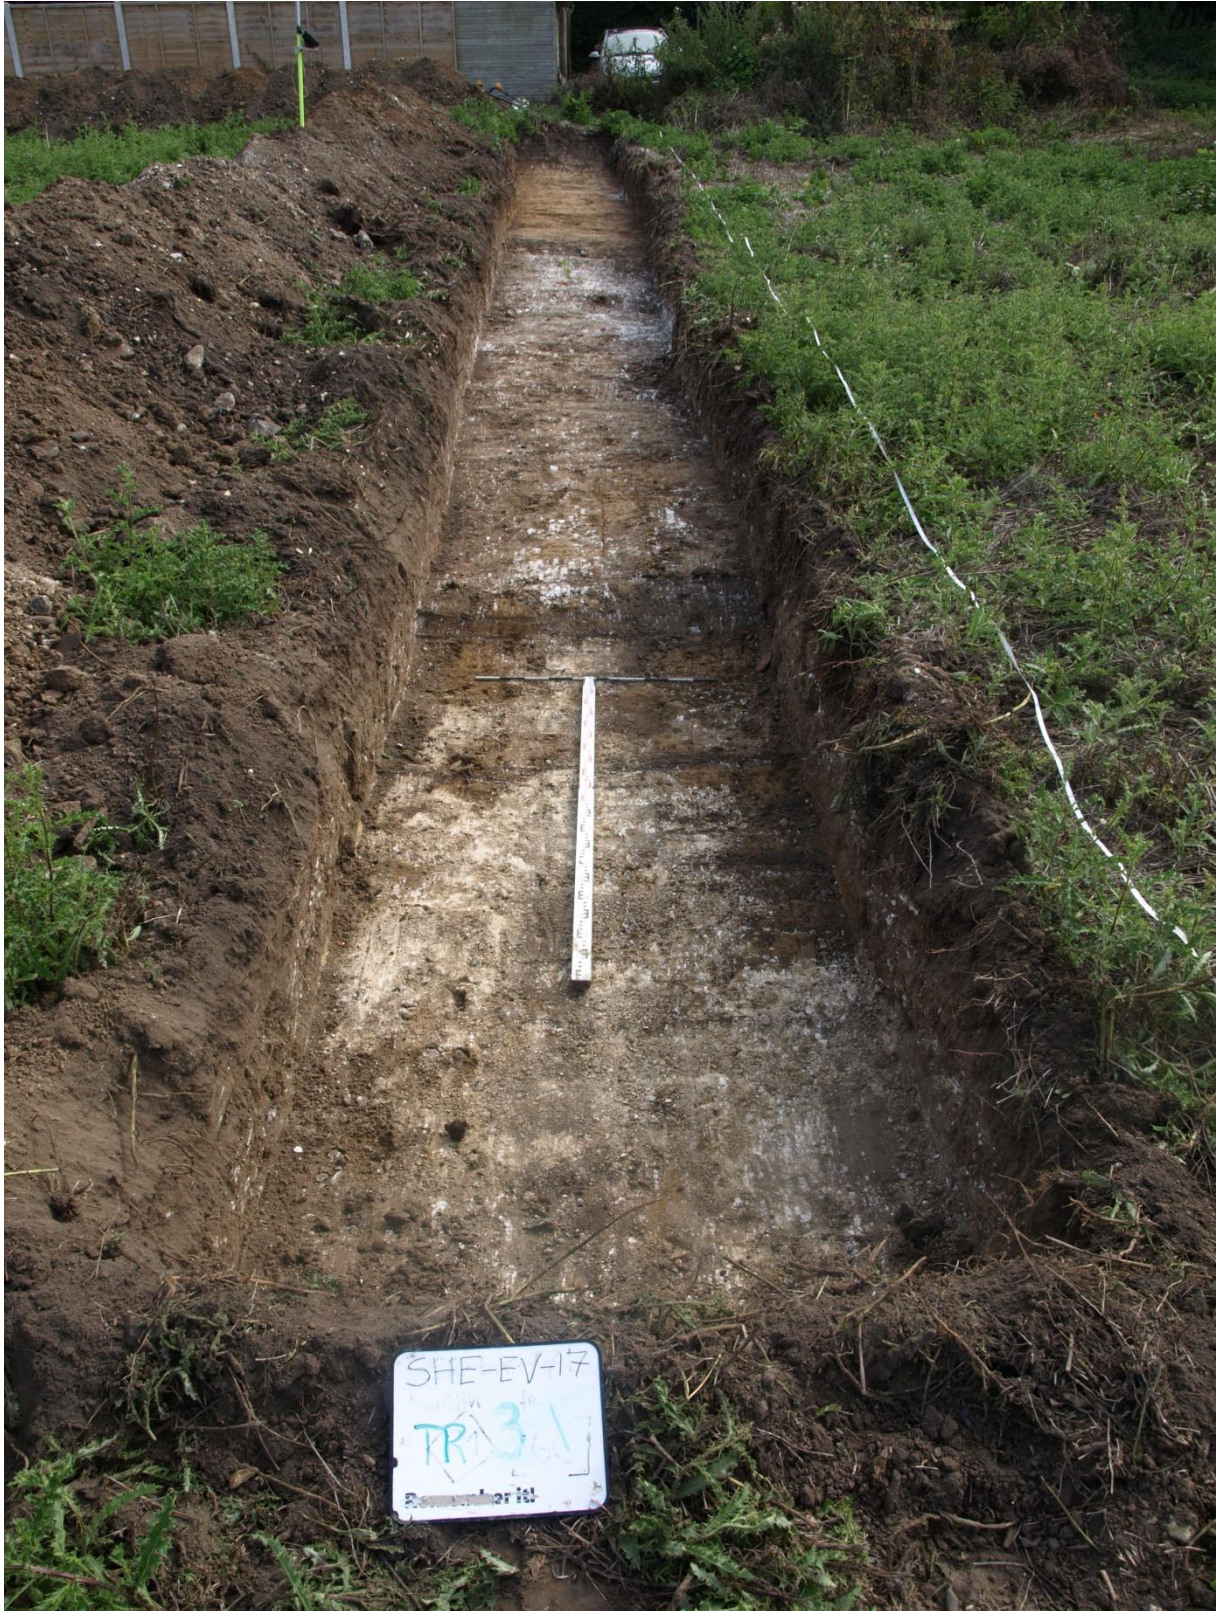
Plate 15: Showing Evaluation Trench 3. Looking south, one and two metre scales.

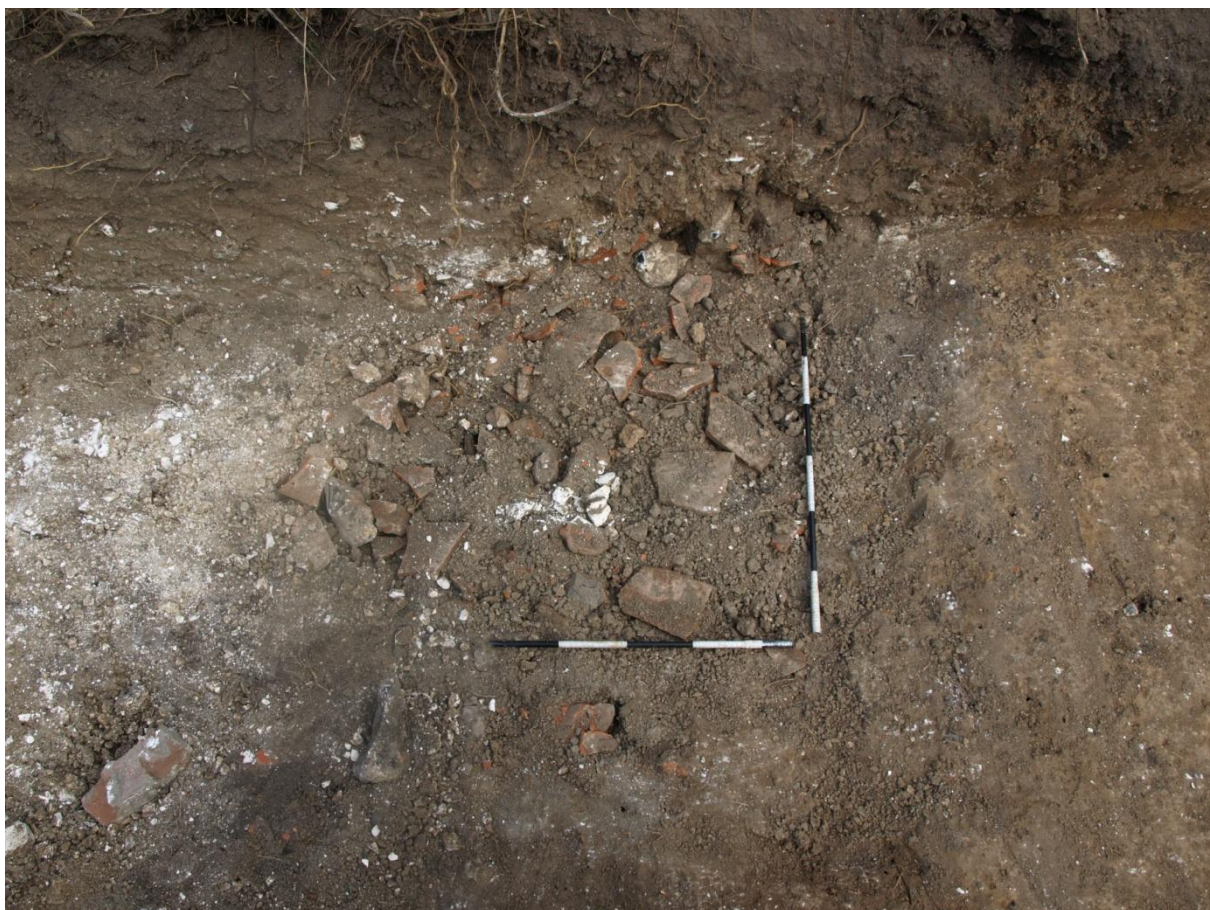
Plate 16: Modern tile-spread in Evaluation Trench 3. Half-metre scales.

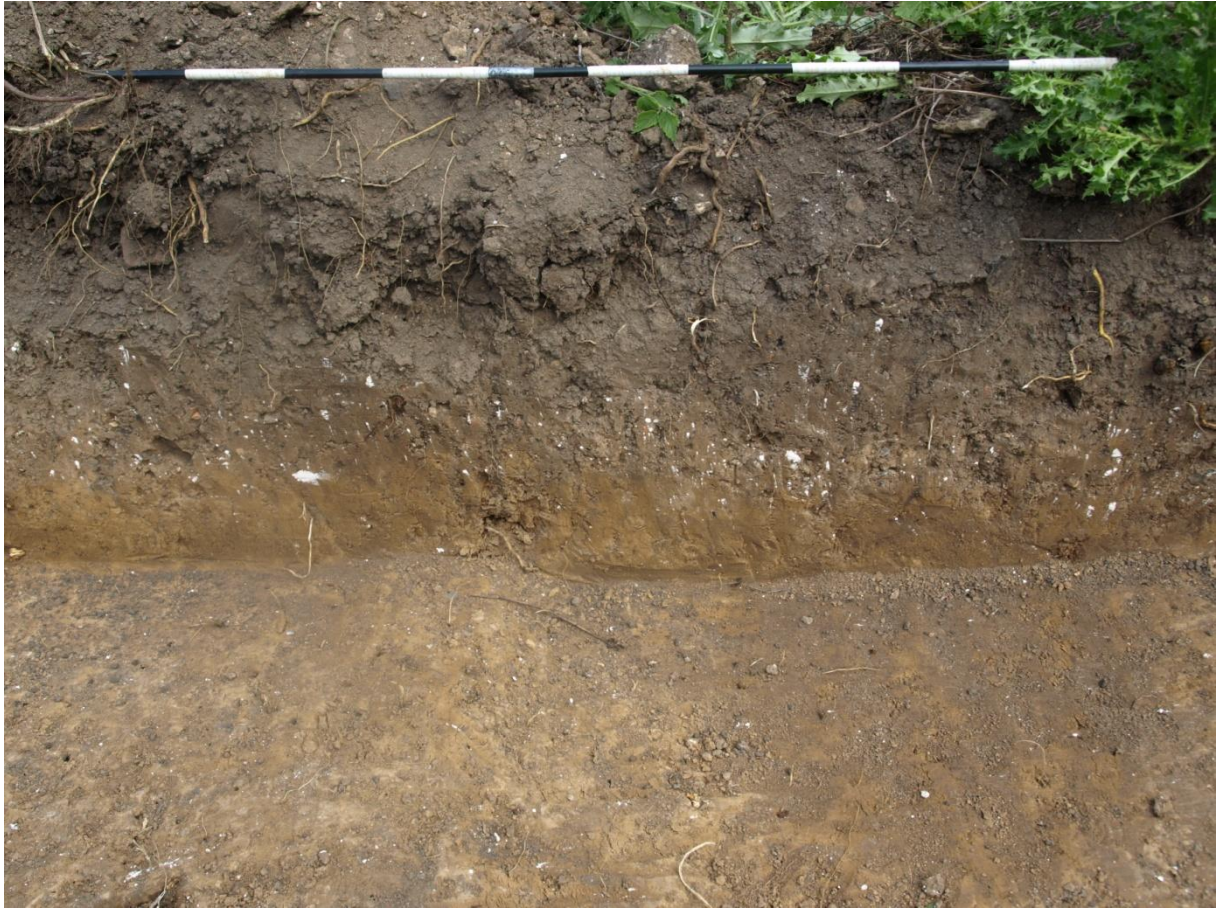
Plate 17: Showing representative section 3.1 in Evaluation Trench 3. Looking east, one metre scale.

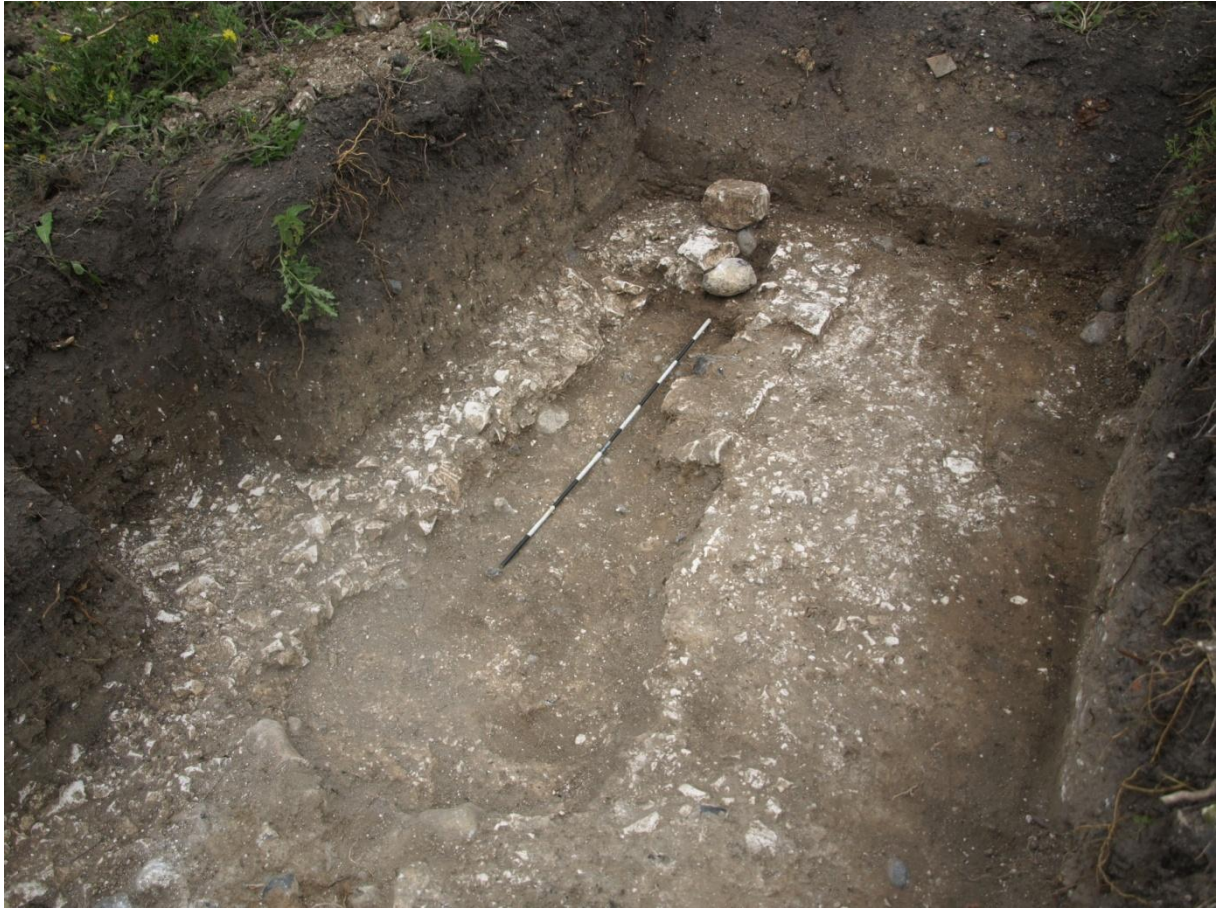
(207) Wall deposit. Squared small to medium size chalk blocks. As a bonding material – clutch (chalky paste)

Plate 18: Showing chalk wall (207) and its construction cut [205] revealed in Trench 2. Looking north-east, one-metre scale.

The only feature of archaeological interest was recorded in Trench 2 and comprised an E-W orientated chalk block wall. A cartographic assessment of the site has been carried out, with historic Ordnance Survey maps provided below (Figures 6-14 & Plates 1-6) and appears to be very little evidence to suggest the presence of a building or boundary wall since the late 19th century. This is confirmed by a very detailed map from Hasted's "History and Topographical Survey Of Kent" (dated to 1778). It is therefore possible that it predates the 18th century and certainly the 19th century, unless it is associated with a small temporary structure not present during surveys. The orientation of the wall is of interest, being perpendicular to, and therefore respecting, the adjacent Gore Lane. It is therefore recommended that any additional archaeological work, should it be necessary, takes into consideration historic maps pre-dating the 19th century which may provide an idea as to the provenance of the wall.

The archaeological evaluation has been successful in fulfilling the primary aims and objectives of the Specification and identified intact structural deposits preserved *in situ* at a level of approximately 15.5m aOD within the southern extent of the site, adjacent to Gore

Lane. Development proposals, which comprise the construction of new domestic premises are therefore likely to impact on archaeological remains. Further archaeological mitigation, should it be necessary, will need to be determined in consultation with the Kent County Council Archaeological Officer and local planning authority.

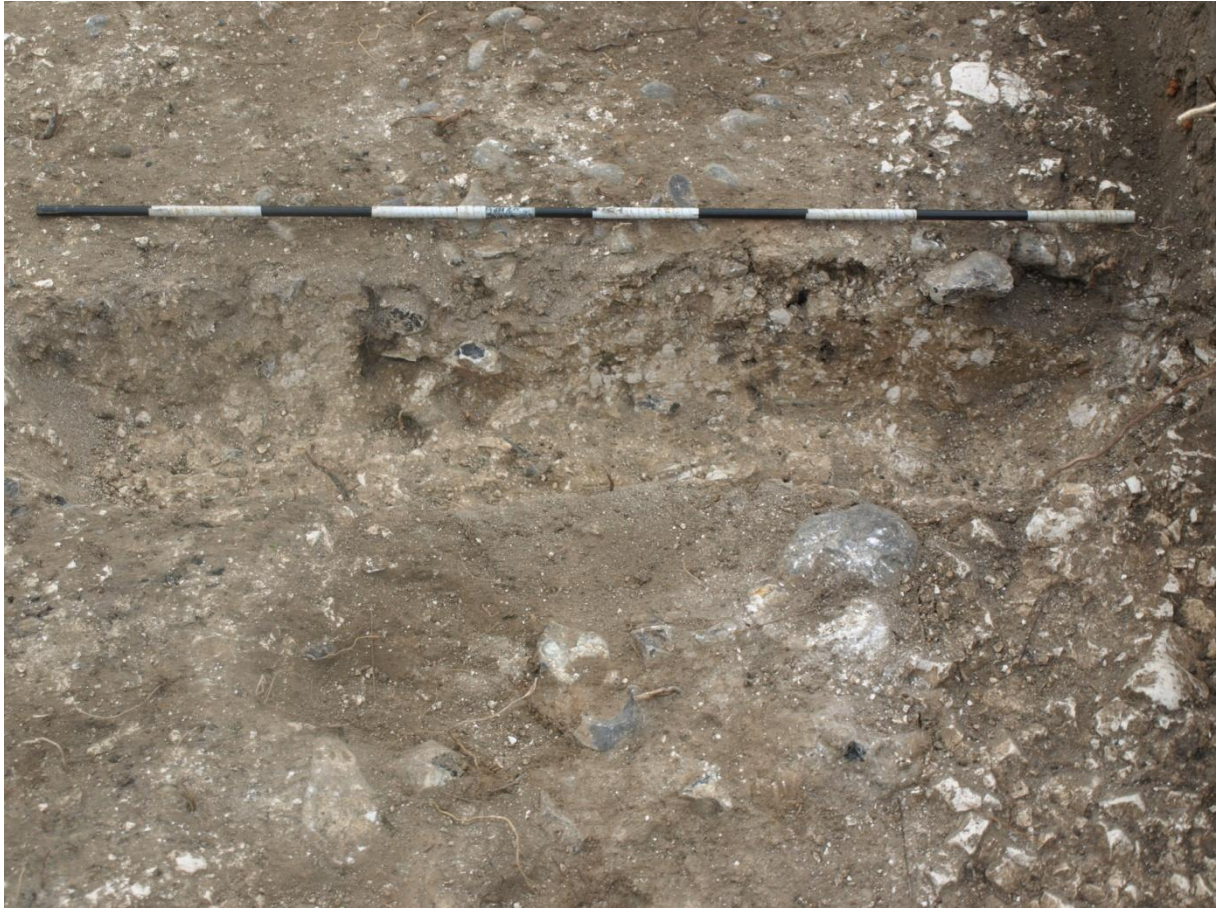
[205] Cut for wall construction

(206) back-fill. Dark grey clay-silt with infrequent flint cobbles.

Plate 19: Showing section through wall construction cut [205]. Looking west, one metre scale.

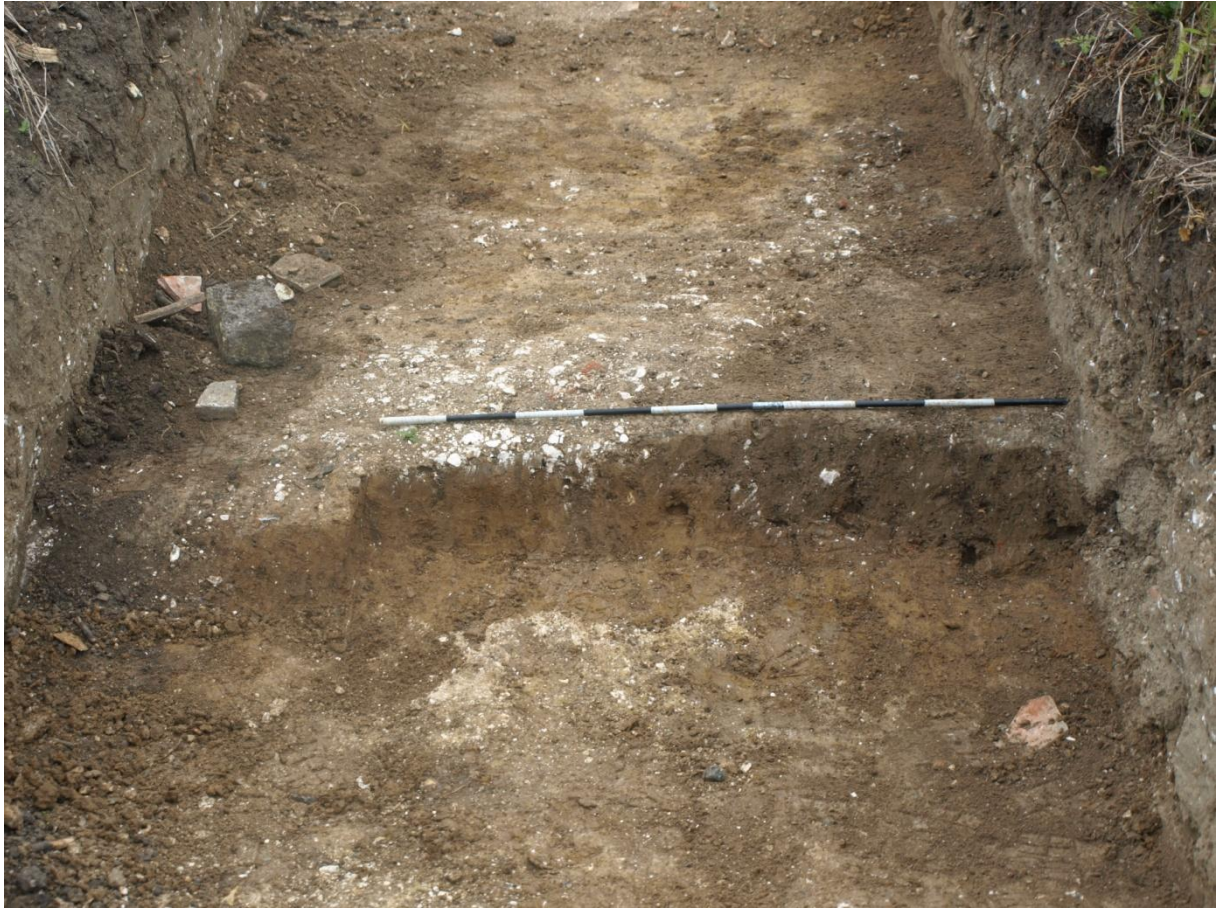
Rubbish Pit [307] was sub-oval in plan with very steep sides and mainly flat base. Its back-fill context (308) comprised dark brown clay-silt with modern roof tiles, glass and crushed bricks.

Plate 20: Showing modern rubbish pit [307] in Evaluation Trench 3. Looking south, one metre scale.

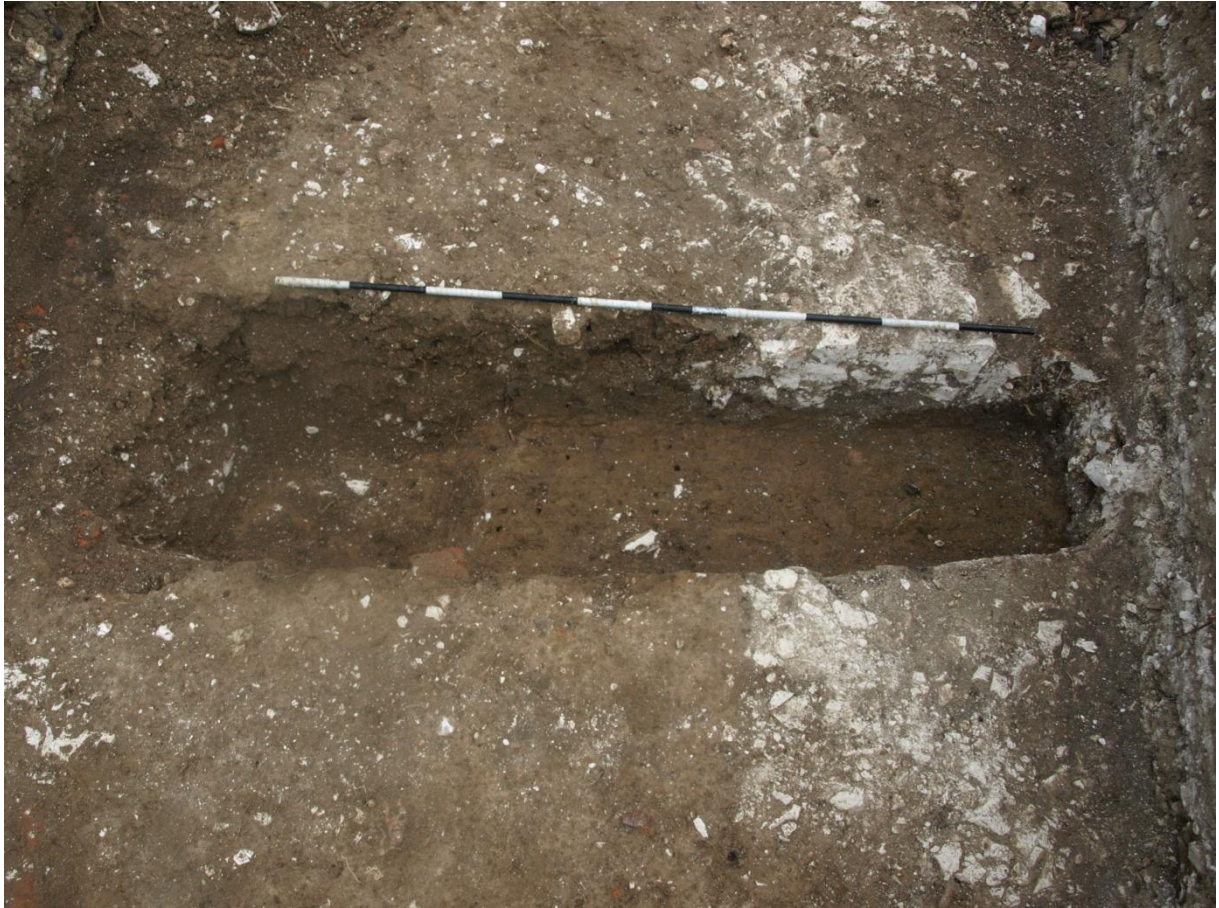
Plate 21: Showing section through modern pit [307] and chalk dump (309) in Trench 3. Looking south, one-metre scale.
