# Archaeological Evaluation of Land north-west of El Ashere, Wye Road, Boughton Aluph, Kent

Site Code: EAW-EV-18

(Planning Application: 17/00999/AS)

**SWAT Archaeology**

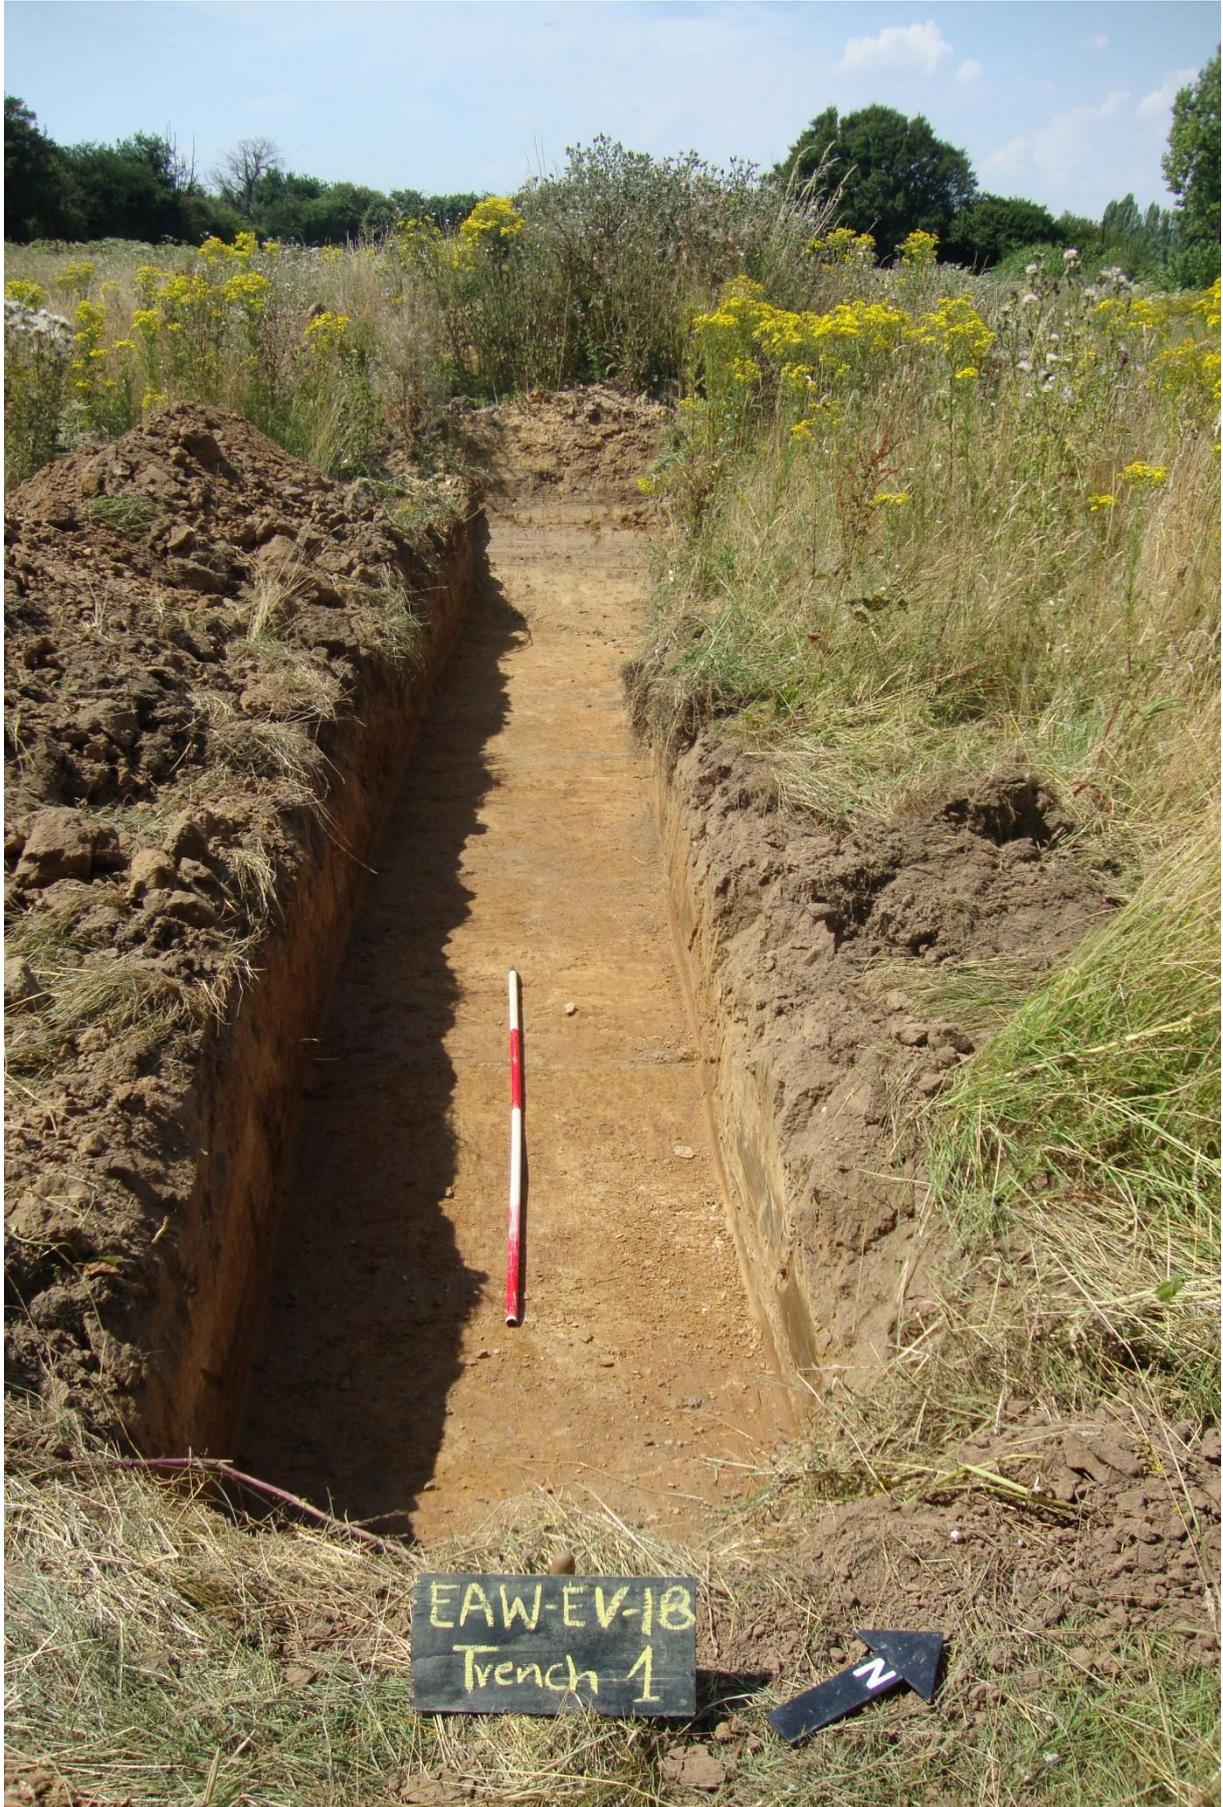
Plate 1: Looking NWW at Trench 1.

The plan is recorded in Figure 1 (see also Plate 1). The trench lay on a NWW-SSE alignment, measured approximately 25m by 1.50m and had a maximum depth of 0.40m.

Undisturbed natural geology was identified across the trench as silty sand at a depth of approximately 0.40m (58.60m aOD) below the present ground surface of 59.00m aOD at the SSE end of the trench. The natural geology was sealed by mid-dark brown silty subsoil **(101)** which was sealed by dark grey-brown silty topsoil **(100)**.

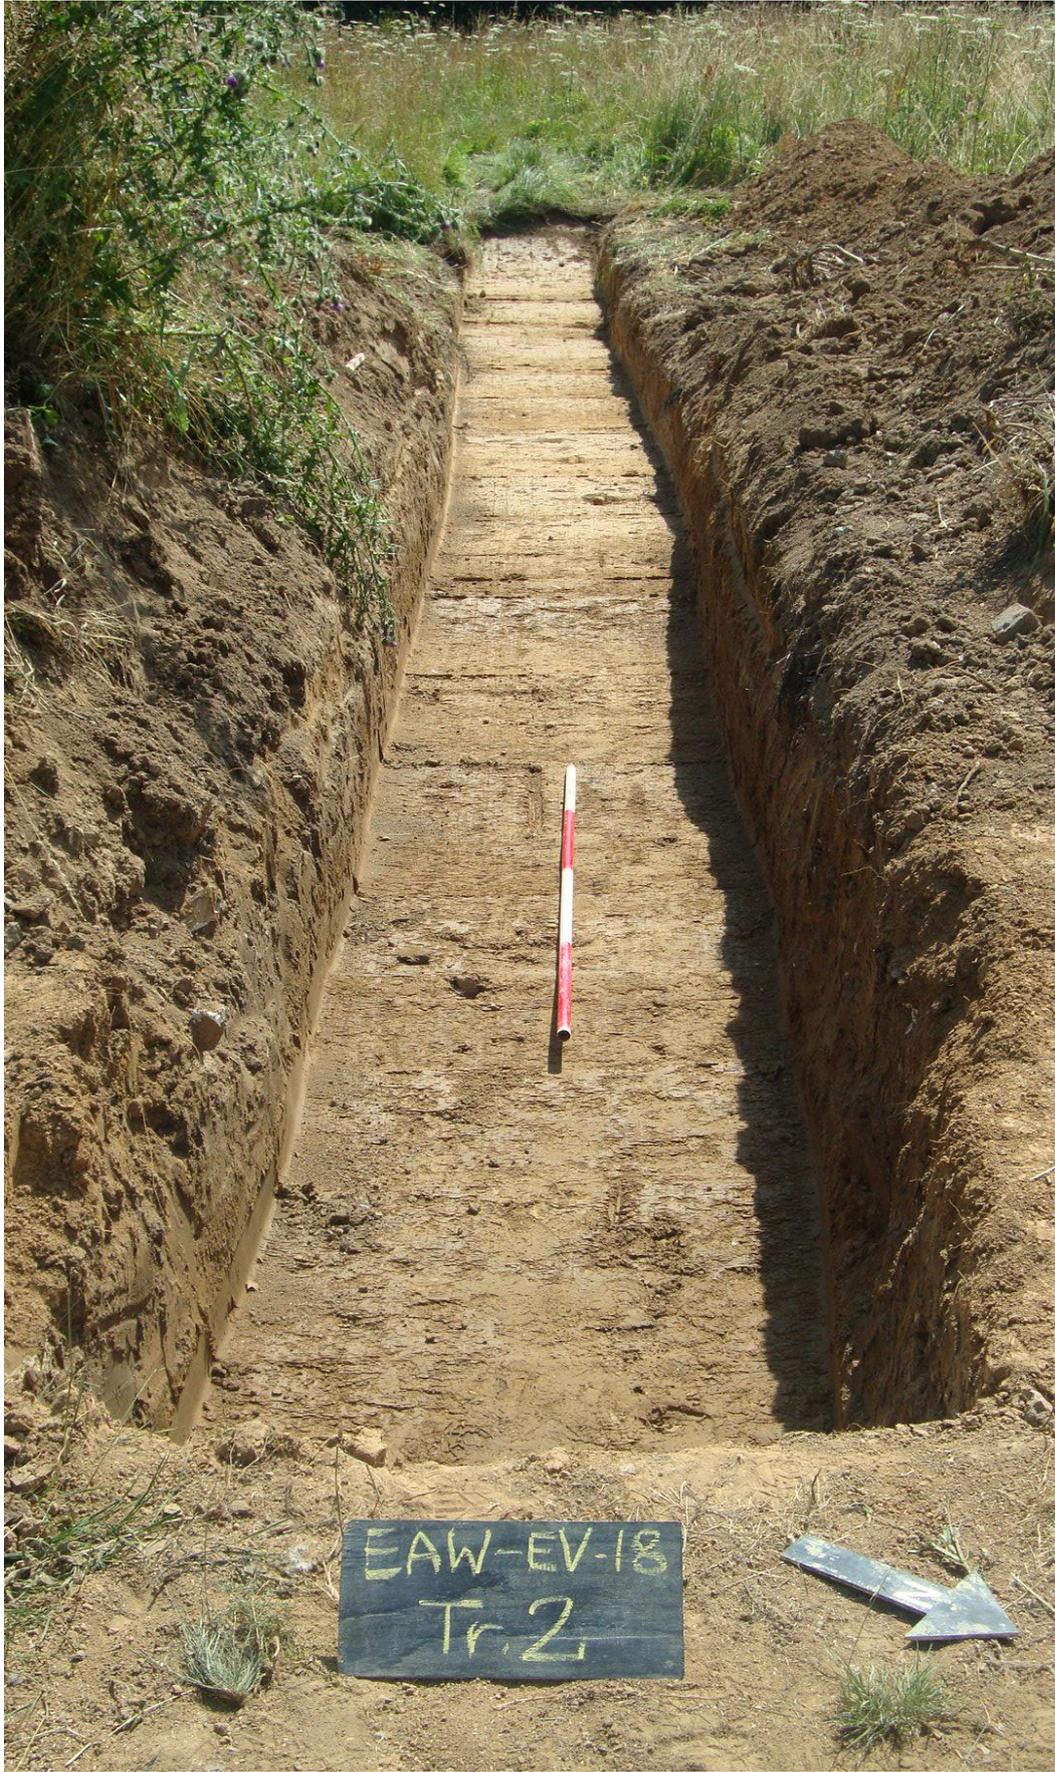
Plate 2. Looking SW at Trench 2.

The plan is recorded in Figure 1 (see also Plate 2). The trench lay on a NE-SW alignment, measured approximately 25m by 1.50m and had a maximum depth of 0.40m.

Undisturbed natural geology was identified across the trench as silty sand at a depth of approximately 0.40m (58.60m aOD) below the present ground surface of 59.00m aOD at the SW end of the trench.

The natural geology was sealed by mid-dark brown silty subsoil **(201)** which was sealed by dark grey-brown silty topsoil **(200)**.

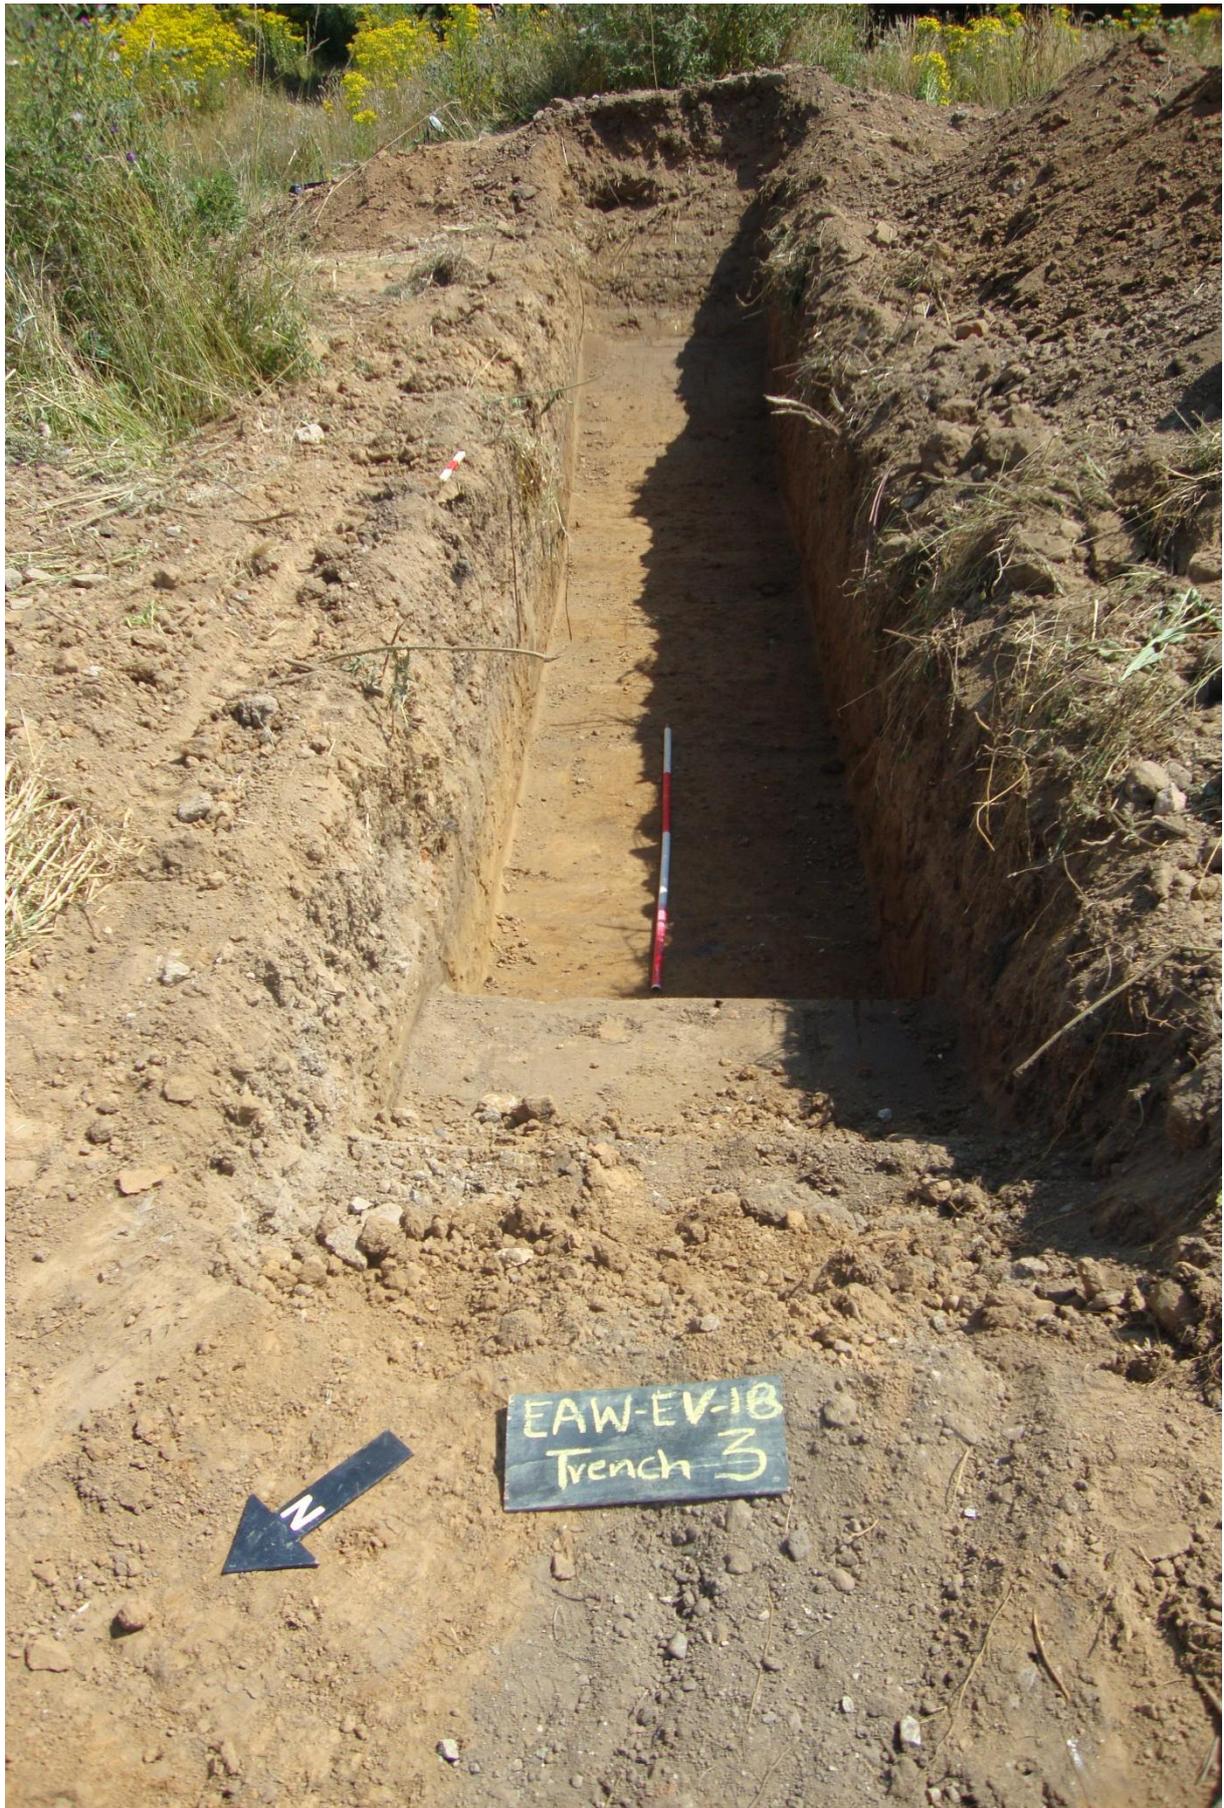
Plate 3: Looking SEE at Trench 3.

The plan is recorded in Figure 1 (see also Plate 1). The trench lay on a NWW-SSE alignment, measured approximately 25m by 1.50m and had a maximum depth of 0.40m.

Undisturbed natural geology was identified across the trench as silty sand at a depth of approximately 0.40m (58.60m aOD) below the present ground surface of 59.00m aOD at the SSE end of the trench. The natural geology was sealed by mid-dark brown silty subsoil **(301)** which was sealed by dark grey-brown silty topsoil **(300)**.

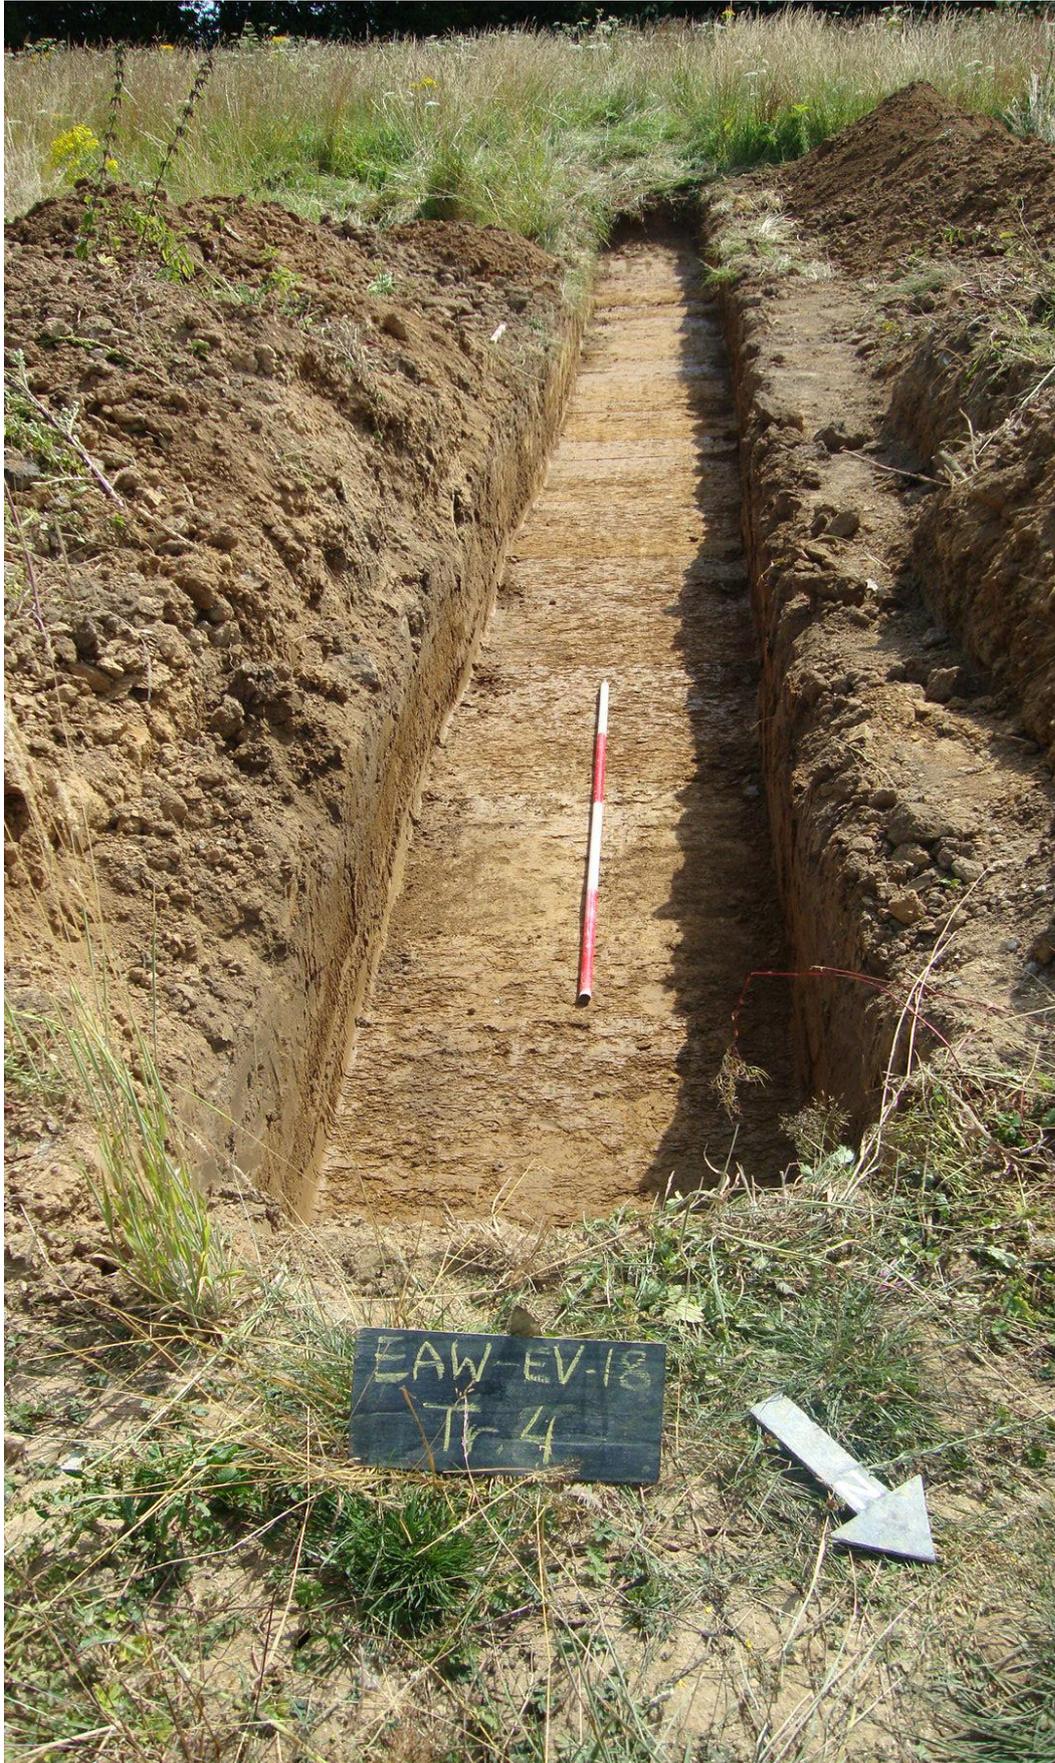
Plate 4: Looking SSW at Trench 4.

The plan is recorded in Figure 1 (see also Plate 2). The trench lay on a NNE-SSW alignment, measured approximately 25m by 1.50m and had a maximum depth of 0.40m.

Undisturbed natural geology was identified across the trench as silty sand at a depth of approximately 0.40m (58.60m aOD) below the present ground surface of 59.00m aOD at the SSW end of the trench. The natural geology was sealed by mid-dark brown silty subsoil **(401)** which was sealed by dark grey-brown silty topsoil **(400)**.

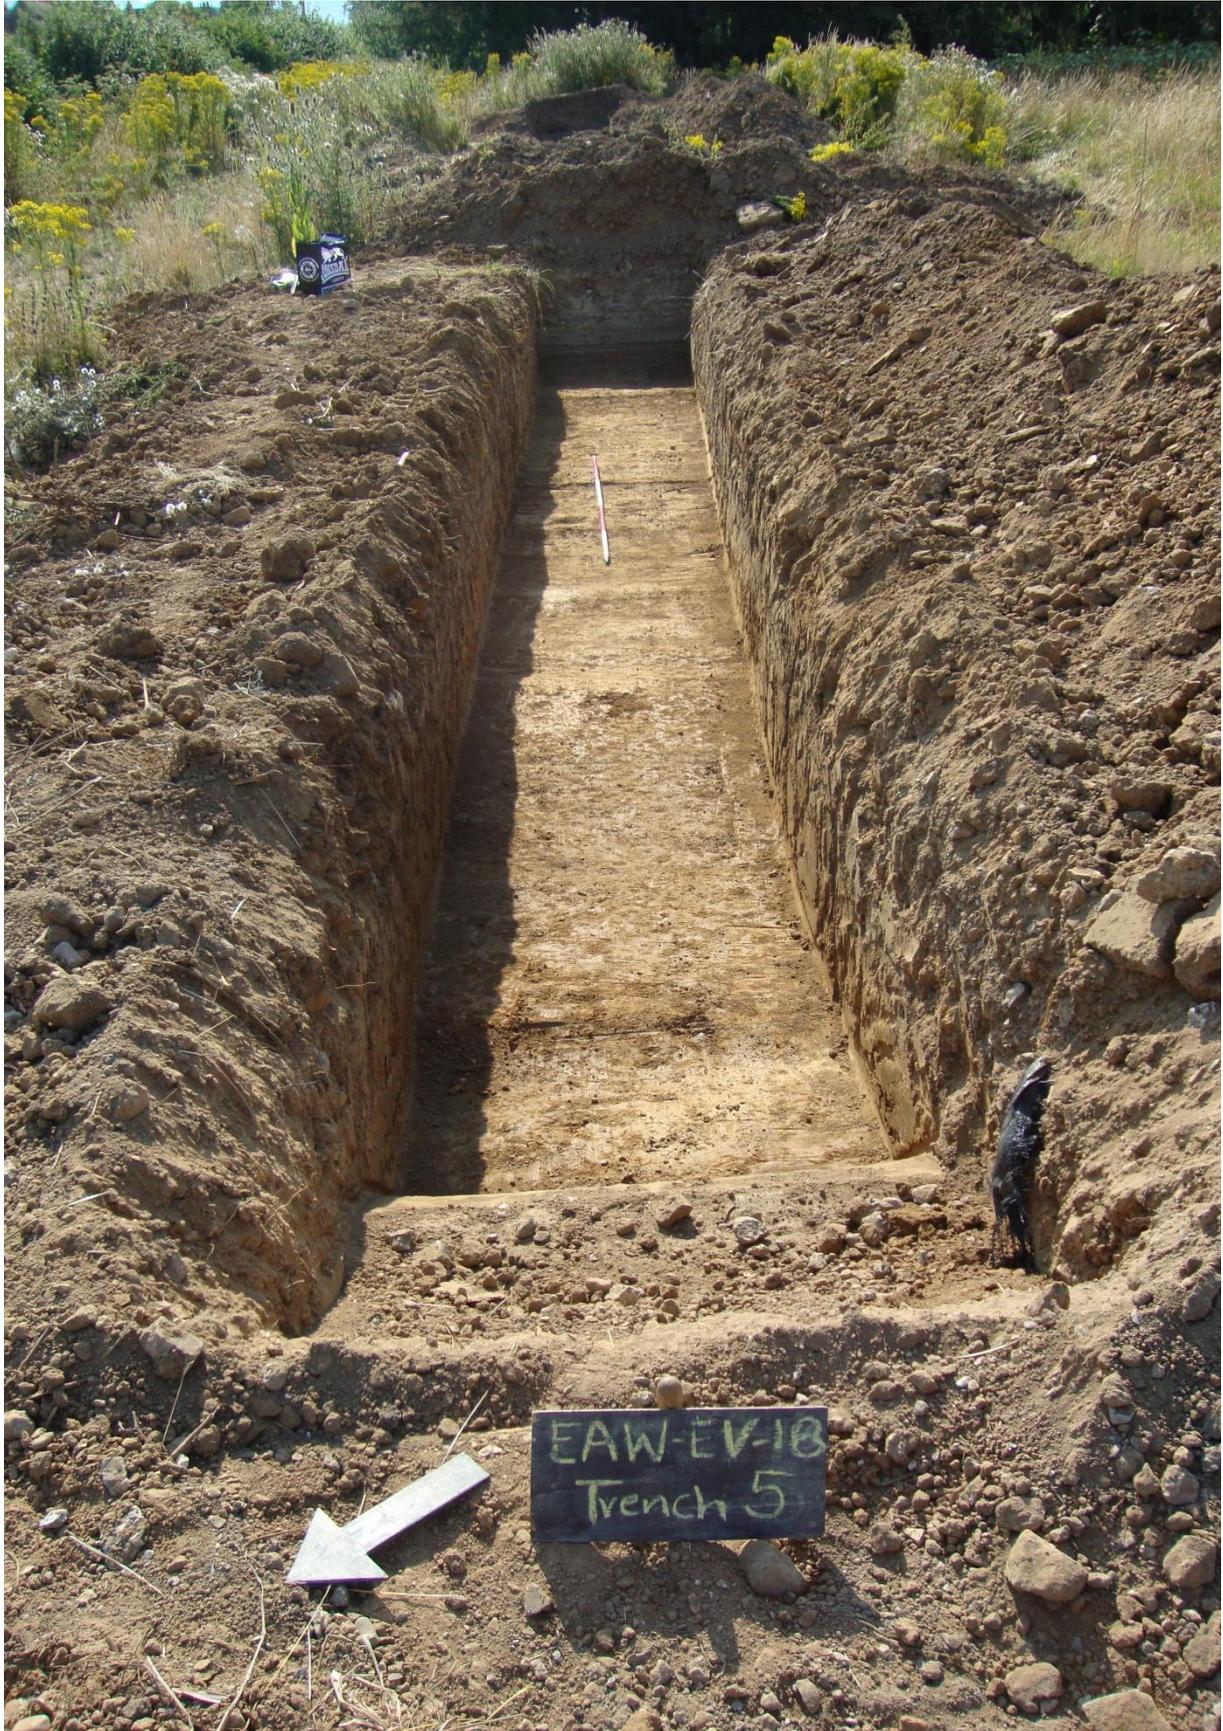
Plate 5: Looking SEE at Trench 5.

The plan is recorded in Figure 1 (see also Plate 1). The trench lay on a NWW-SSE alignment, measured approximately 25m by 1.50m and had a maximum depth of 0.40m.

Undisturbed natural geology was identified across the trench as silty sand at a depth of approximately 0.40m (58.60m aOD) below the present ground surface of 59.00m aOD at the SSE end of the trench. The natural geology was sealed by mid-dark brown silty subsoil **(501)** which was sealed by dark grey-brown silty topsoil **(500)**.

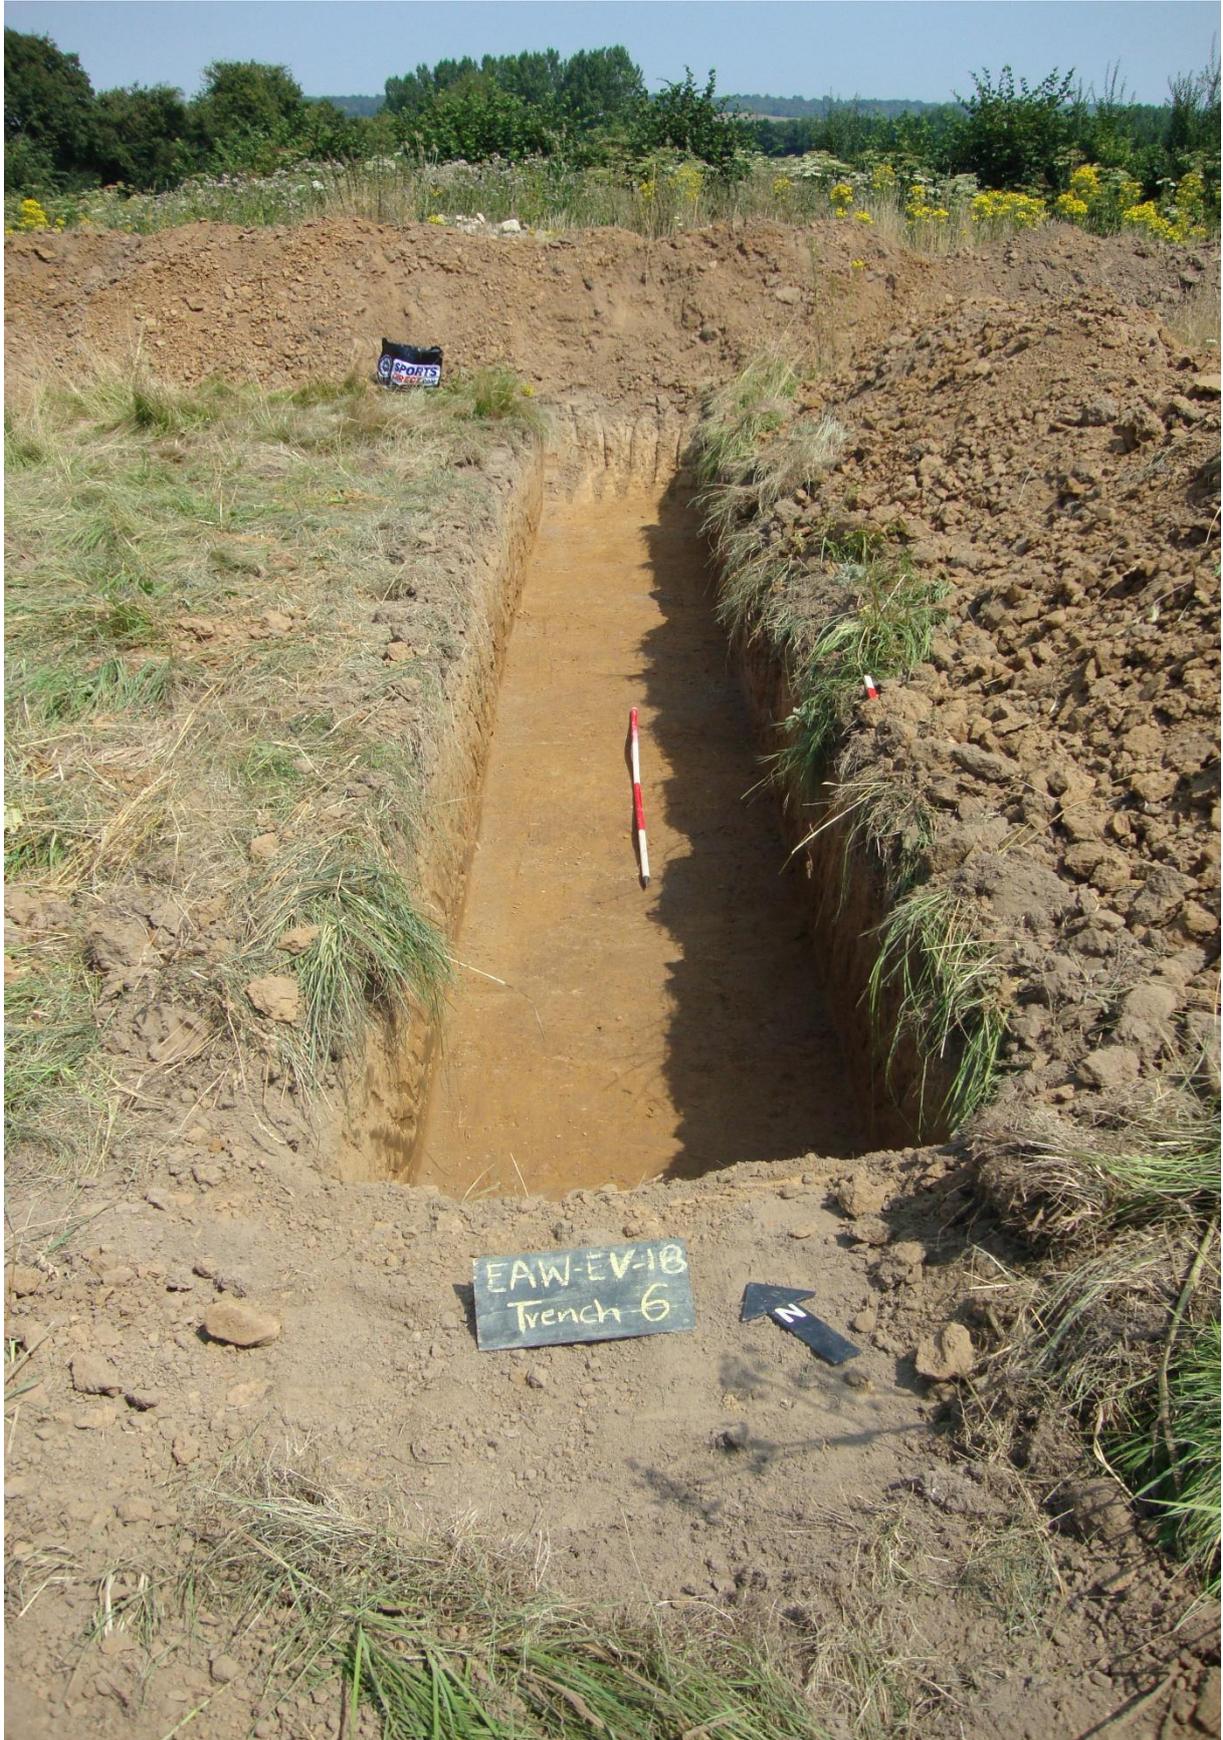
Plate 6: Looking NNE at Trench 6.

The plan is recorded in Figure 1 (see also Plate 2). The trench lay on a NNE-SSW alignment, measured approximately 25m by 1.50m and had a maximum depth of 0.40m.

Undisturbed natural geology was identified across the trench as silty sand at a depth of approximately 0.40m (57.60m aOD) below the present ground surface of 58.00m aOD at the SW end of the trench. The natural geology was sealed by mid-dark brown silty subsoil **(601)** which was sealed by dark grey-brown silty topsoil **(600)**.

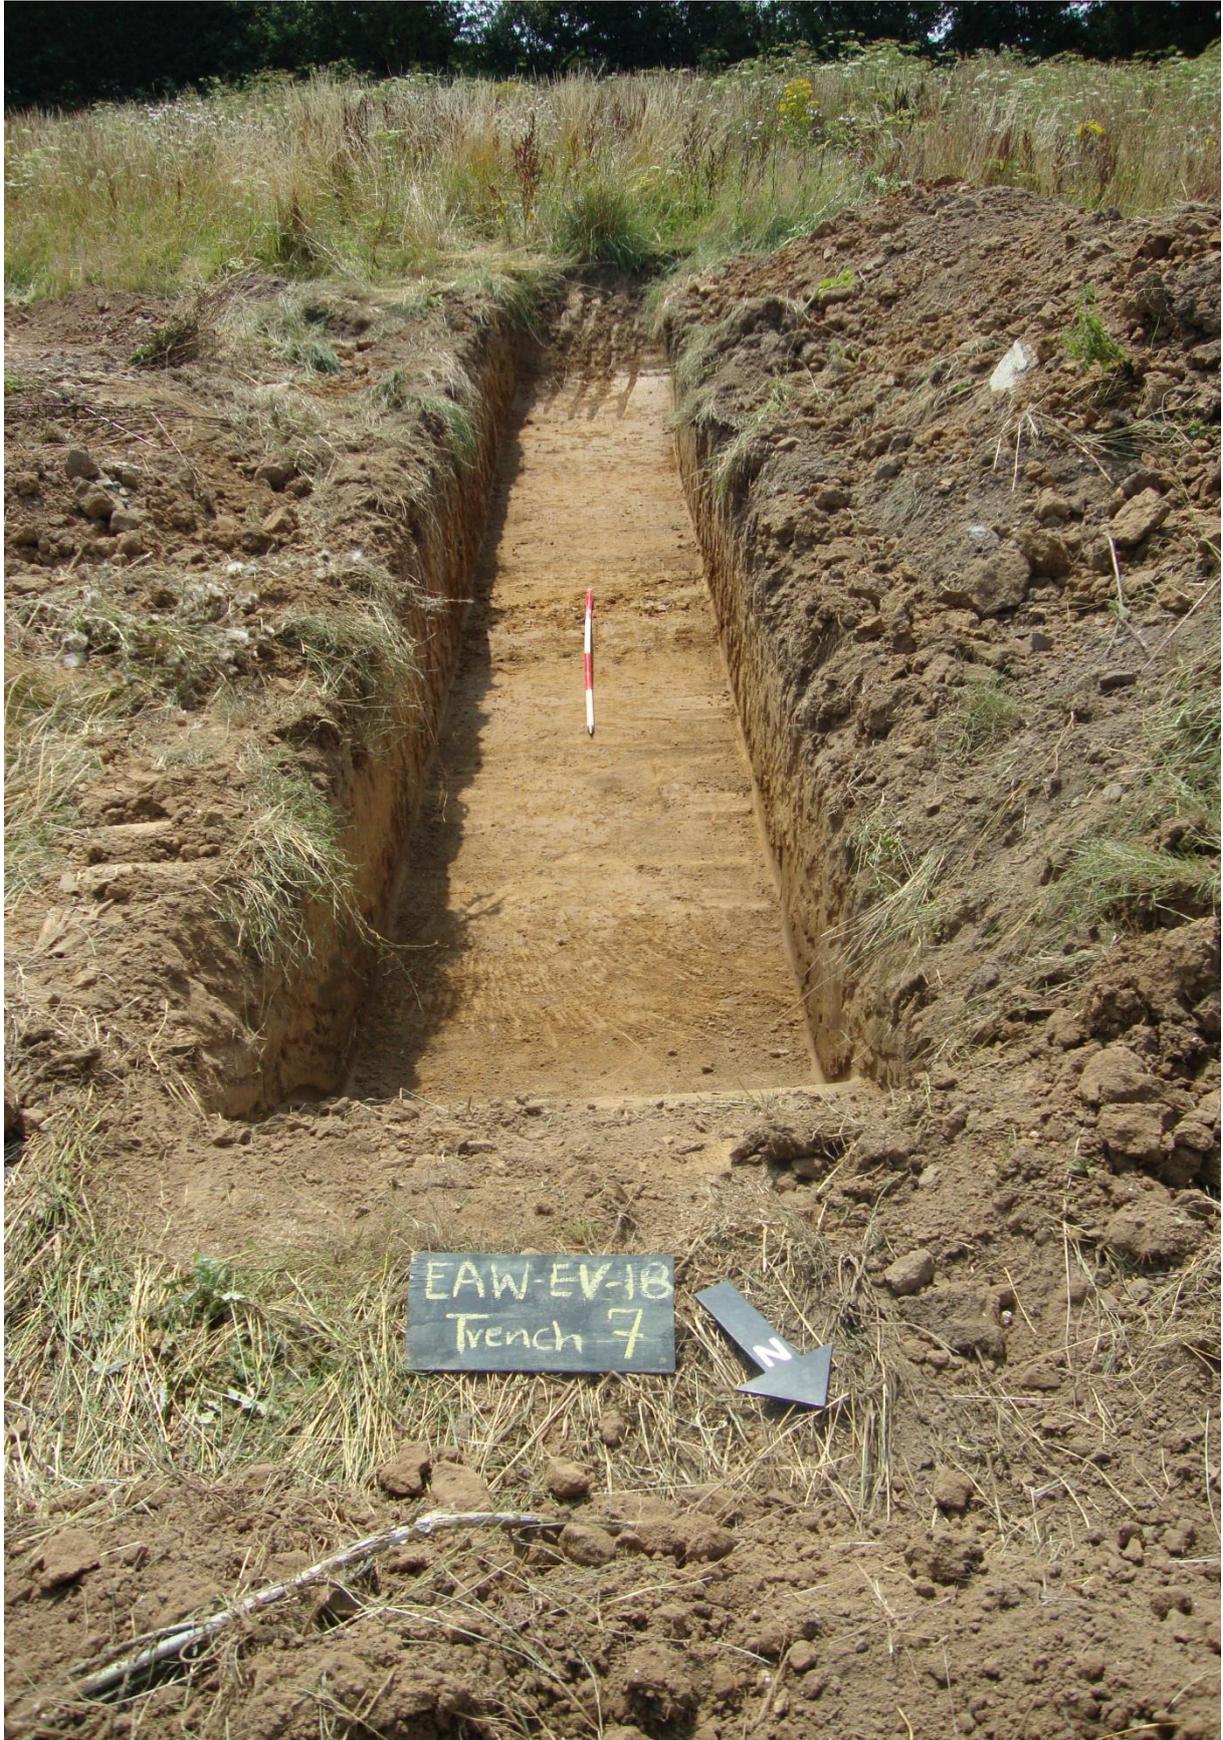
Plate 7: looking SSW at Trench 7.

The plan is recorded in Figure 1 (see also Plate 1). The trench lay on a NWW-SSE alignment, measured approximately 25m by 1.50m and had a maximum depth of 0.40m. A land drain was identified in the central area of the trench.

Undisturbed natural geology was identified across the trench as silty sand at a depth of approximately 0.40m (57.60m aOD) below the present ground surface of 58.00m aOD at the SSE end of the trench. The natural geology was sealed by mid-dark brown silty subsoil **(701)** which was sealed by dark grey-brown silty topsoil **(700)**.

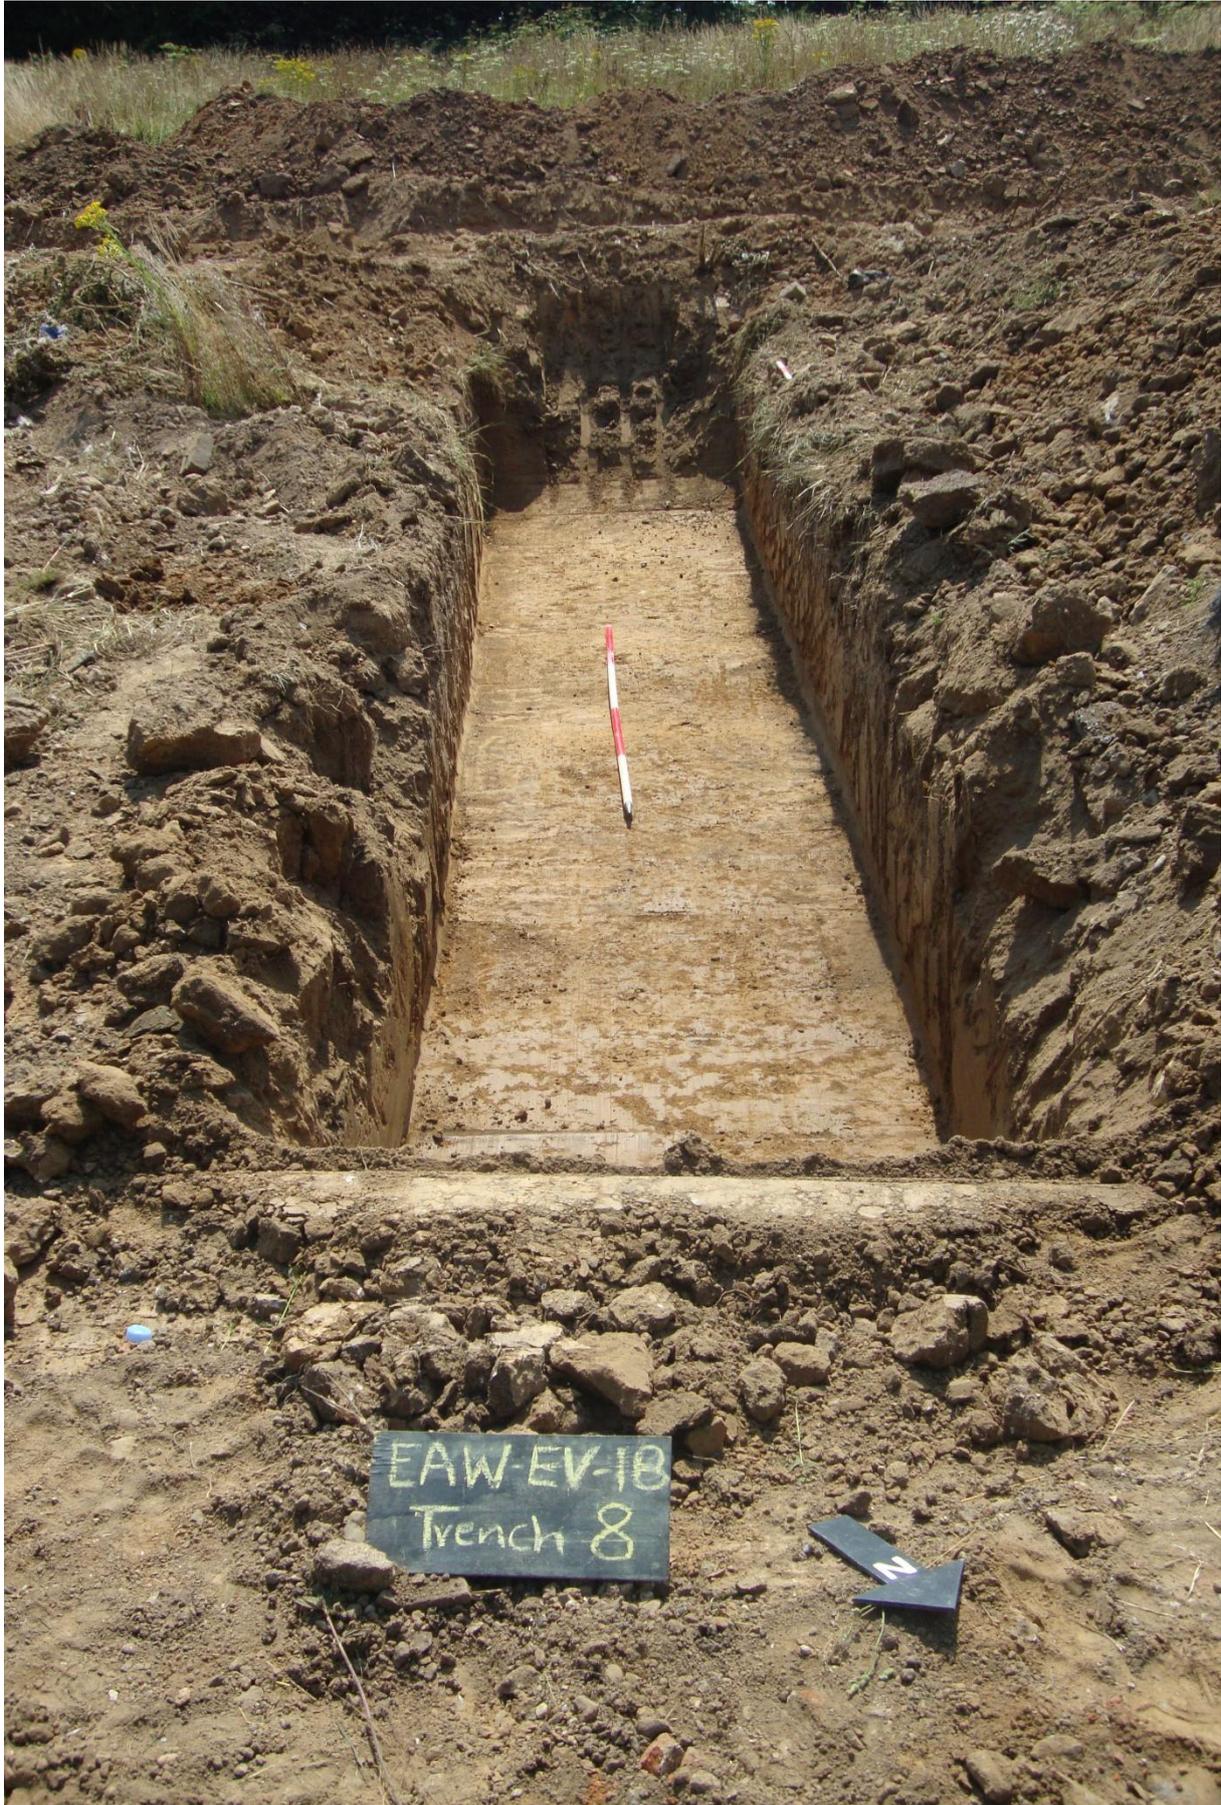
Plate 8: looking SSW at Trench 8.

The plan is recorded in Figure 1 (see also Plate 2). The trench lay on a NE-SW alignment, measured approximately 25m by 1.50m and had a maximum depth of 0.40m.

Undisturbed natural geology was identified across the trench as silty sand at a depth of approximately 0.40m (57.60m aOD) below the present ground surface of 58.00m aOD at the SW end of the trench. The natural geology was sealed by mid-dark brown silty subsoil **(801)** which was sealed by dark grey-brown silty topsoil **(800)**.
