Archaeological Evaluation of Land adjacent to Southease, Derringstone Hill, Barham, Kent

Site Code: BAR/EV/18

(Planning Application: CA/17/02393/FUL)

SWAT Archaeology

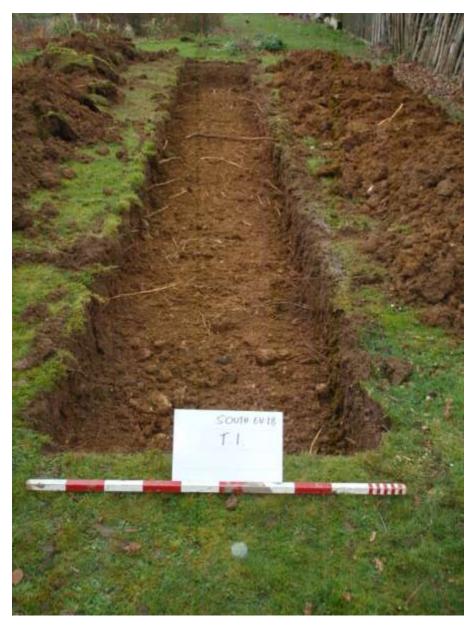
Plate 2. Trench 1 (looking NNE)

9.1 Trench orientation: NNE/SSW. Depth: 0.25m. Width: 1.8m. Length: 22m. No archaeology was detected. Topsoil (101) was dark brown silty topsoil loosely compacted under turf and 15cm thick overlaying clayey subsoil (102) mottled light brown with flint nodule inclusions. OD heights are 71.50m a OD at the NNE end of trench and 70.10m aOD at the SSW end of trench (Figure 1 & Plates 2, 4).

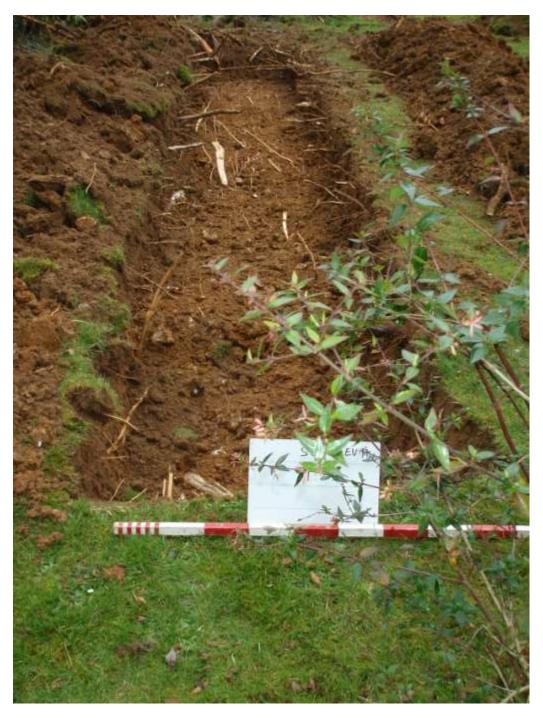
Plate 3. Trench 2 (looking N)

9.1 Trench orientation: about N/S. Depth: 0.28m. Width: 1.8m. Length: 12m. No archaeology was detected. Topsoil (201) was dark brown silty topsoil loosely compacted under turf and 15cm thick overlaying clayey subsoil (202) mottled light brown with flint nodule inclusions. OD heights are 71.52m a OD at the NNE end of trench and 70.80m aOD at the SSW end of trench (Figure 1 & Plates 3, 5).

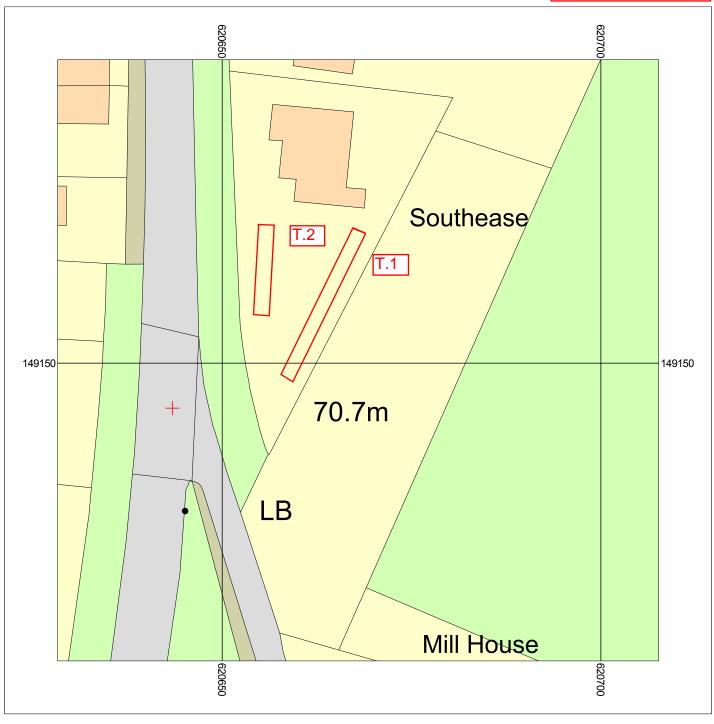
Figure 1.
Location of trenches

The Archaeological Specification called for an evaluation by trial trenching comprising a first phase of two trenches 20m long and 1.8m wide within the footprint of the proposed housing development. However, due to site restrictions Trench 1 was 22m long and Trench 2 was 12m long (Figure 1). A 4.5 ton 360° tracked mechanical excavator with a flat-bladed ditching bucket was used to remove the topsoil and subsoil to expose the natural geology. All archaeological work was carried out in accordance with the specification. A single context recording system was used to record the deposits, and context recording numbers were assigned to all deposits for recording purposes. All archaeological work was carried out in accordance with CCC, SWAT and CIfA standards and guidance.

The evaluation has identified no archaeological features within the two trenches (Figure 1).
