**Snagbrook Farm, 115-117 Eyhorne  
Street, Hollingbourne, Kent; Heritage  
Impact Assessment**

# Snagbrook Farm, 115-117 Eyhorne Street, Hollingbourne, Kent; Heritage Impact Assessment

*SWAT Archaeology has been commissioned by Mr and Mrs Love to prepare a Heritage Impact Assessment relating to the proposed development area (Site) of Snagbrook Farm, 115-117 Eyhorne Street, Hollingbourne, Kent.*

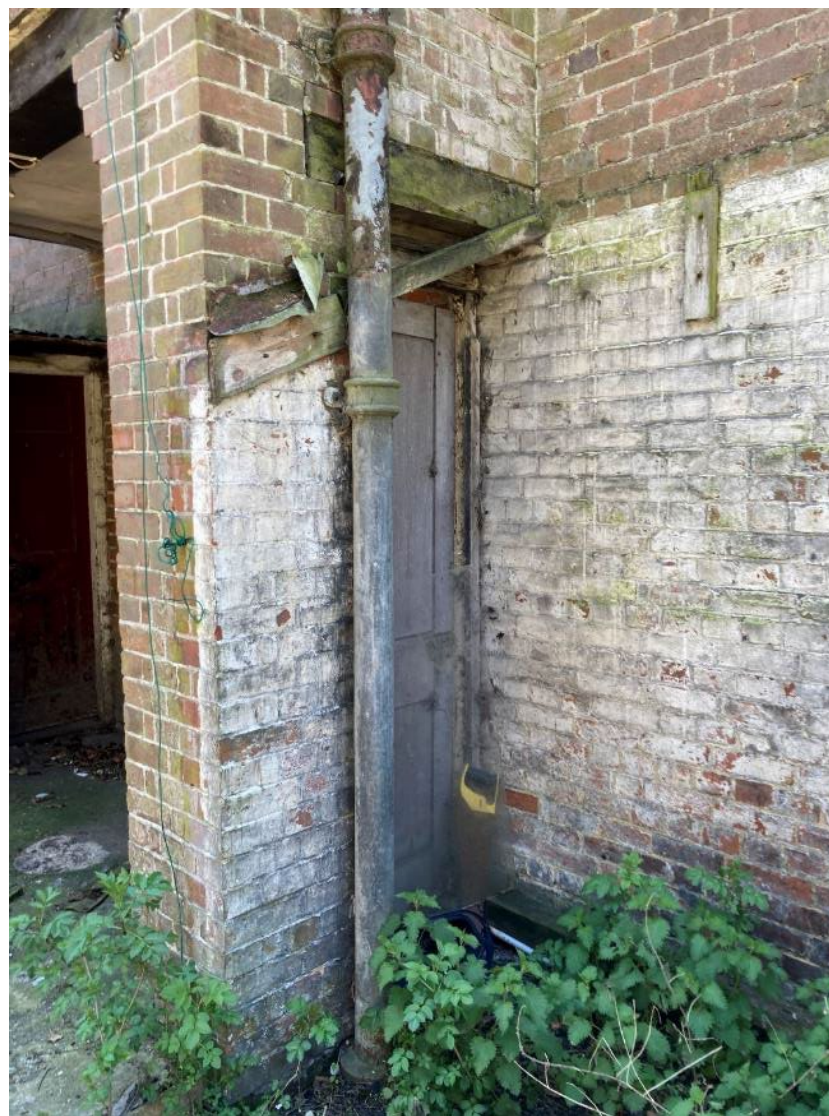
Plate 14: Close up of brick pillar for extension to the rear of the western elevation

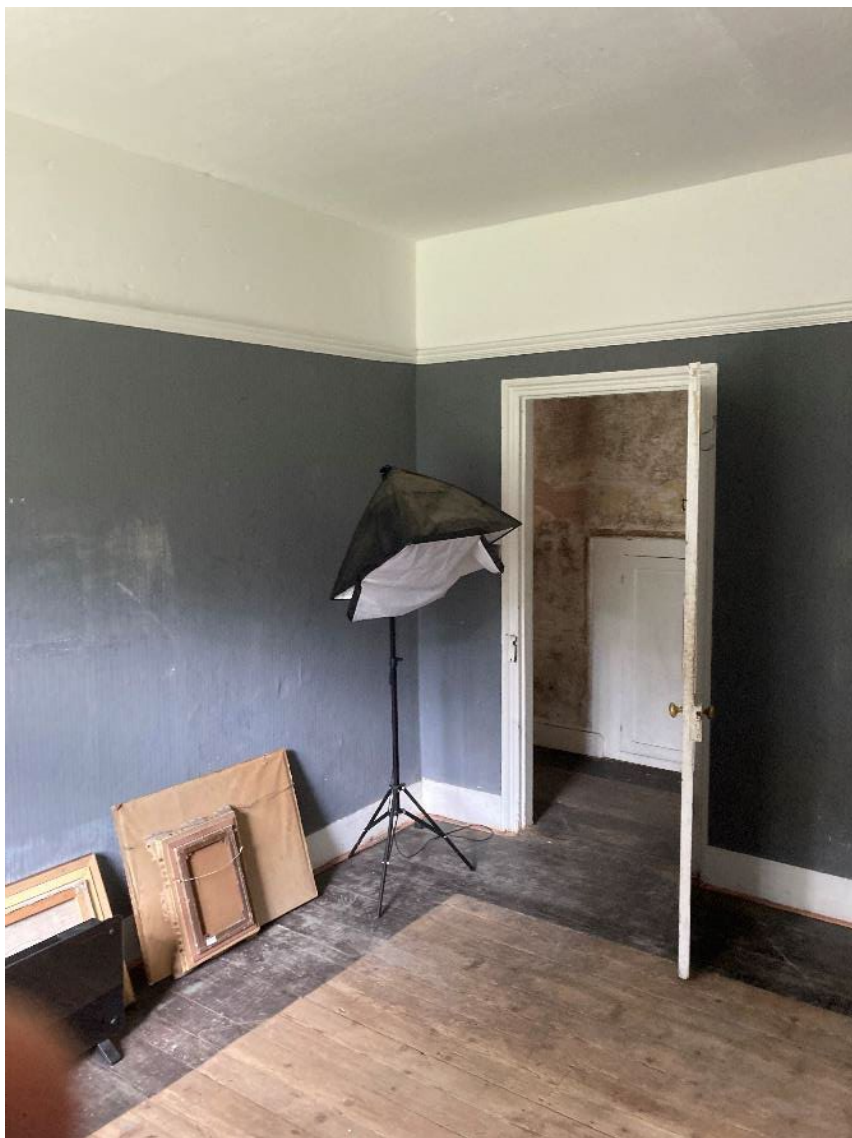
Plate 21: Room 1, new door proposed to be created and doorway blocked but left in-situ

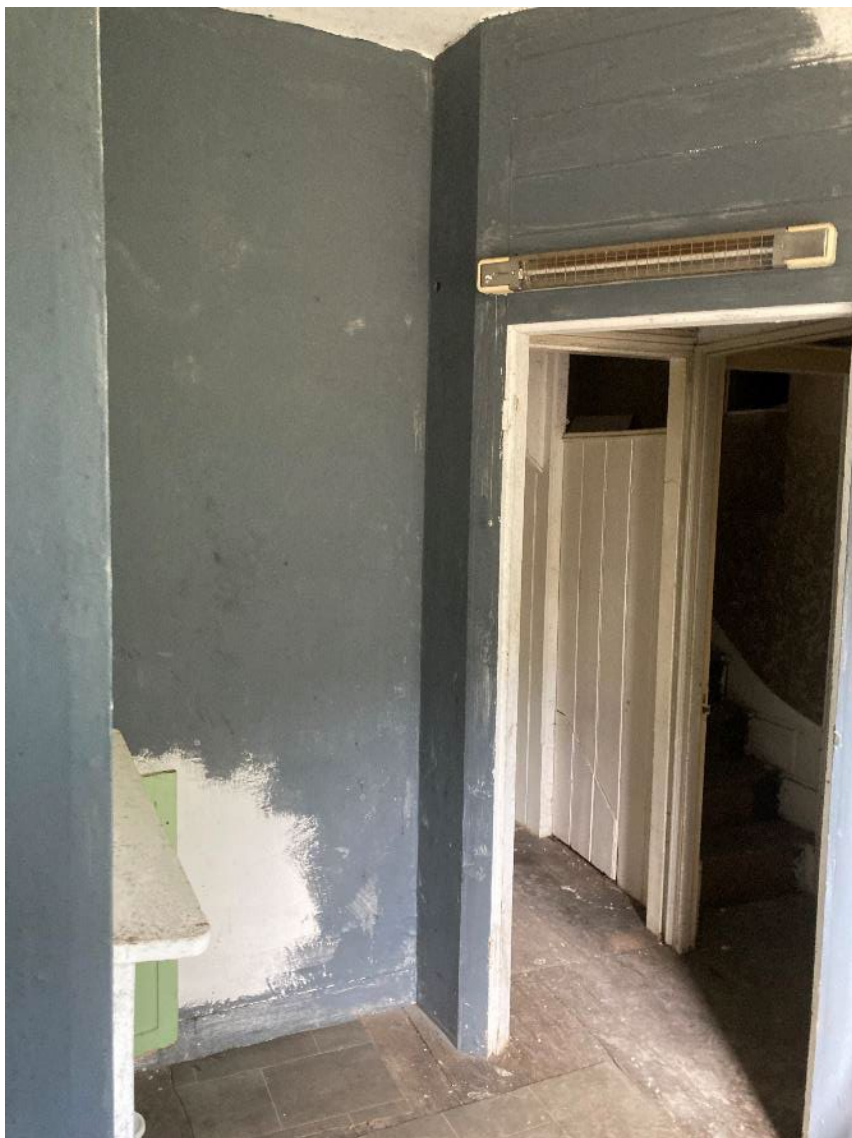
Plate 23: Room 2, showing area to be knocked through

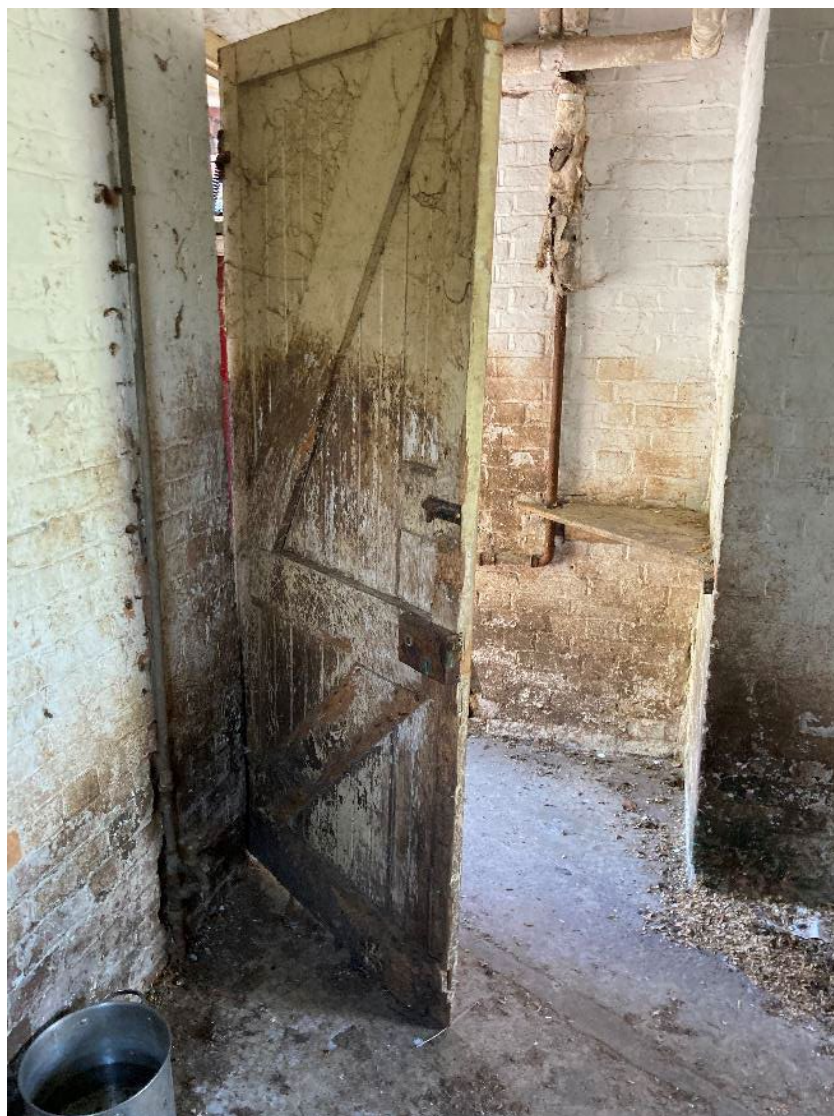
Plate 36: Room 7, showing part of wall area to be demolished

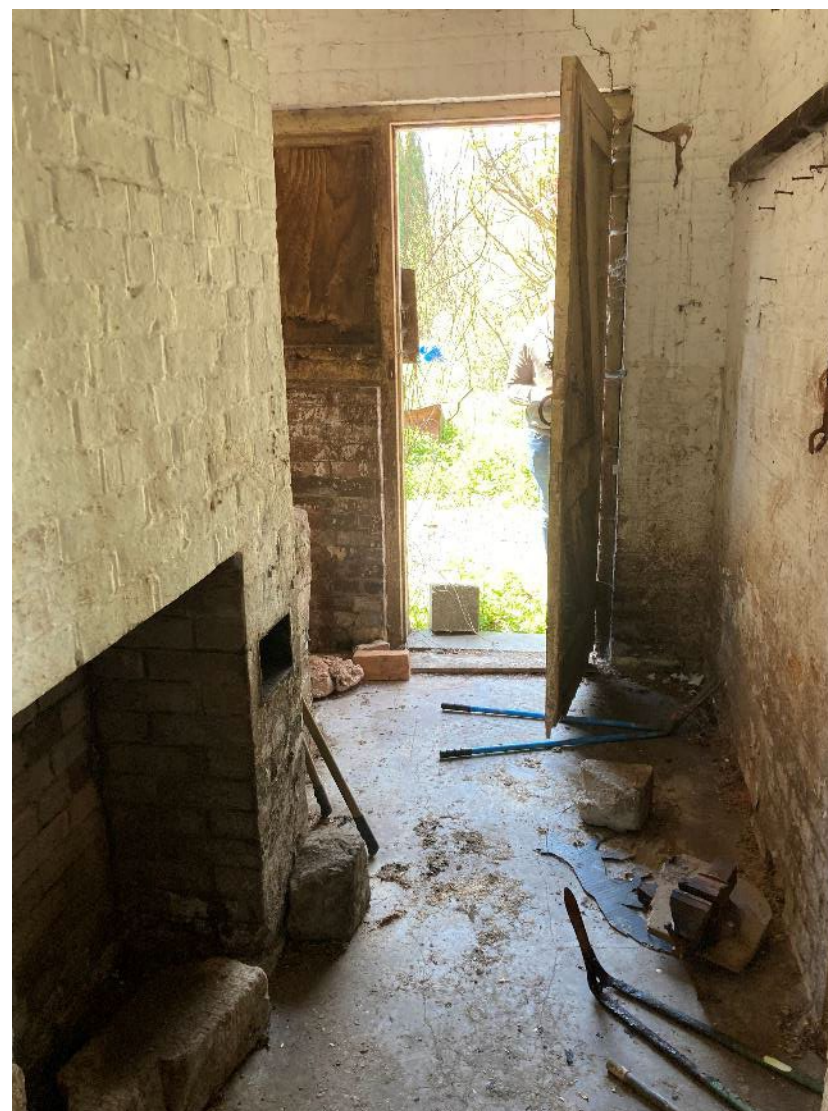
Plate 37: Room 7, showing part of wall area to be demolished
