**Archaeological Evaluation of land at Royal Victoria  
Hospital, Radnor Park Avenue, Folkestone  
CT19 5BN**

Report date: 28/04/2021

**SWAT ARCHAEOLOGY**

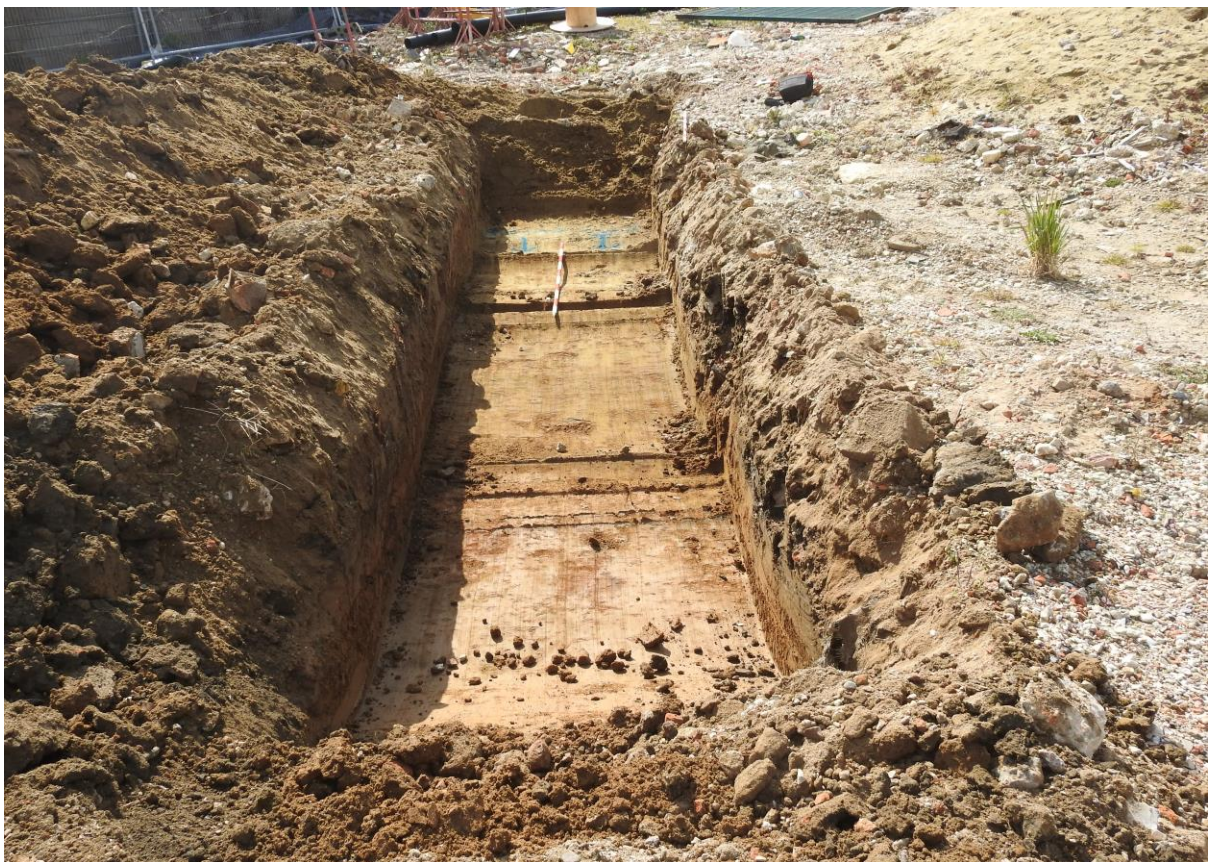
- 5.2.1 Trench 1 (Figure 3) was placed in north-eastern part of the site in NbW-SbE alignment and measured 12.32 metre in length by 1.8metre in width and 0.83metre in depth. It exposed natural geology context (103) comprising yellow-green-grey sand-silt with infrequent sandstone and orange clay lenses. No archaeological cuts or deposits were exposed in this trench. A 0.1metre-thin band of orange brickearth context (102) was found capping greensand deposit.

Plate 4: Showing evaluation Trench 1. Looking south with two-metre scale.

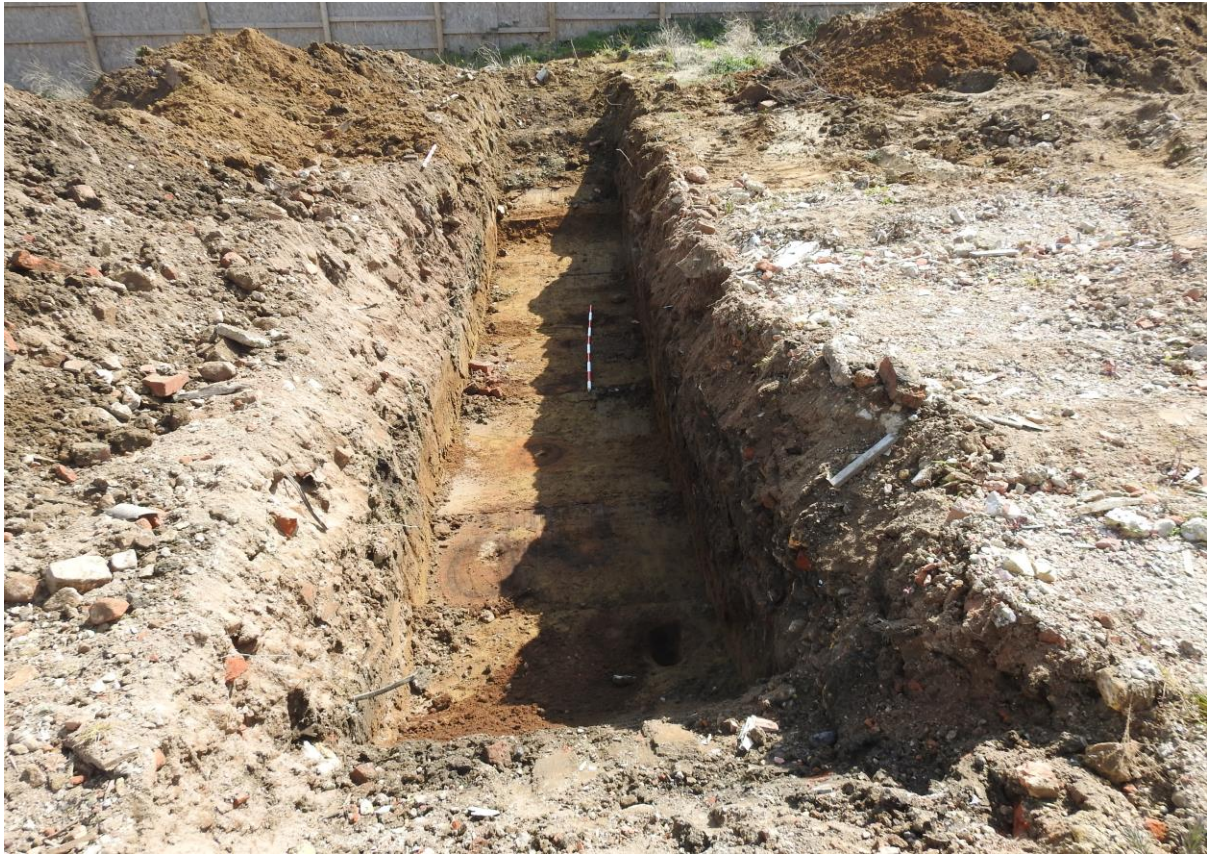
- 5.2.2 Trench 2 (Figure 3) was placed in north-eastern part of the site in WNW-ESE alignment and measured 13.03 metre in length by 1.8metre in width and 1.41metre in depth. It exposed natural geology context (203) comprising yellow-green-grey sand-silt with infrequent sandstone and orange clay lenses. No archaeological cuts or deposits were exposed in this trench. A 0.1metre thin band of orange brickearth (context (202)) was found capping greensand deposit. Several geological concretions were found within exposed parent material. These consisted of sandstone core surrounded by ferrous oxide staining with distinctive manganese 'halo' what was giving post-hole like appearance in plan.

Plate 5: Showing evaluation Trench 2. Looking east with two-metre scale.

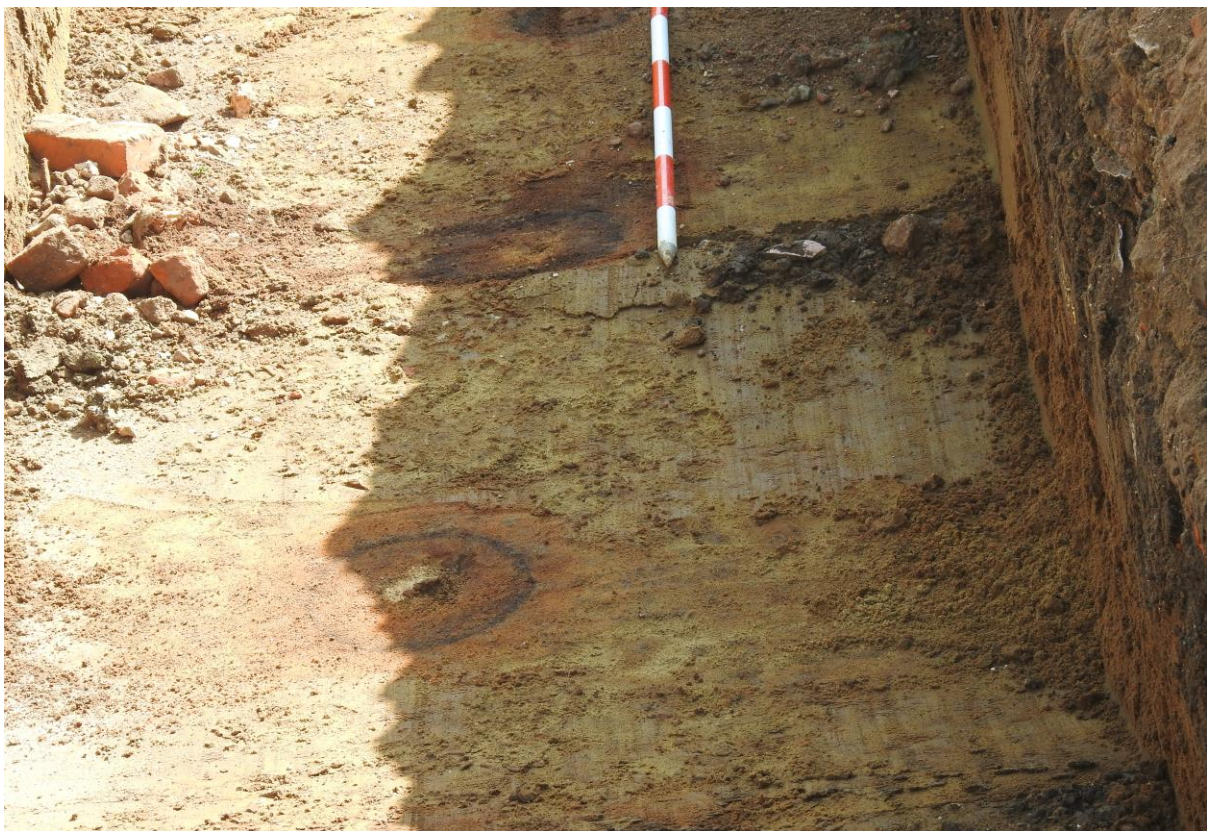
- 6.1.2 Several geological features were exposed in Trenches 2, 7 and 8. These concretions consisted of sandstone core surrounded by ferrous oxide stained-sand with distinctive manganese 'halo' that was giving off post-hole like appearance in plan.

- 6.1.3 Manganese and iron minerals in these concretions precipitated from the ambient or surrounding water in two ways: hydrogenetically, in which the minerals precipitate from cold ambient seawater; and diagenetically, in which minerals precipitate from sediment pore waters. The latter occurs in seawater that has been modified by chemical reactions within the sediment.

Plate 6: Mineral concretions exposed in Trench 2 (close up). Each scale segment equals 0.2metre.

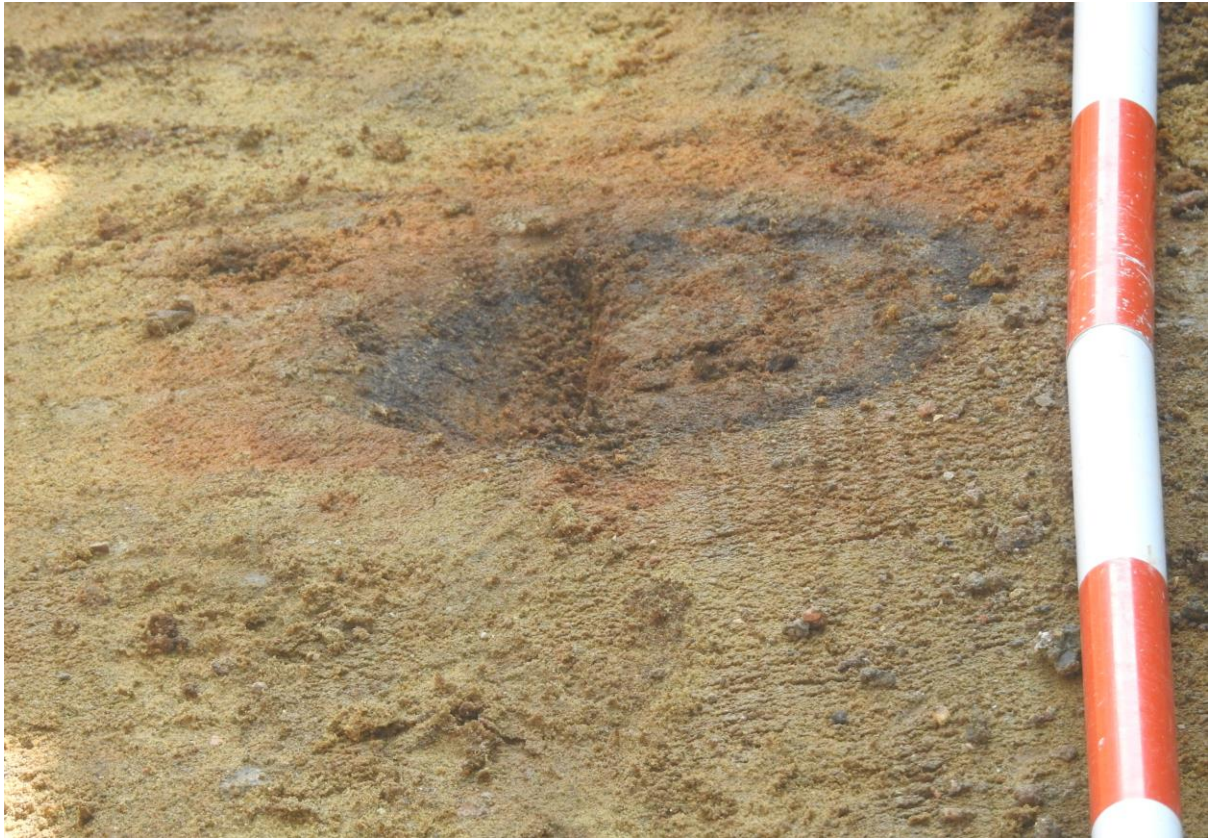
Plate 7: Another example of mineral concretions exposed in Trench 2 (close up). Each scale segment equals 0.2metre.

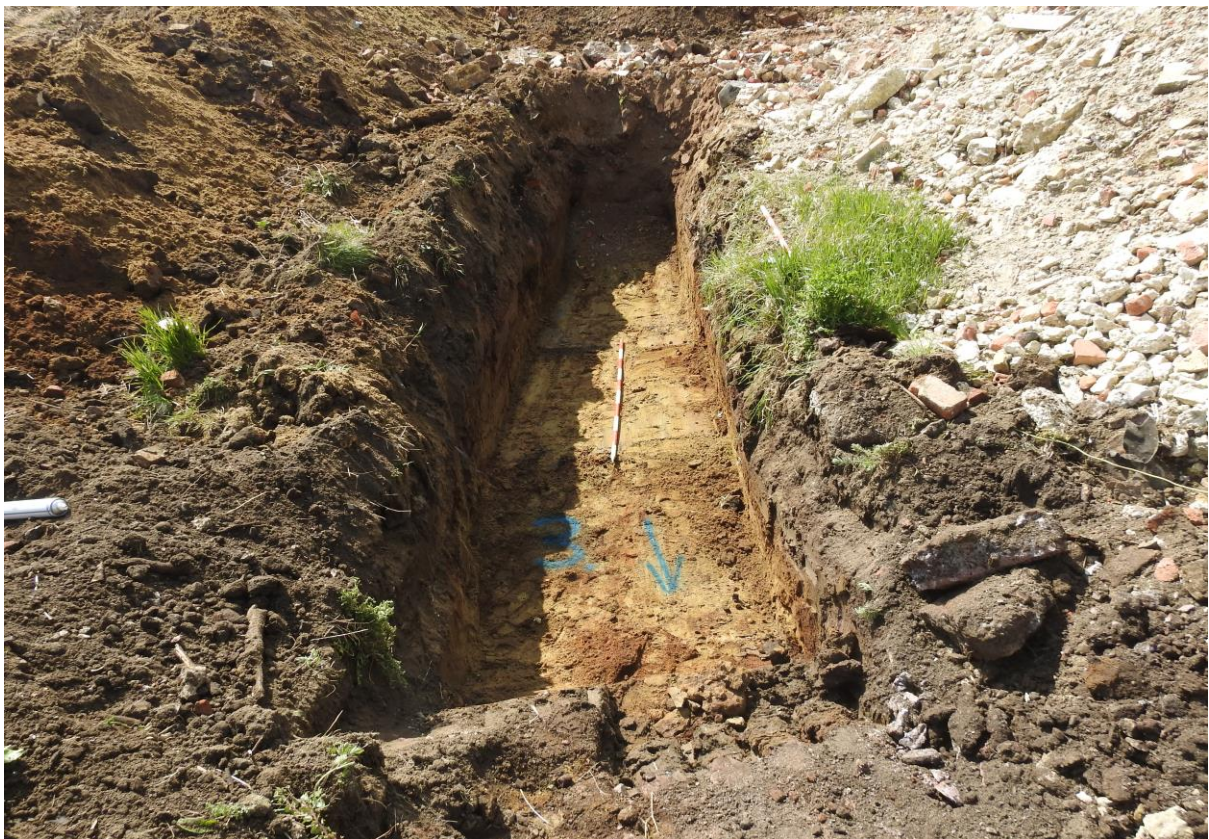
- 5.2.3 Trench 3 (Figure 3) was placed in north-eastern part of the site in NbE-SbW alignment and measured 11.69 metre in length by 1.8metre in width and 1.54metre in depth. It exposed natural geology context (303) comprising yellow-green-grey sand-silt with infrequent sandstone and orange clay lenses. No archaeological cuts or deposits were exposed in this trench.

Plate 8: Showing evaluation Trench 3. Looking south with two-metre scale.

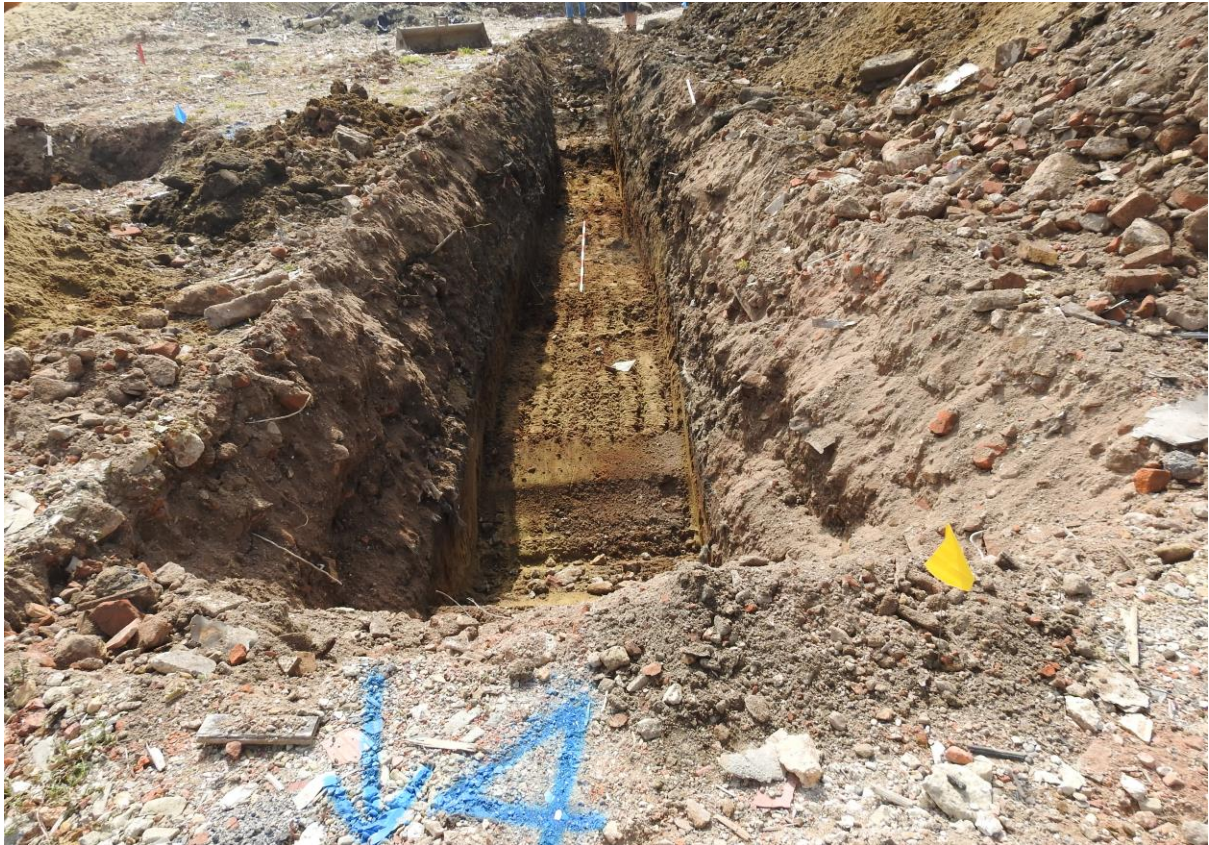
- 5.2.4 Trench 4 (Figure 3) was placed in north-eastern part of the site in NNE-SSW alignment and measured 13.28 metre in length by 1.8metre in width and 0.7metre in depth. It exposed natural geology context (403) comprising yellow-green-grey sand-silt with infrequent sandstone and orange clay lenses. No archaeological cuts or deposits were exposed in this trench.

Plate 9: Showing evaluation Trench 4. Looking south with two-metre scale.

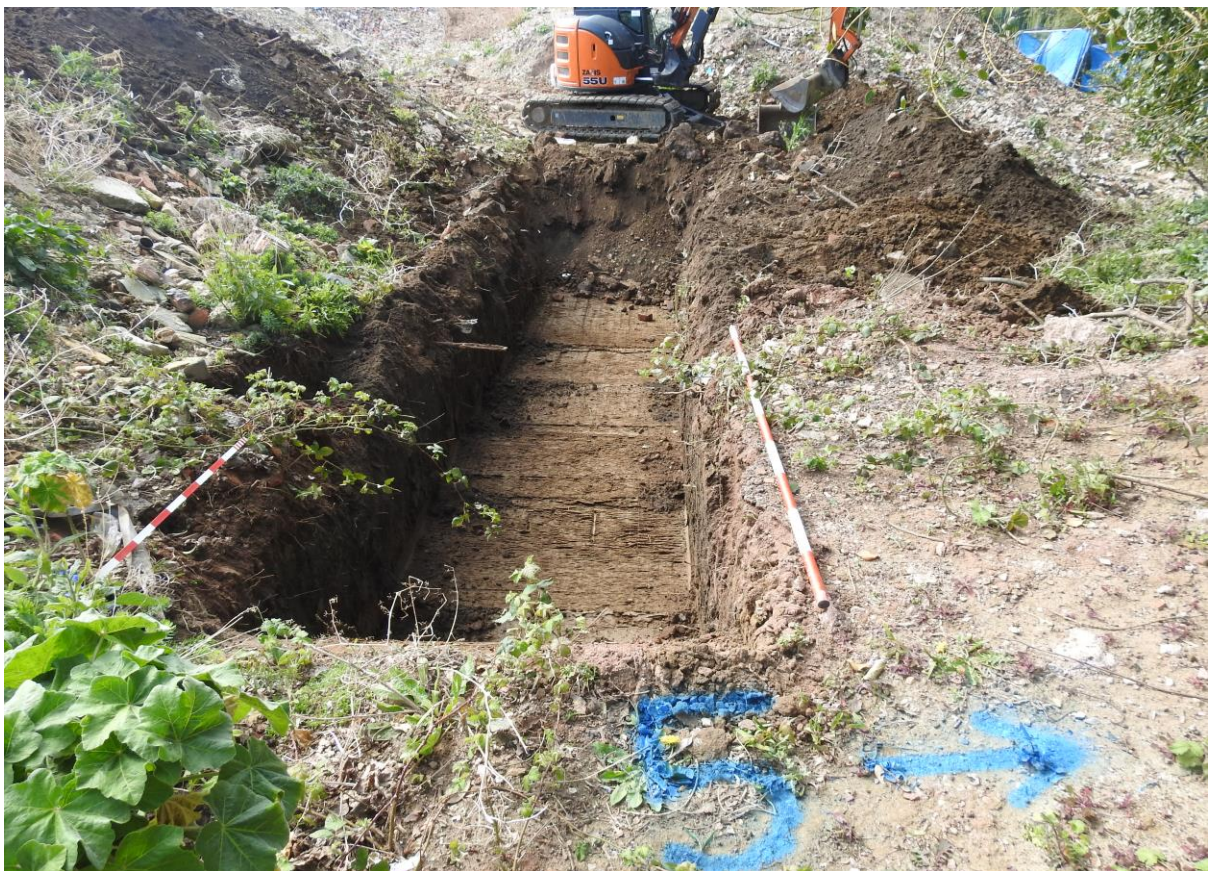
- 5.2.5 Trench 5 (Figure 3) was placed in north-eastern part of the site in ENE-WSW alignment and measured 11.58 metre in length by 1.8metre in width and 0.8metre in depth. It exposed natural geology context (503) comprising yellow-green-grey sand-silt with infrequent sandstone and orange clay lenses. No archaeological cuts or deposits were exposed in this trench.

Plate 10: Showing evaluation Trench 5. Looking west with one- and two-metre scales.

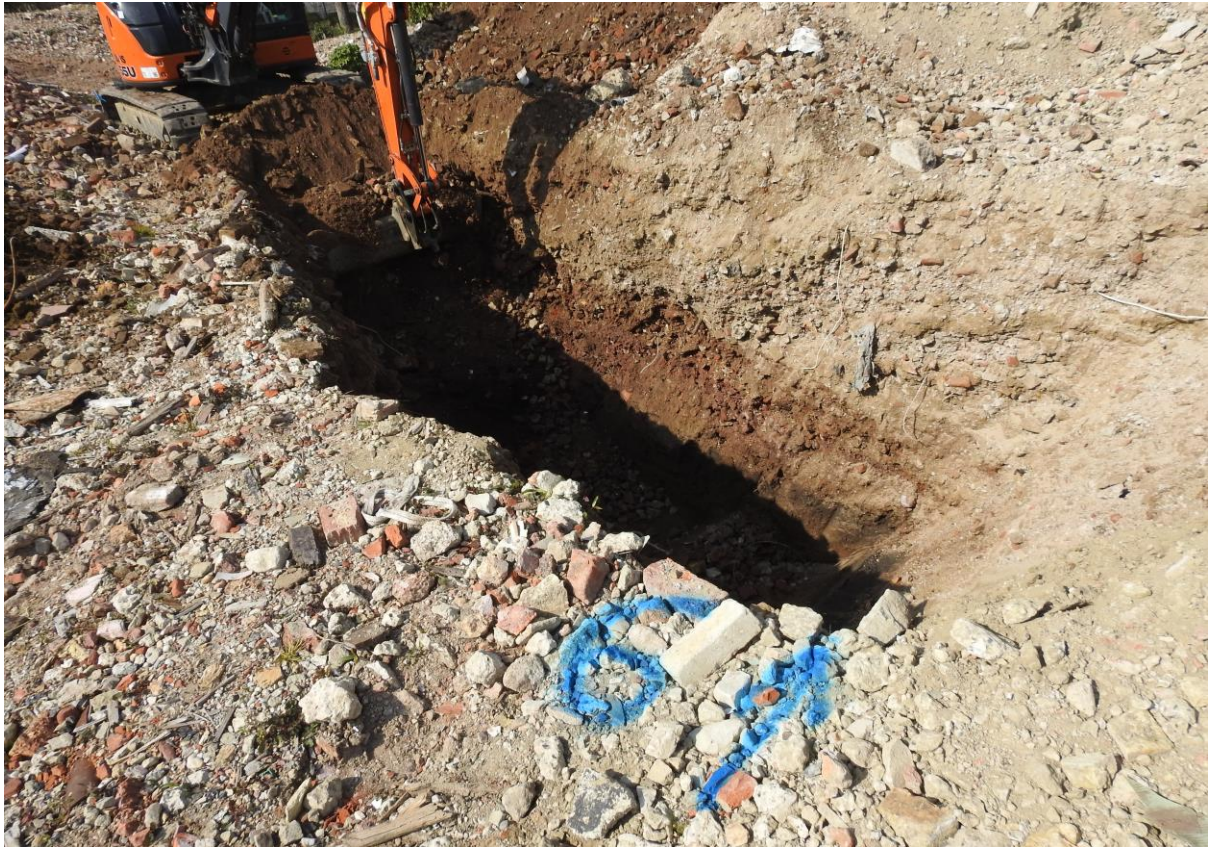
- 5.2.6 Trench 6 (Figure 3) was placed in north-eastern part of the site in ESE-WNW alignment and measured 11.48 metre in length by 1.8metre in width and 4.04metre in depth. It exposed natural geology context (603) comprising yellow-green-grey sand-silt with infrequent sandstone and orange clay lenses. No archaeological cuts or deposits were exposed in this trench.

Plate 11: Showing evaluation Trench 6, looking north-west.

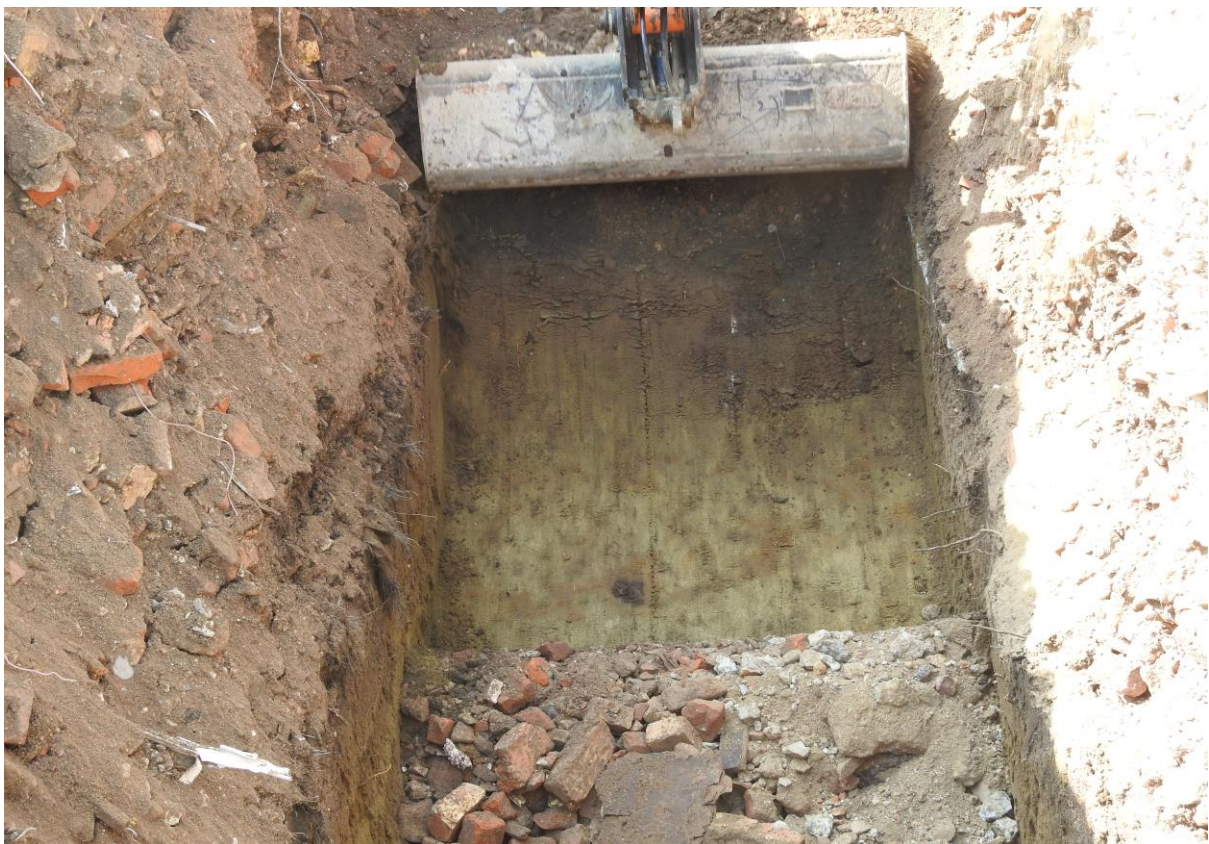
Plate 12: Showing exposed natural surface in evaluation Trench 6.

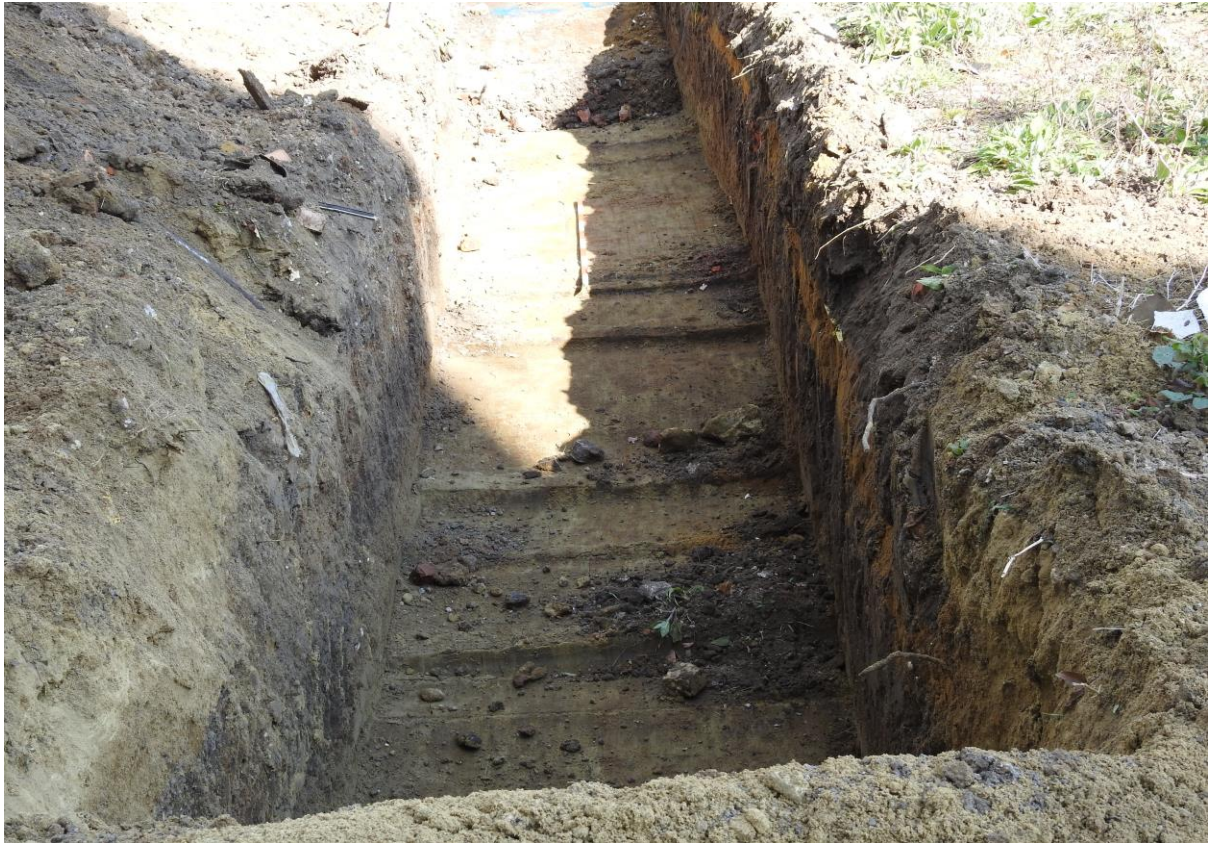
- 5.2.7 Trench 7 (Figure 3) was placed in north-central part of the site in east-west alignment and measured 6.6metre in length by 1.8metre in width and 0.88metre in depth. It exposed natural geology context (703) comprising yellow-green-grey sand-silt with infrequent sandstone and orange clay lenses. No archaeological cuts or deposits were exposed in this trench. Several geological features were exposed in this trench, similar composition to anomalies exposed in trench 2.

Plate 13: Showing evaluation Trench 7. Looking east with two-metre scale.

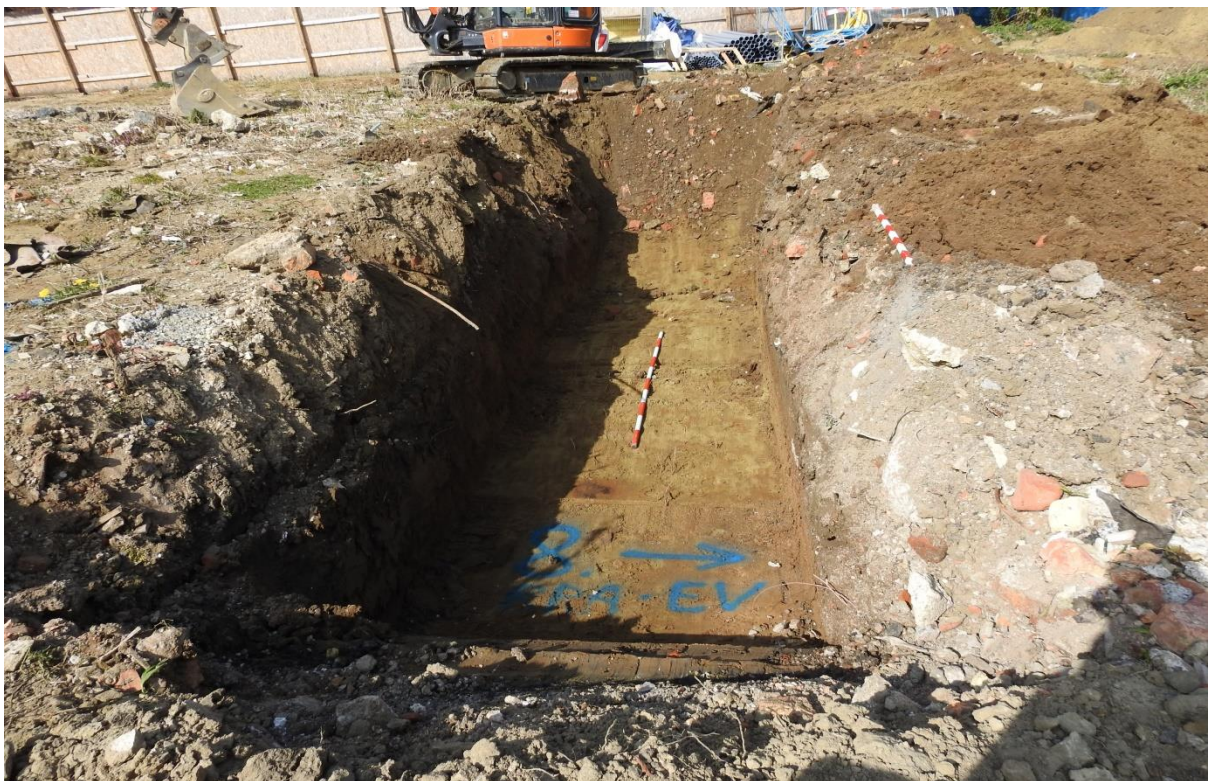
- 5.2.8 Trench 8 (Figure 3) was placed in north-western part of the site in WbN-EbS alignment and measured 10.56metre in length by 1.8metre in width and 0.63metre in depth. It exposed natural geology context (803) comprising yellow-green-grey sand-silt with infrequent sandstone and orange clay lenses. No archaeological cuts or deposits were exposed in this trench.

Plate 14: Showing evaluation Trench 8. Looking west with two-metre scale.

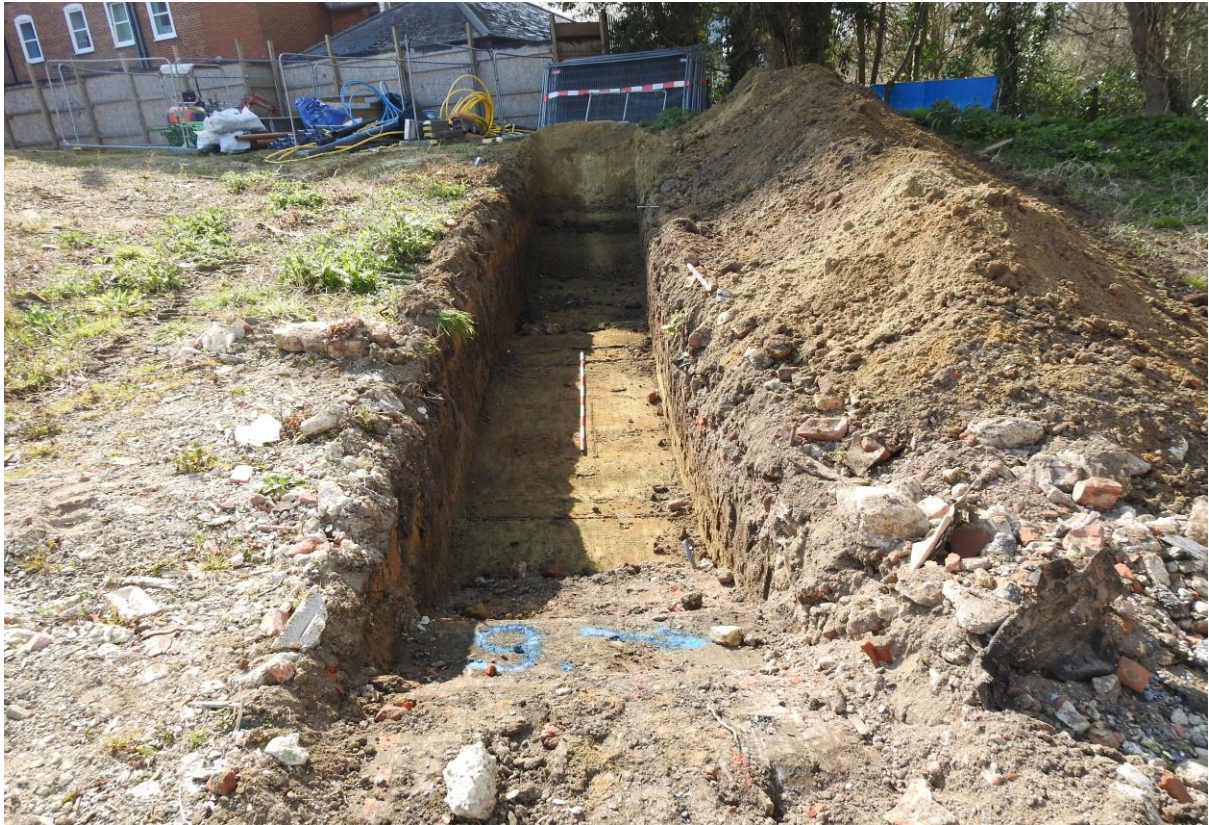
- 5.2.9 Trench 9 (Figure 3) was placed in north-western part of the site in WSW-ENE alignment and measured 12.2metre in length by 1.8metre in width and 0.93metre in depth. It exposed natural geology context (903) comprising yellow-green-grey sand-silt with infrequent sandstone and orange clay lenses. No archaeological cuts or deposits were exposed in this trench.

Plate 15: Showing evaluation Trench 9. Looking west with two-metre scale.

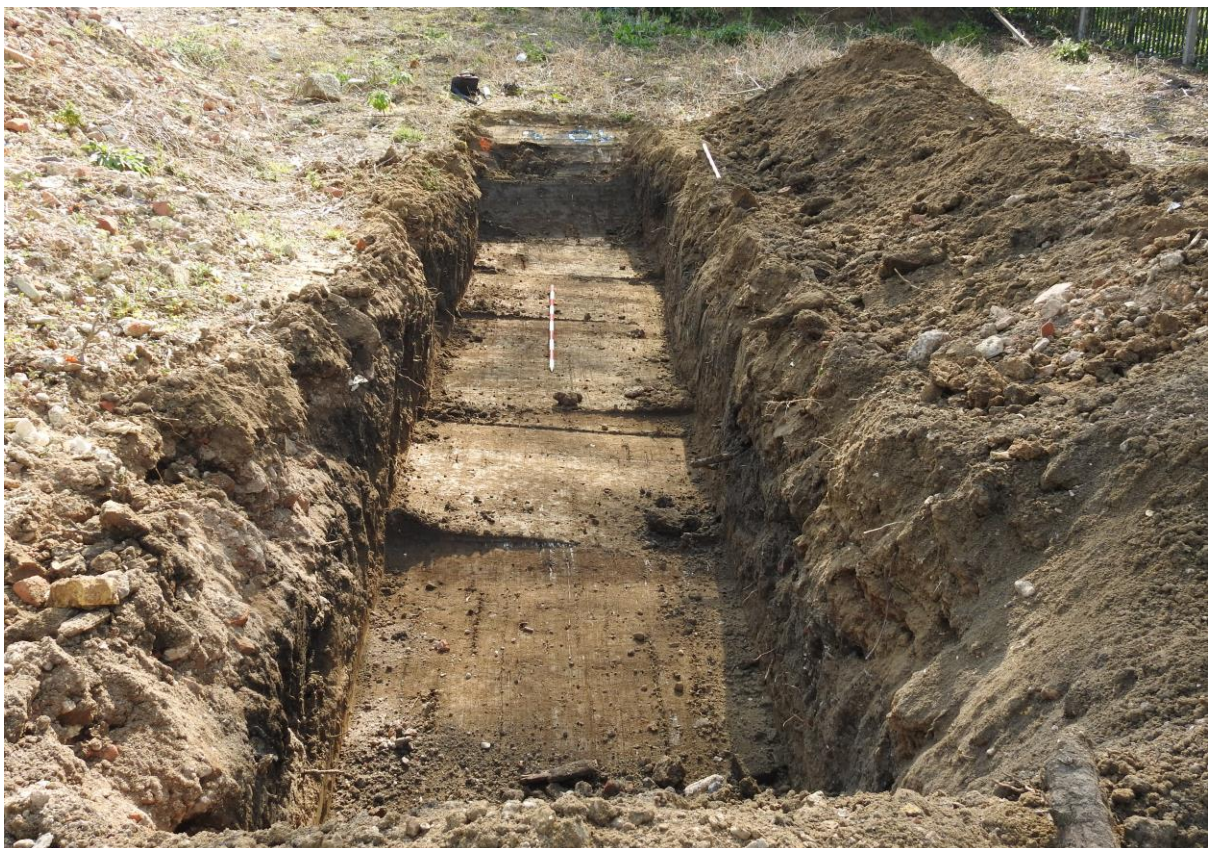
- 5.2.10 Trench 10 (Figure 3) was placed in north-western part of the site in south-west; north-east alignment and measured 10.8metre in length by 1.8metre in width and 0.69metre in depth. It exposed natural geology context (1003) comprising yellow-green-grey sand-silt with infrequent sandstone and orange clay lenses. No archaeological cuts or deposits were exposed in this trench.

Plate 16: Showing evaluation Trench 10. Looking south-west with two-metre scale.

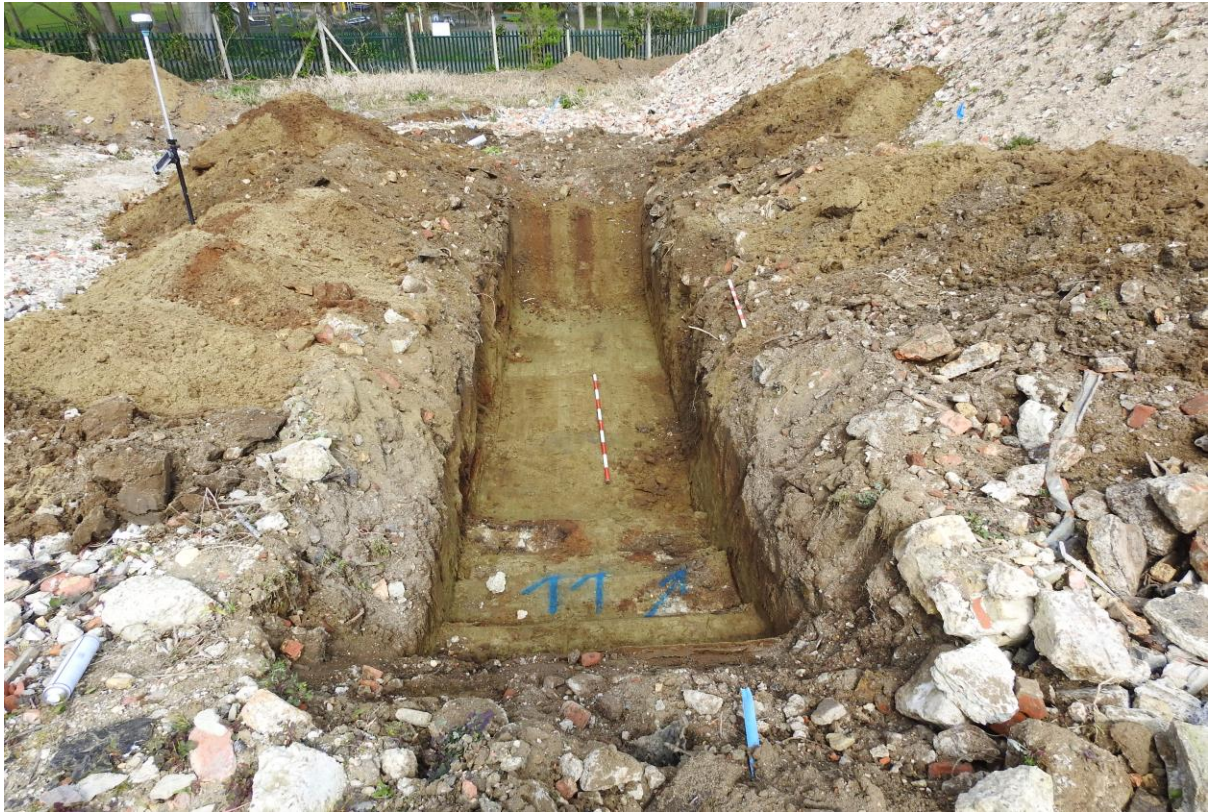
- 5.2.11 Trench 11 (Figure 3) was placed in north-western part of the site in NNW-SSE alignment and measured 9.42metre in length by 1.8metre in width and 0.57metre in depth. It exposed natural geology context (1103) comprising yellow-green-grey sand-silt with infrequent sandstone and orange clay lenses. No archaeological cuts or deposits were exposed in this trench.

Plate 17: Showing evaluation Trench 11. Looking north-west with two-metre scale.

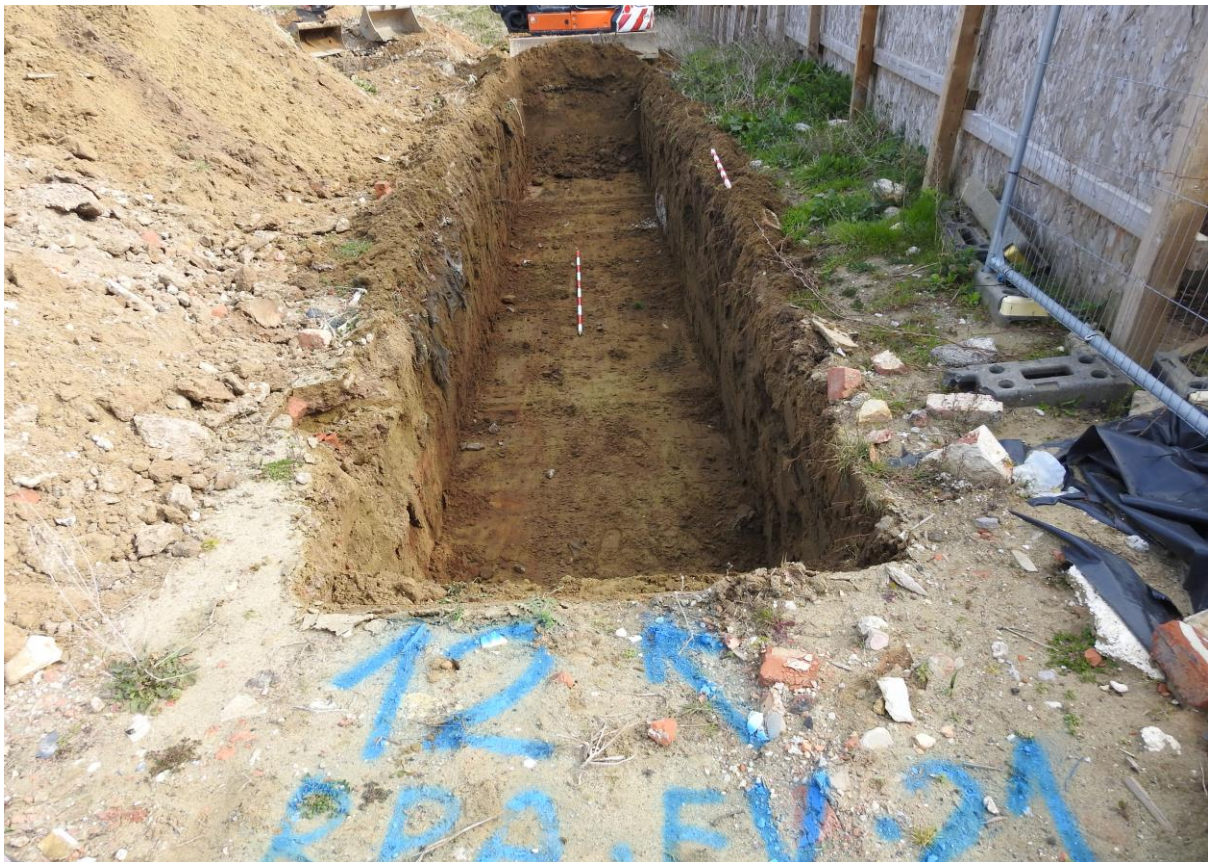
5.2.12 Trench 12 (Figure 3) was placed in north-eastern part of the site in NbE-SbW alignment and measured 9.31 metre in length by 1.8metre in width and 0.82metre in depth. It exposed natural geology context (1203) comprising yellow-green-grey sand-silt with infrequent sandstone and orange clay lenses. No archaeological cuts or deposits were exposed in this trench.

Plate 18: Showing evaluation Trench 12. Looking north-east with two-metre scale.
