ARCHAEOLOGICAL EVALUATION OF Land at Turkey Mill Business Park, Ashford Road, Maidstone, Kent ME14 5PP

Report date: 10/03/2021

Site code: **TMM-EV-21**

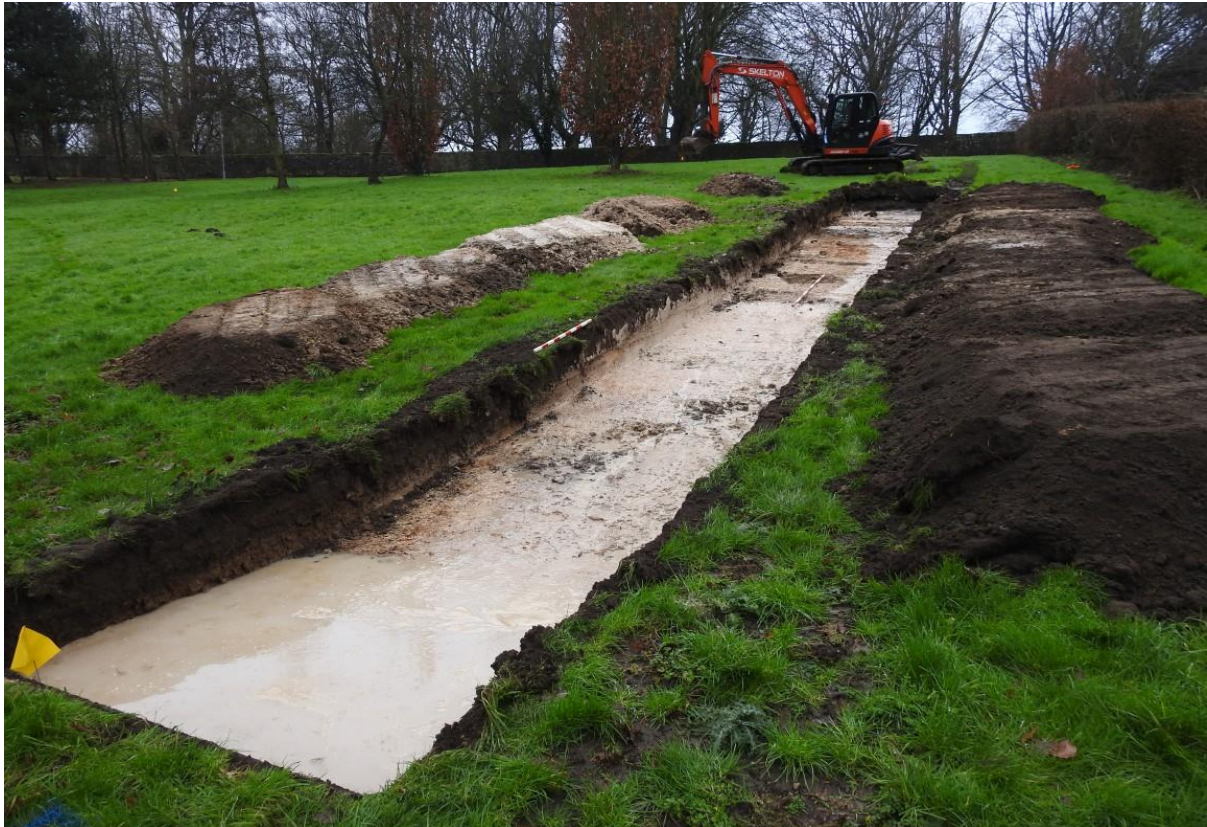
Plate 3: Showing evaluation Trench 1. Looking south with two-metre scale inside the trench.

- 5.1.6 No archaeological cuts, deposits or artefacts were revealed during the course of evaluation.
- 5.2 Trench Narratives
- 5.2.1 Trench 1 (Figure 3) was placed in north-western part of the site in north-northeast; south-southwest alignment and measured 1.8metre wide by 18.66metres in length and 0.48metre in maximum depth. (103) comprising light yellow-grey clay-sand-silt with infrequent sandstone flecks. Modern cut for possible fence post and treebale were exposed in southern part of this trench. A water spring was also exposed at southern end of this trench and rapidly filled-in its northern end. No archaeological cuts, deposits or artefacts were revealed in this trench.

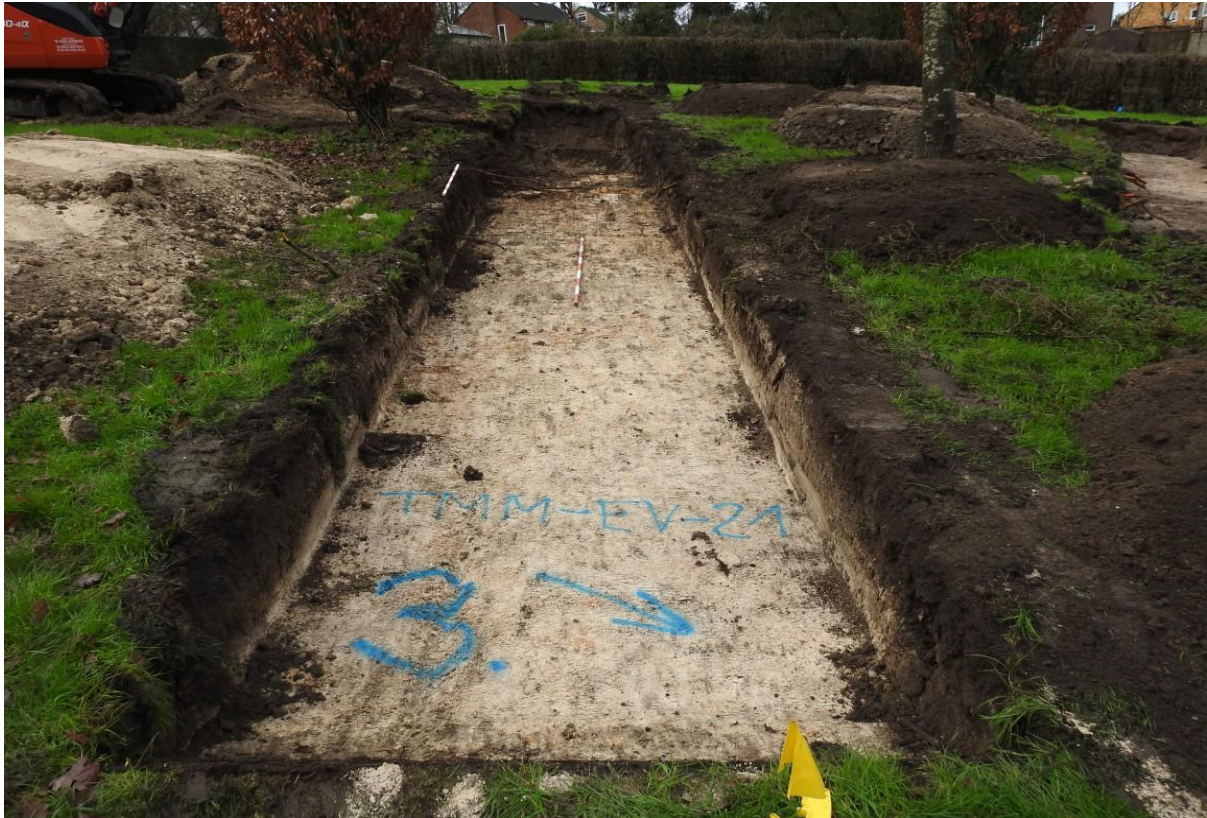
Plate 5: Showing evaluation Trench 3. Looking west with two-metre scale.

- 5.2.3 Trench 3 (Figure 3) was placed in central-western part of the site in east-west alignment and measured 1.8metre wide by 16.50metres in length and 1.05 metre in maximum depth where an extension was excavated to better understand exposed remains. It exposed modern levelling deposit comprising garden soil with metal debris capping natural geology context (203). A one-brick course soil retention wall (remains) was exposed at western end of this trench. Bricks looks modern, definitely post war and bonding material used was hard concrete-like mortar. No archaeological cuts, deposits or artefacts were revealed here.

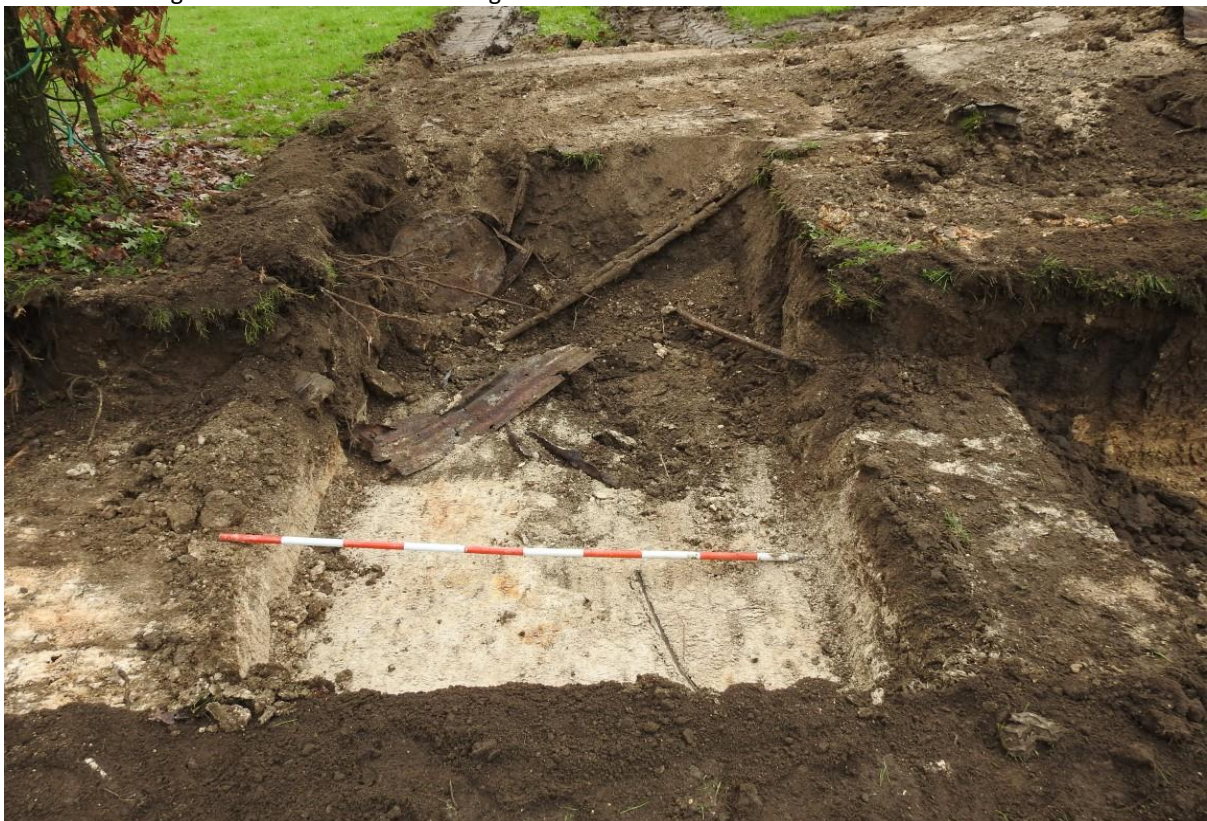
Plate 6: Modern waste revealed in Trench 3. Looking south with two-metre scale.

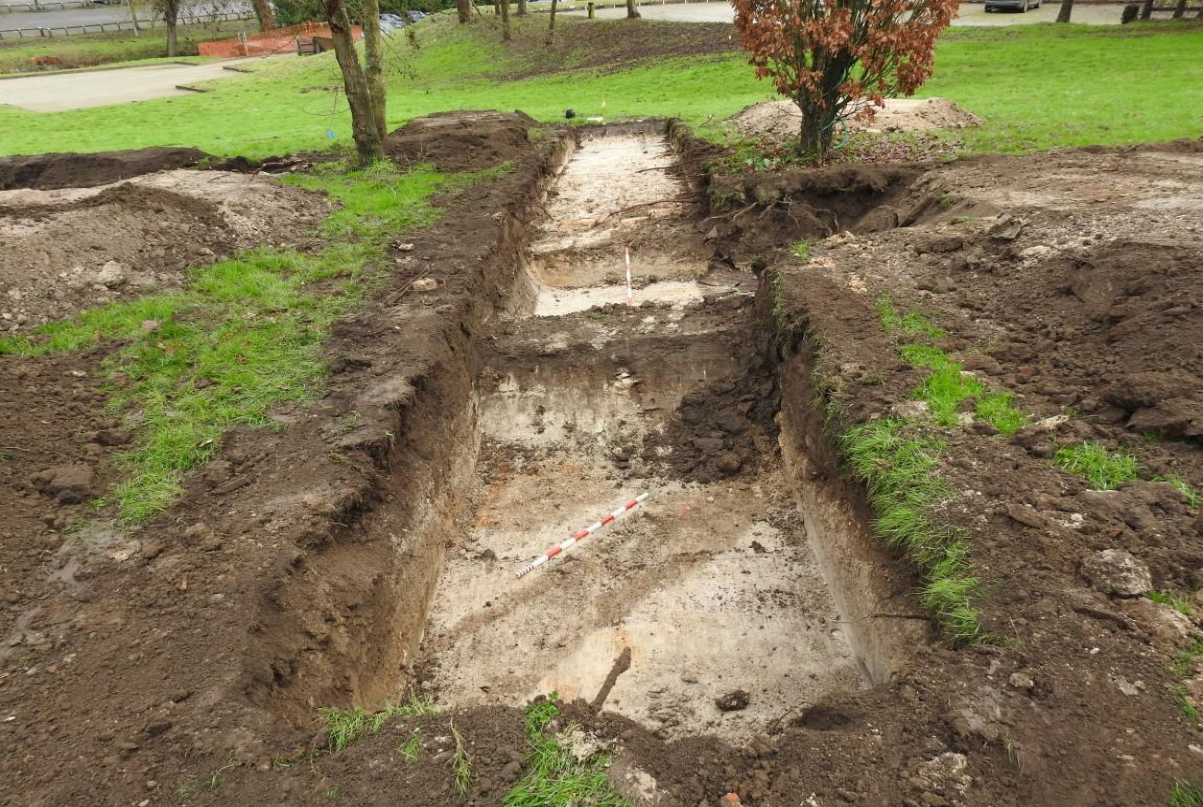
Plate 7: Showing evaluation Trench 3 looking eastwards. Retention wall visible in foreground with one-metre scale.

- 6.2 Remains of soil retention walls were exposed in Trenches 3, 8 and 8A. Retaining wall exposed in Trench 3 could be directly related to the allotment gardens whilst the walls exposed in trenches 8 and 8A could be a part of paper mill development. The car-park area occupying eastern and central part of the site was originally a slope descending northwards to the river Len therefore the evaluation came to conclusion that these wall were essential at keeping soil in place and preventing from washing it down to the river Len.

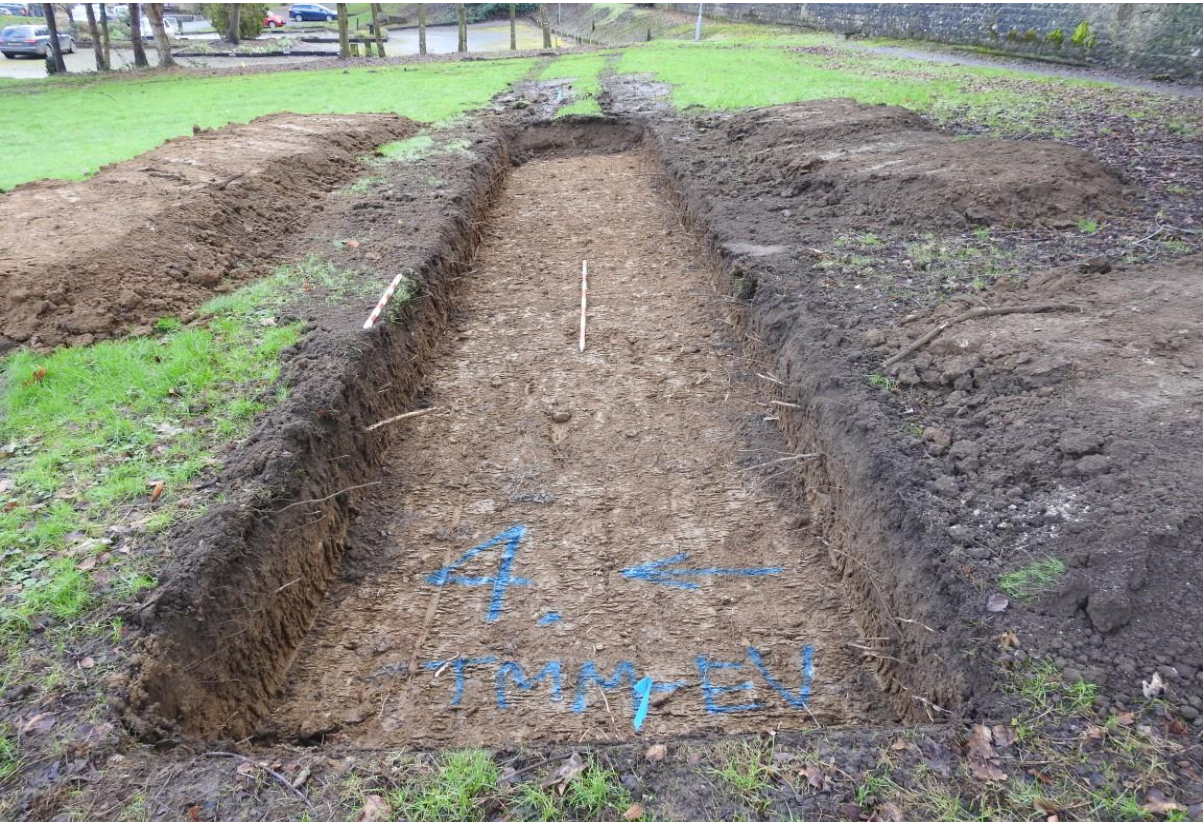
Plate 8: Showing evaluation Trench 4. Looking east with two-metre scale.

- 5.2.4 Trench 4 (Figure 3) was placed in south-western part of the site in NE-SE alignment and measured 1.8metre wide by 15.50metre long and 0.43 metre in maximum depth. Trench has exposed natural

geology (403) comprising orange-brown clay-sand-silt with infrequent angular stones. No archaeological cut or deposits were exposed here.

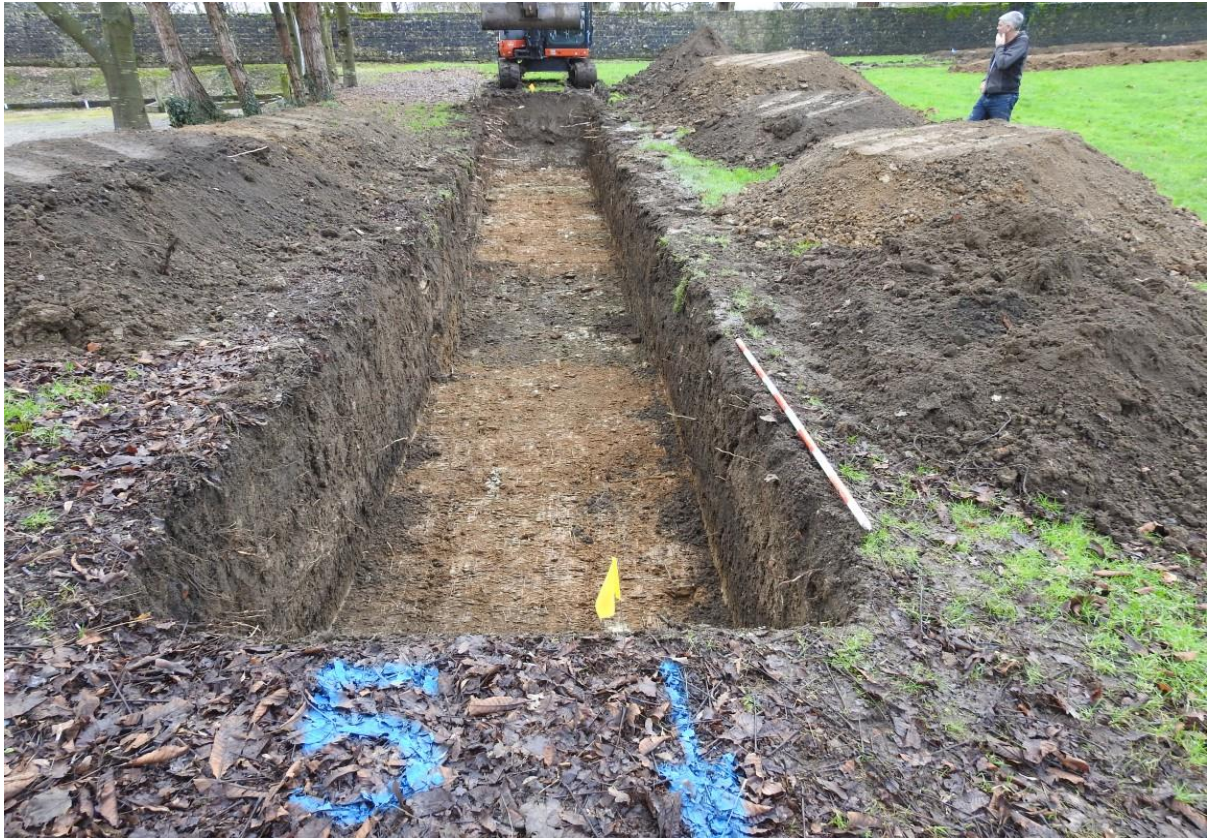
Plate 9: Showing evaluation Trench 5. Looking south with two-metre scale.

- 5.2.5 Trench 5 (Figure 3) was placed in central part of the site in north-south alignment and measured 1.8metre wide by 18.56metres in length and 1.4metre in maximum depth. Trench has exposed vast modern levelling deposit capping natural geology context 503 comprising orange-grey clay-sand-silt with infrequent sandstone flecks. No archaeological cuts, deposits or artefacts were revealed here.

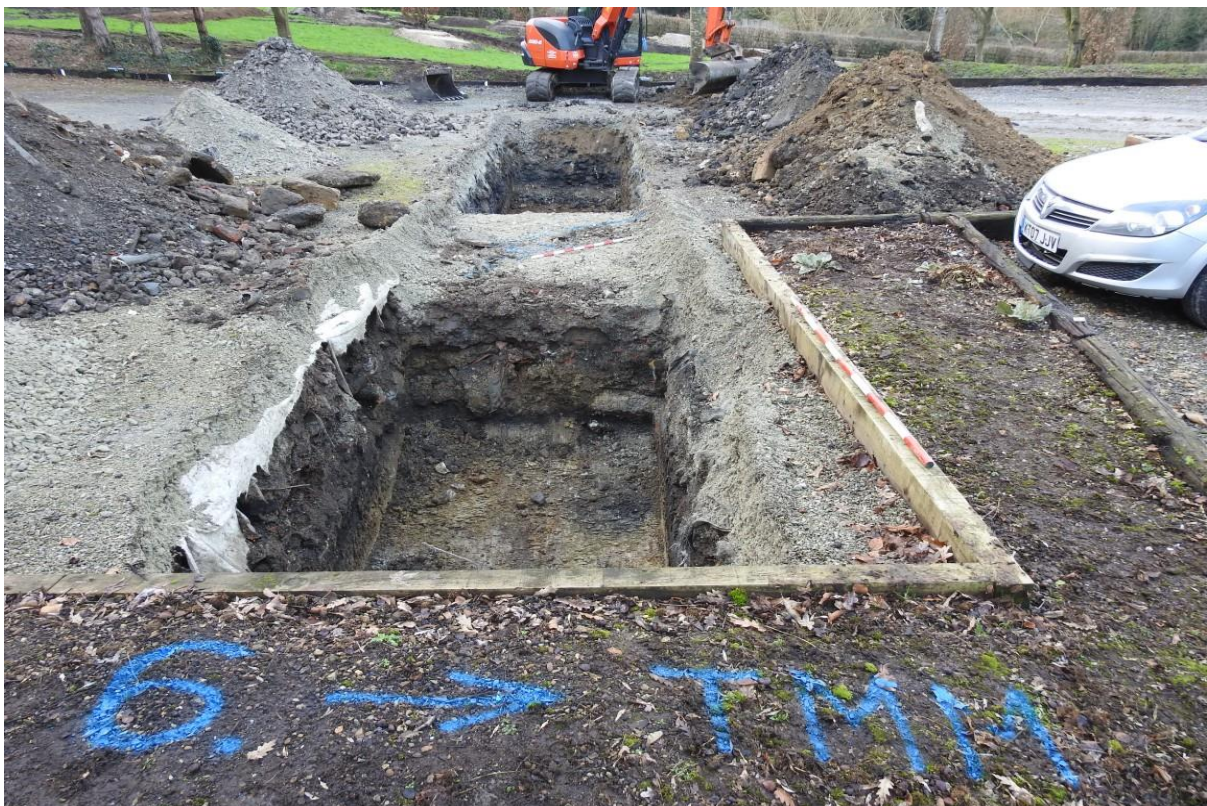
Plate 10: Showing evaluation Trench 6. Looking west with one and two-metre scales.

- 5.2.6 Trench 6 (Figure 3) was placed in north-eastern part of the site in east-west alignment and measured 1.8metre wide by 15metre long and 1.5metre in maximum depth. Trench has exposed vast modern levelling deposit capping natural geology 603 comprising orange-grey clay-sand-silt with infrequent angular stones. A green staining within exposed natural geology surface derived from overlaying demolition debris. Modern service trench was exposed roughly in the middle part of this trench. No archaeological cuts, deposits or artefacts were revealed here.

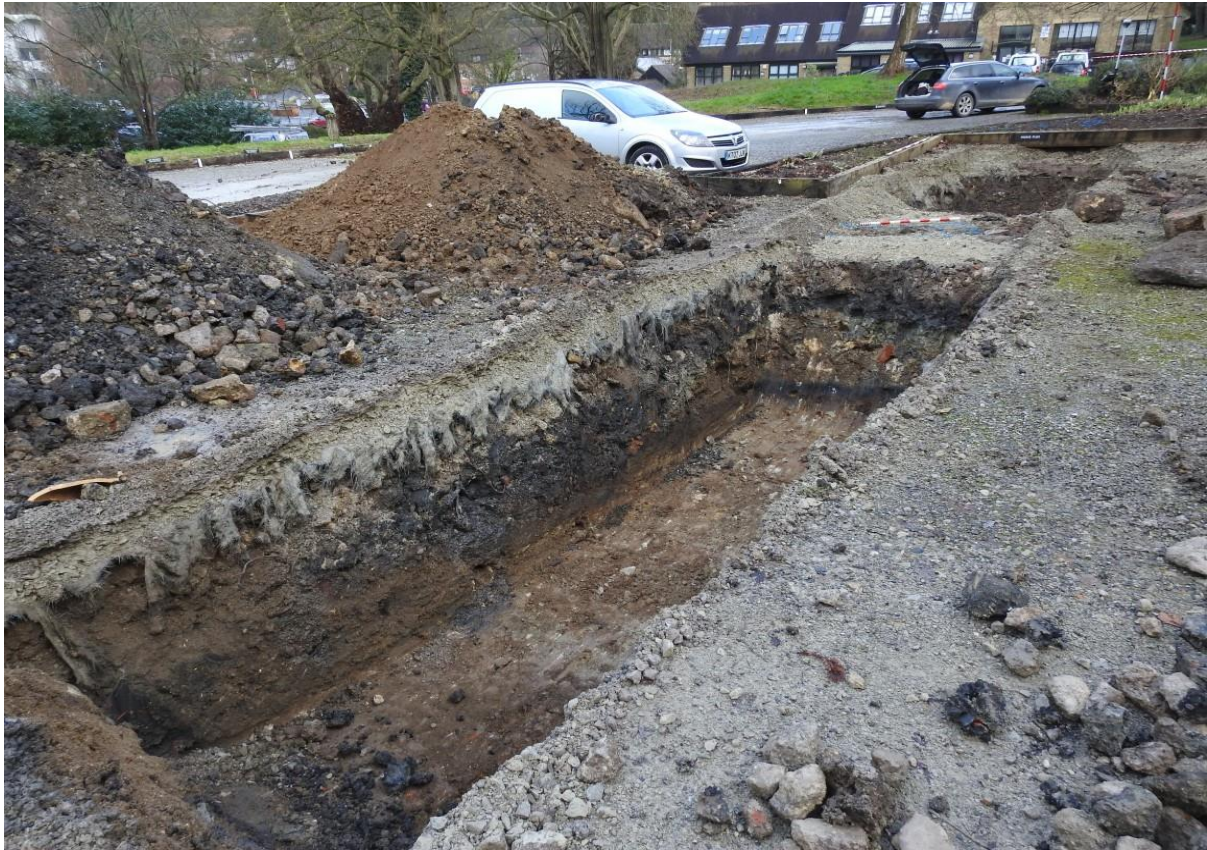
Plate 11: Overlook onto Trench 6 looking north-east towards river Len. One metre scale.

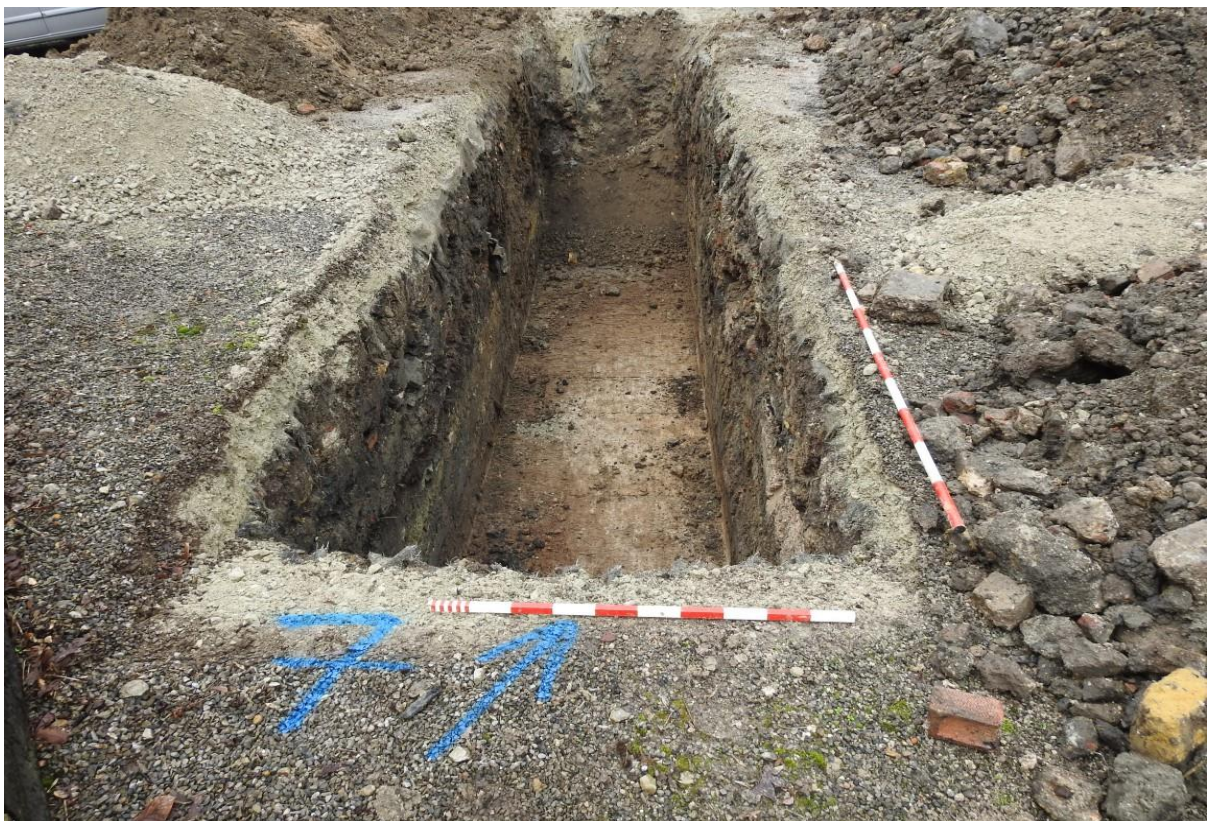
Plate 12: Showing Trench 7. Looking north-west with one- and two-metre scales.

- 5.2.7 Trench 7 (Figure 3) was placed in north-eastern part of the site in north-south alignment and measured 1.8metre wide by 16.68metre in length and 2.8metre in maximum depth. Trench has exposed vast modern levelling deposit capping natural geology context 703 comprising orange-grey clay-sand-silt with infrequent sandstone flecks. No archaeological cuts, deposits or artefacts were revealed here.

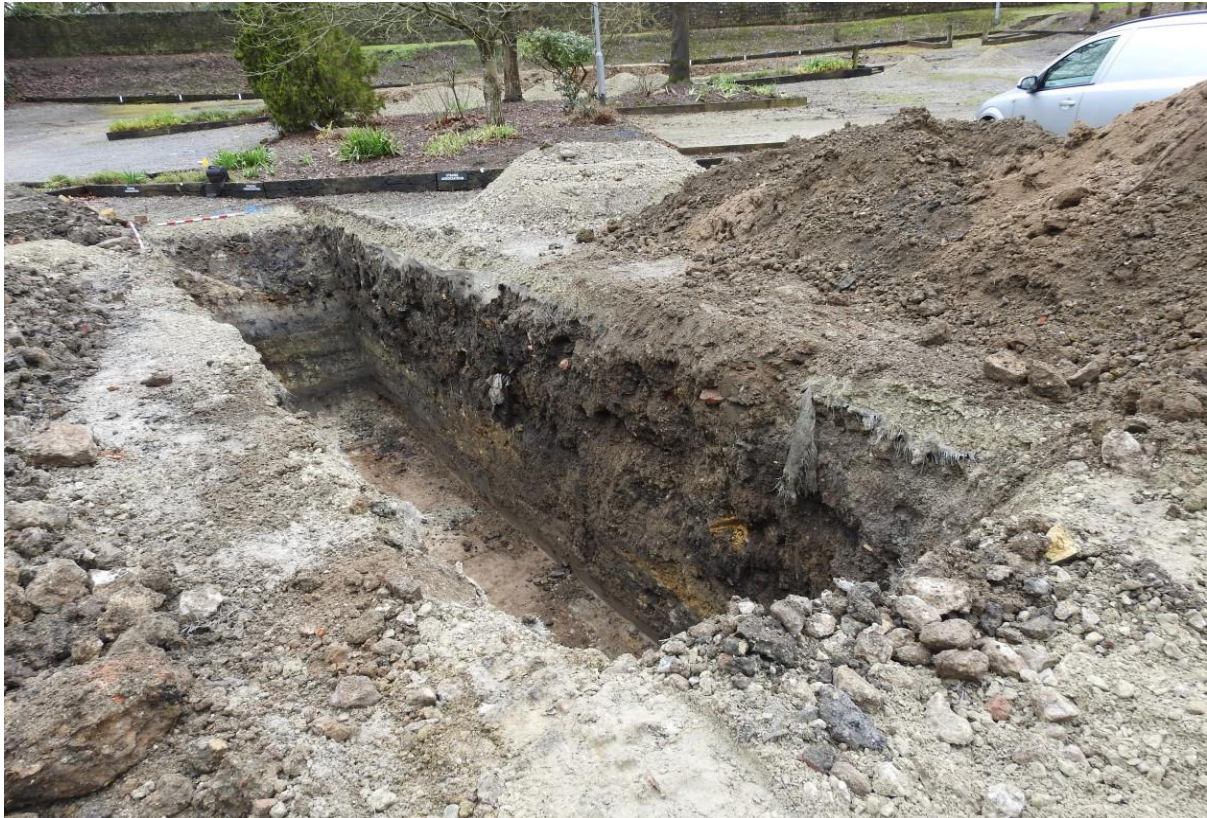
Plate 13: Evaluation Trench 7 looking north with one-metre scale at its distant end.

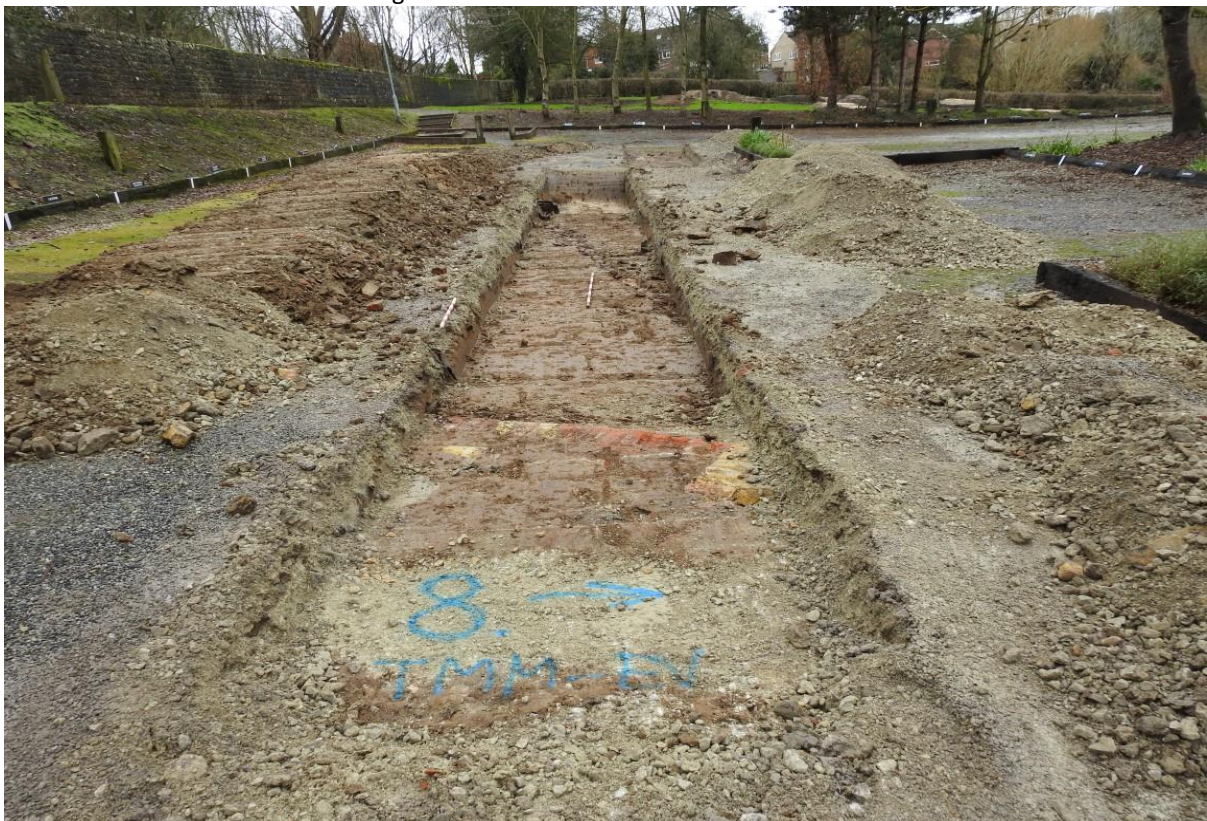
Plate 14: Trench 8 looking west. Slightly curving retention wall visible in foreground. Ceramic pipe visible in background. Looking west with two-metre scales.

- 5.1.5 Trench 8 located to the south has exposed shallow walls, probably functioning as a soil retention barrier. Majority of the bricks appears to be post war; bonding material is partially soft yellow sandy but in most places very hard, fine grained concrete-like mortar was used.

- 5.2.8 Trench 8 (Figure 3) was placed in south-eastern part of the site in east-west alignment and measured 1.8metre wide by 18.12 metre in length and 0.8metre in maximum depth. Trench has exposed natural geology context 803 comprising orange-grey clay-sand-silt with infrequent angular stones and sandstone flecks. Trench has exposed modern soil retention wall at its eastern end and ceramic pipe in east west alignment. No archaeological cuts, deposits or artefacts were revealed here.

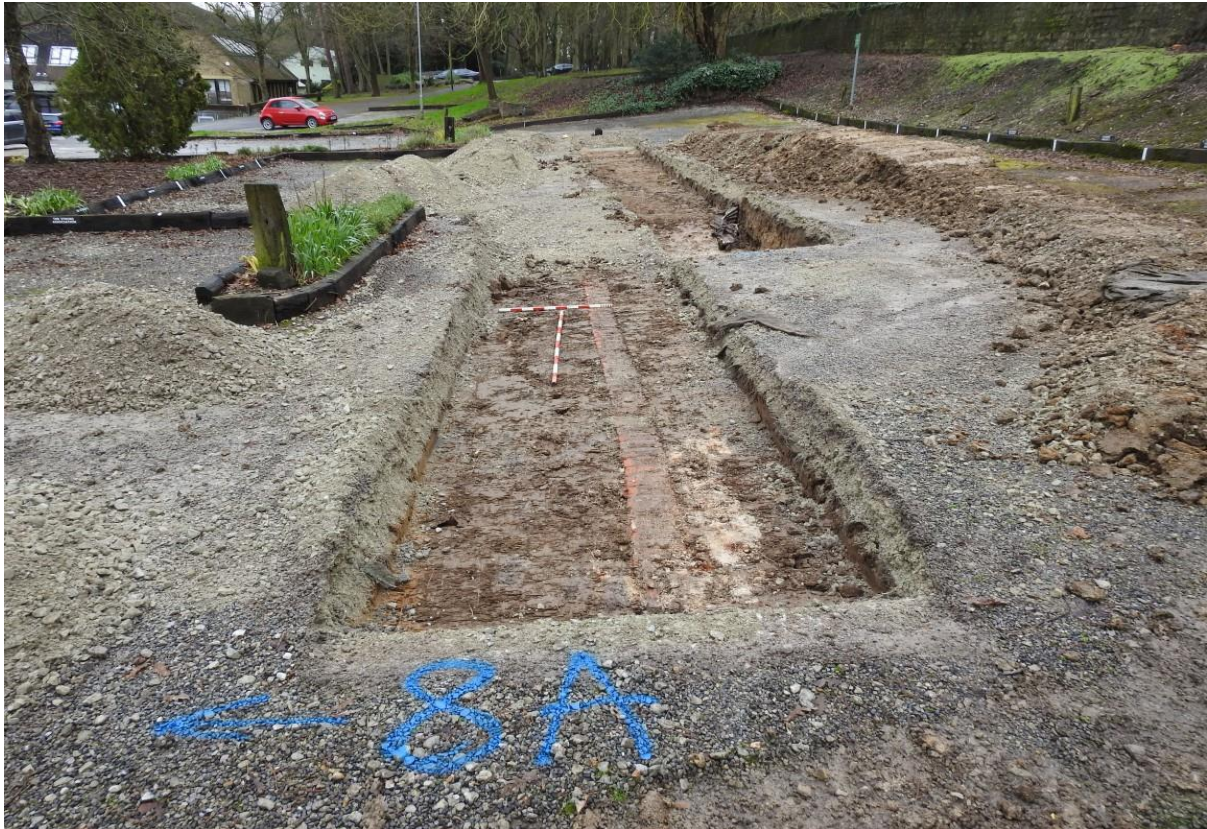
Plate 15: Showing Trench 8A and retention wall in foreground. Looking east with one- and two-metre scales.

- 5.2.9 Trench 8A (Figure) this contingency trench was placed adjacently to the west of Trench 8 discussed above in the same alignment. It measured 1.8metre wide by 9.45metre in length and 0.25metre in maximum depth. It exposed modern soil retention wall in roughly east-west alignment cutting through natural geology concealed by recent car-park surface consisting of small stones aggregate. No archaeological cuts, deposits or artefacts were revealed here.

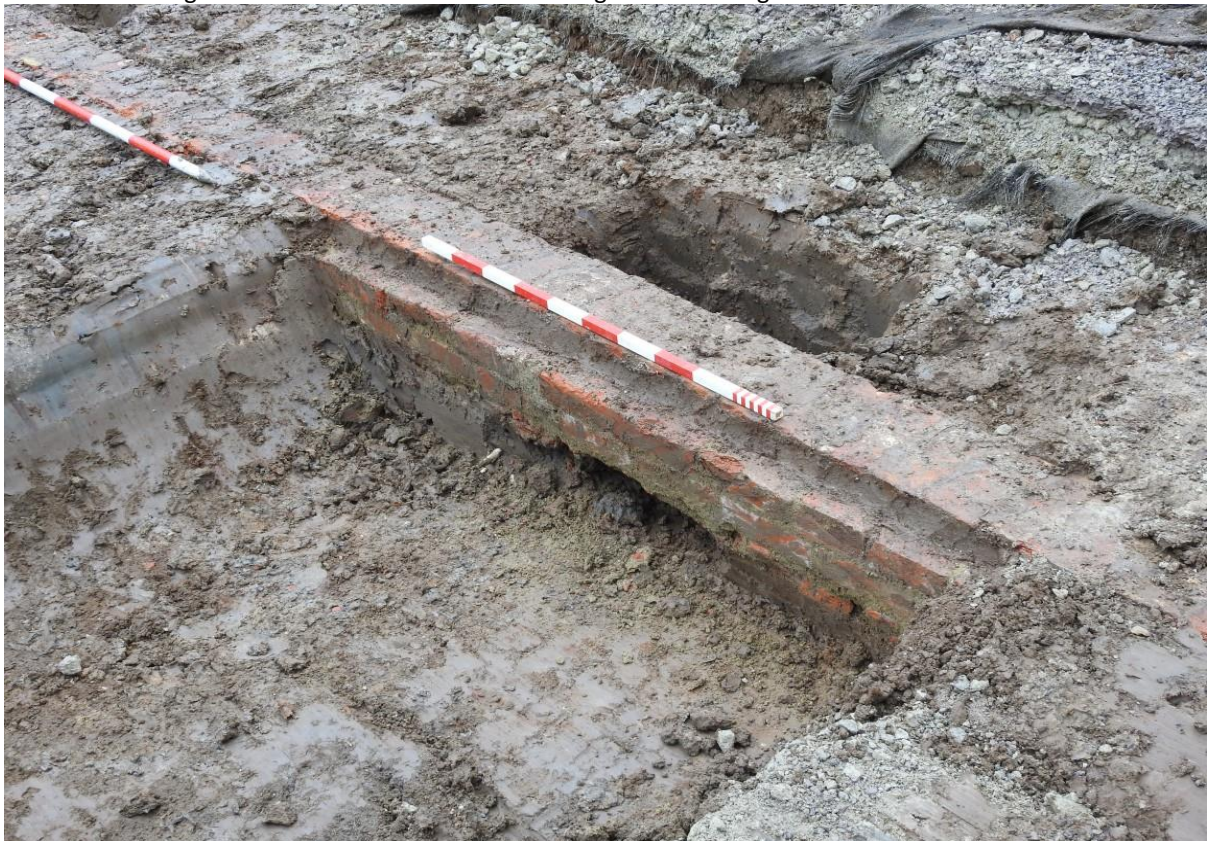
Plate 16: Showing exposed retention wall in Trench 8A. Looking south-east with one-metre scale.

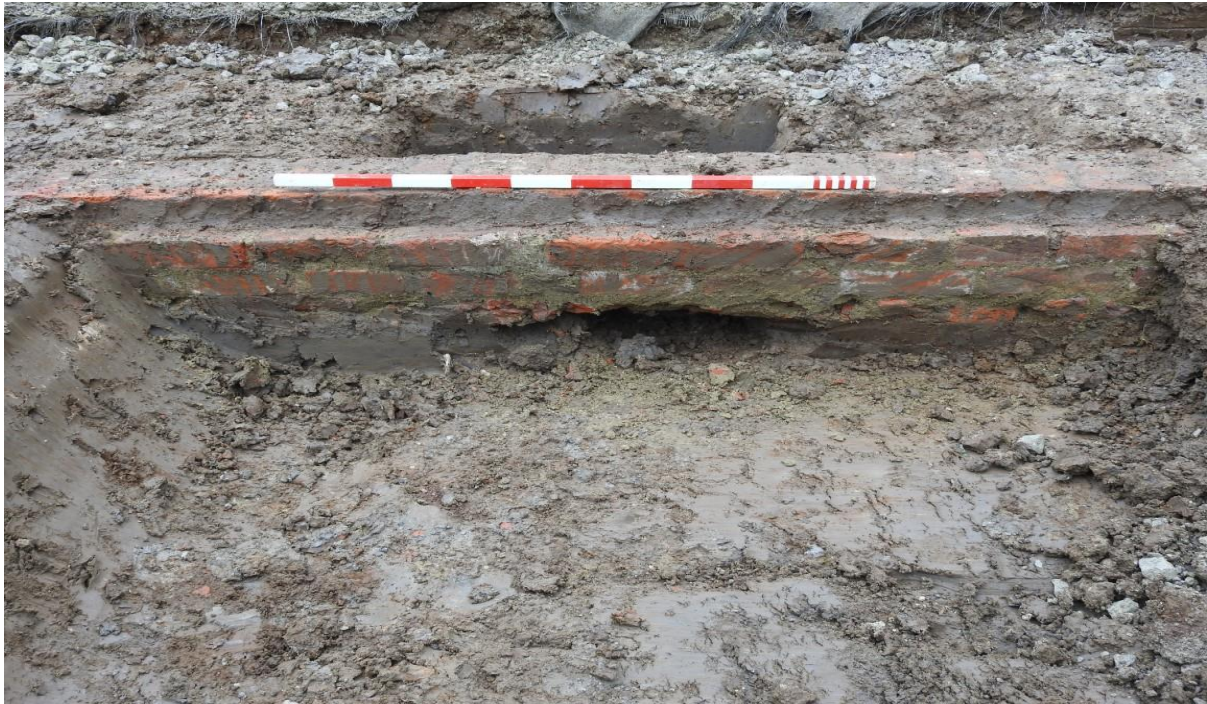
Plate 17: Wall exposed in Trench 8A looking south with one-metre scale.

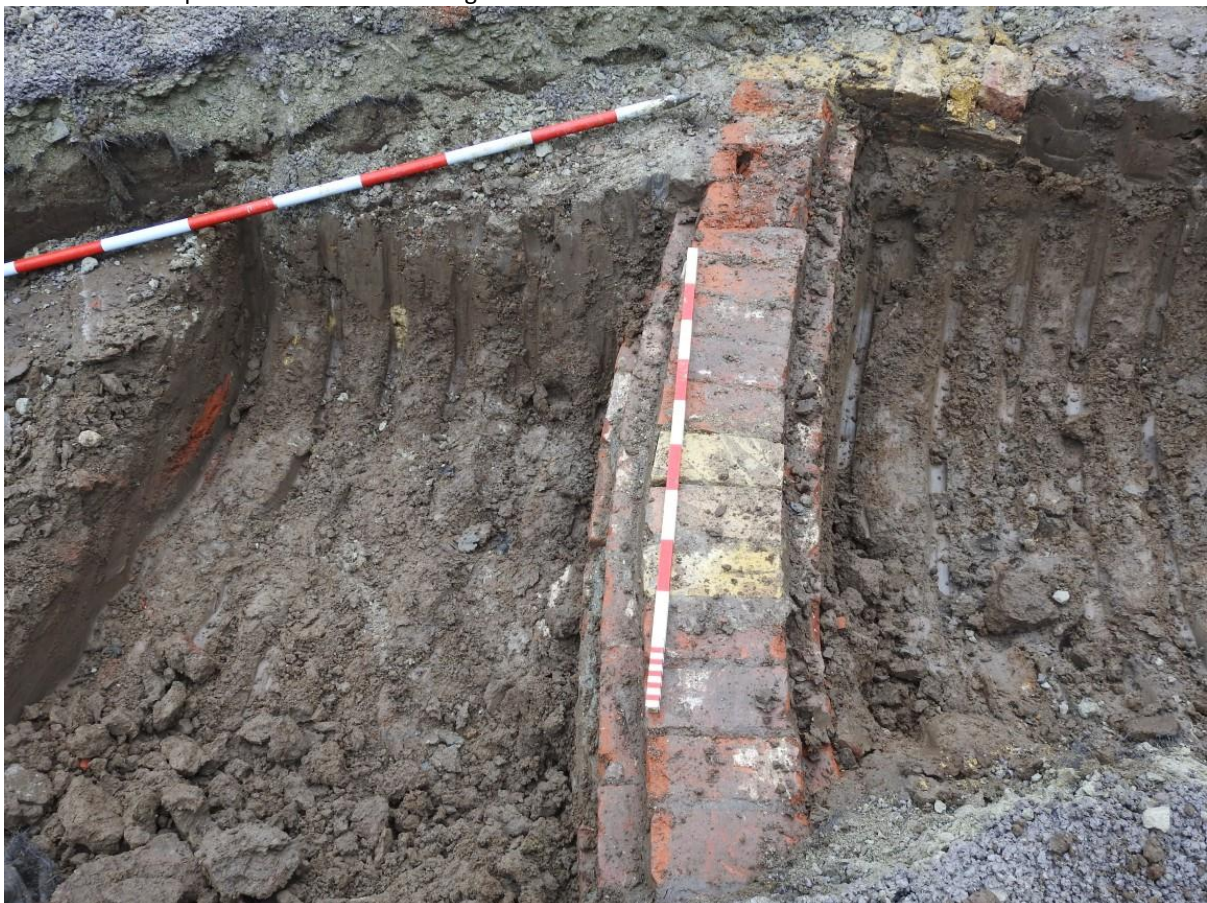
Plate 18: Showing retention wall exposed in eastern end of evaluation trench 8. Looking north with one- and two-metre scales.

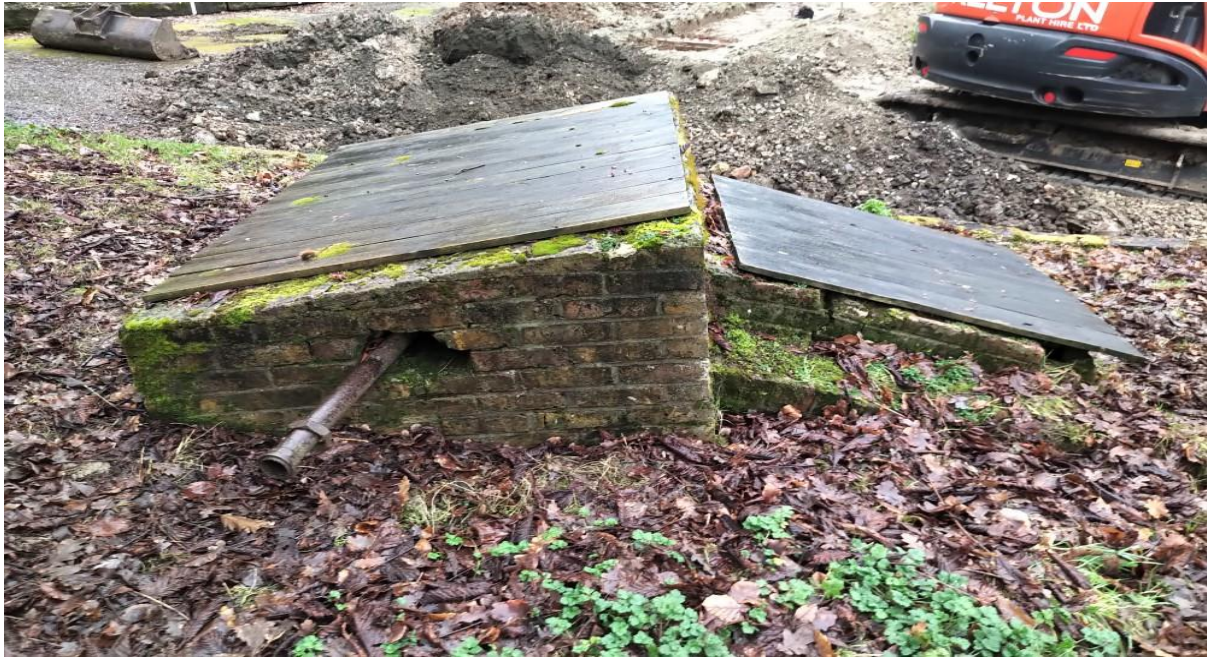
Plate 19: Showing fresh water well and reservoir situated in south eastern part of the site.

- 5.1.4 The southern extent of carpark contained ceramic pipes possibly diverting water from adjacent stream. Pipes are connected to the well/manhole structure which was a part of a paper mill water supply. The overflow from inspected well conveys water to the river Len, partially through ceramic pipes that were superseded by plastic ones during the construction of car park.

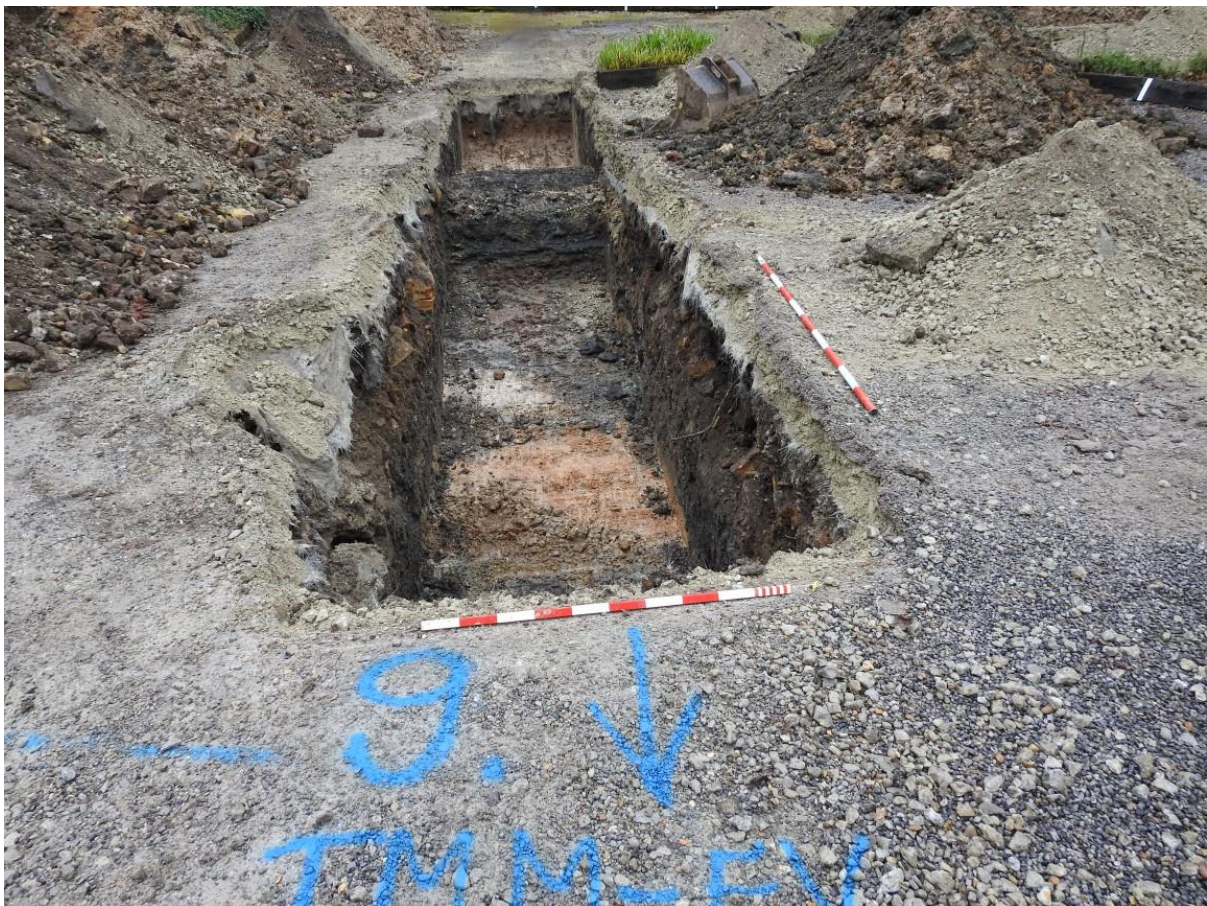
Plate 20: Showing evaluation Trench 9. Looking south with one- and two-metre scales.

- 5.2.10 Trench 9 (Figure 3) was placed in eastern part of the site in north-south alignment and measured 1.8metre wide by 17.32metre long and 2.2 metre in maximum depth. Trench exposed natural geology context 903 comprising orange-grey clay-sand-silt with infrequent sandstone flecks. A modern service trench was exposed in southern part of evaluation trench. No archaeological cuts, deposits or artefacts were revealed here.
