# Archaeological Recording of land on the north side of Boundary Road, Ramsgate, Kent

Site Code BRR-WB-21

Date of report 11/05/2021

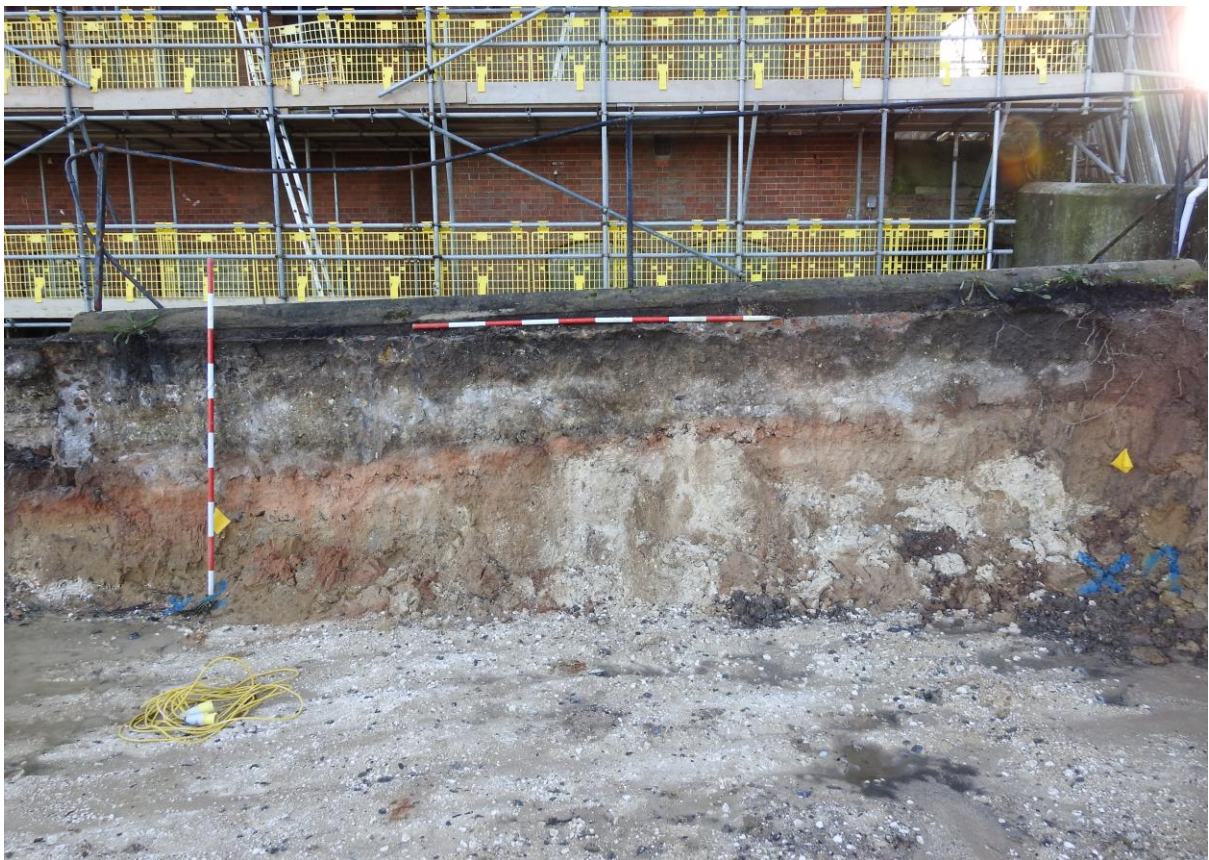
**10.4** Section 1 (Plate 2 and 3, Figure 4) recorded between markers X1 and X3 is showing uneven, wavy and sloping chalk bedrock horizon overlaid by HEAD deposit. The natural geology is sealed with made ground material comprising deposits of brick, hardcore and concrete. Material forming made ground was deposited in order to provide levelled platform for construction of the building located immediately to the south and associated driveway. Some of the material described as made ground is a later modern

Plate 2: Western part of Section 1 (X1 – X2). Looking south with two-metre scales.

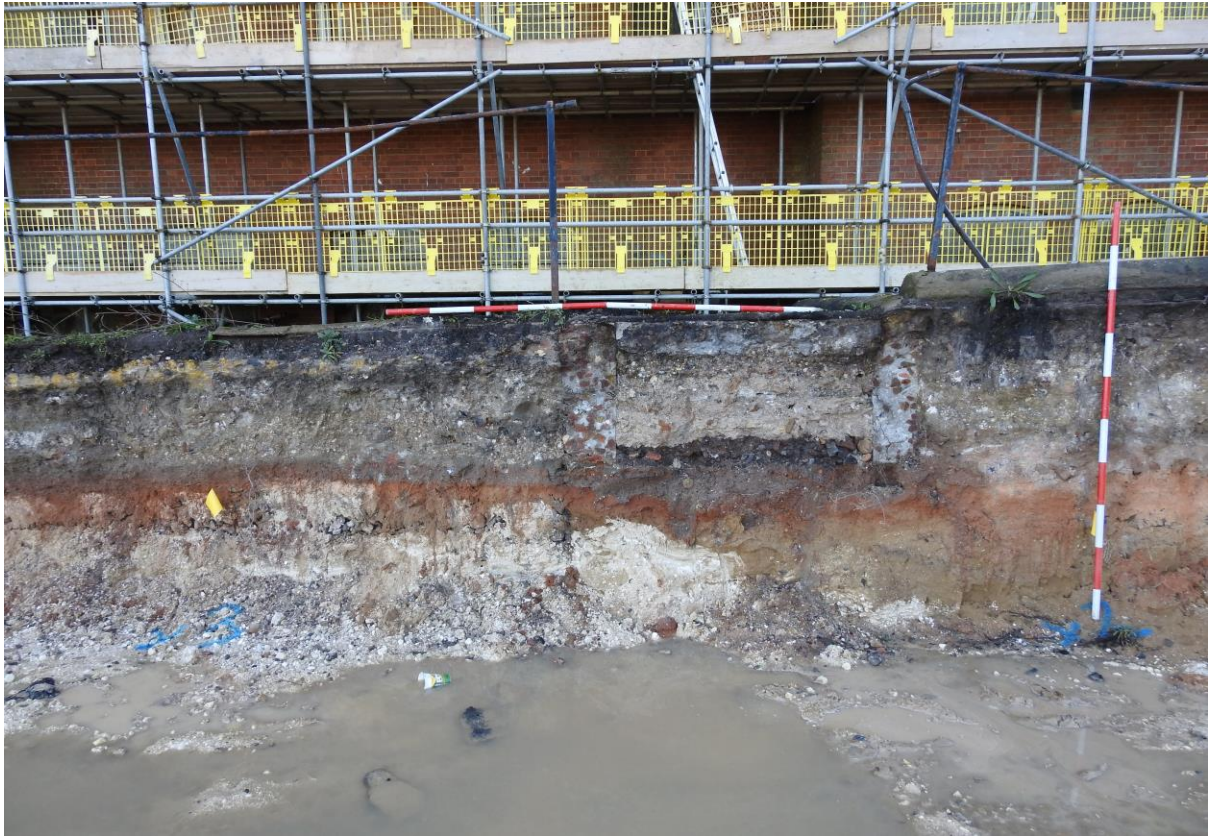
Plate 3: Eastern part of Section 1 (X2 – X3). Looking south with two-metre scales.

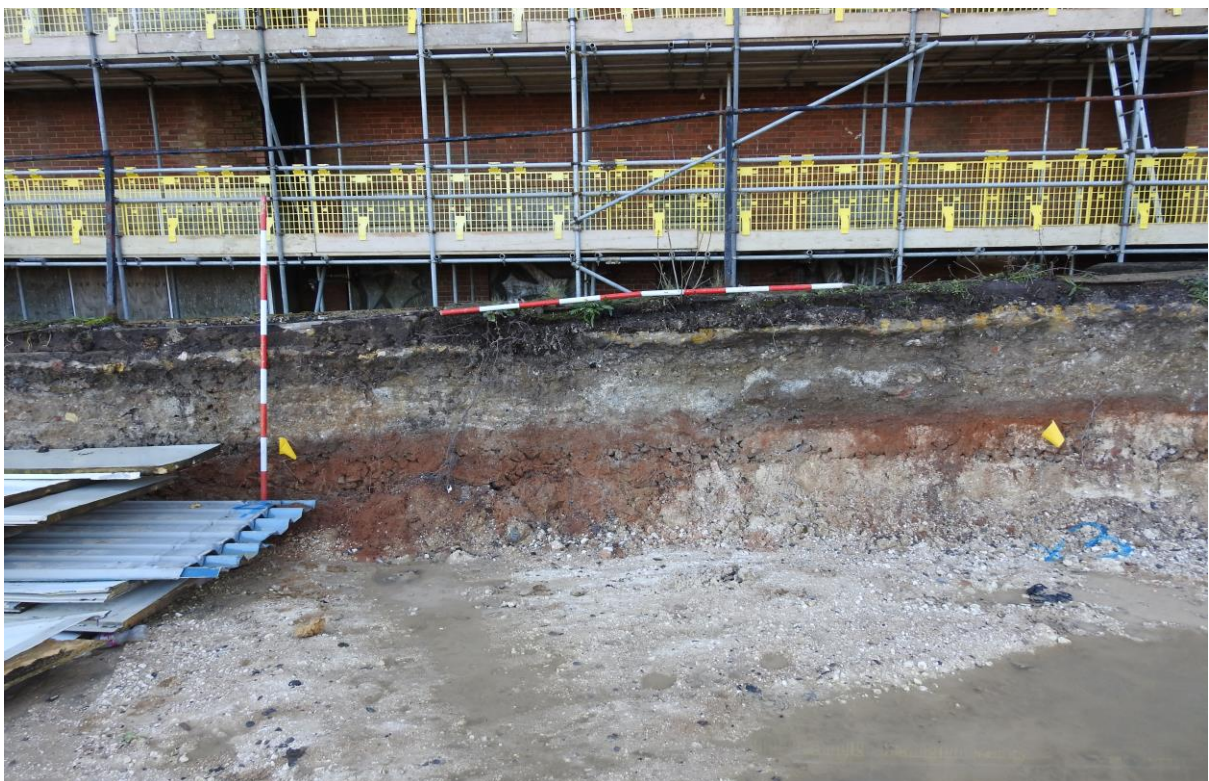
10.5 Continuation of the Section 1 to the east was recorded in photographs and is marked in plan with labels X3 to X10. Between markers X3 to X6 it shows continuation of made ground deposits and the natural horizon descending below site horizon (base of reduced ground).

Plate 4: Section X3 – X4, looking south with two-metre scales.

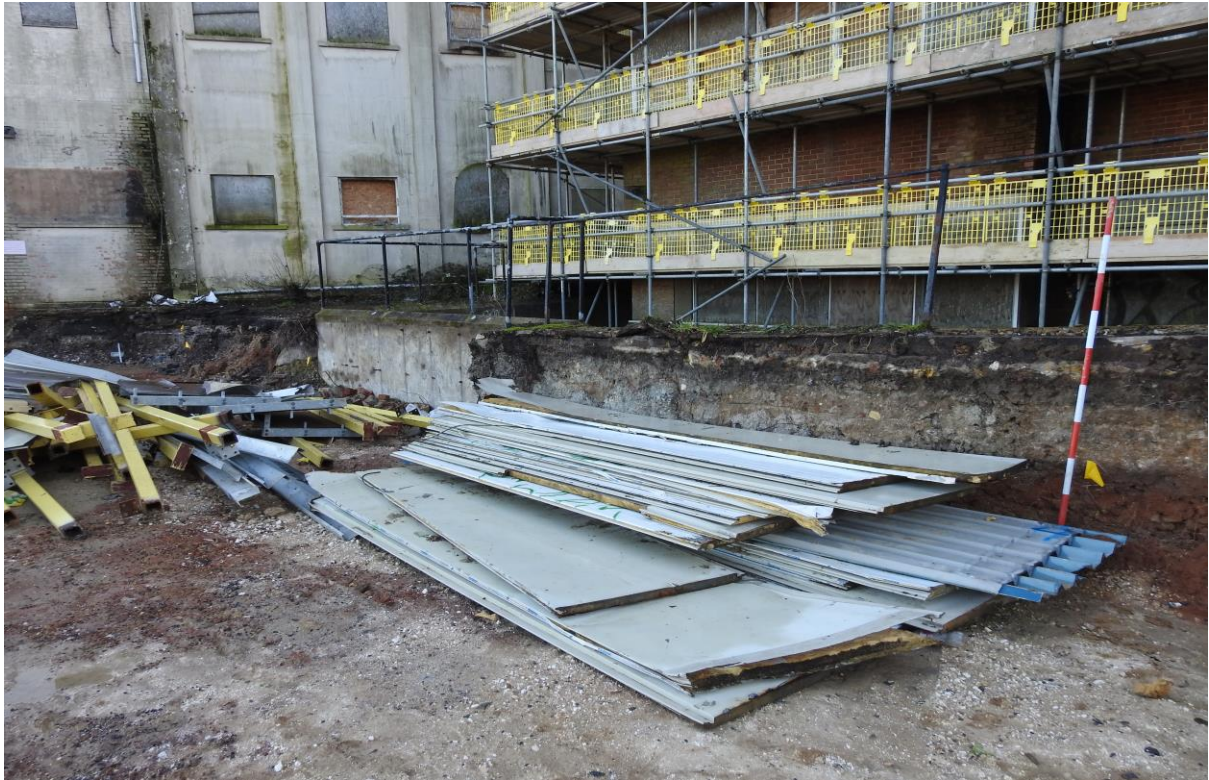
Plate 5: Section X4 – X5, looking south-east with two-metre scale.

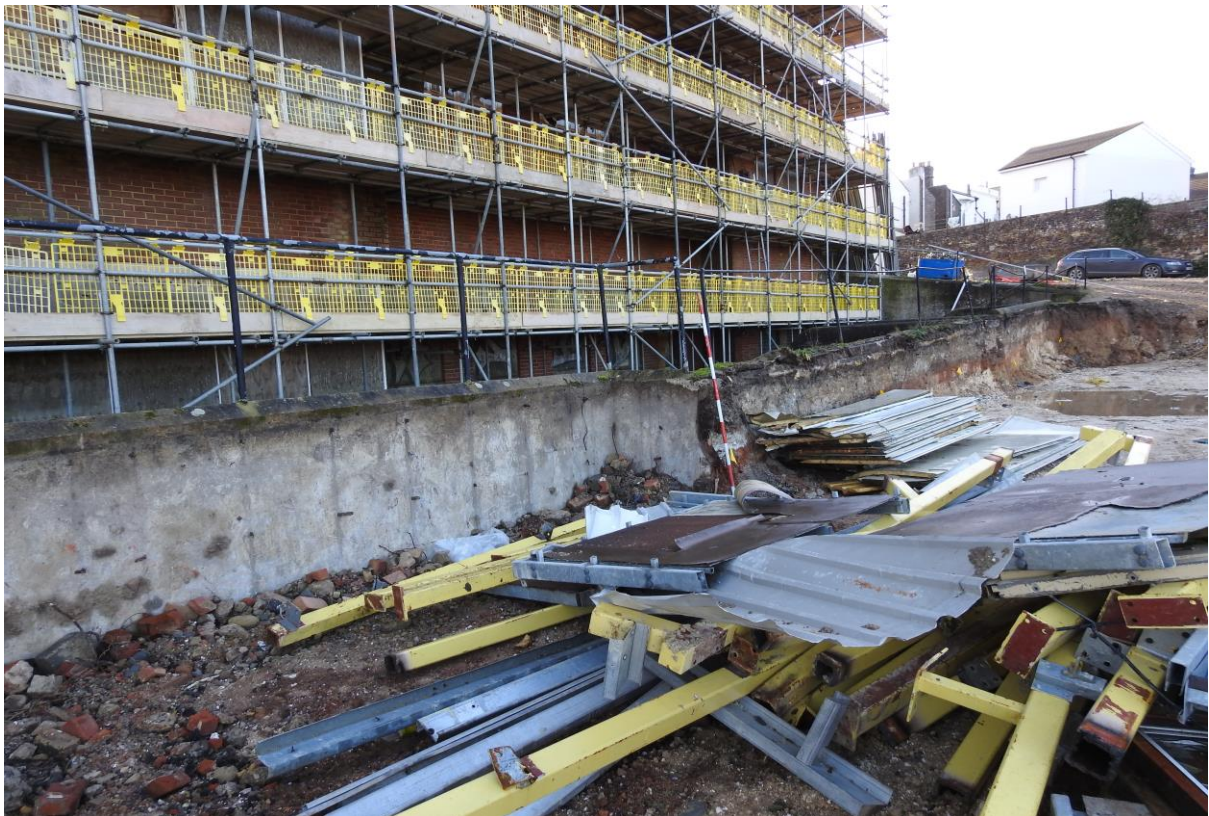
Plate 6: Section X5-X6, looking south-west with two-metre scale.

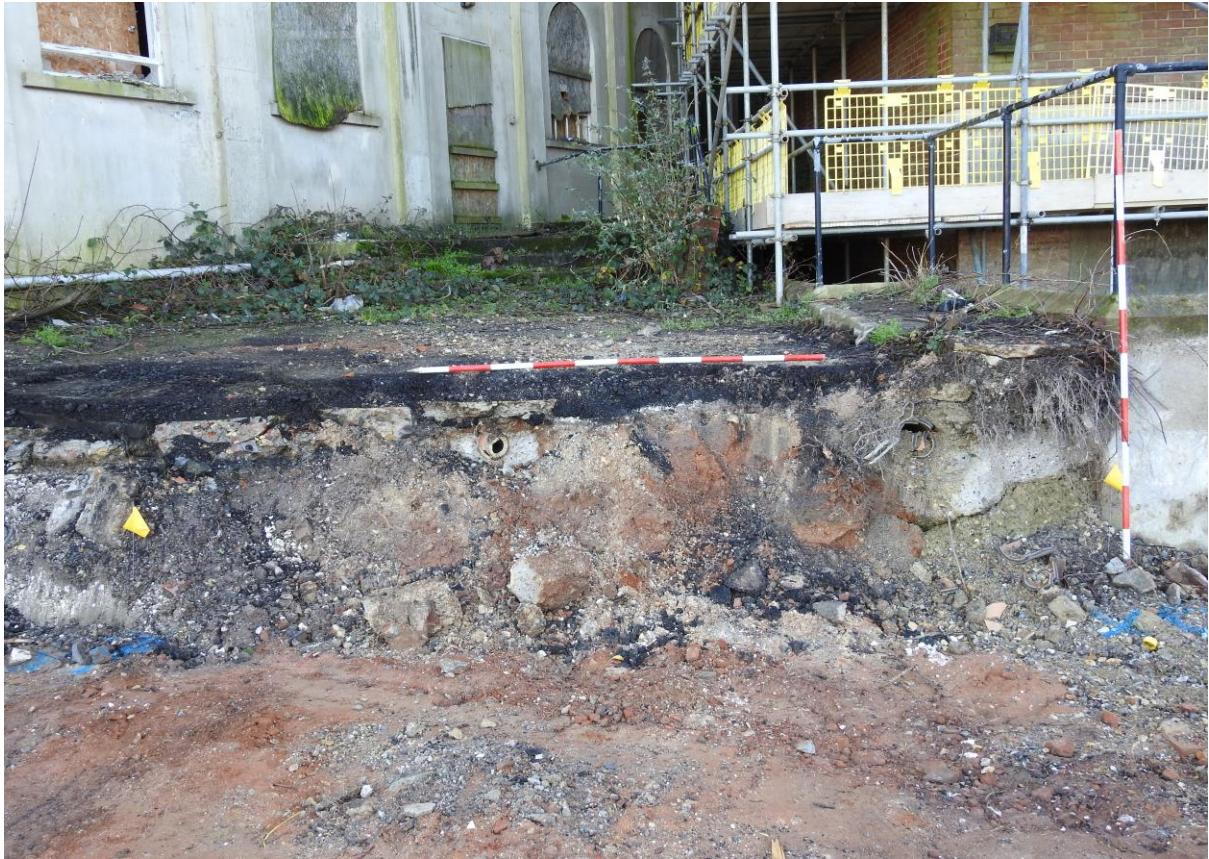
10.6 Further to the east between markers X6 and X7 section is showing concrete elevation of the wall with fragment of perpendicularly aligned wall aside X6. The face of the concrete is clean, indicating that it was an inside face of sunken building. The wall was 1.3metres high and its 0.1metres at the top was weathered. On the other side of the wall there is a subterrean passage that goes around the main building and on the east there is a corner of the wall that turns to the south.

Plate 7: Section X6-X7, looking south with two-metre scales.

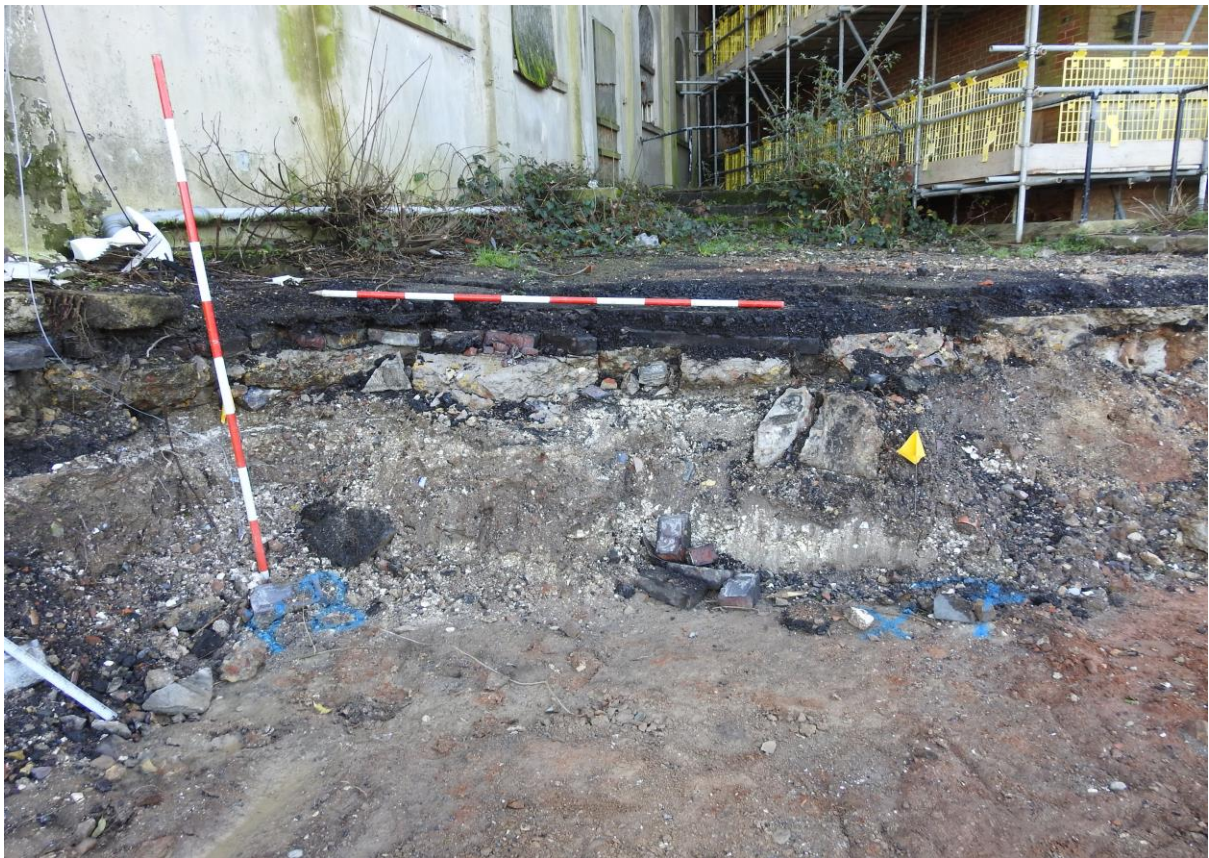
10.7 Further to the east between markers X7 and X8 the section (plate 7 and 8) is about 1.2metres high and shows made ground dominated by concrete boulders overlaid by concrete (flat boulder) surface that also seals brown ceramic drain pipe covered with cast coarse concrete filling shallow wide trench. Another service trench with plastic, compound pipe was exposed near marker X7 located near the building. Both service trenches are aligned perpendicularly to the section face. Above the concrete surface there is a levelling layer of tarmac beads. Both surface layers were 0.2metres thick.

Plate 8: Section X7-X8, looking south with two-metre scales.

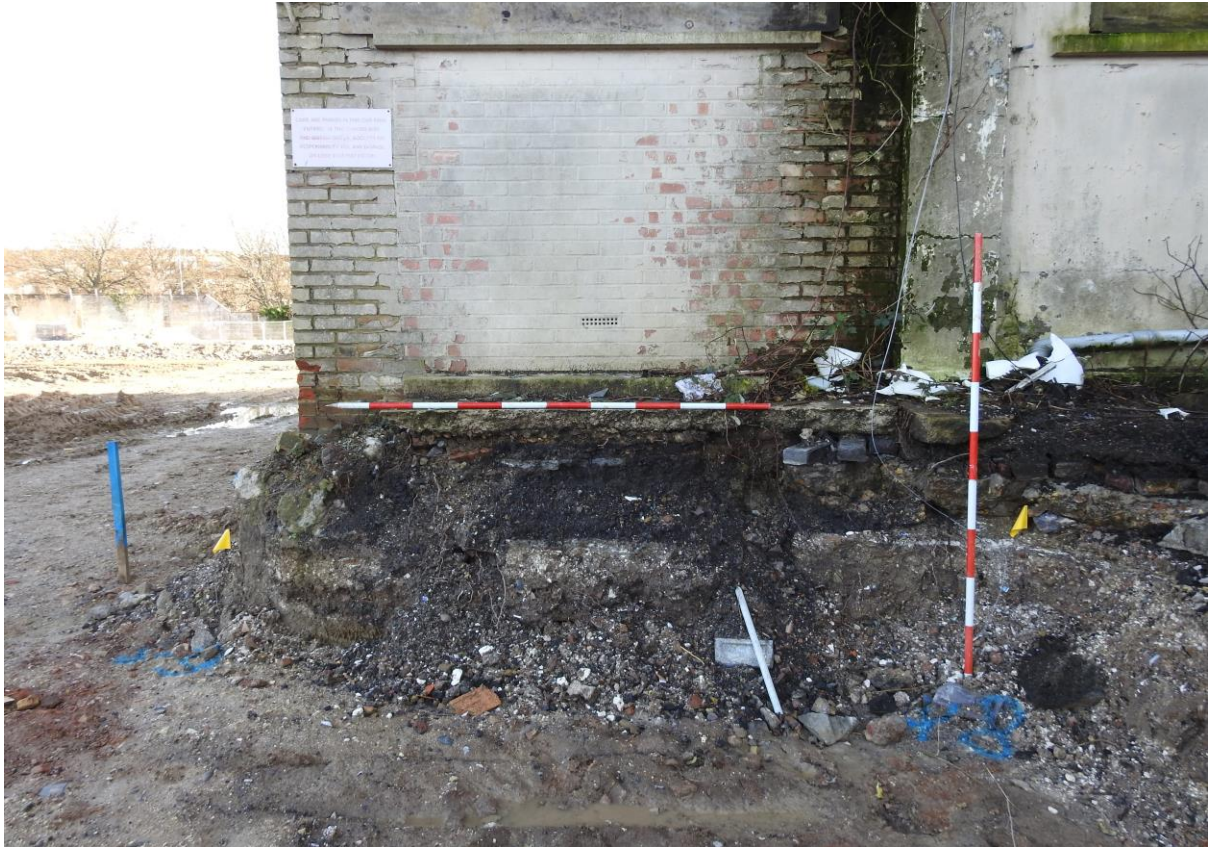
10.8 Next segment of the section (Plate 9) between markers X8 and X9 was facing west and is showing concrete foundations of standing building. The foundations were obscured by material that was filling the foundation trench and overlying tarmac surface. Next section segment X9 to X10 (Plate 10) that was facing north is showing the same foundations but clean and from other side.

Plate 9: Section X8-X9, looking south-east with two-metre scales.

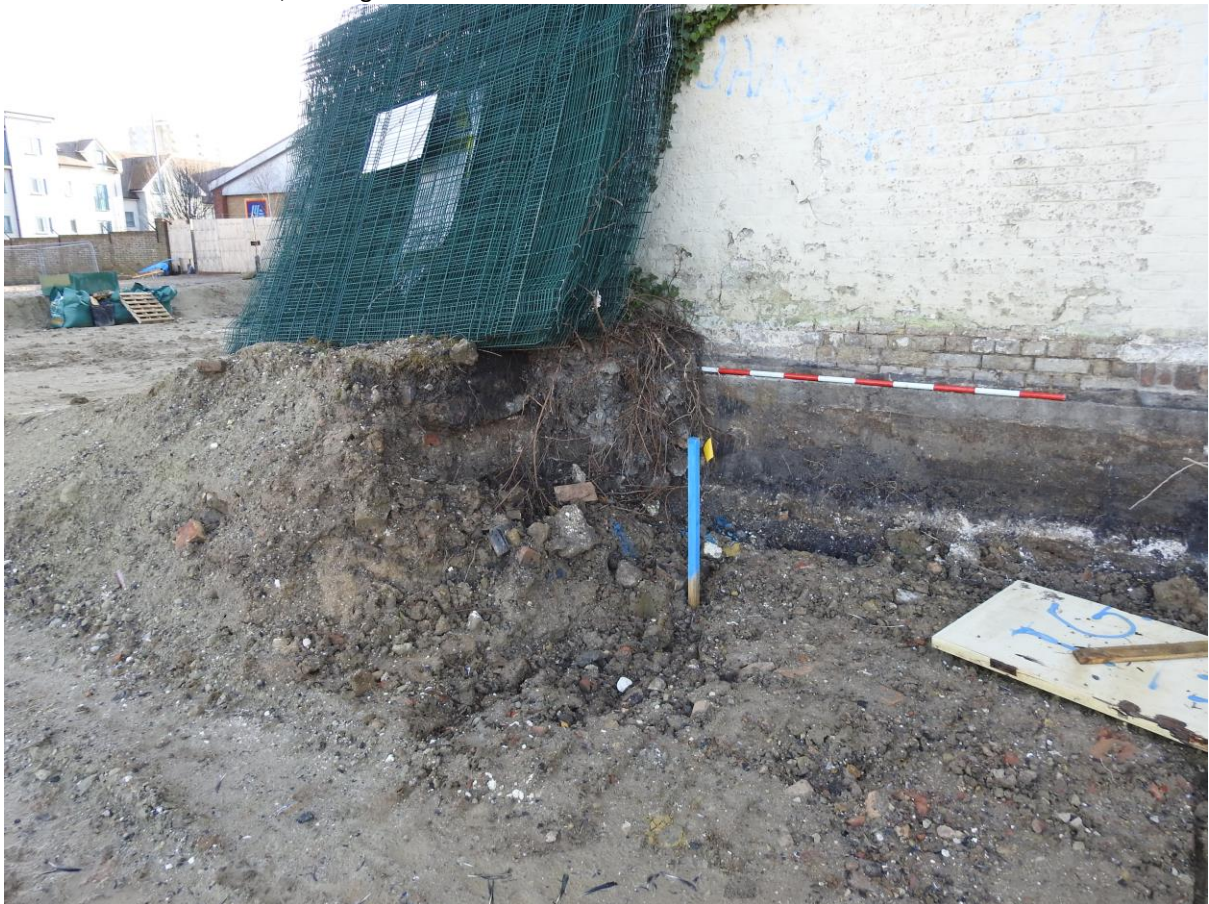
Plate 12: Showing loose loam with rubble forming batter that extends from X11 to south-eastern gate which is visible in background. Looking south-east with two-metre scale.

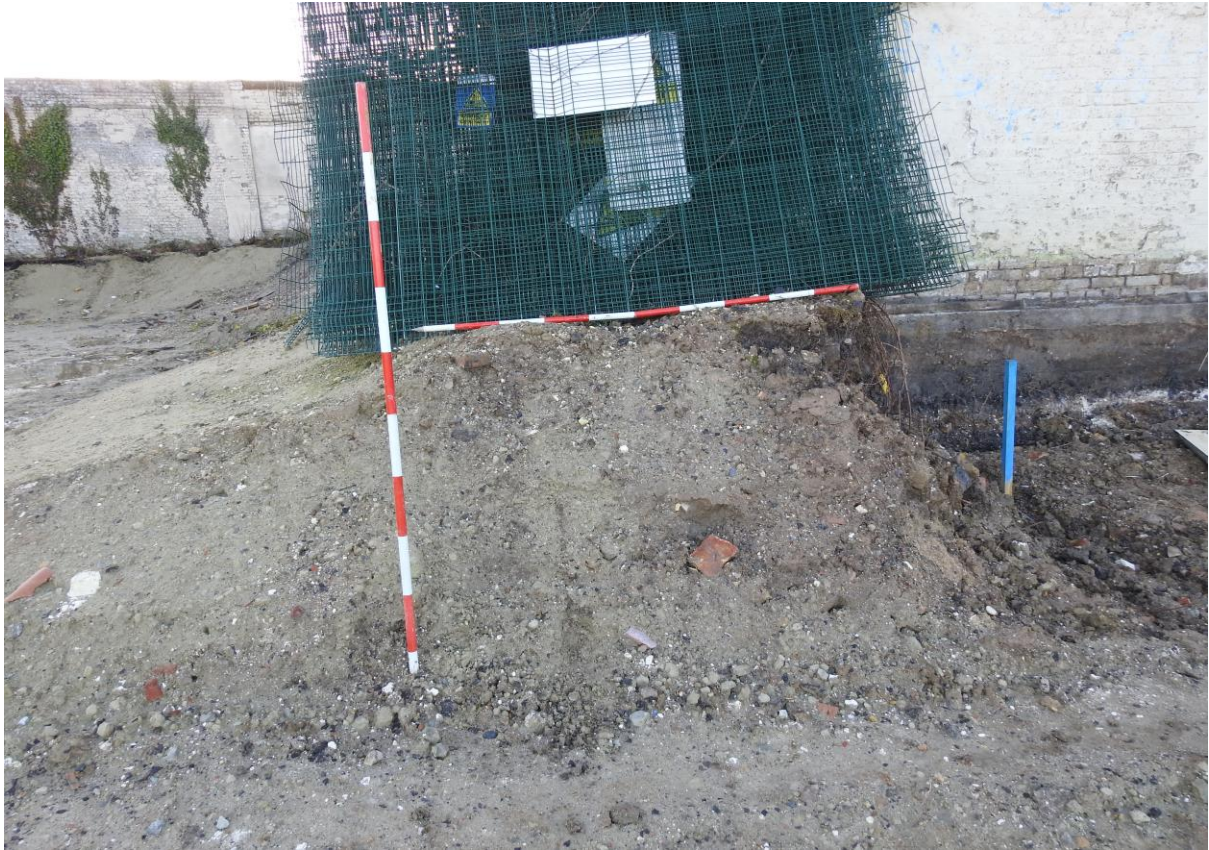
Plate 13: Showing loose loam with rubble forming batter that extends from X11 to south-eastern gate. Looking south with two-metre scale.

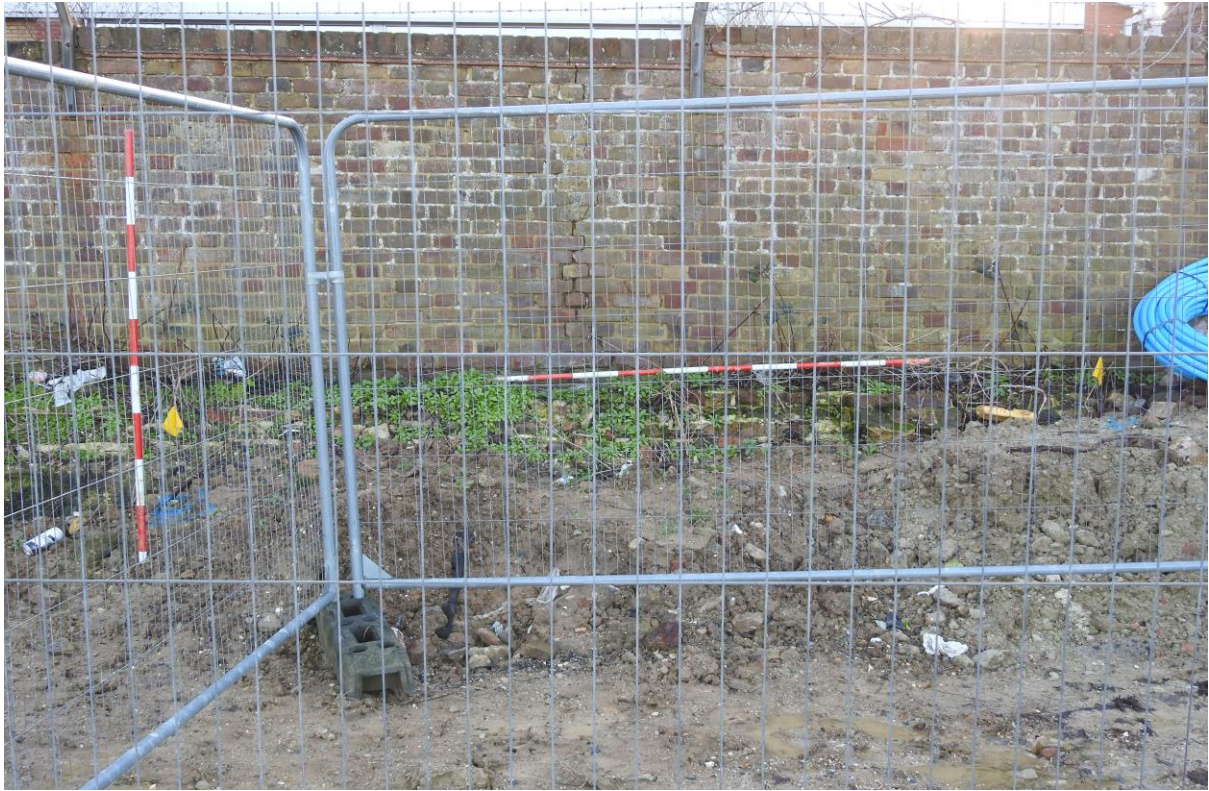
10.10 Within south east corner of the site trench depth decreased further from 0.6metres to 0.2m at the corner. The section between markers A and C (Plate 17 and 18) is showing robust concrete foundations and brick walls aligned perpendicularly to southern boundary wall. These structures are mostly obscured by trench battering between markers A and B. Within edge of the site, the structures still continues below trench base and were demolished in the past. The brickwork was the same as original brickwork of the boundary wall.

Plate 17: Showing section A-B, looking south with two-metre scales.

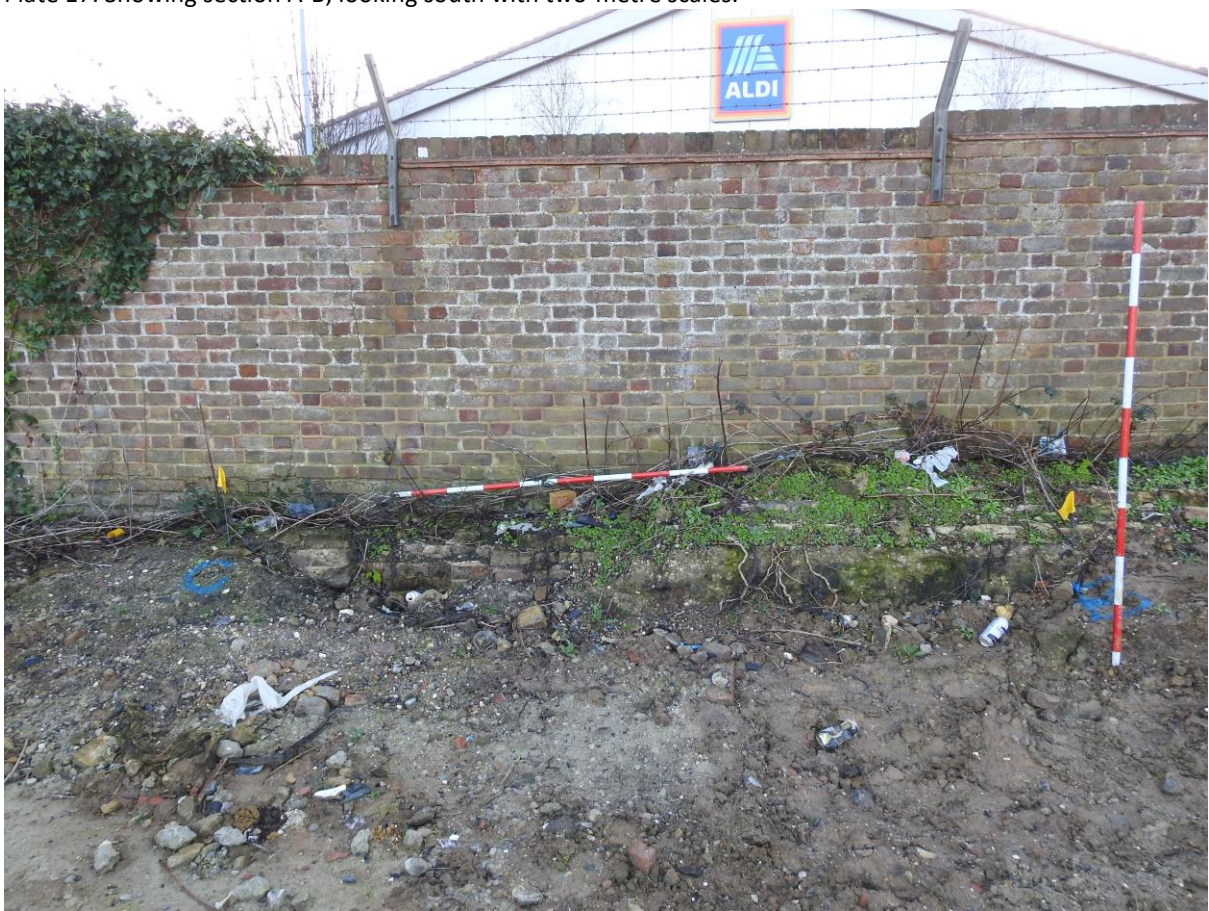
Plate 18: Showing section B-C, looking south with two-metre scales.

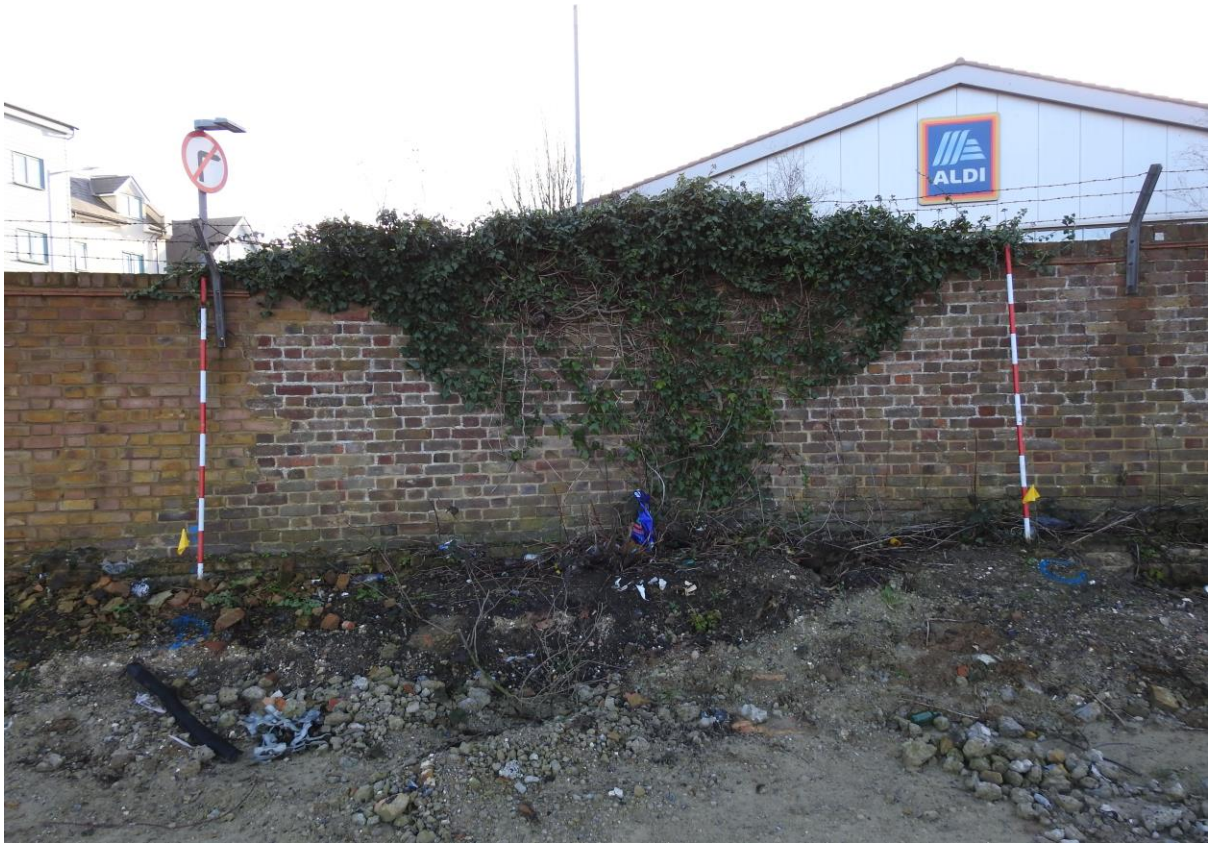
10.11 Further to the east part of section between markers C-G is showing rubble material and trench depth was decreasing to 0.1metres. Last segment of section between F and G was facing west and was located alongside eastern boundary wall. It shows pavement concrete slabs and chalk bedding. Immediately to the north there was fenced off concrete floor with hatch openings (Plate 22).

Plate 19: Section C-D, looking south with two-metre scales.

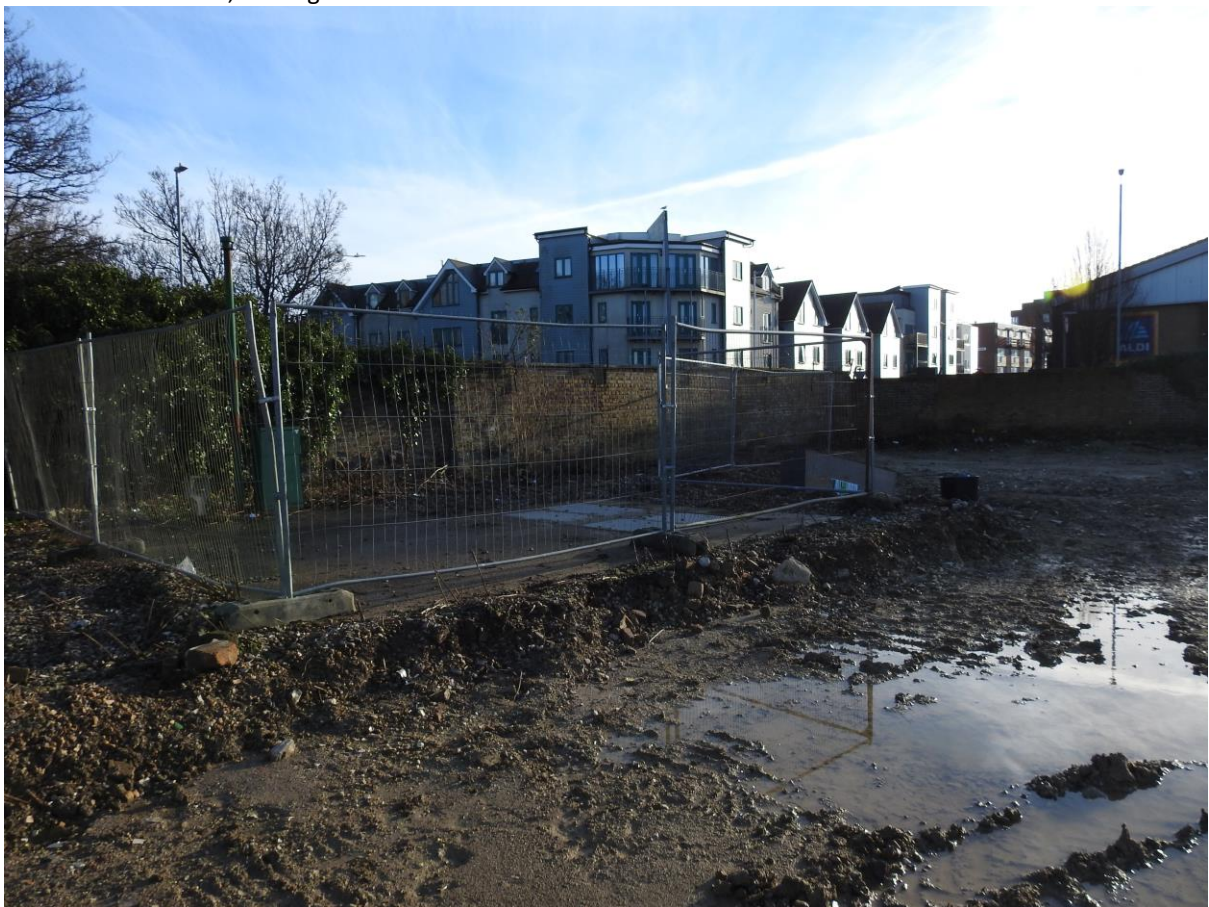
Plate 22: Showing inaccessible area between points G and H. Looking south.

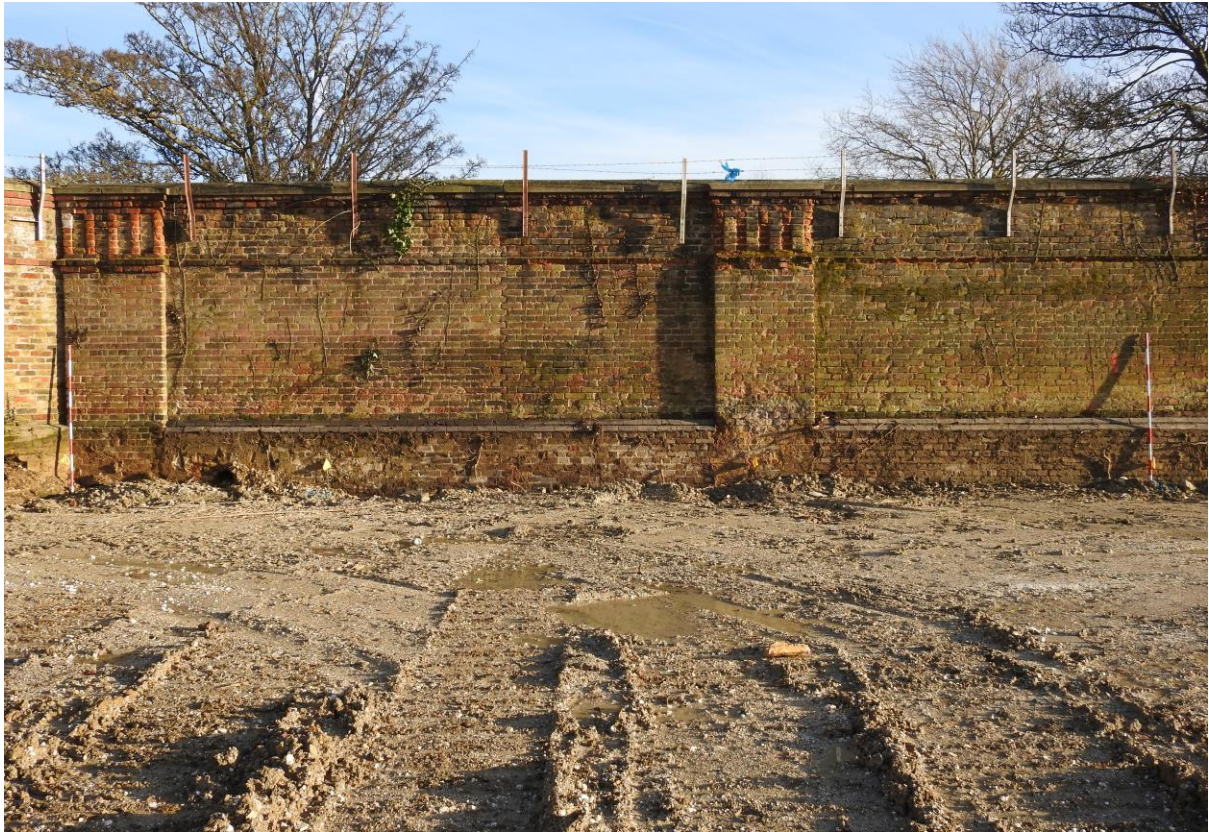
Plate 27: Section P-S, looking south-east with two-metre scales.

10.12 No reduction was done within northern half of the site which was evident by the presence of concrete ramp leading to northern gate. It is also evident that ground here was reduced-terraced in the past prior to installation of storage tanks. Most likely some concrete surface was removed along with storage tanks. The surface exposed here was obscured by bulldozer tracks and material was brown clayey loam and marl. Marl was dominating within eastern extent of the area. Material comprised fragments of chalk, flint, brick, concrete and tarmac. There were no visible remains of the massive storage tanks. A section recorded along eastern boundary wall between markers G-X shows elevation of the boundary wall (Plate 23-28). The lack of dirt on wall face indicates that it wasn't buried. No reduction of the ground alongside northern and northern half of western boundary is shown on Plates 27 to 33

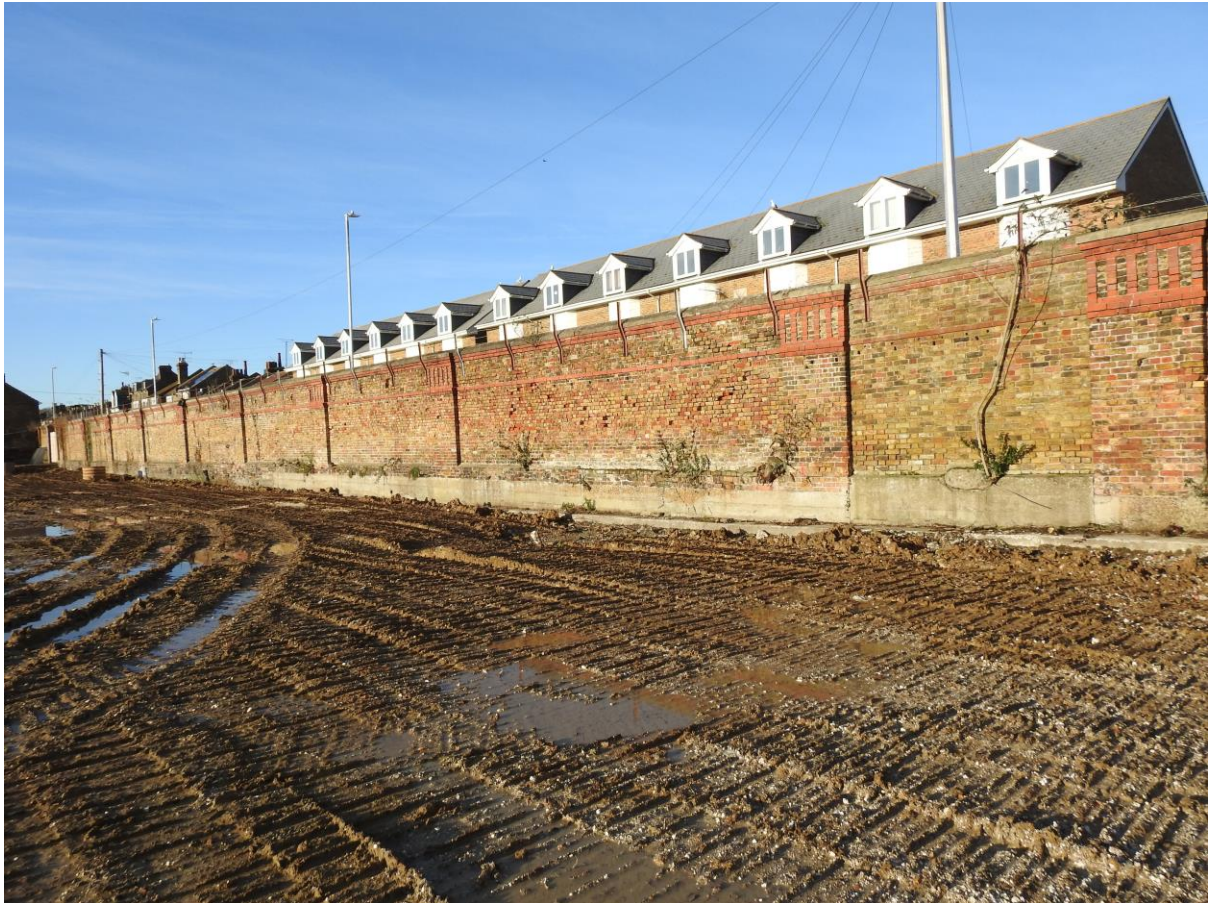
Plate 29: Showing northern boundary of the Site (between X and northern corner)

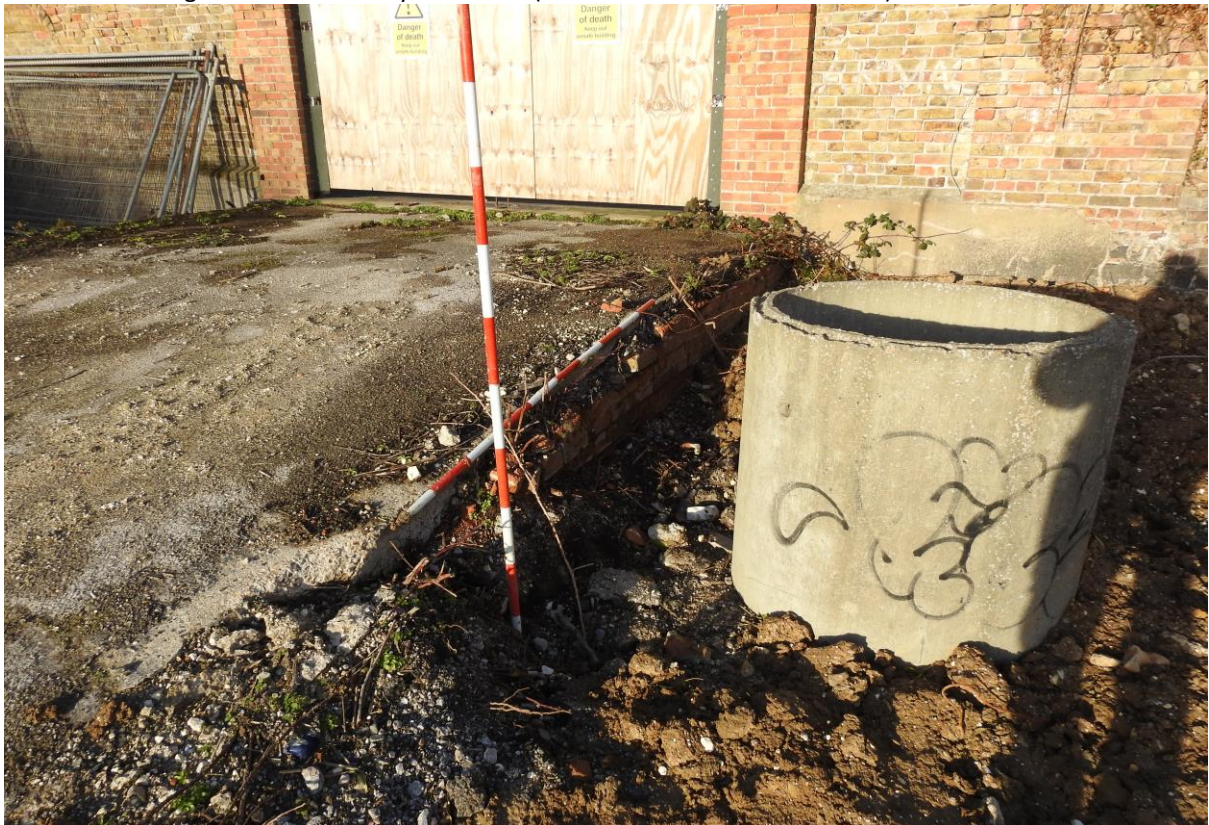
Plate 30: Showing exposed ramp at northern gate (adjacent to northern corner of PDA). Looking north with two-metre scales.

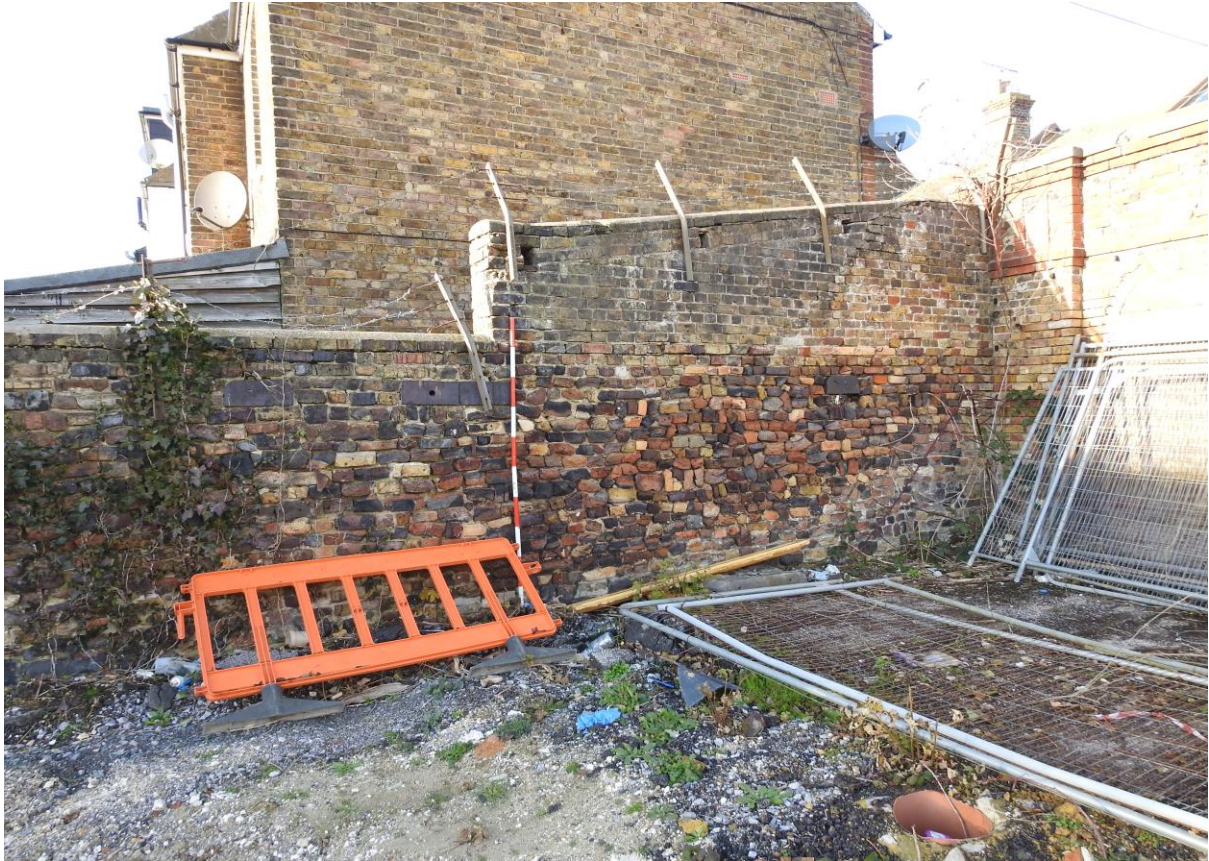
Plate 31: Showing section of north-western wall (approx. 8 metres) at northern corner of the Site. Looking north-west with two-metre scales.

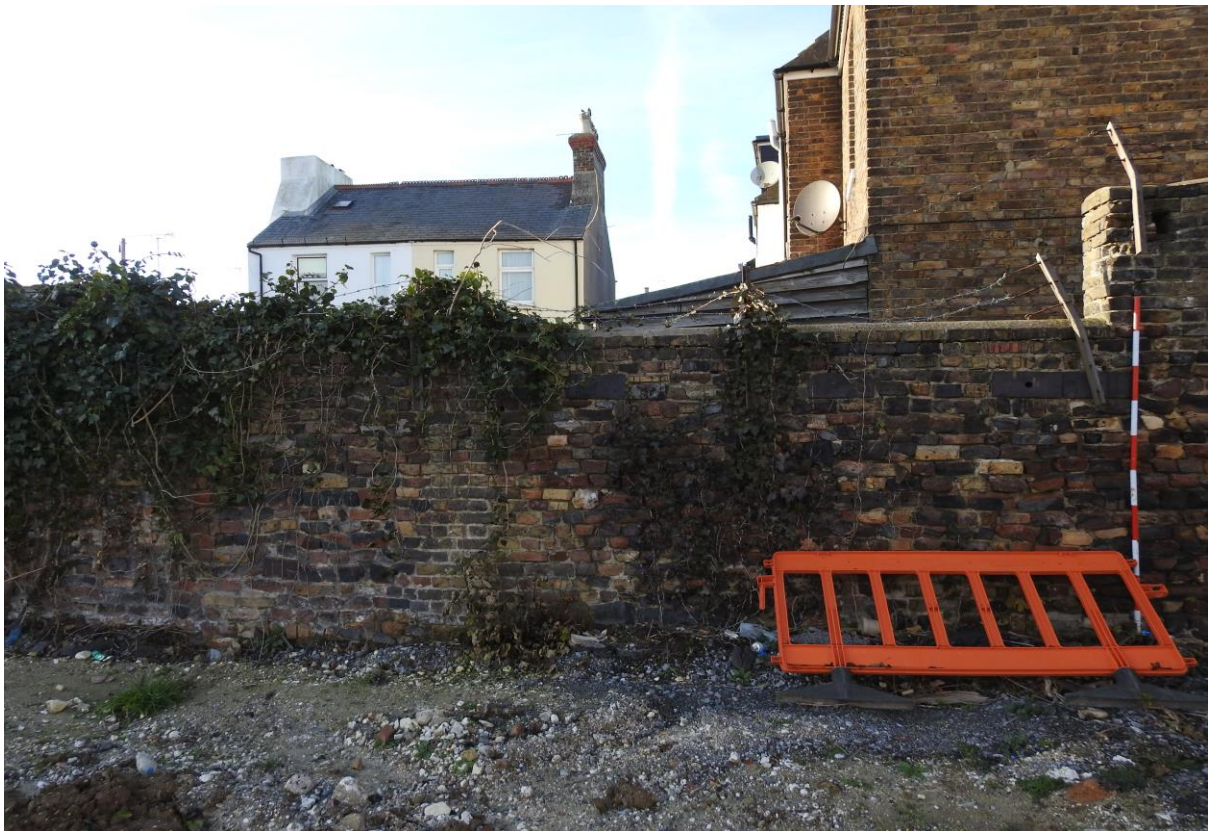
Plate 32: Showing section of north-western wall (approx. 6 metres) at northern corner of the Site. Looking north-west with two-metre scale.

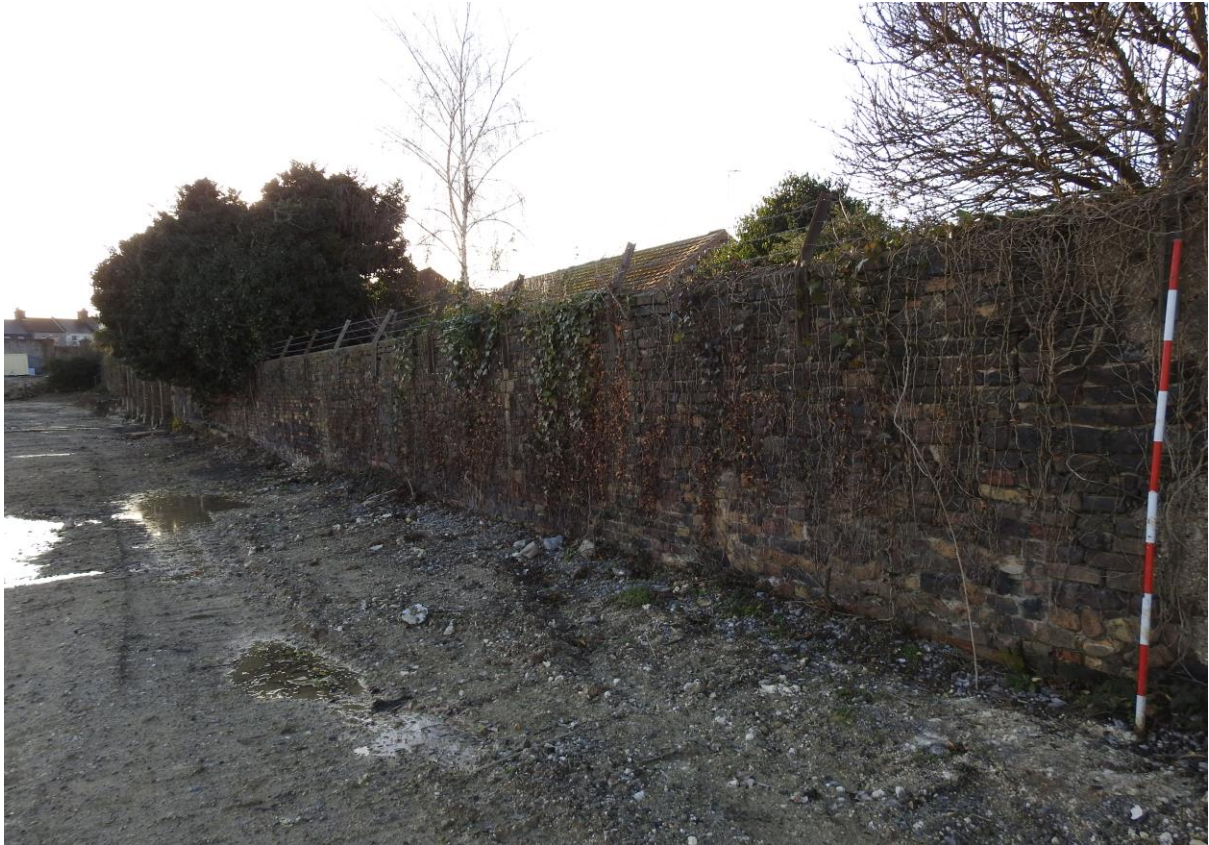
Plate 33: Northern section of north-western boundary wall. Point Z1 in background. Looking south-west with two-metre scale.
