# Archaeological Recording of land on the north side of Boundary Road, Ramsgate, Kent

Site Code BRR-WB-21

Date of report 11/05/2021

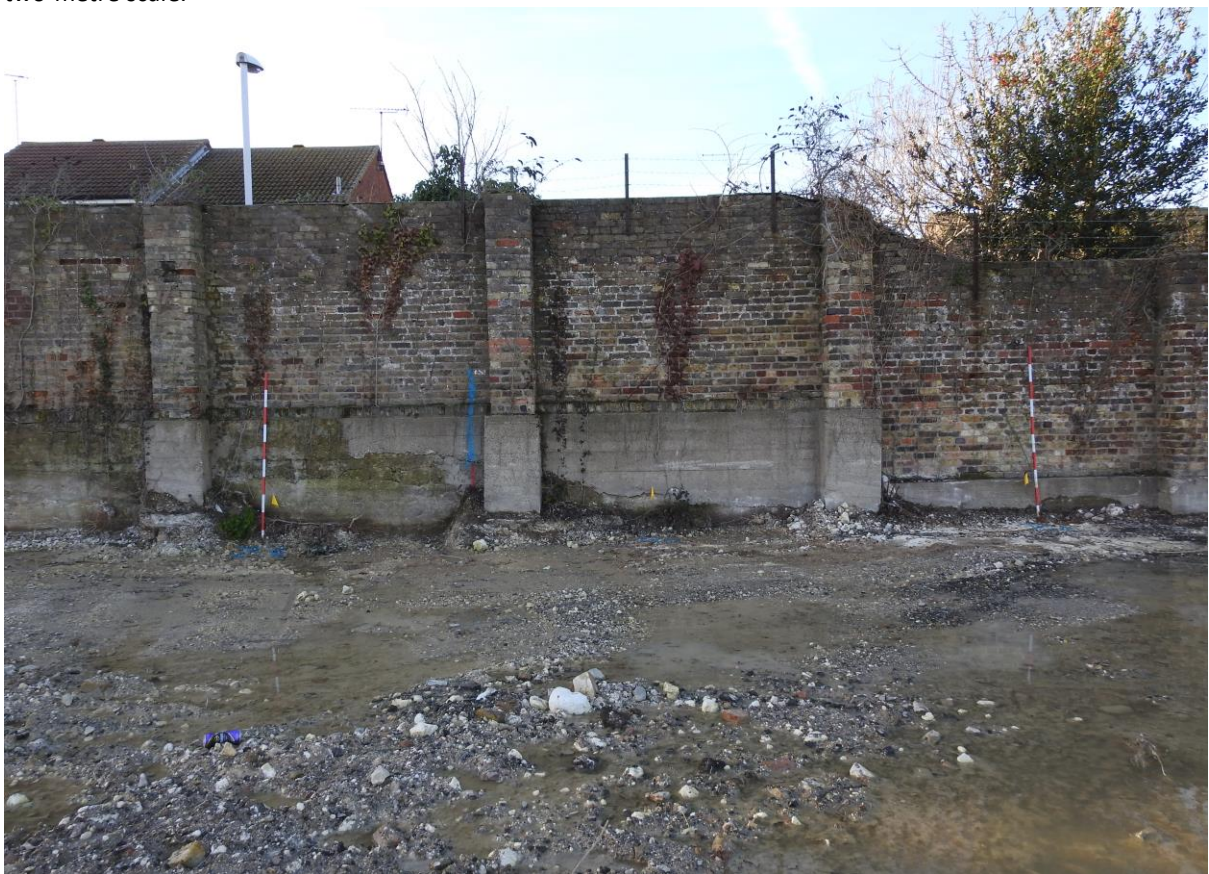
10.13 Section alongside western boundary wall within southern half of the site indicated by markers Z1 to Z11 shows section through the sloping ground comprising modern rubble and thick concrete surface (Plate 34-40). Made ground was sealing brown outcropping brickearth.

Plate 34: Showing Section Z1-Z3 at southern part of western boundary wall. Looking west with two-metre scales.

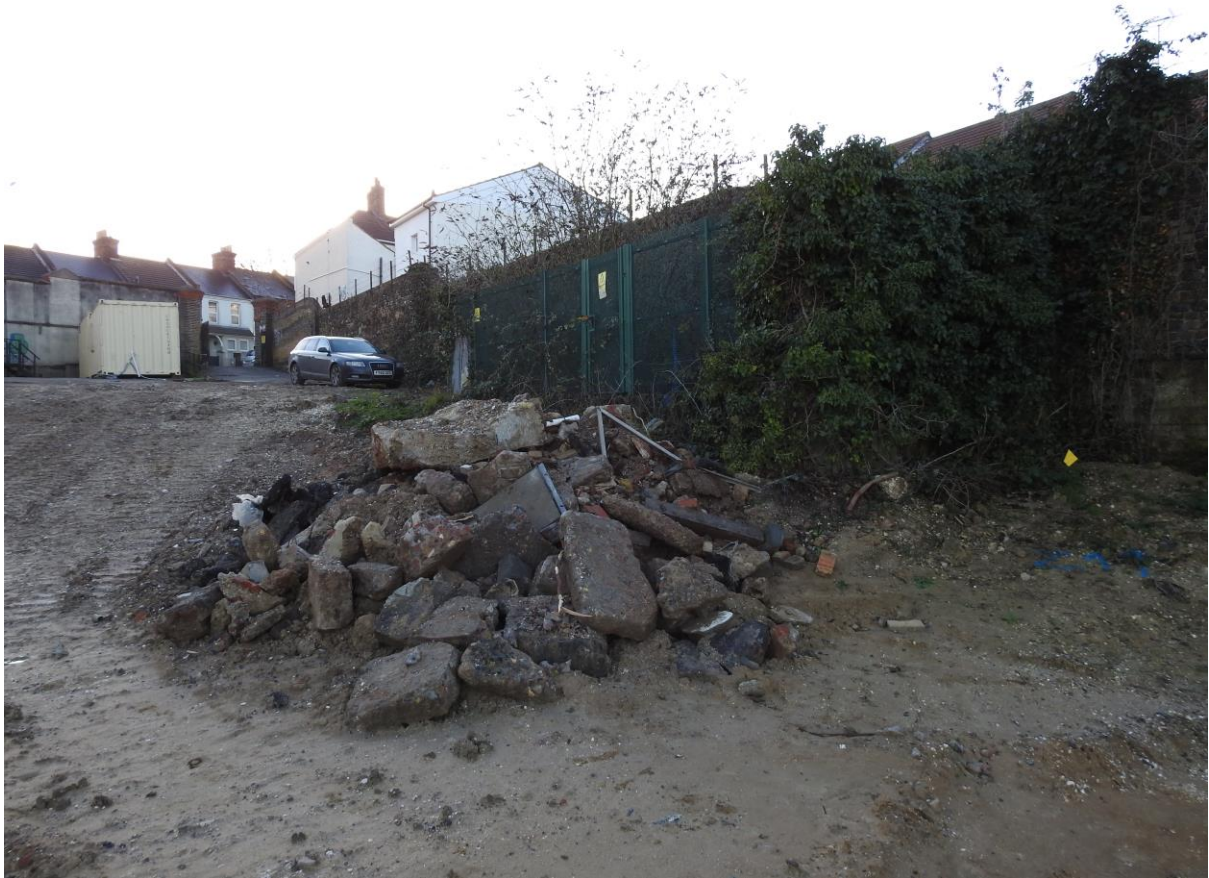
Plate 39: Showing inaccessible section after Z11 to the east.

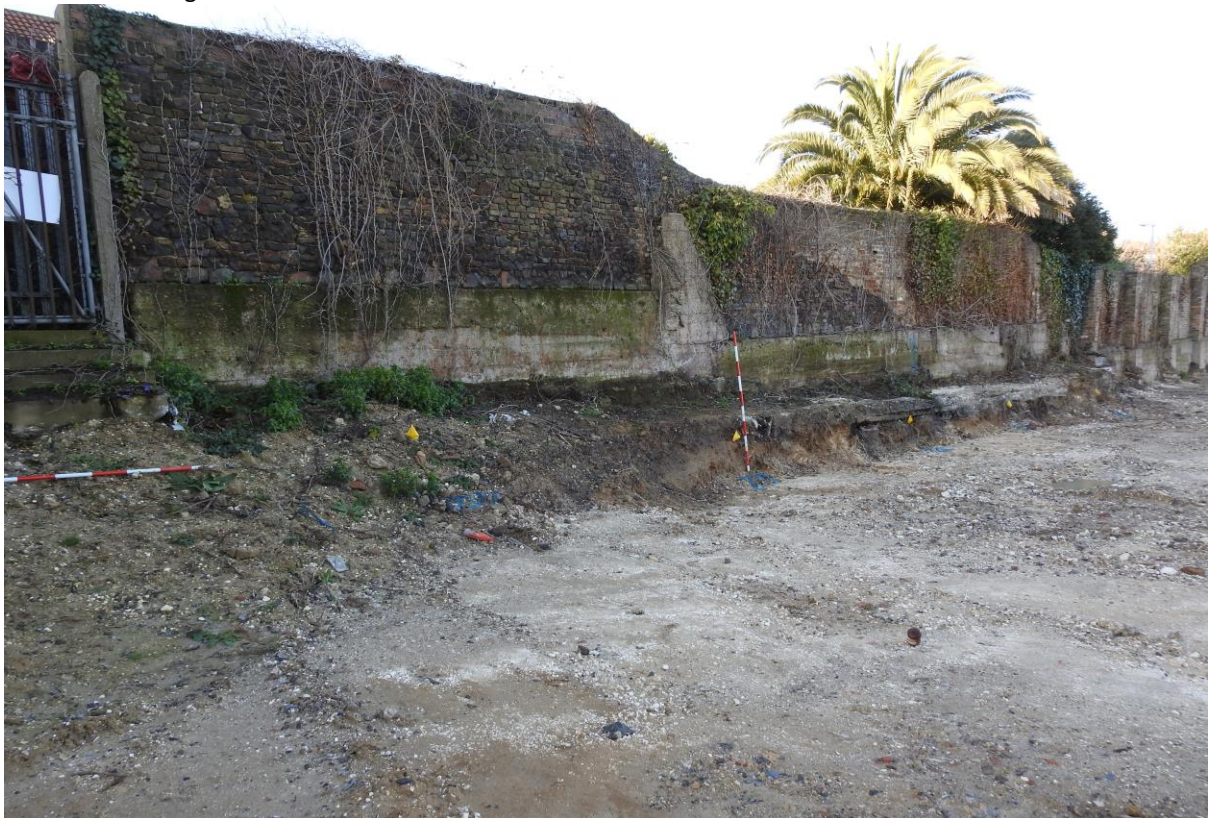
Plate 40: Overlook on southern part of western boundary wall, section Z1 - Z11, looking north with two-metre scales.
