# Archaeological Evaluation of land at White Horse Inn, High Street, Cranbrook, Kent TN17 3EX

Report date: 13/01/2022

## **SWAT ARCHAEOLOGY**

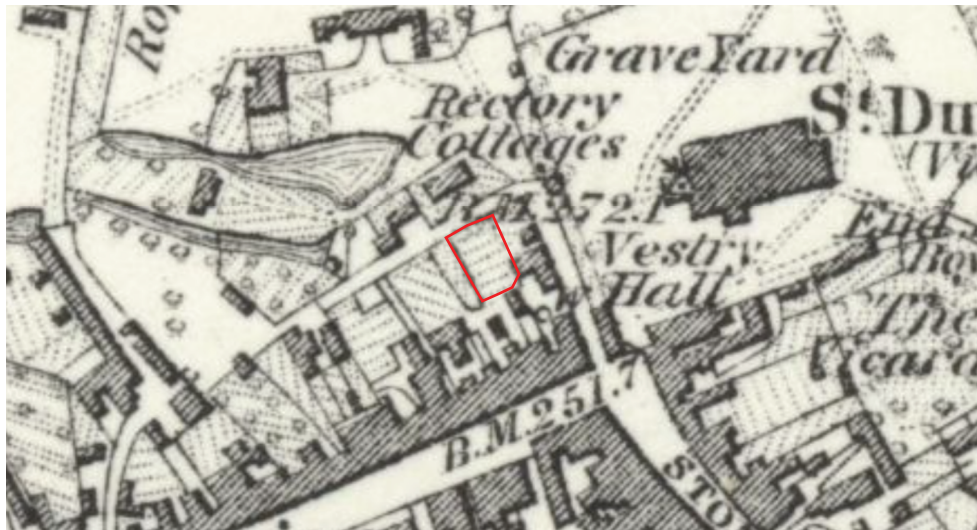
Figure 5: Extract from 1870 OS map (Kent Sheet LXX; Surveyed: 1870, Published: 1874). Showing garden within PDA.

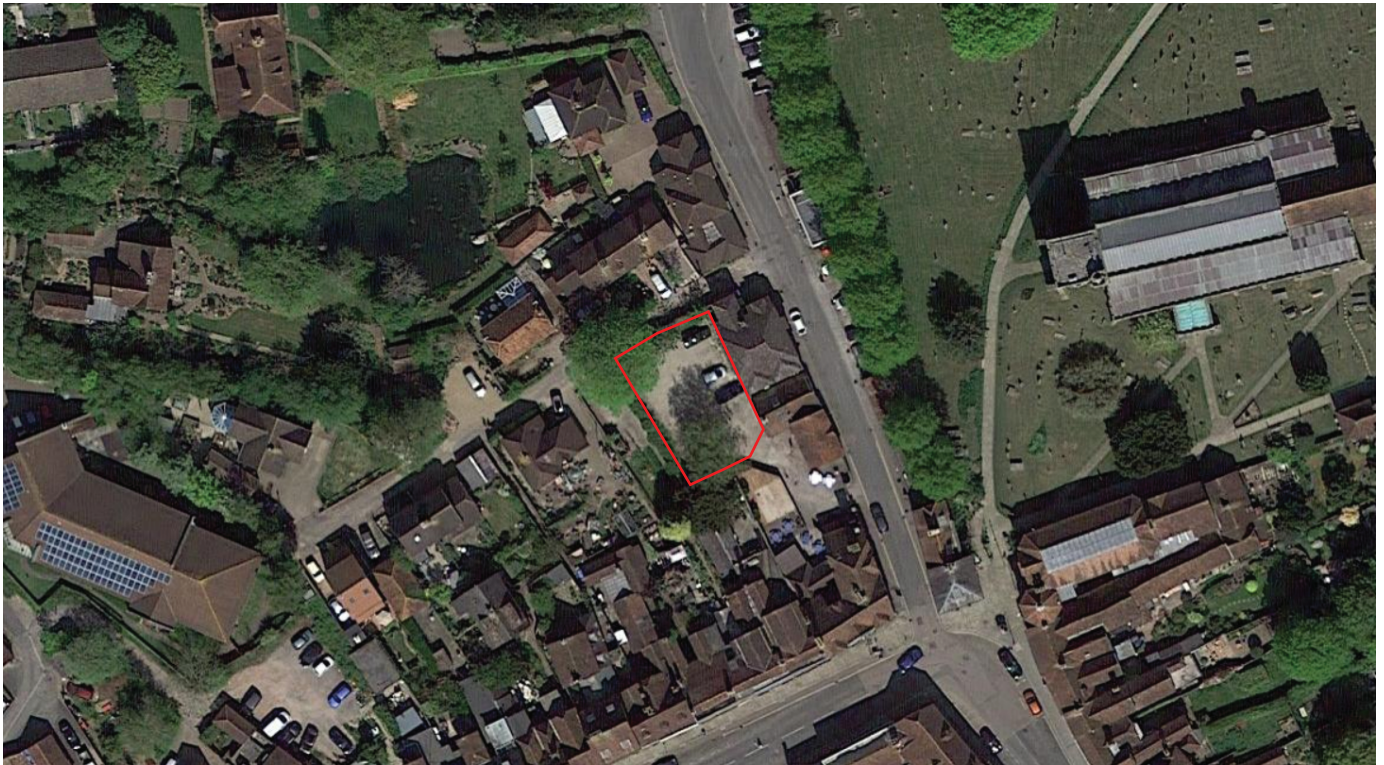
*Figure 8: Aerial map 2020. The building next door to the east has been rebuilt between 1960 and 1990. Previous building had almost the same footprint but the roof was gabled that can be seen on 1940 and 1960 aerial photographs.*

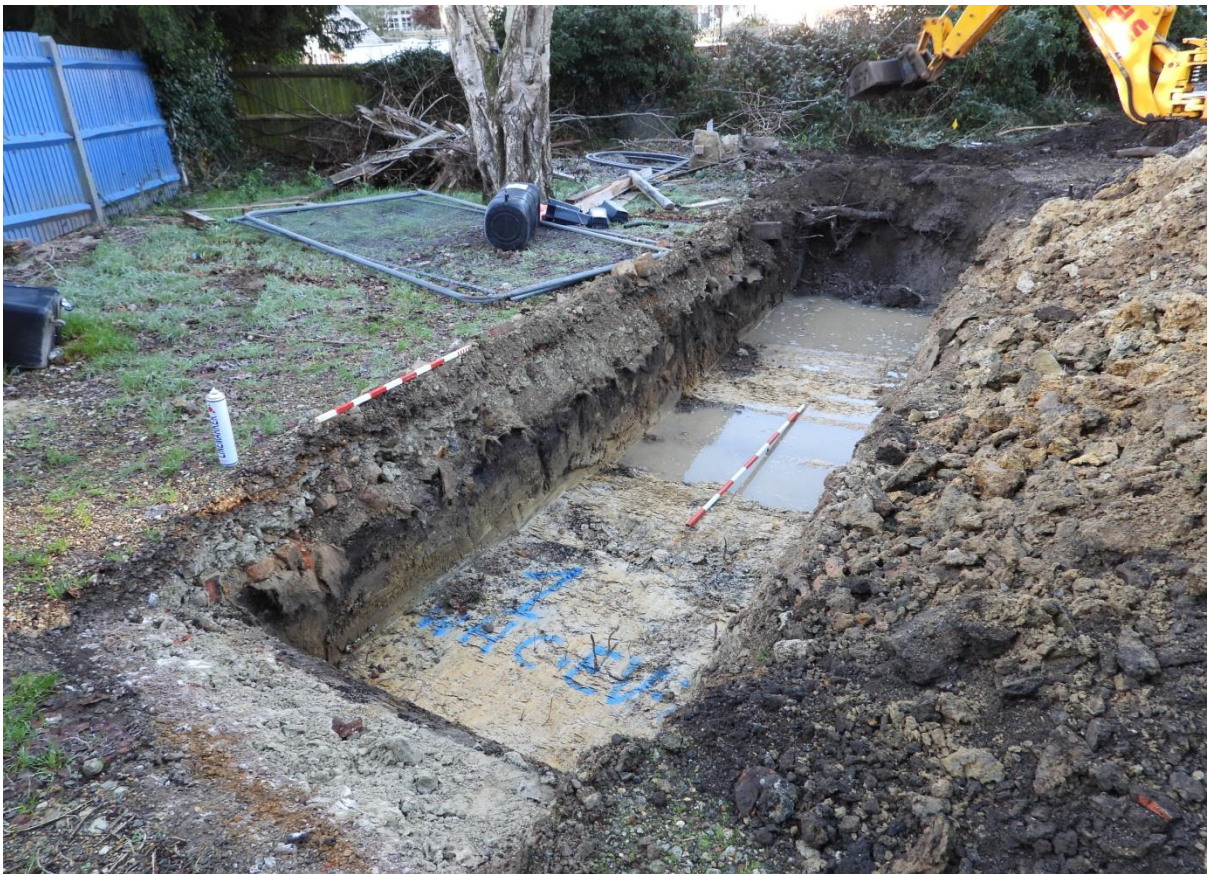
*Plate 2: Looking south-east at trench 1; 2metre scale rod at the base of the trench.*

- 5.2.1 Trench 1 (Figure 3, Plates) was placed in southern part of the site in east-west alignment and measured 9 metres in length by 1.8metre in width and 1metre in depth. It exposed natural geology at its base, context (105) comprising mid yellowish brown silty clay. Excavated material was a sequence of made ground material (101, 106, 102, 103, 107 and 108). Top layer (106) was 0.1metres thick comprising of tarmac patches sealed with black gravelly loam with frequent modern building material. Context was overlying 0.43metres thick layer of grey gravel (101) with occasional brick fragment. The gravel was placed on top of geotextile membrane. Underneath the membrane 0.2metres thick layer (102) was located and was cut by modern cut filled with hardcore (104). Layer (102) was firm, black silty clay with occ. brick fragments. Underneath layer (102) there was 0.32metres thick layer (103) of grey mottled mid yellowish brown silty clay with occasional brick. The material is mainly re deposited natural. Context (102) was sealing small layer (107) located on the east side of context (104). Layer (107) was grey mottled silty clay with frequent gravel.

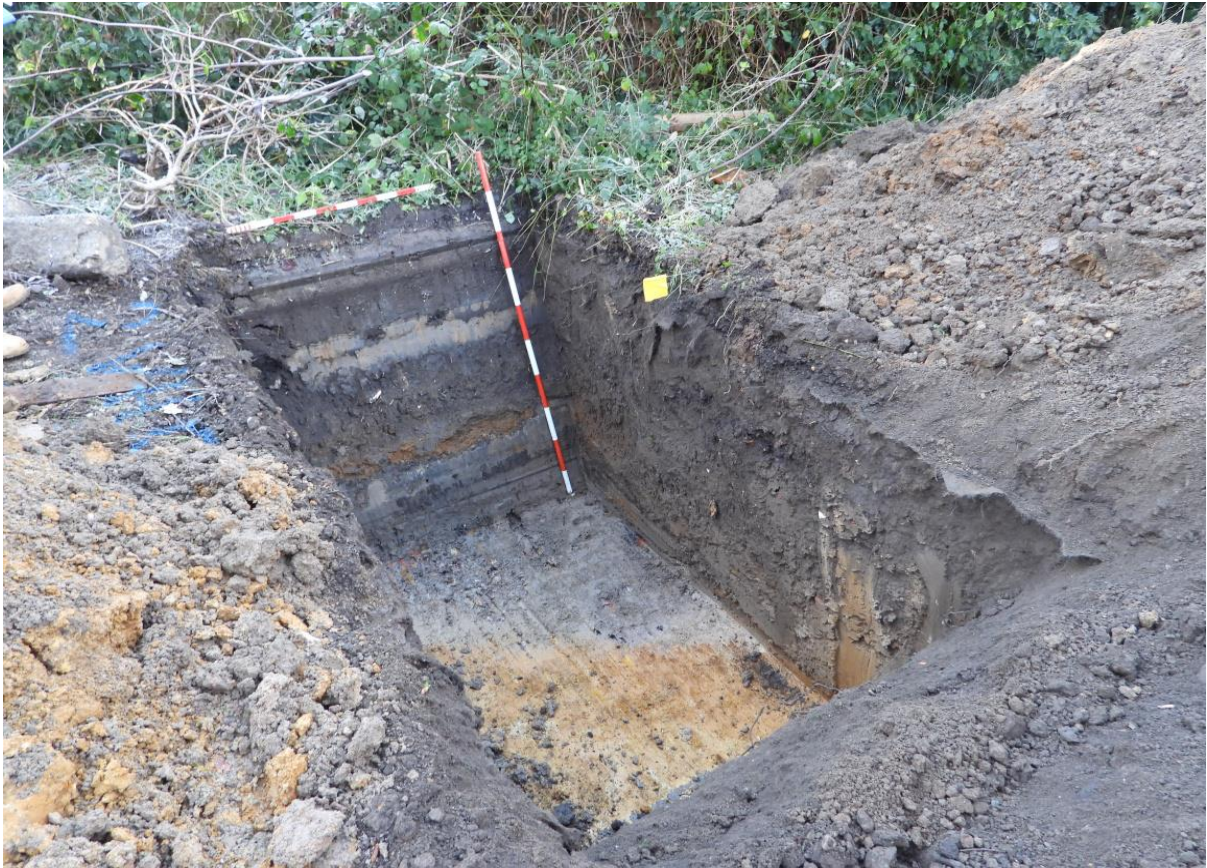
*Plate 3: Looking south west at trench 2; 2metres scale rod*

- 5.2.2 Trench 2 (Figure 3) was placed in south-western part of the site in north-east, south-west alignment and measured 4metre in length by 1.8metre in width and 1.9metre in depth. Trench has exposed edge of vast cut cutting natural geology context (205) comprising mid orangey brown silty clay. Excavated material was a sequence of made ground (201) fill material (202 and 203). Made ground layer was 0.31metres thick comprising of gravel and hardcore mixed with top soil. Top fill (202) was dark brown clayey silt with occ. brick fragments and lenses of crushed brick. Lower fill (203) was mid grey silty clay with occasional brick fragment. Context was getting brighter downwards. Both contexts (202 and 203) were filling cut [204] and were extending outside of the cut where they were forming horizontal layers. Cut [204] had its eastern edge exposed, steep side and base wasn't reached. It's unknown if the cut [204] was deliberate recent cut related to development or if it's an edge of older or natural feature like water stream or pond that would be connected with the moat to the north west. Anyhow the bricks recovered from trench base were modern indicating that feature was filled in second half of 20<sup>th</sup> century.

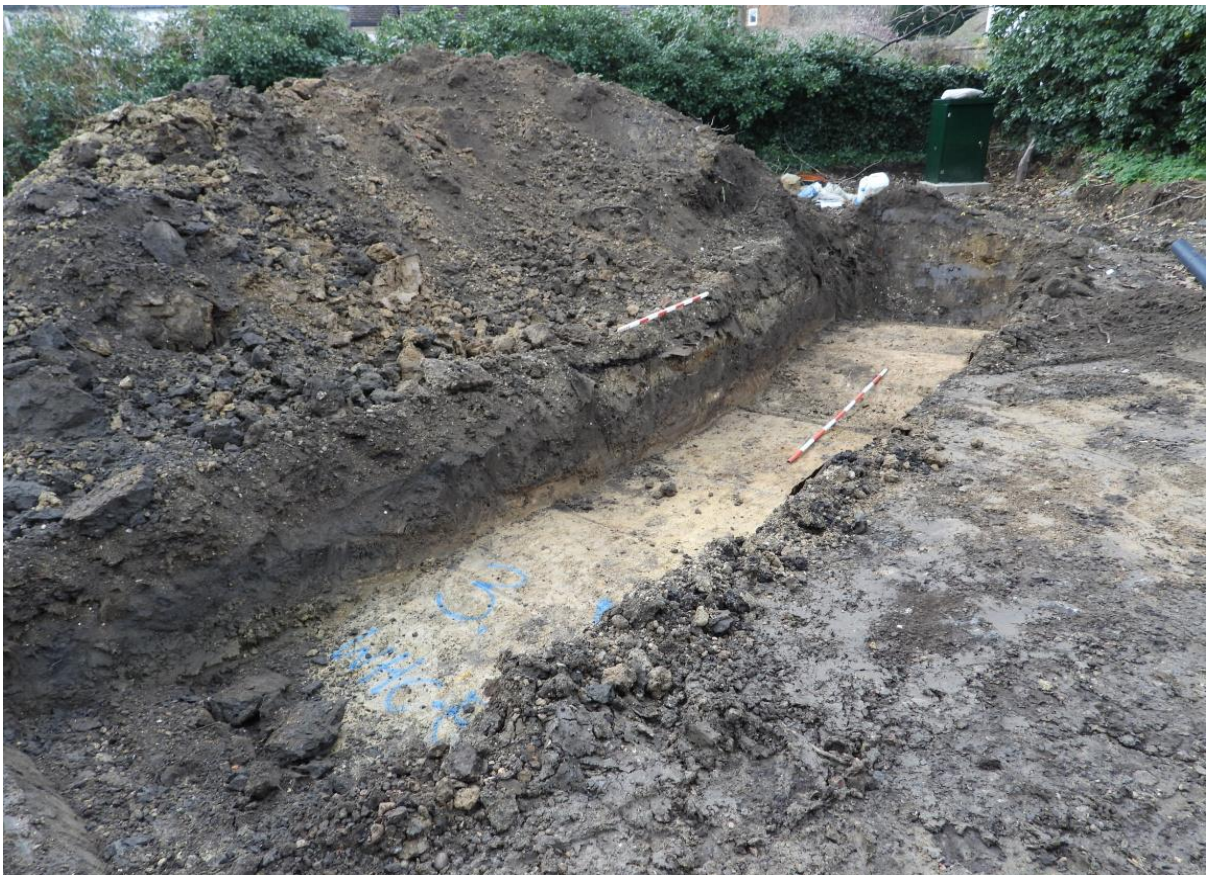
*Plate 4: Looking north east at trench 3; 2metres scale rod at the base of the trench*

- 5.2.3 Trench 3 (Figure 3) was placed in northern extent of the site in east-west alignment and measured 9 metres in length by 1.8metre in width and 0.8metre in depth. It exposed natural geology at its base, context (305) comprising light yellowish brown silty clay. Excavated material was a sequence of made ground material (301, 302, 303 and 304). Top

layer (301) was 0.22metres thick comprising of tarmac patches sealed with black gravelly loam with frequent modern building material. Located underneath the latter there was 0.2metres thick layer (302) of light grey mixed gravel. Located underneath the latter there was 0.2metres thick layer (303) of black loam with occasional brick fragment. Located underneath the latter there was 0.1metres thick trample layer (304) of black mottled light yellowish brown loam with occasional brick fragment overlying natural (305). A modern/ Victorian steep-sided linear was exposed in the middle part of this trench. Feature [306] was found in NW-SE alignment fairly parallel to the site boundaries. Sample excavated section revealed uniform backfill (307) comprising mid-grey clay-silt with Victorian potsherds and modern sewage pipe fragments. Feature measured 1.1metre in width and 0.23metre in depth.

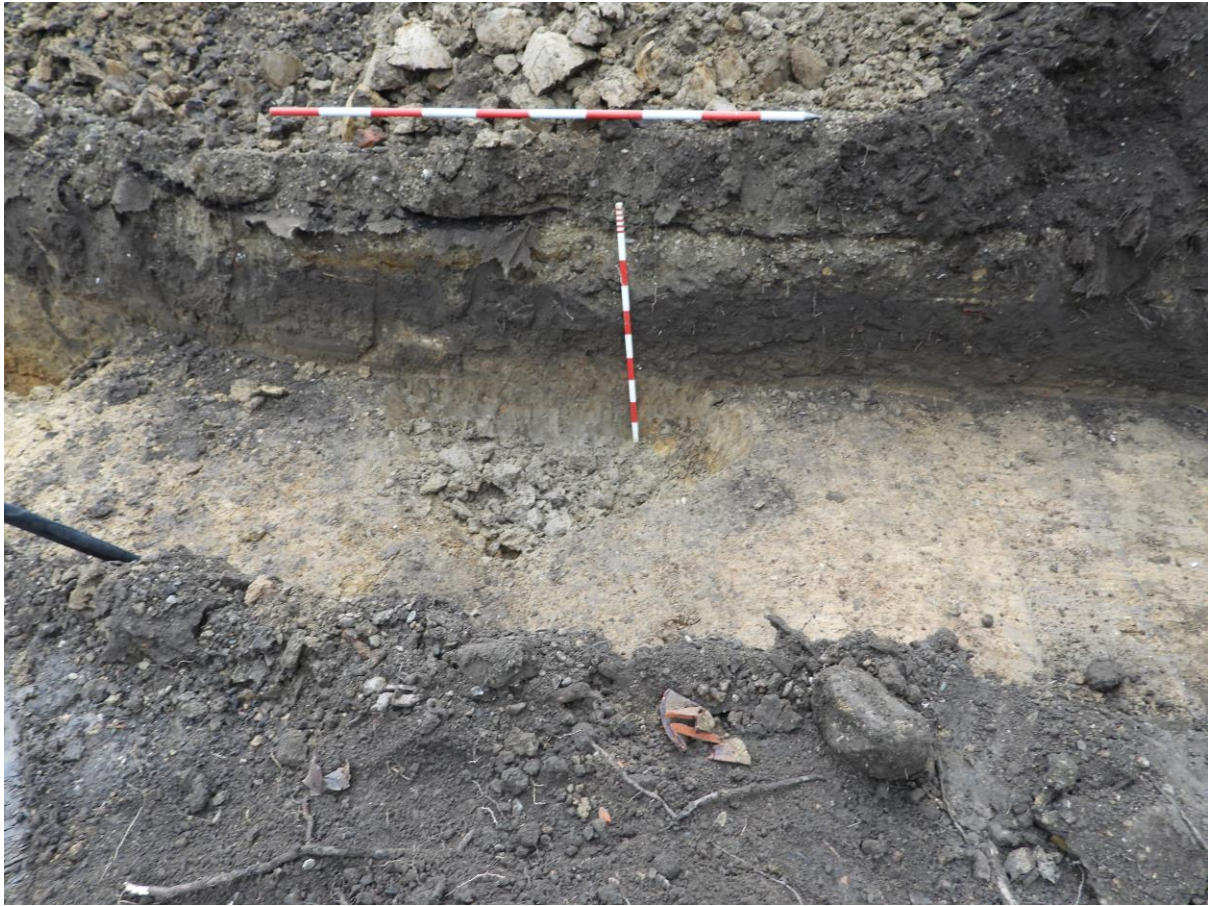
*Plate 5: Showing evaluated modern linear revealed in Trench 3. Looking south with one and two metre scales.*

- 6.1 Victorian/ modern potsherds and red ceramic pipe fragments were found in Trench 3. Modern brick fragments were noted within all levelling deposits across the site. No earlier finds has been recovered during the course of evaluation.
