ARCHAEOLOGICAL EVALUATION OF Land at Turkey Mill Business Park, Ashford Road, Maidstone, Kent ME14 5PP

Report date: 10/03/2021

Site code: **TMM-EV-21**

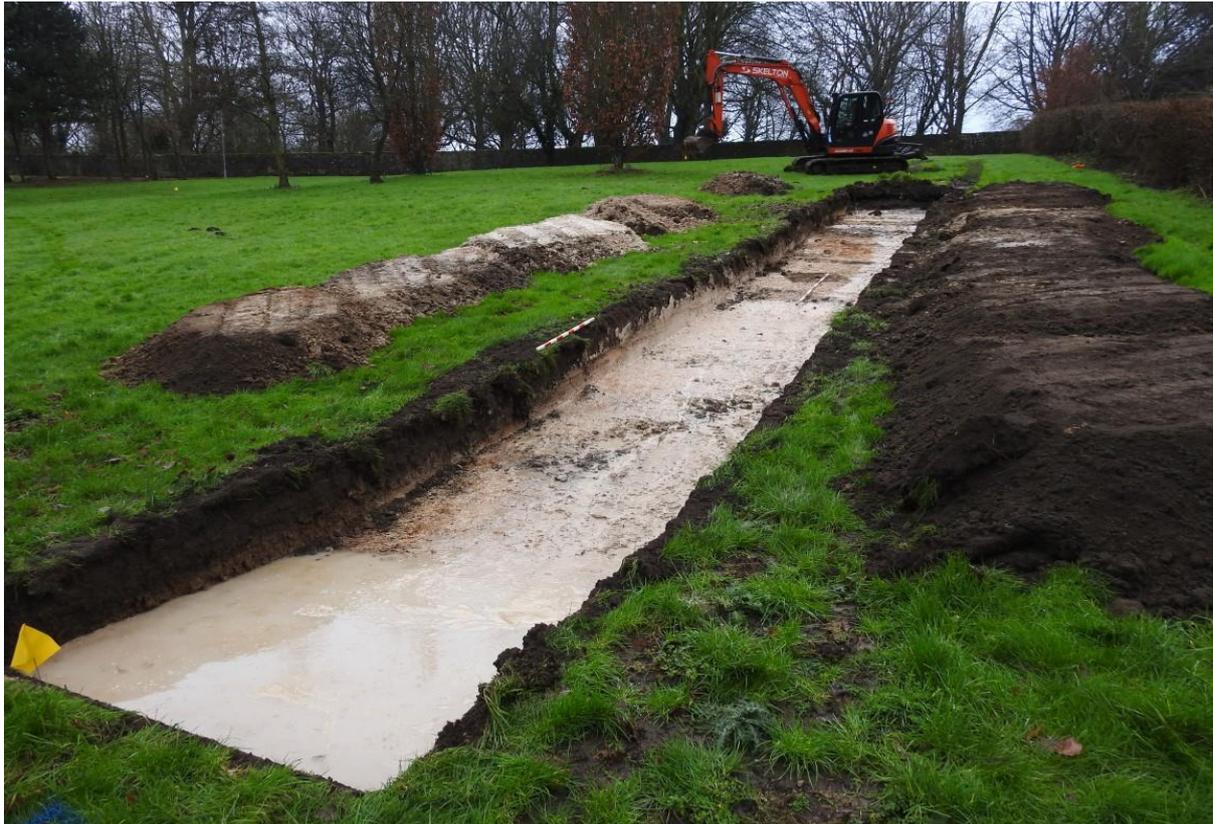
Plate 3: Showing evaluation Trench 1. Looking south with two-metre scale inside the trench.

- 5.1.6 No archaeological cuts, deposits or artefacts were revealed during the course of evaluation.
- 5.2 Trench Narratives
- 5.2.1 Trench 1 (Figure 3) was placed in north-western part of the site in north-northeast; south-southwest alignment and measured 1.8metre wide by 18.66metres in length and 0.48metre in maximum depth. (103) comprising light yellow-grey clay-sand-silt with infrequent sandstone flecks. Modern cut for possible fence post and treebale were exposed in southern part of this trench. A water spring was also exposed at southern end of this trench and rapidly filled-in its northern end. No archaeological cuts, deposits or artefacts were revealed in this trench.

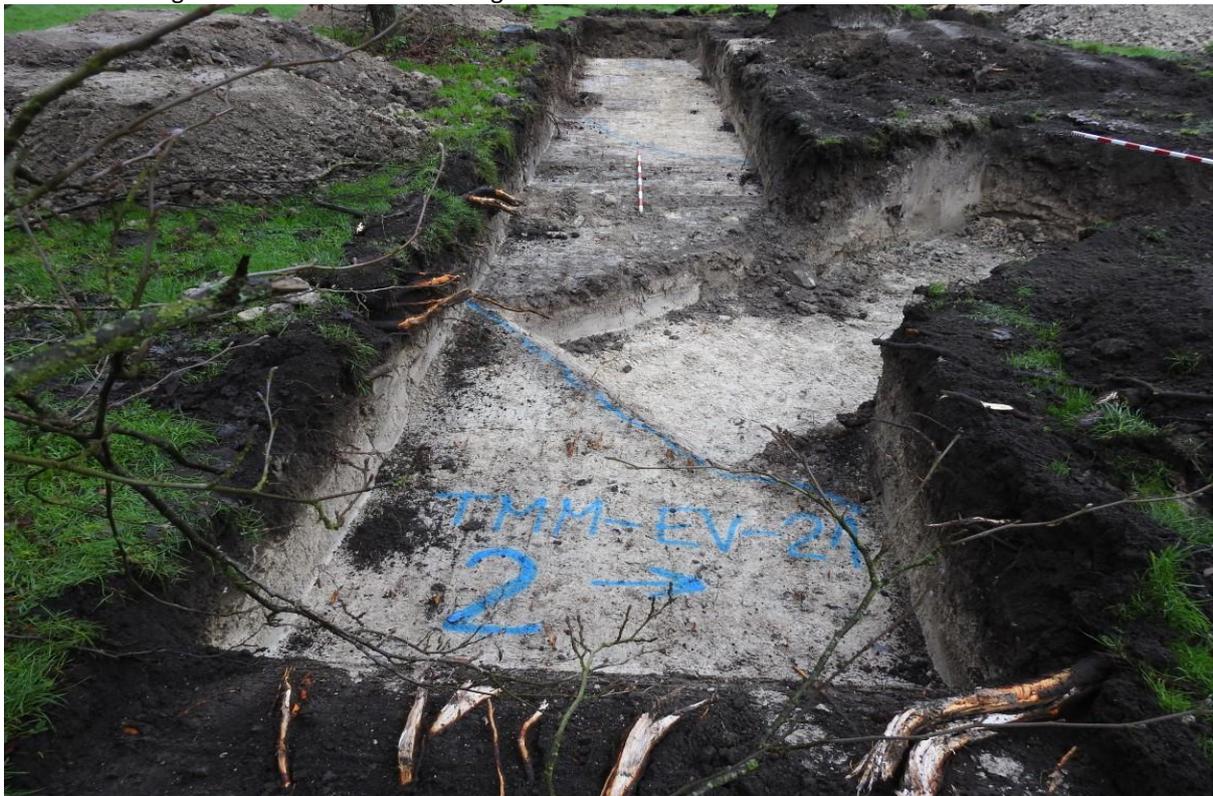
Plate 4: Showing evaluation Trench 3. Modern footpath visible in the middle ground. Looking west with two-metre scale.

- 5.2.3 Trench 3 (Figure 3) was placed in central-western part of the site in east-west alignment and measured 1.8metre wide by 16.50metres in length and 1.05 metre in maximum depth where an extension was excavated to better understand exposed remains. It exposed modern levelling deposit comprising garden soil with metal debris capping natural geology context (203). A one-brick course soil retention wall (remains) was exposed at western end of this trench. Bricks looks modern, definitely post war and bonding material used was hard concrete-like mortar. No archaeological cuts, deposits or artefacts were revealed here.

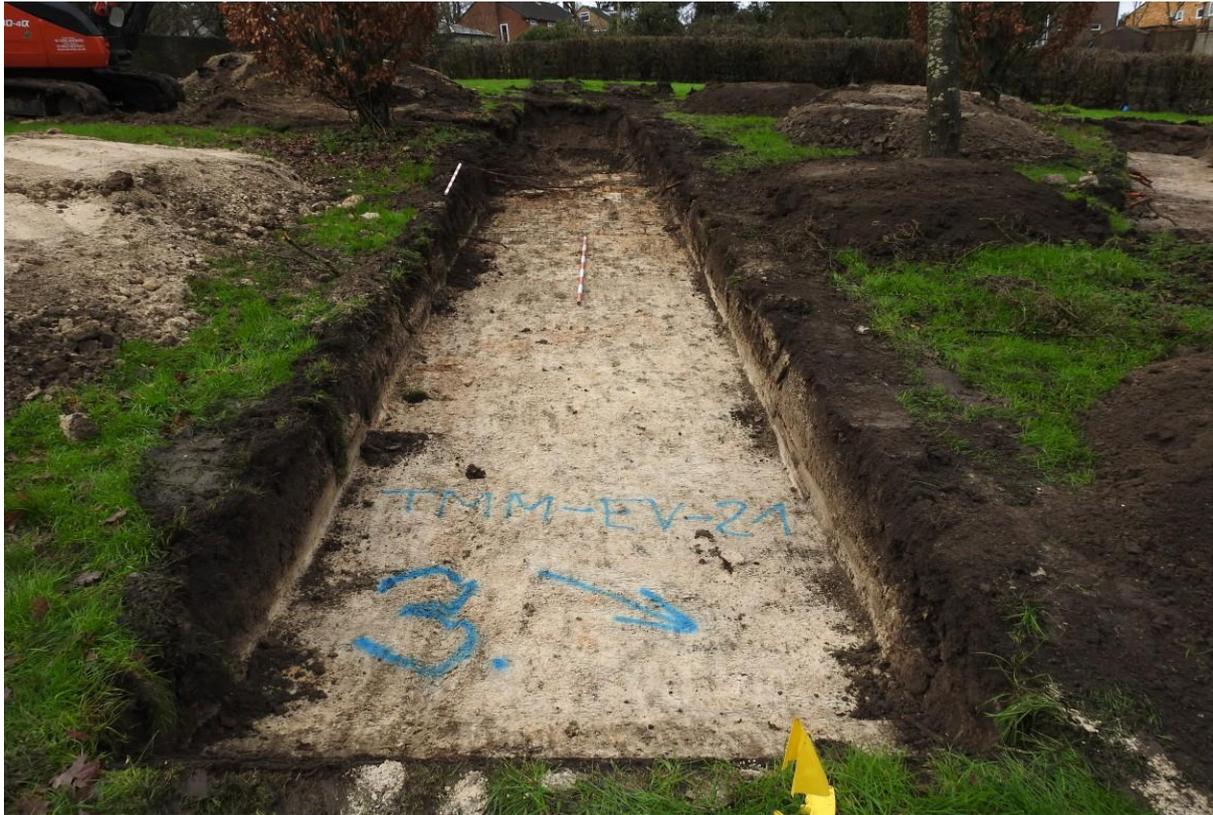
Plate 5: Showing evaluation Trench 3. Looking west with two-metre scale.

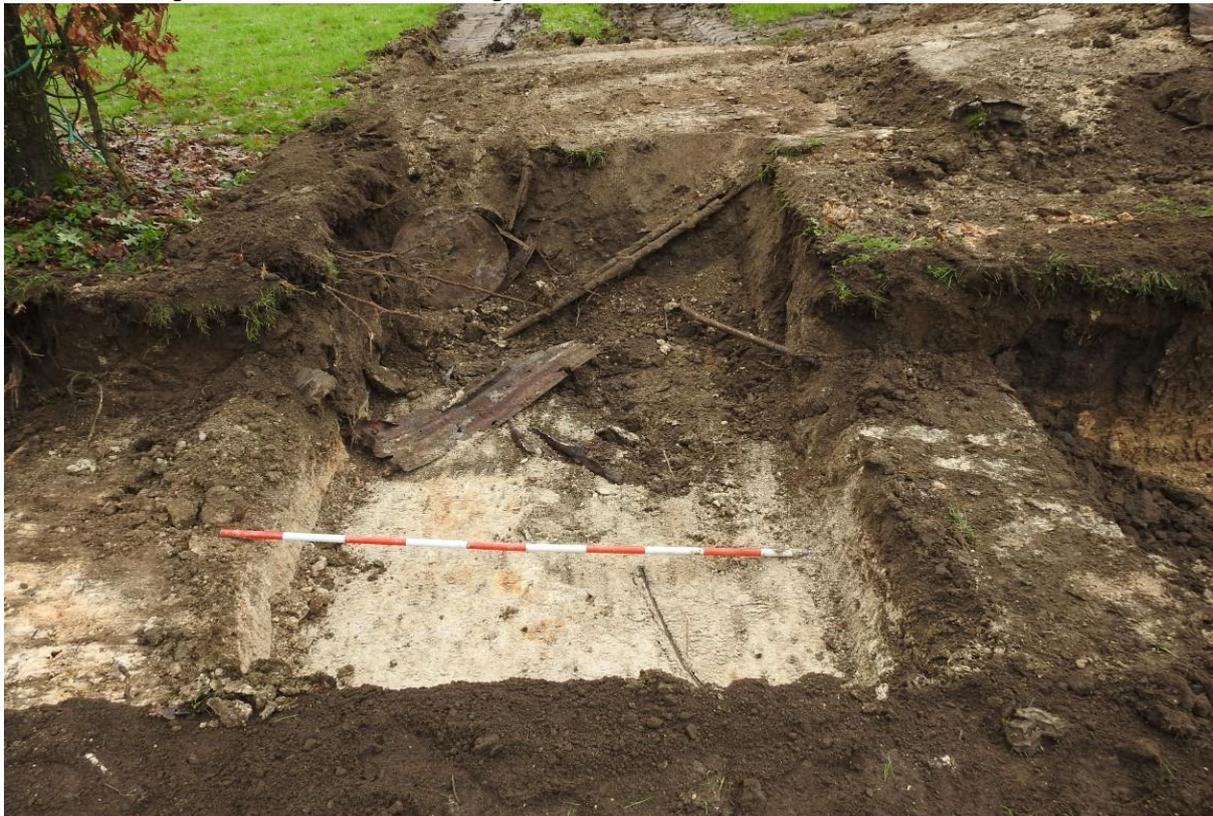
Plate 6: Modern waste revealed in Trench 3. Looking south with two-metre scale.

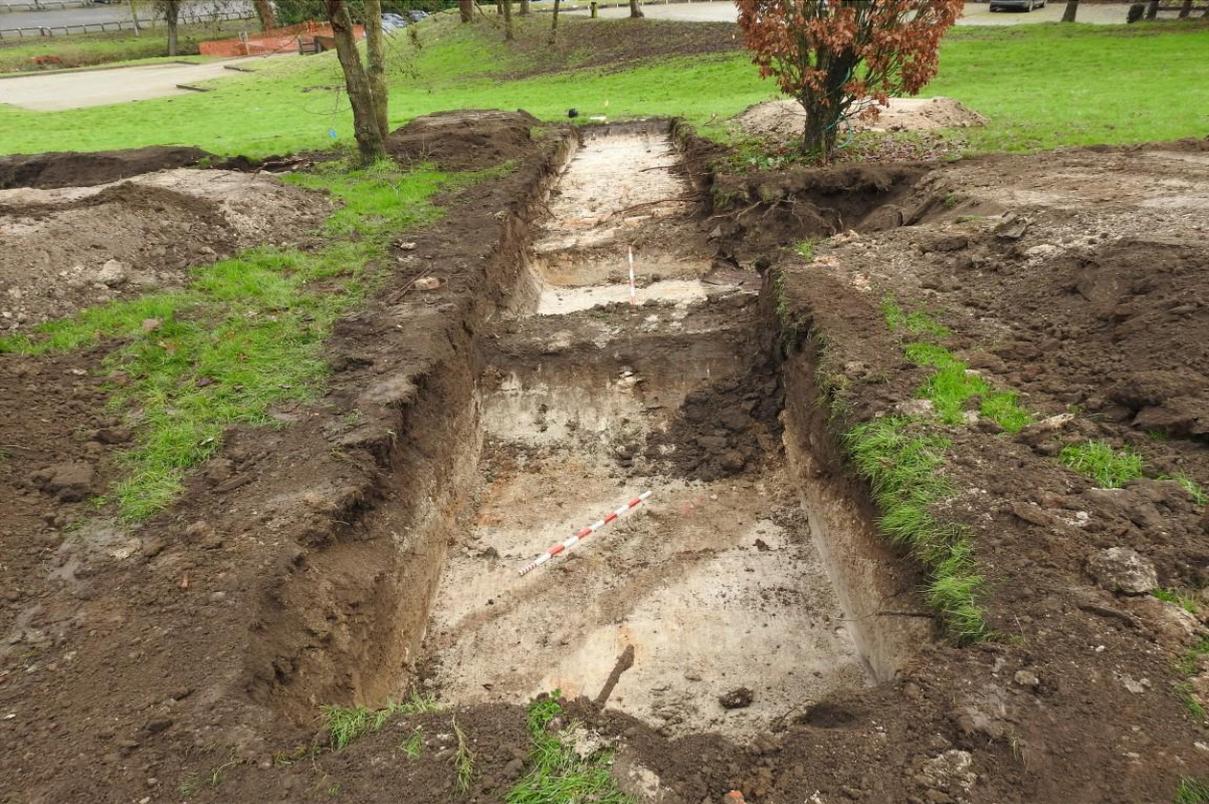
Plate 7: Showing evaluation Trench 3 looking eastwards. Retention wall visible in foreground with one-metre scale.

- 6.2 Remains of soil retention walls were exposed in Trenches 3, 8 and 8A. Retaining wall exposed in Trench 3 could be directly related to the allotment gardens whilst the walls exposed in trenches 8 and 8A could be a part of paper mill development. The car-park area occupying eastern and central part of the site was originally a slope descending northwards to the river Len therefore the evaluation came to conclusion that these wall were essential at keeping soil in place and preventing from washing it down to the river Len.

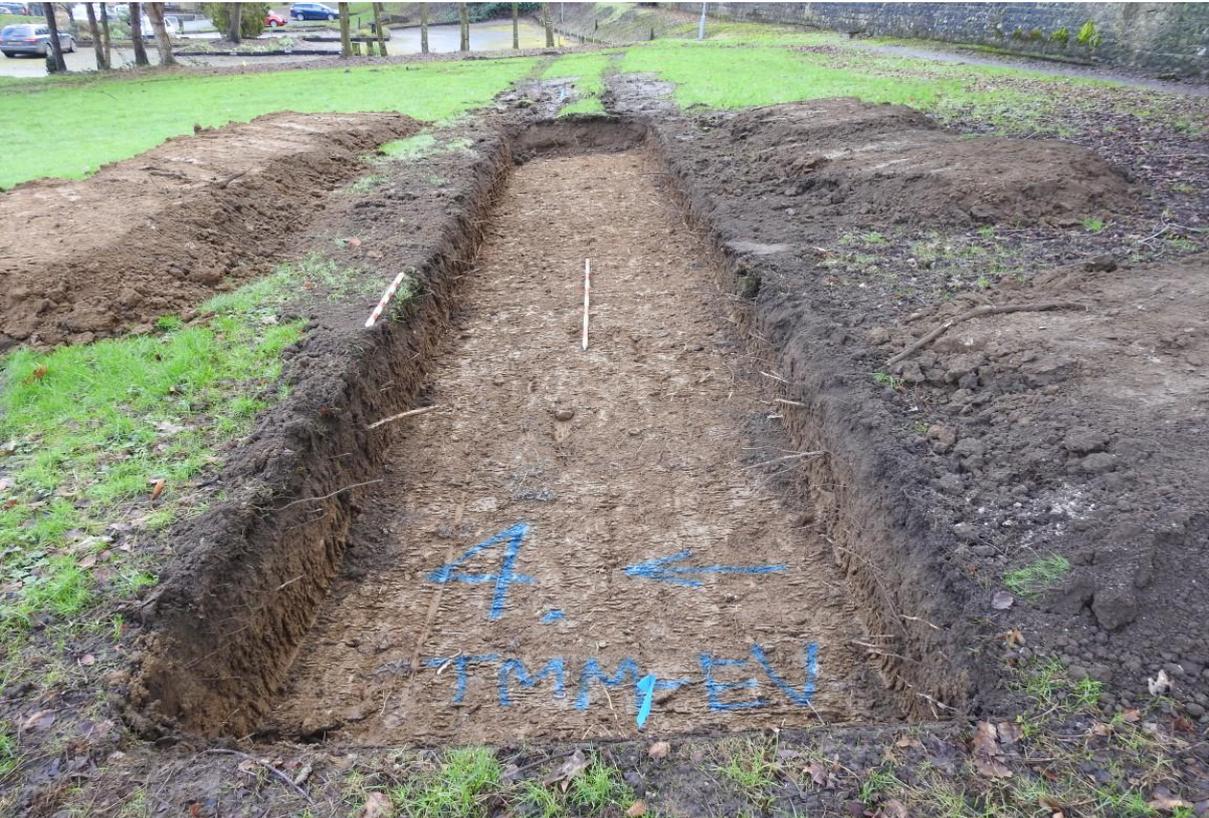
Plate 8: Showing evaluation Trench 4. Looking east with two-metre scale.

- 5.2.4 Trench 4 (Figure 3) was placed in south-western part of the site in NE-SE alignment and measured 1.8metre wide by 15.50metre long and 0.43 metre in maximum depth. Trench has exposed natural

geology (403) comprising orange-brown clay-sand-silt with infrequent angular stones. No archaeological cut or deposits were exposed here.

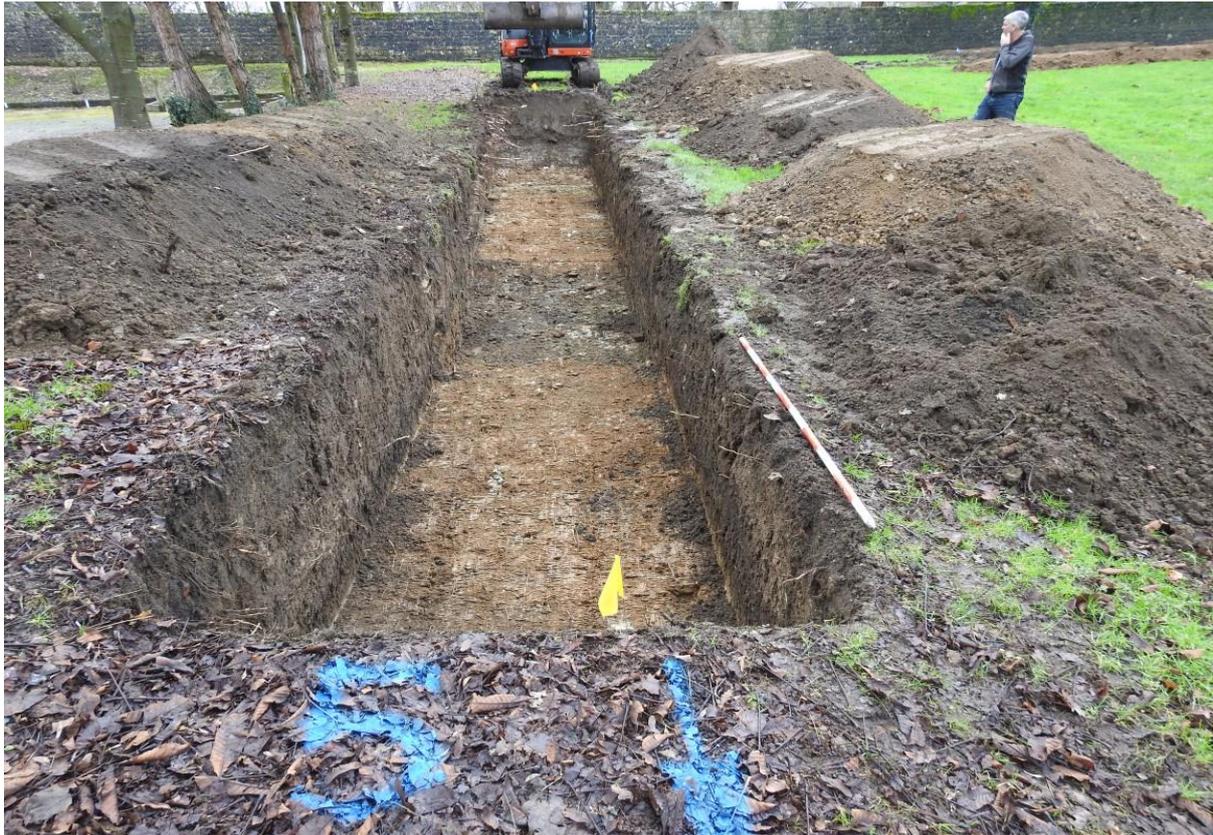
Plate 9: Showing evaluation Trench 5. Looking south with two-metre scale.

- 5.2.5 Trench 5 (Figure 3) was placed in central part of the site in north-south alignment and measured 1.8metre wide by 18.56metres in length and 1.4metre in maximum depth. Trench has exposed vast modern levelling deposit capping natural geology context 503 comprising orange-grey clay-sand-silt with infrequent sandstone flecks. No archaeological cuts, deposits or artefacts were revealed here.

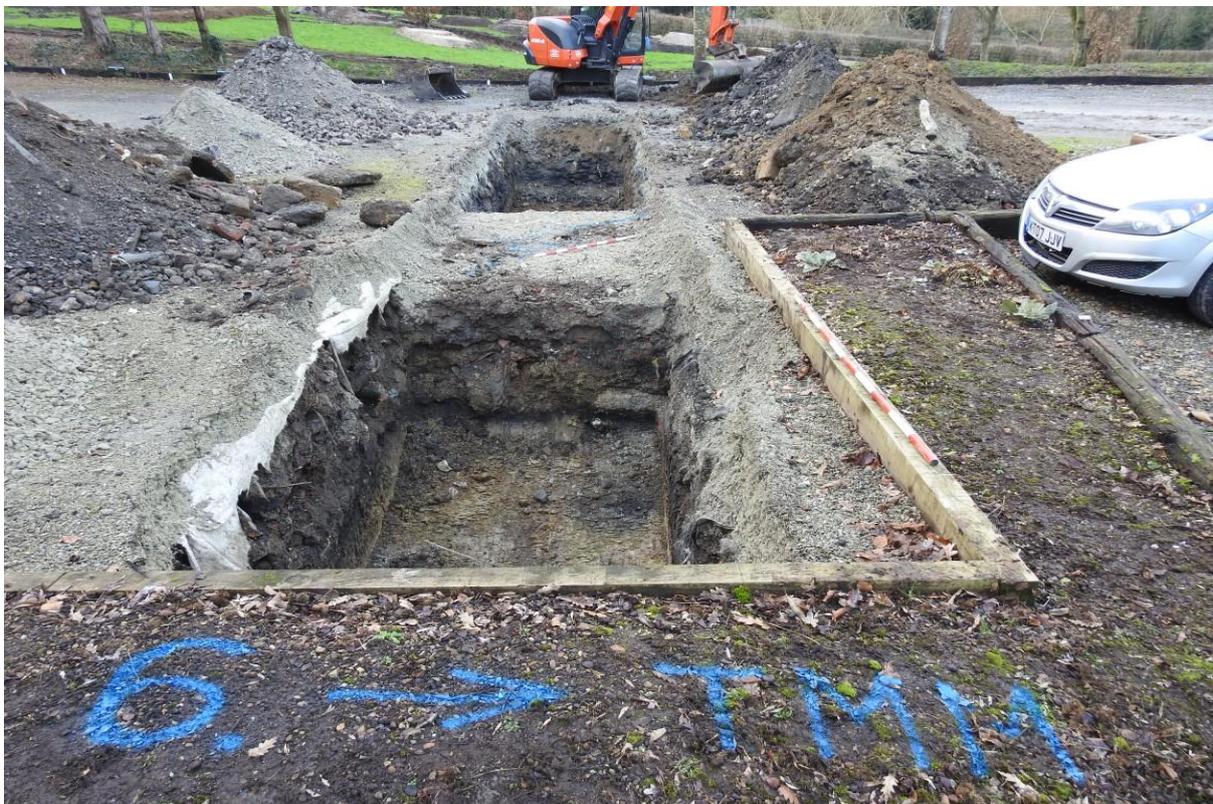
Plate 10: Showing evaluation Trench 6. Looking west with one and two-metre scales.

- 5.2.6 Trench 6 (Figure 3) was placed in north-eastern part of the site in east-west alignment and measured 1.8metre wide by 15metre long and 1.5metre in maximum depth. Trench has exposed vast modern levelling deposit capping natural geology 603 comprising orange-grey clay-sand-silt with infrequent angular stones. A green staining within exposed natural geology surface derived from overlaying demolition debris. Modern service trench was exposed roughly in the middle part of this trench. No archaeological cuts, deposits or artefacts were revealed here.

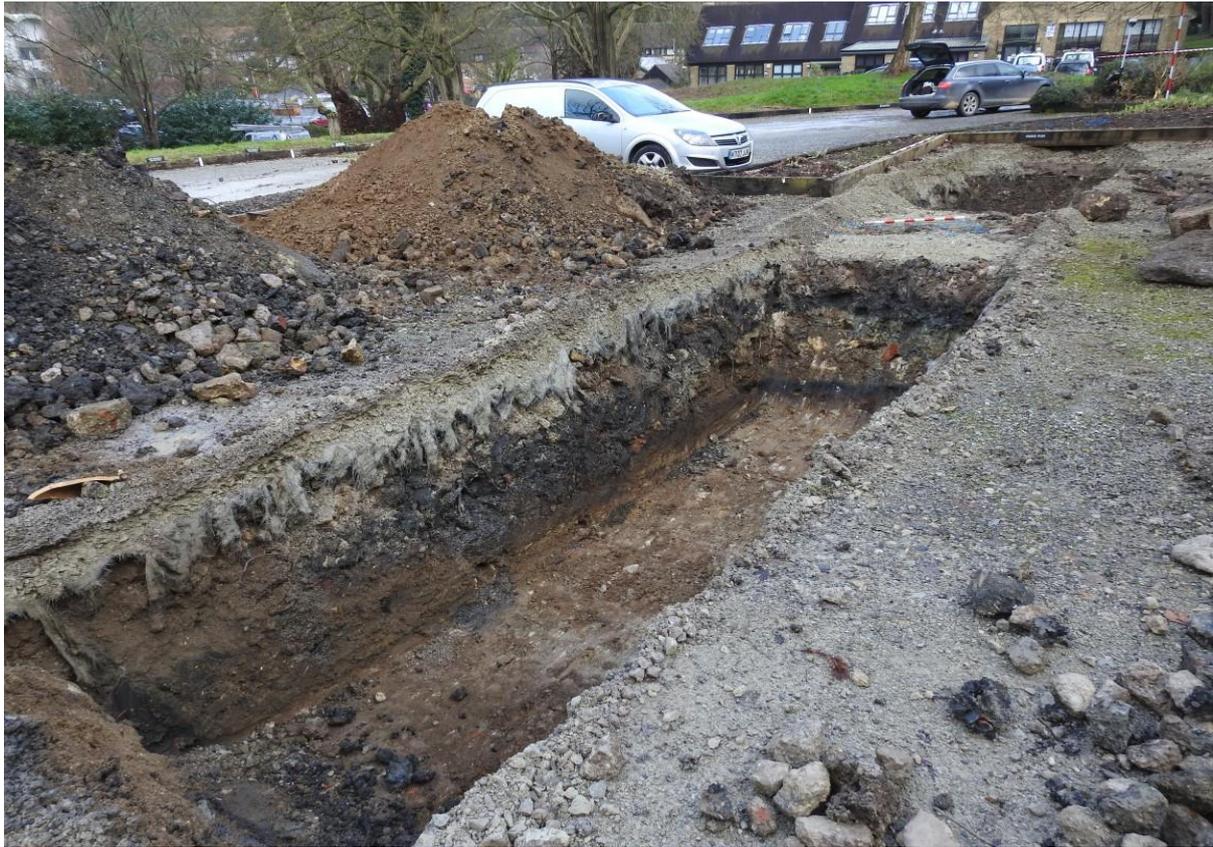
Plate 11: Overlook onto Trench 6 looking north-east towards river Len. One metre scale.

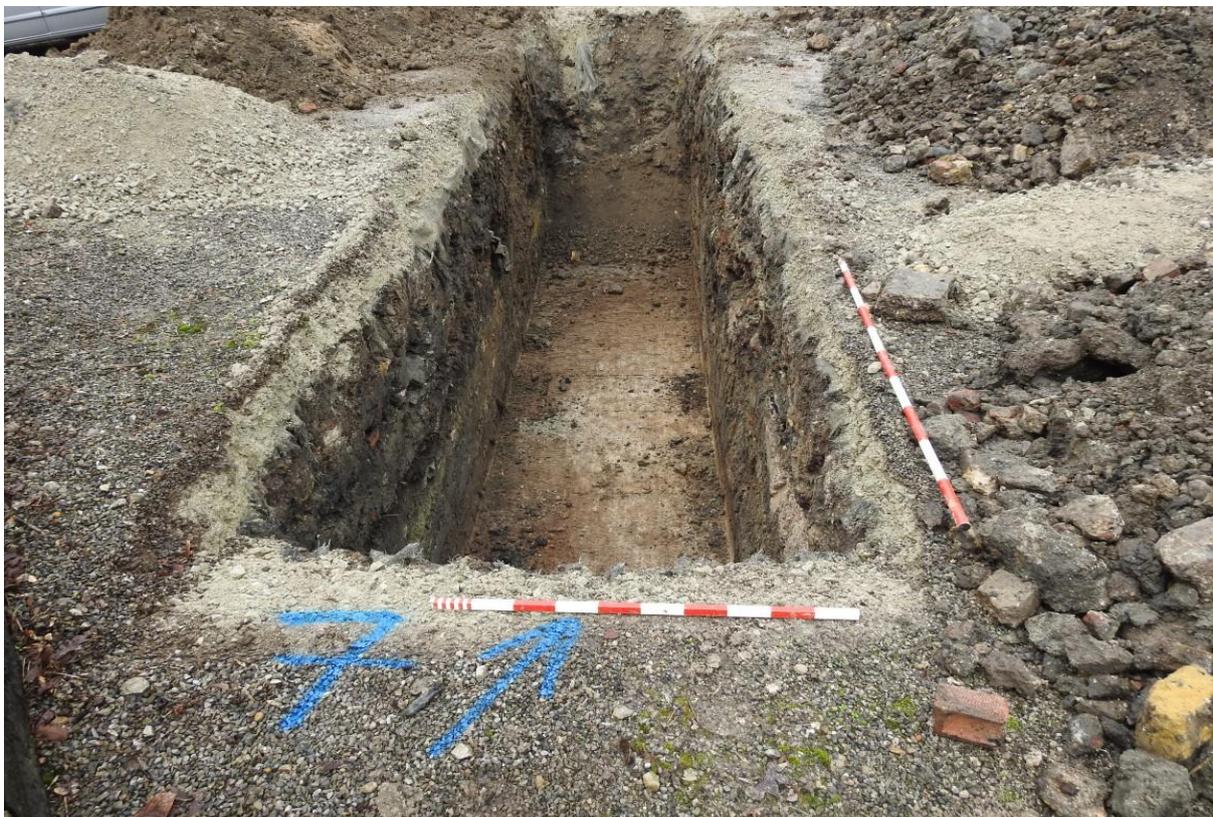
Plate 12: Showing Trench 7. Looking north-west with one- and two-metre scales.

- 5.2.7 Trench 7 (Figure 3) was placed in north-eastern part of the site in north-south alignment and measured 1.8metre wide by 16.68metre in length and 2.8metre in maximum depth. Trench has exposed vast modern levelling deposit capping natural geology context 703 comprising orange-grey clay-sand-silt with infrequent sandstone flecks. No archaeological cuts, deposits or artefacts were revealed here.

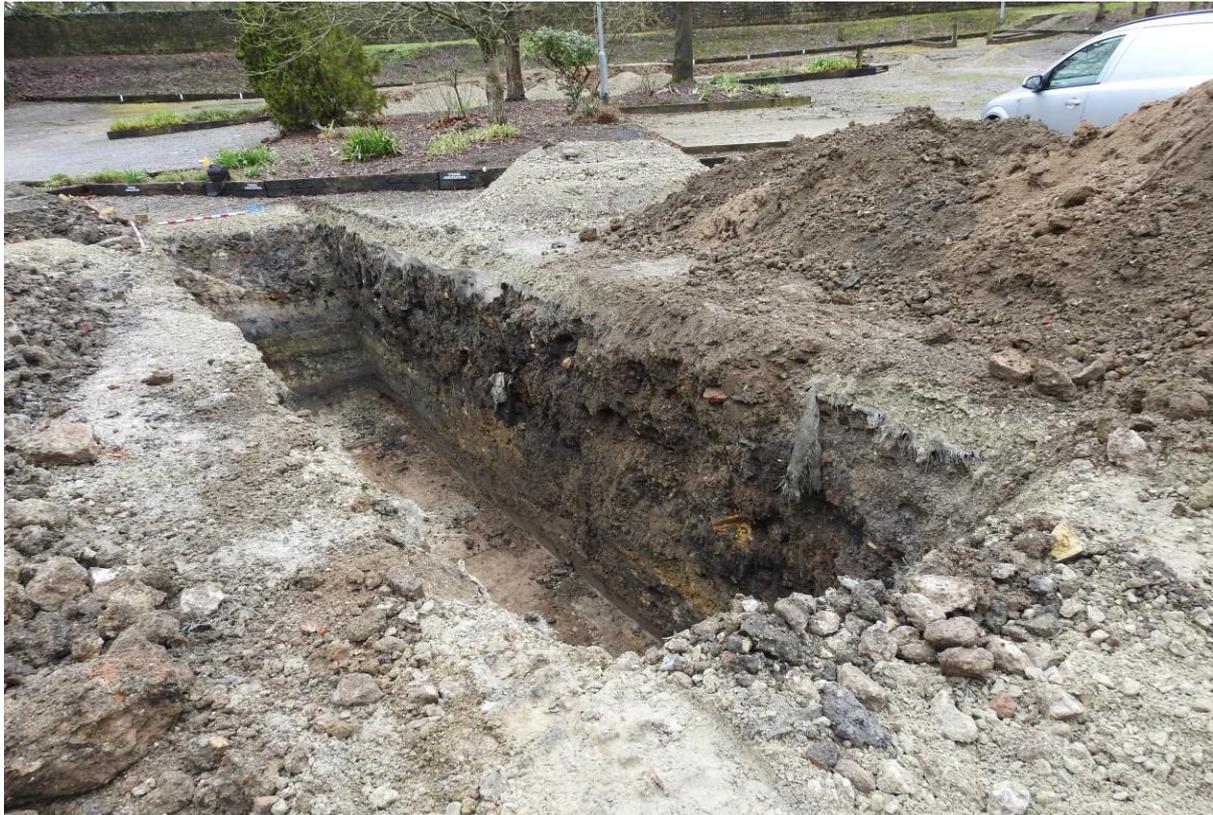
Plate 13: Evaluation Trench 7 looking north with one-metre scale at its distant end.

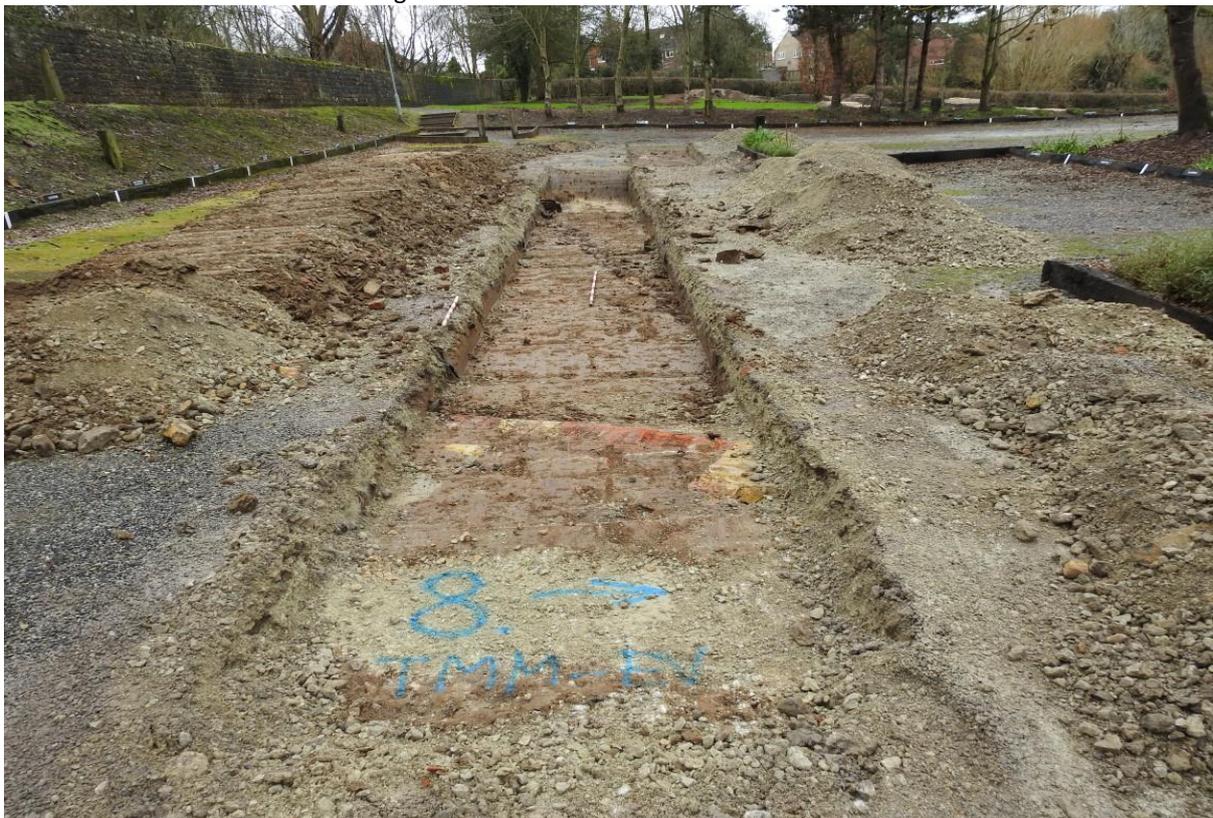
Plate 14: Trench 8 looking west. Slightly curving retention wall visible in foreground. Ceramic pipe visible in background. Looking west with two-metre scales.

- 5.1.5 Trench 8 located to the south has exposed shallow walls, probably functioning as a soil retention barrier. Majority of the bricks appears to be post war; bonding material is partially soft yellow sandy but in most places very hard, fine grained concrete-like mortar was used.

- 5.2.8 Trench 8 (Figure 3) was placed in south-eastern part of the site in east-west alignment and measured 1.8metre wide by 18.12 metre in length and 0.8metre in maximum depth. Trench has exposed natural geology context 803 comprising orange-grey clay-sand-silt with infrequent angular stones and sandstone flecks. Trench has exposed modern soil retention wall at its eastern end and ceramic pipe in east west alignment. No archaeological cuts, deposits or artefacts were revealed here.

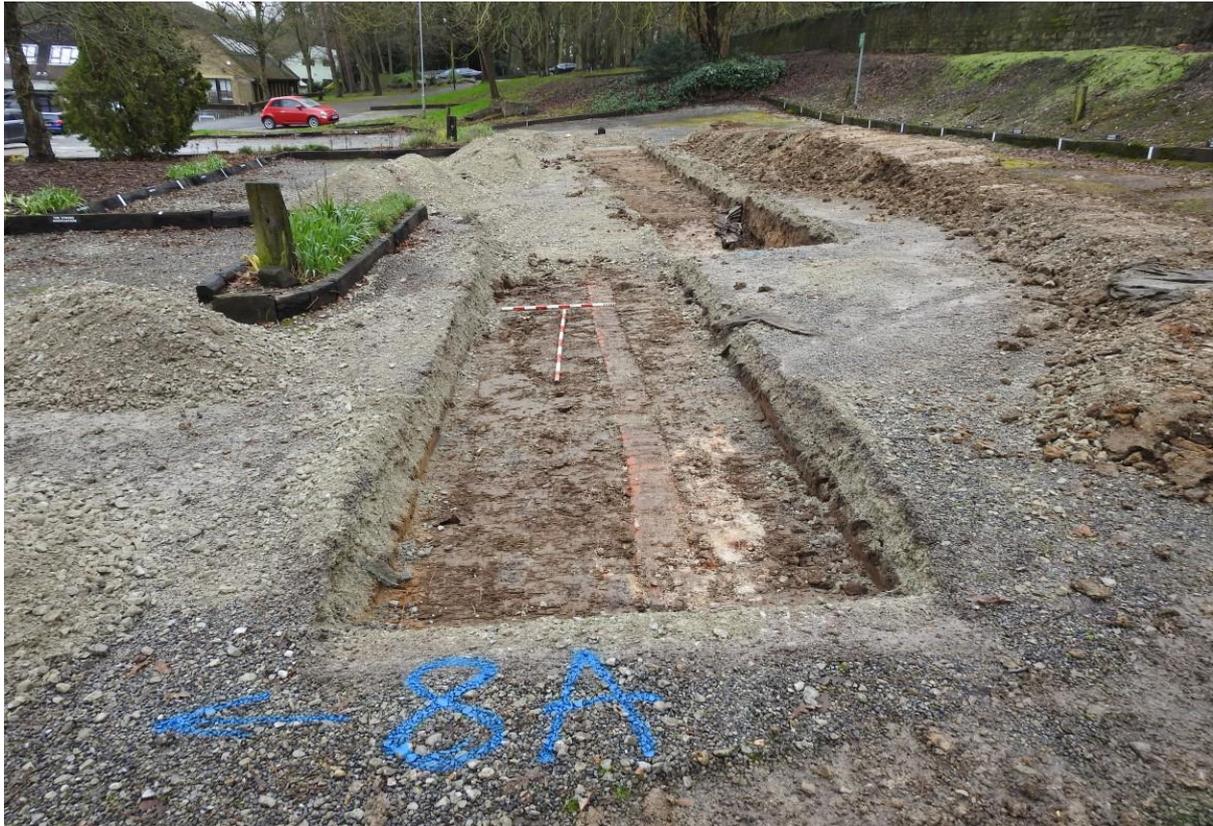
Plate 15: Showing Trench 8A and retention wall in foreground. Looking east with one- and two-metre scales.

- 5.2.9 Trench 8A (Figure) this contingency trench was placed adjacently to the west of Trench 8 discussed above in the same alignment. It measured 1.8metre wide by 9.45metre in length and 0.25metre in maximum depth. It exposed modern soil retention wall in roughly east-west alignment cutting through natural geology concealed by recent car-park surface consisting of small stones aggregate. No archaeological cuts, deposits or artefacts were revealed here.

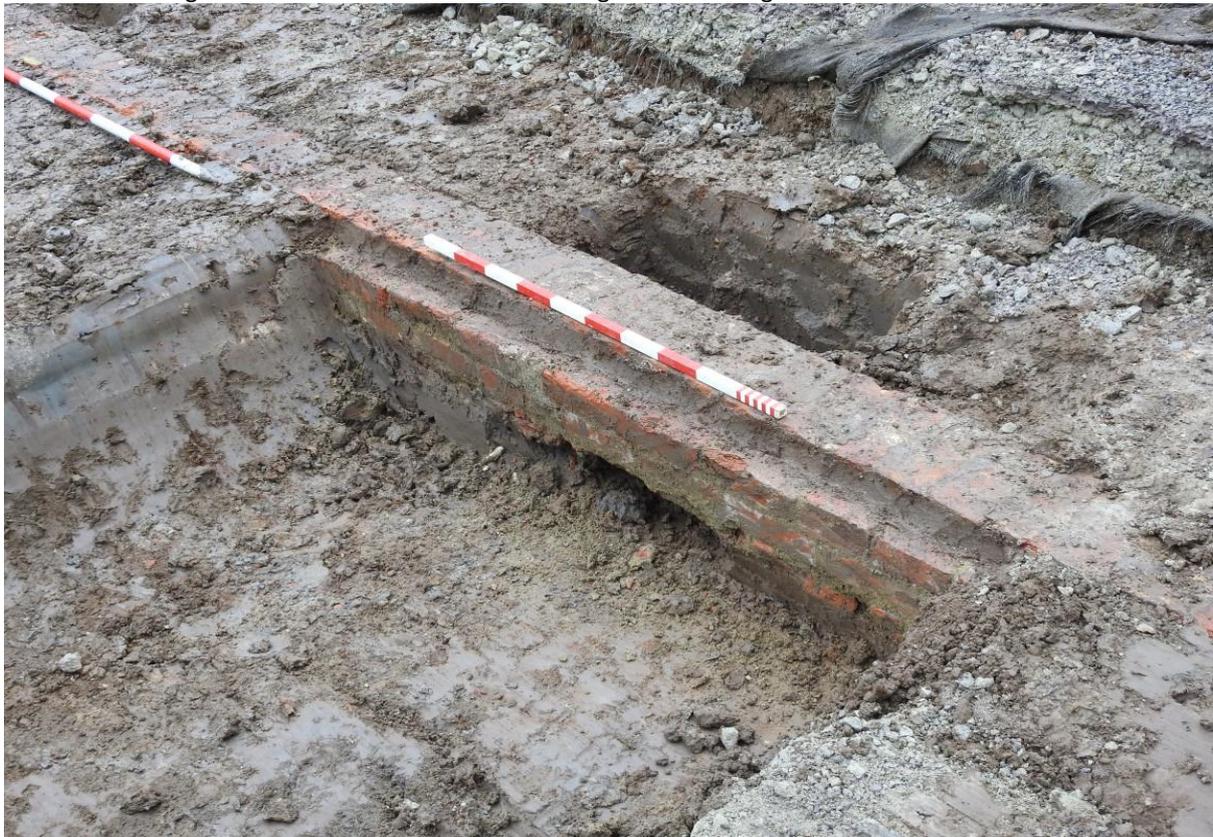
Plate 16: Showing exposed retention wall in Trench 8A. Looking south-east with one-metre scale.

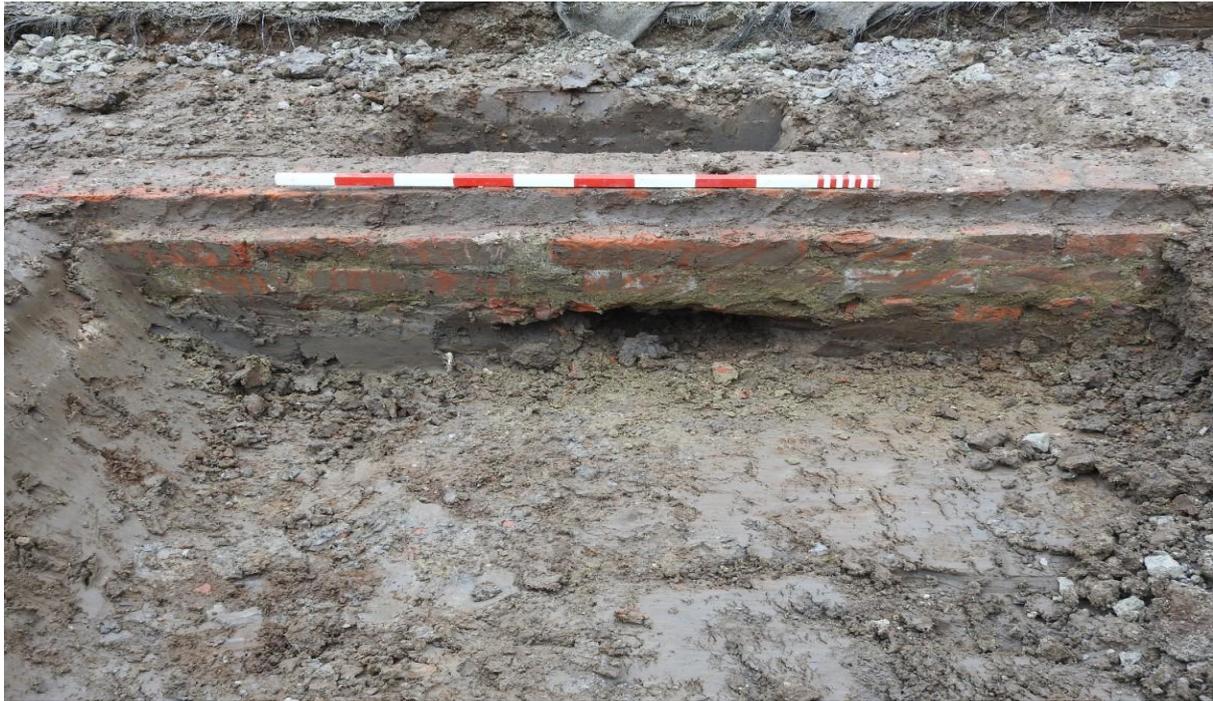
Plate 17: Wall exposed in Trench 8A looking south with one-metre scale.

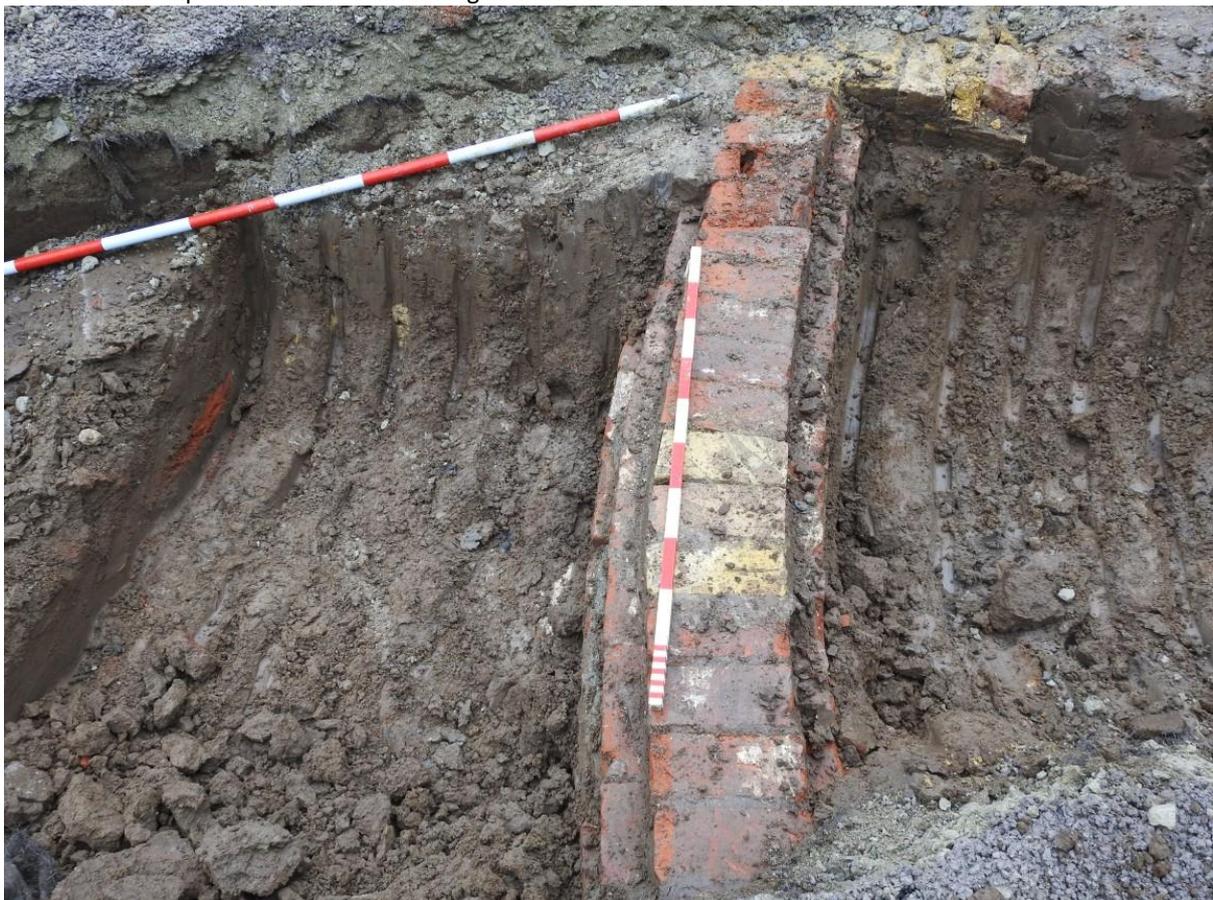
Plate 18: Showing retention wall exposed in eastern end of evaluation trench 8. Looking north with one- and two-metre scales.

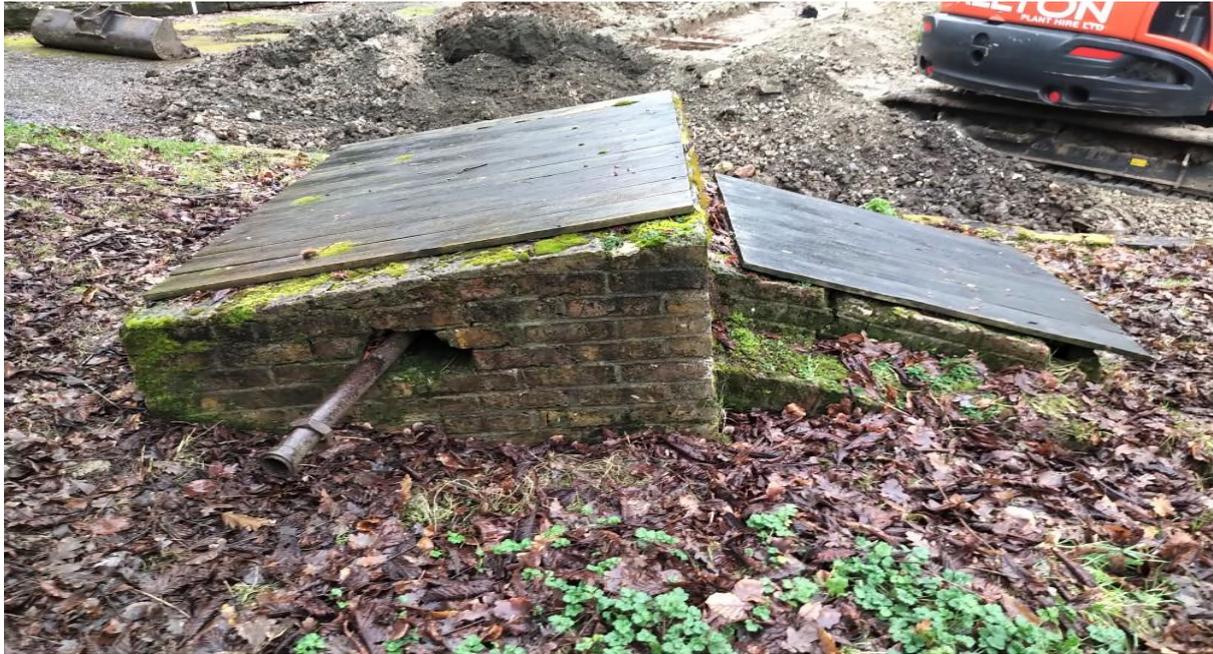
Plate 19: Showing fresh water well and reservoir situated in south eastern part of the site.

- 5.1.4 The southern extent of carpark contained ceramic pipes possibly diverting water from adjacent stream. Pipes are connected to the well/manhole structure which was a part of a paper mill water supply. The overflow from inspected well conveys water to the river Len, partially through ceramic pipes that were superseded by plastic ones during the construction of car park.

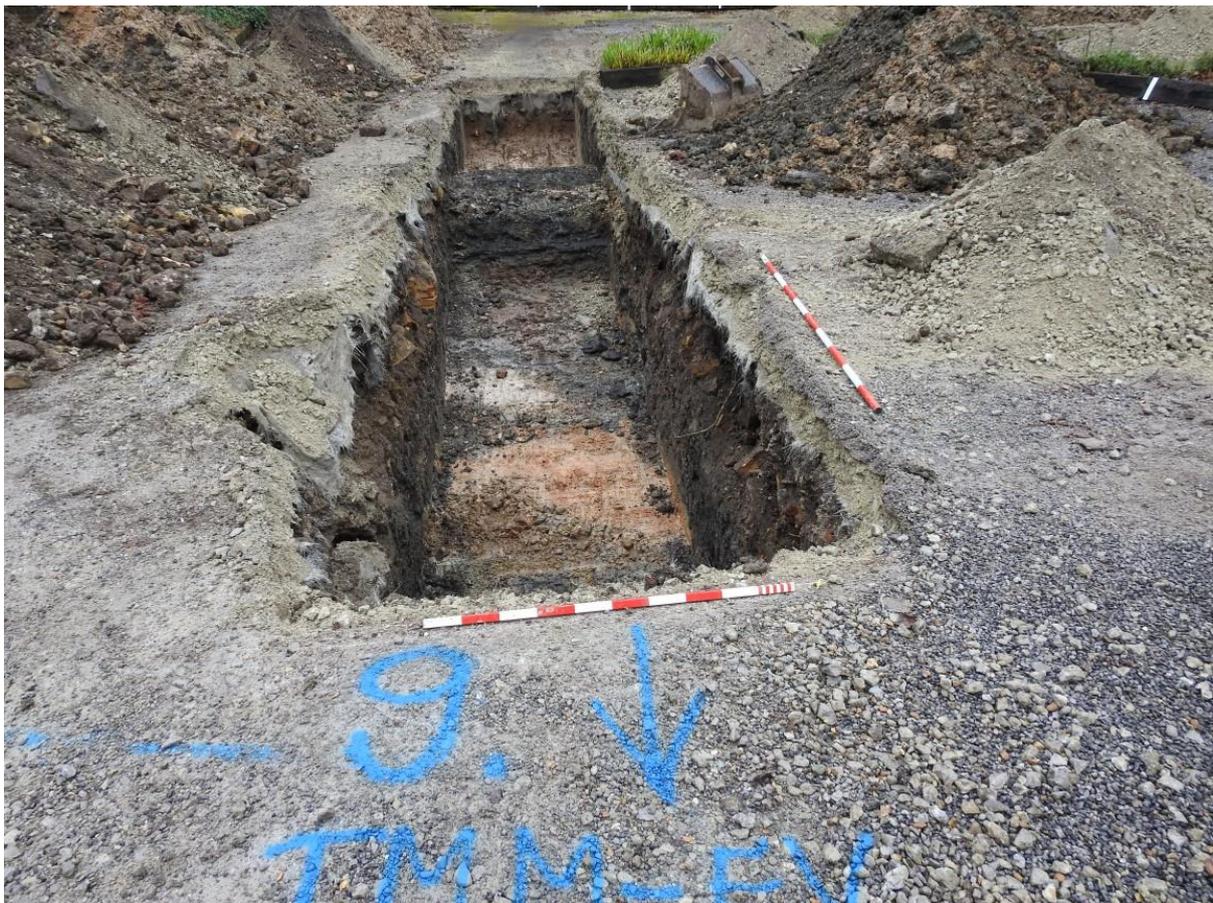
Plate 20: Showing evaluation Trench 9. Looking south with one- and two-metre scales.

- 5.2.10 Trench 9 (Figure 3) was placed in eastern part of the site in north-south alignment and measured 1.8metre wide by 17.32metre long and 2.2 metre in maximum depth. Trench exposed natural geology context 903 comprising orange-grey clay-sand-silt with infrequent sandstone flecks. A modern service trench was exposed in southern part of evaluation trench. No archaeological cuts, deposits or artefacts were revealed here.
