## HISTORIC BUILDING RECORDING OF THE OLD GAS WORKS, BOUNDARY ROAD, RAMSGATE, KENT

September 2021, updated December 2022

Report for Blueberry Development Estates Ltd

## **SWAT ARCHAEOLOGY**

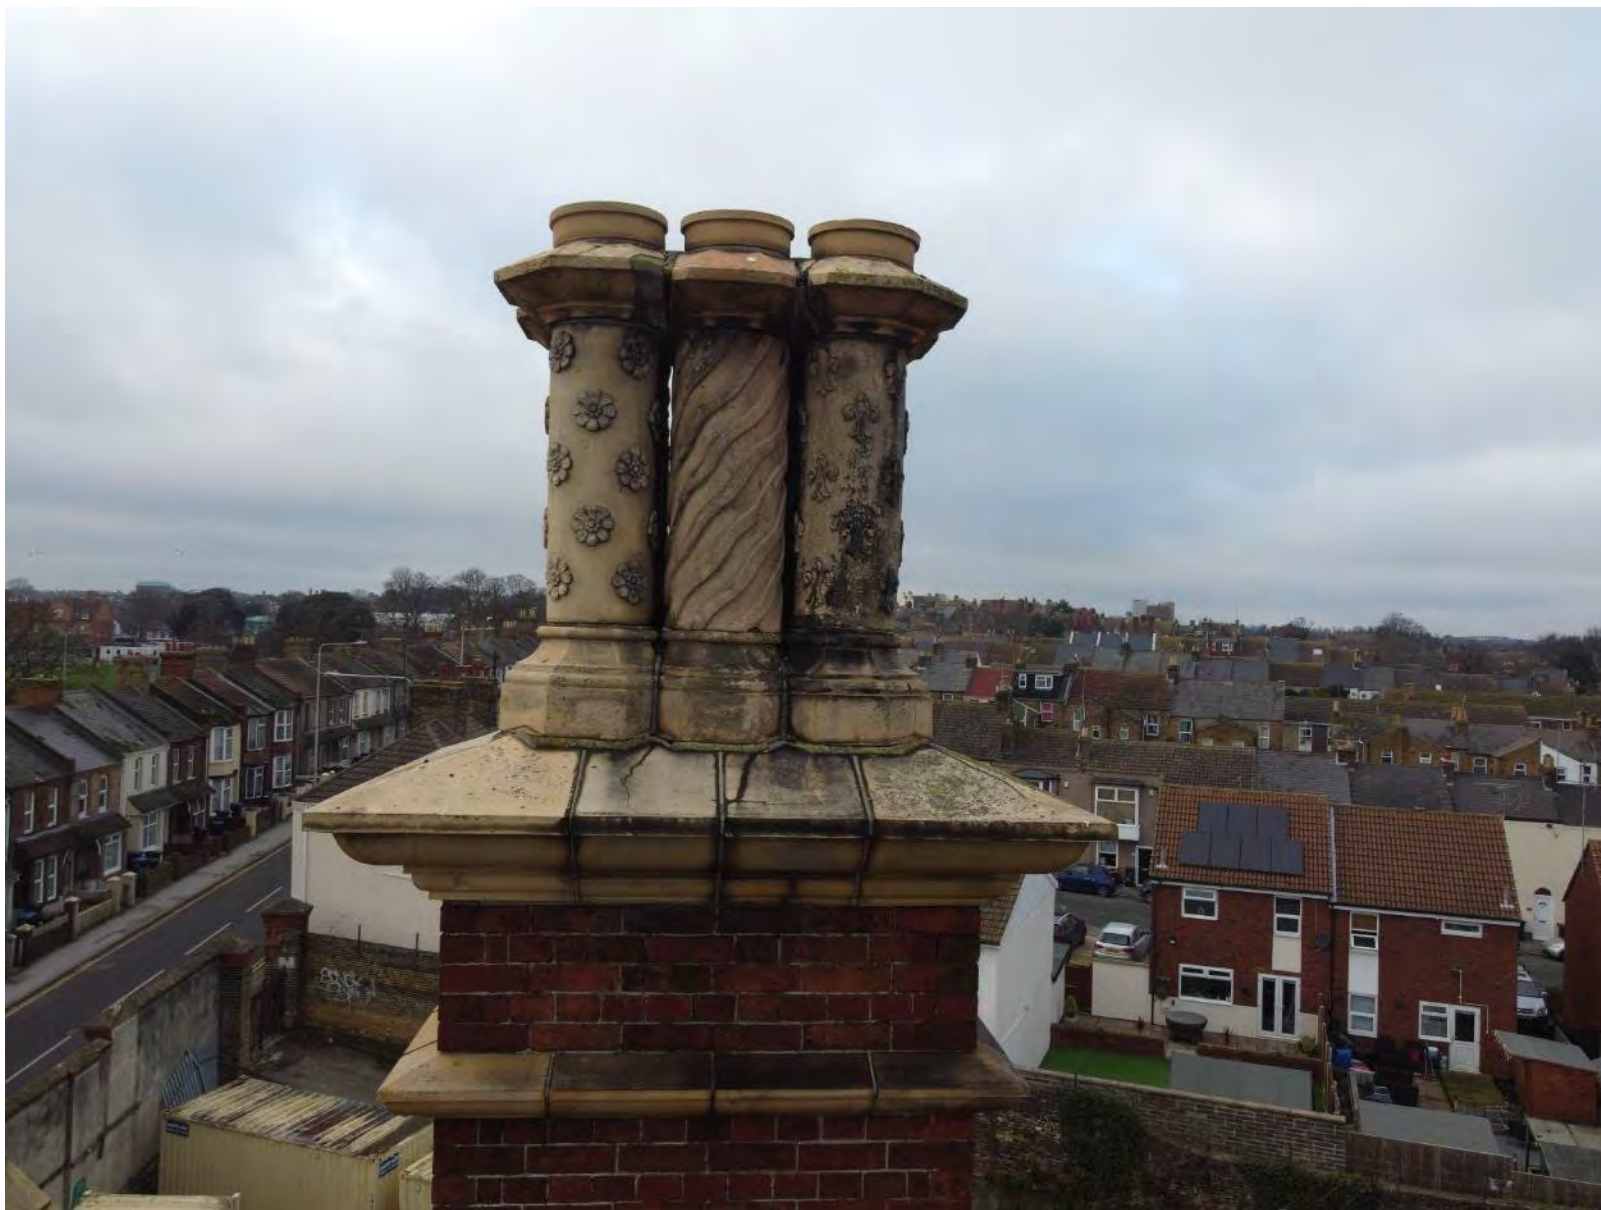
*Plate 23: Close up of the Chimneys western side (December 2020)*

4.1.2 The roof contains four chimneys stacks. All of which based on the historical photos (cover) had ornate moulded chimney pots. All four stacks retain their original cream terracotta moulded crowns and banding below. Only one stack, the north western stack, retains the six original chimney pots (Plates 23-24). The other stacks have all had their pots removed with just the extreme lower portion remaining or replaced with modern metal pipes (Plate 25). The moulded cream terracotta chimney pots of which there are six, consist of four different designs. The designs include fleur de Lys (2), spiral shaft (2), flowers within diamond shaped borders (1) along with a rose style motif (1) meaning that the designs and designs are not identical or mirror each side. There are octagon shaped caps at the top of the chimney pots.

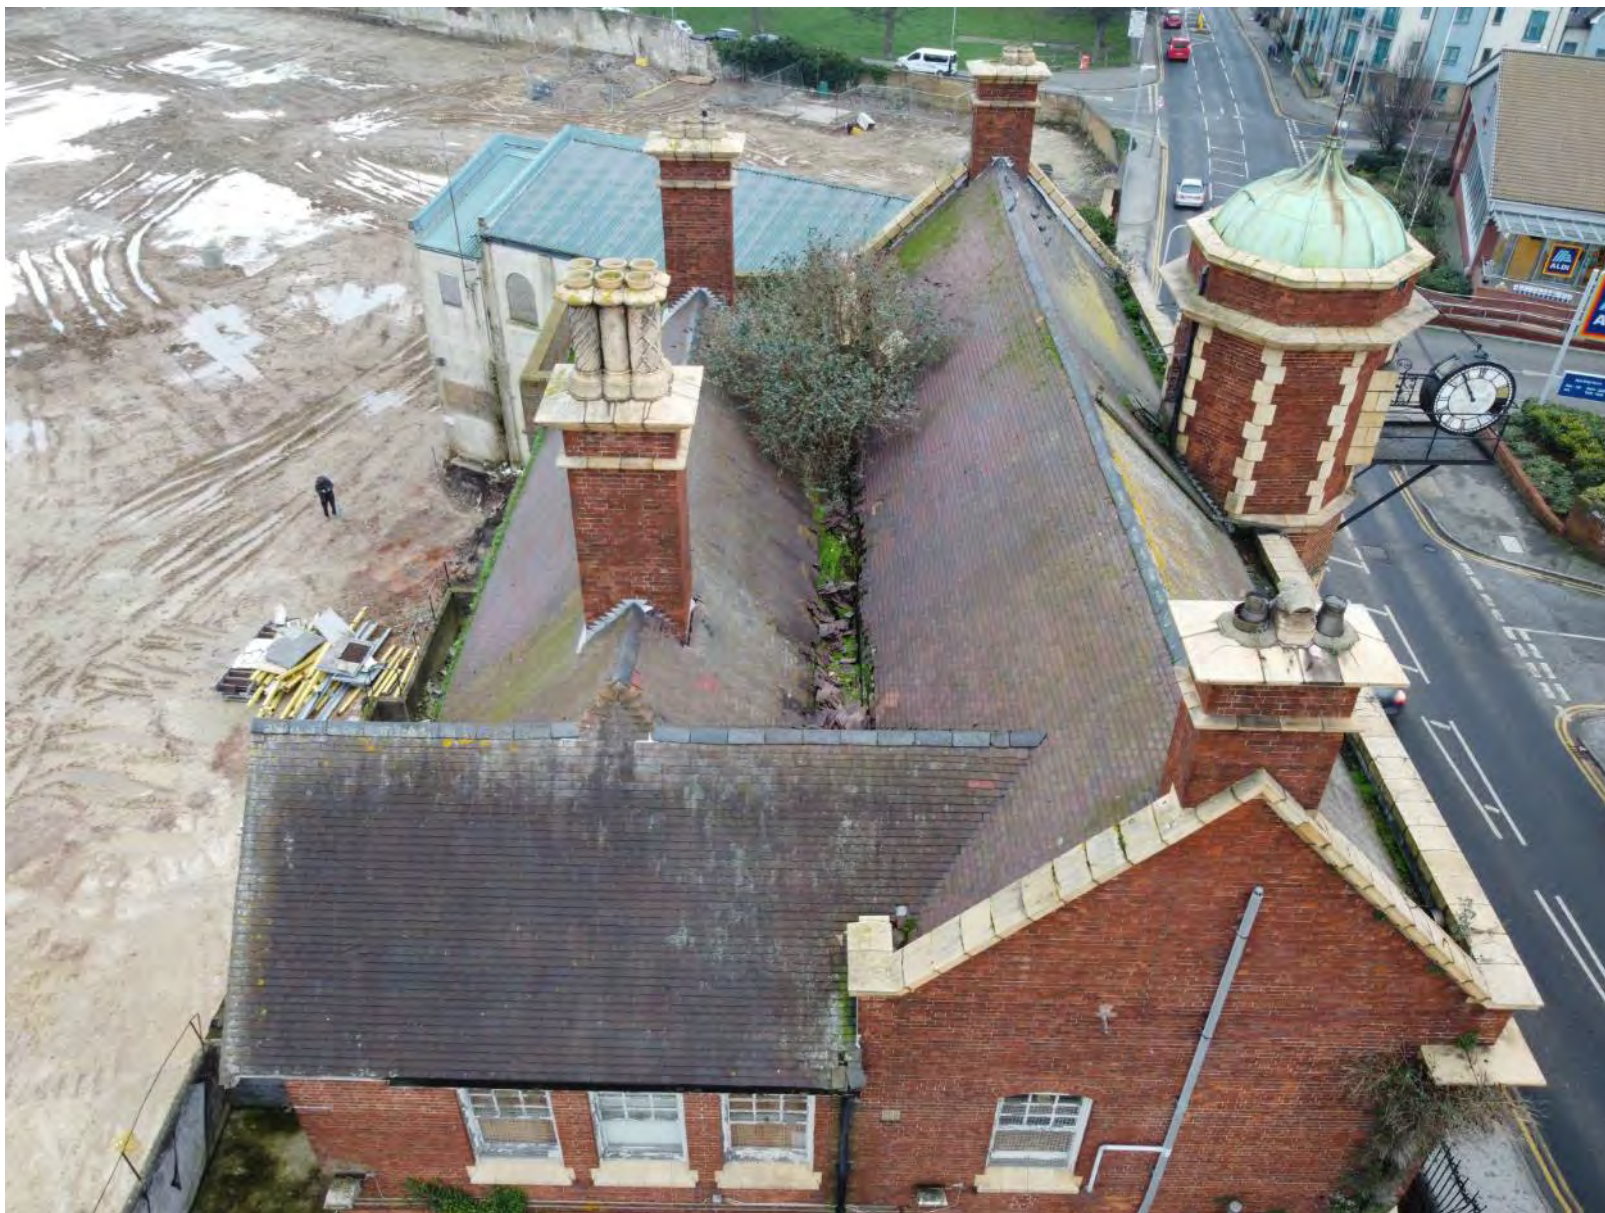
*Plate 24: Close up of Chimneys on eastern side ( December 2020)*

- 6.1.3 The ornate chimney pots that remain are on just one stack. Ornate chimneys began from the Regency period through to the end of the 19<sup>th</sup> century especially revived in the 1830s and 1840s as part of the Gothic Revival. These Gothic Revival designs were loosely based on chimney designs from the 16<sup>th</sup> and 17<sup>th</sup> century houses. These chimney pots tended to follow regular designs with spirals and the fleur de Lys and common patterns used as seen in other Gothic Revival examples from the 1840 -1860s (plates 50 & 51).

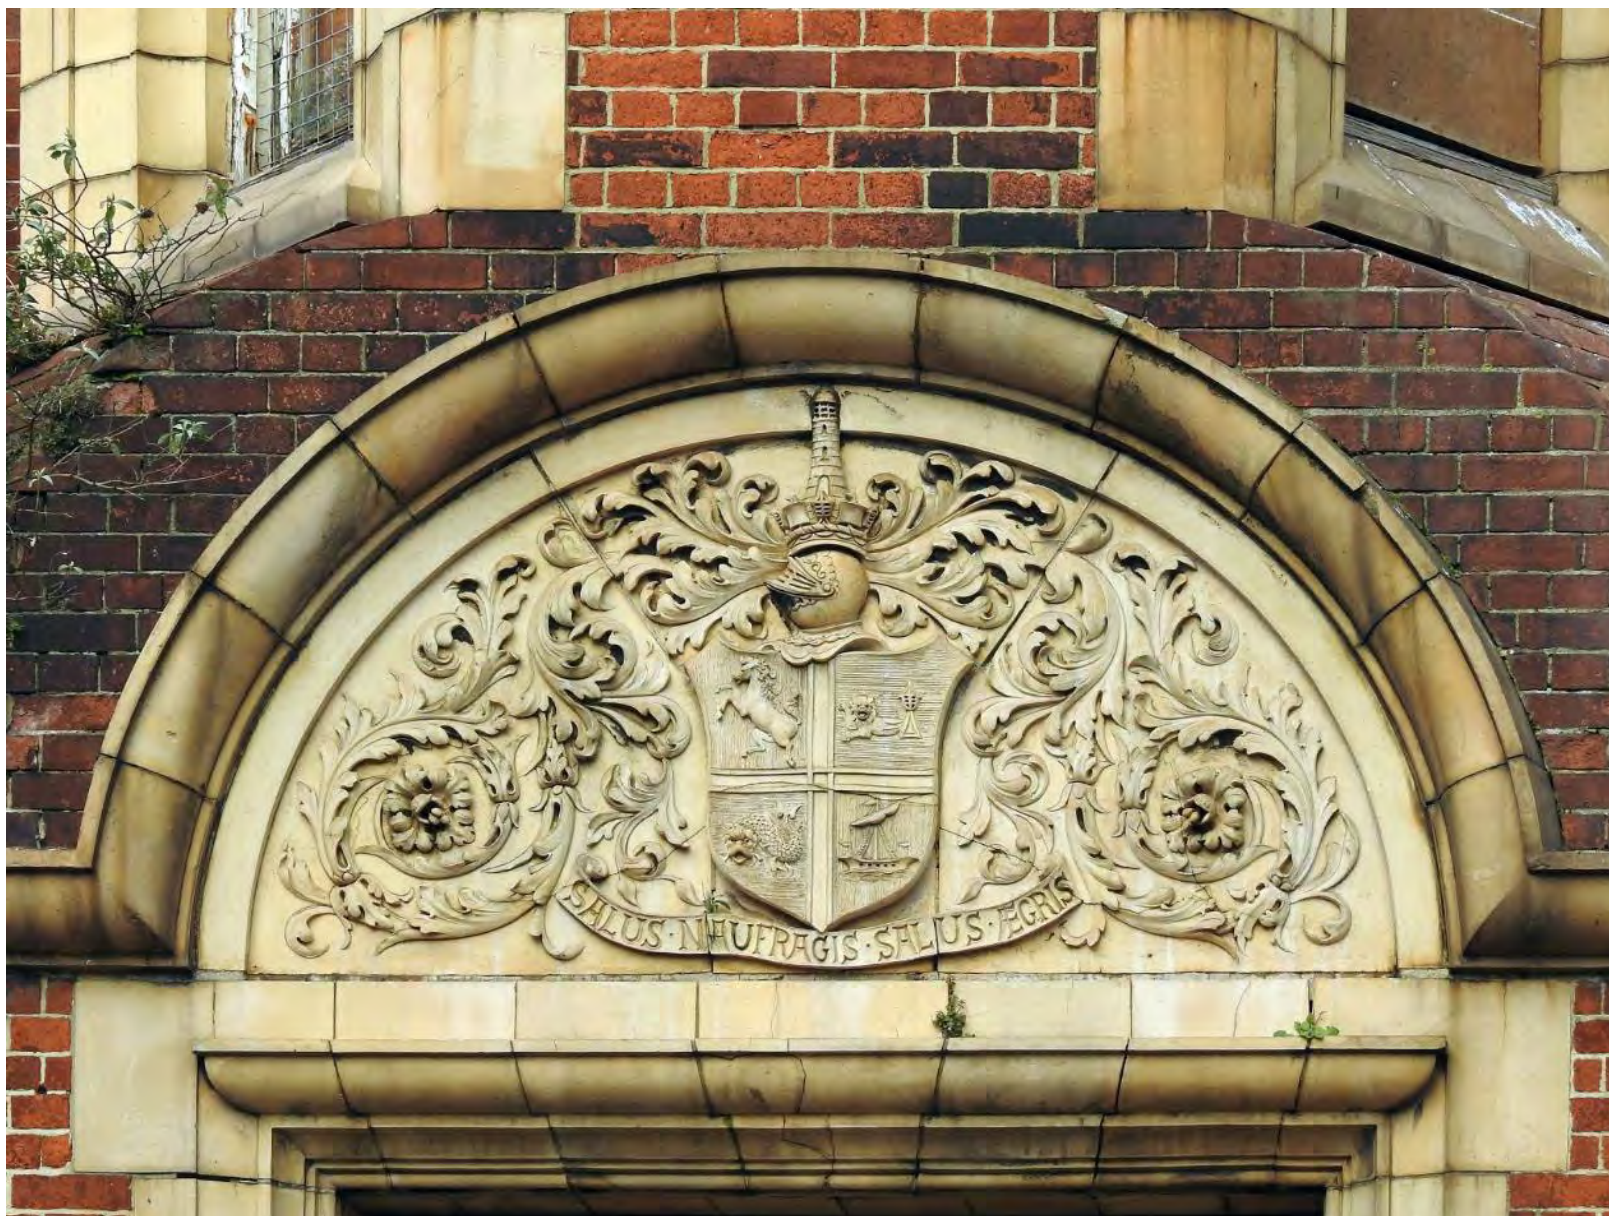
*Plate 31: Ramsgate Corporation coat of arms above the door (December 2020)*

- 4.1.5 The Ramsgate corporation coat of arms remain in relatively good condition although vegetation is growing out of a couple of the terracotta mortar joints (Plate 31). The arms originally joined from three pieces shows evidence of cracks in the terracotta. The styling used in the coat of arms is recognisably that of Ramsgate, but each slightly differed in their design of the individual elements. The balustrading/handrail to the entrance steepers was installed in around 1993 based on a planning application. (L/TH/93/0871)

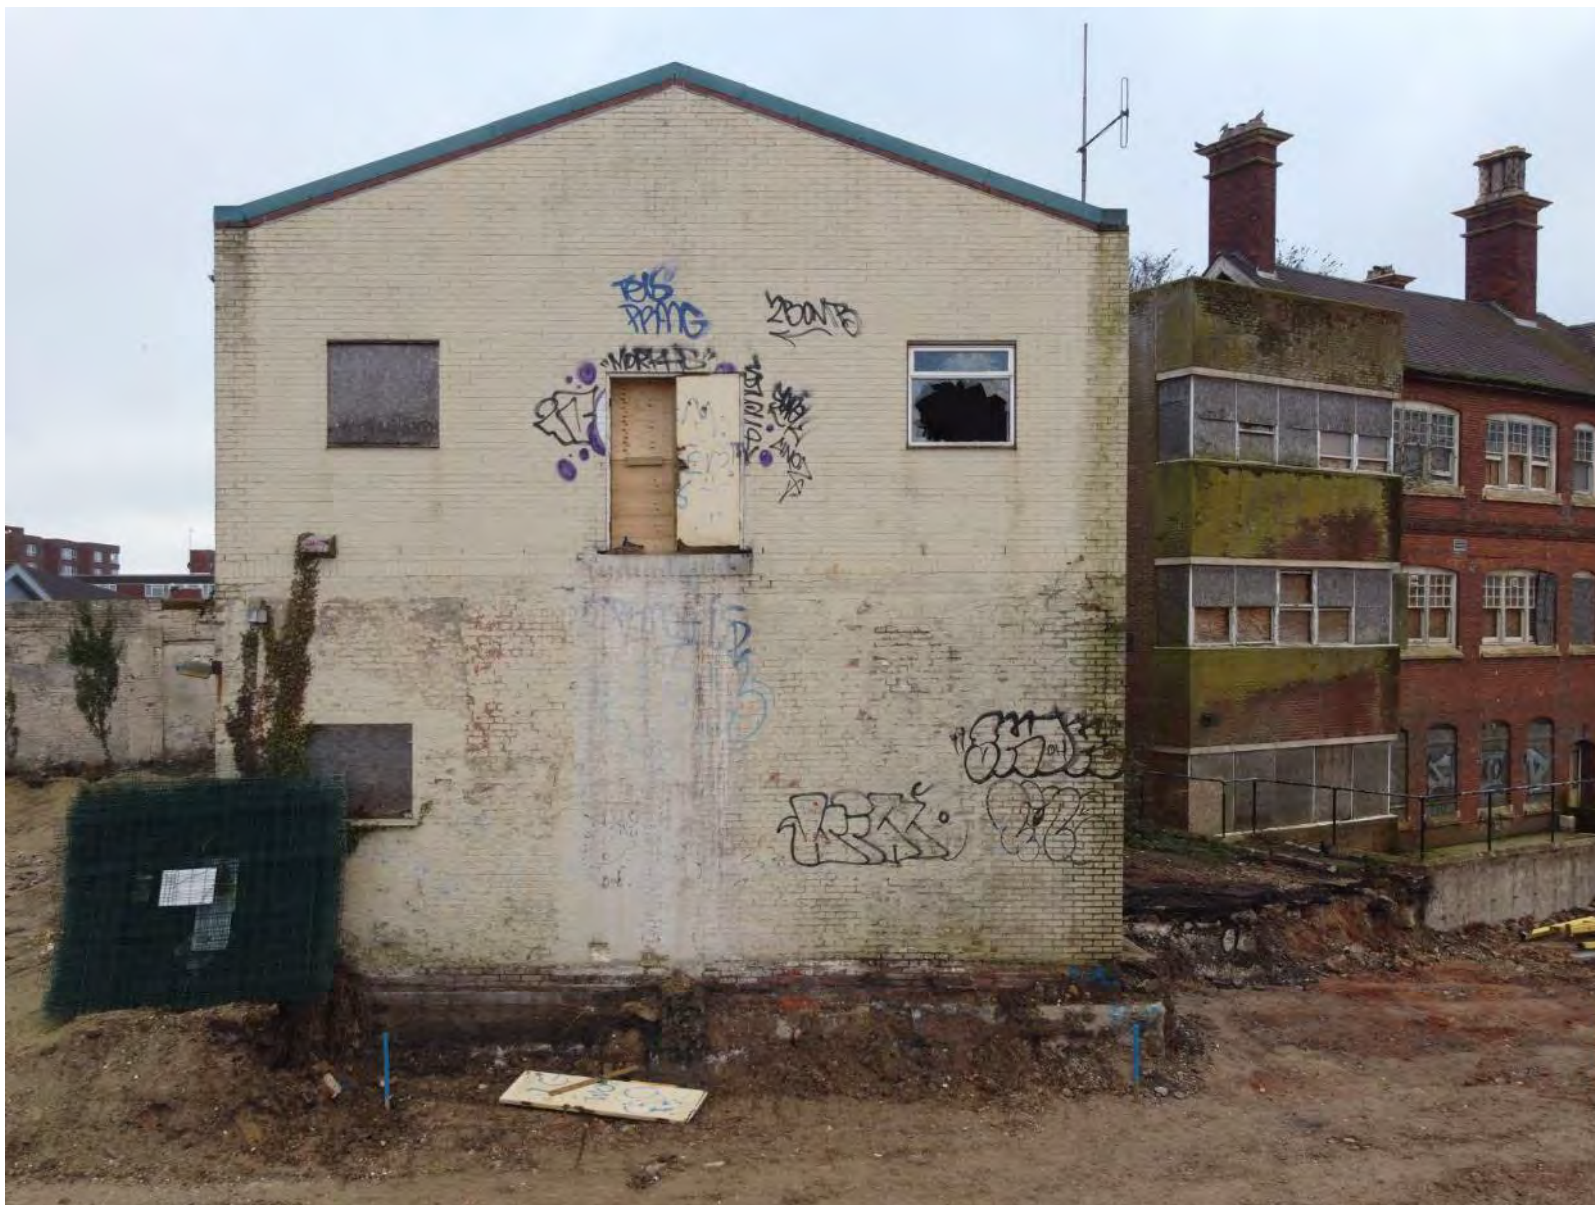
*Plate 41: Adjoining building, northern side (December 2020)*

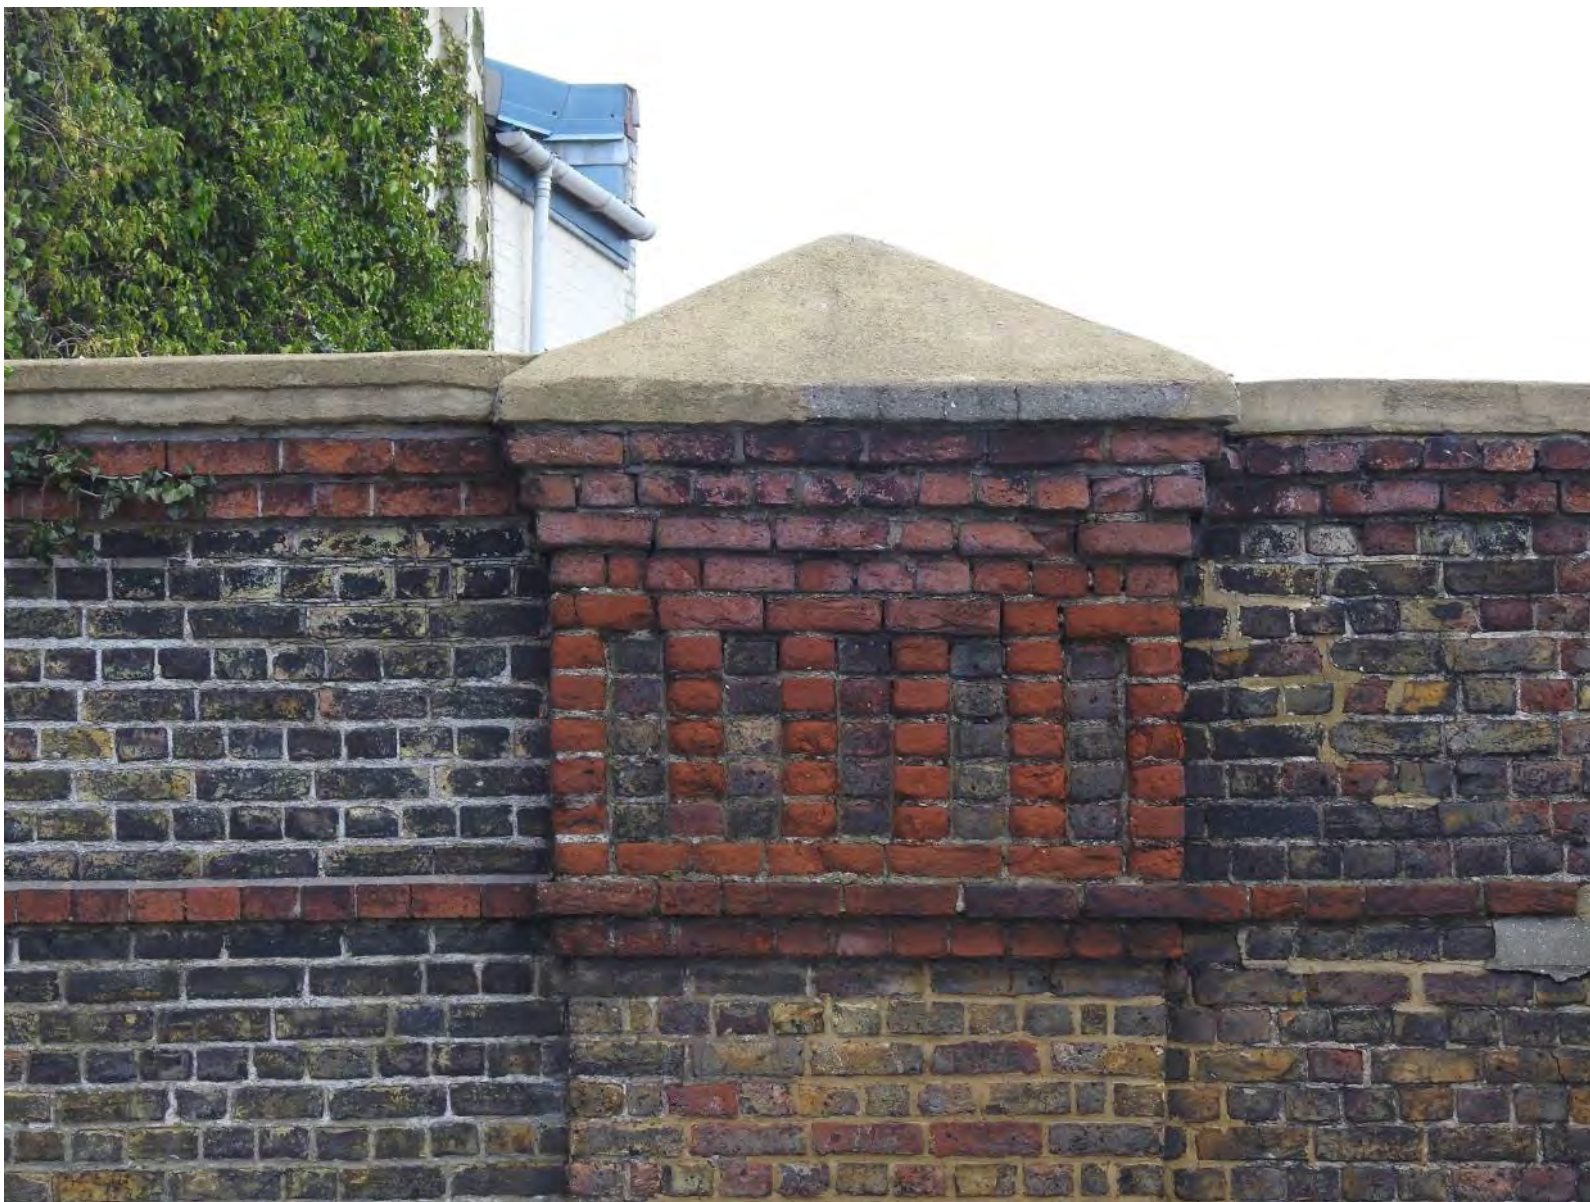
*Plate 46: Corner of wall by south western corner of the main building, scale 1m (August 2021 facing NW)*

4.1.13 The walls were recorded in plates 43-49. Section 1 is to the west of the main building up to the south western corner and included gates and pillars. Section two is to the east of the main building to the second opening. The remaining walls associated with the Ramsgate Gas works has been subject to a separate condition survey as part of planning application F/TH/19/0709.

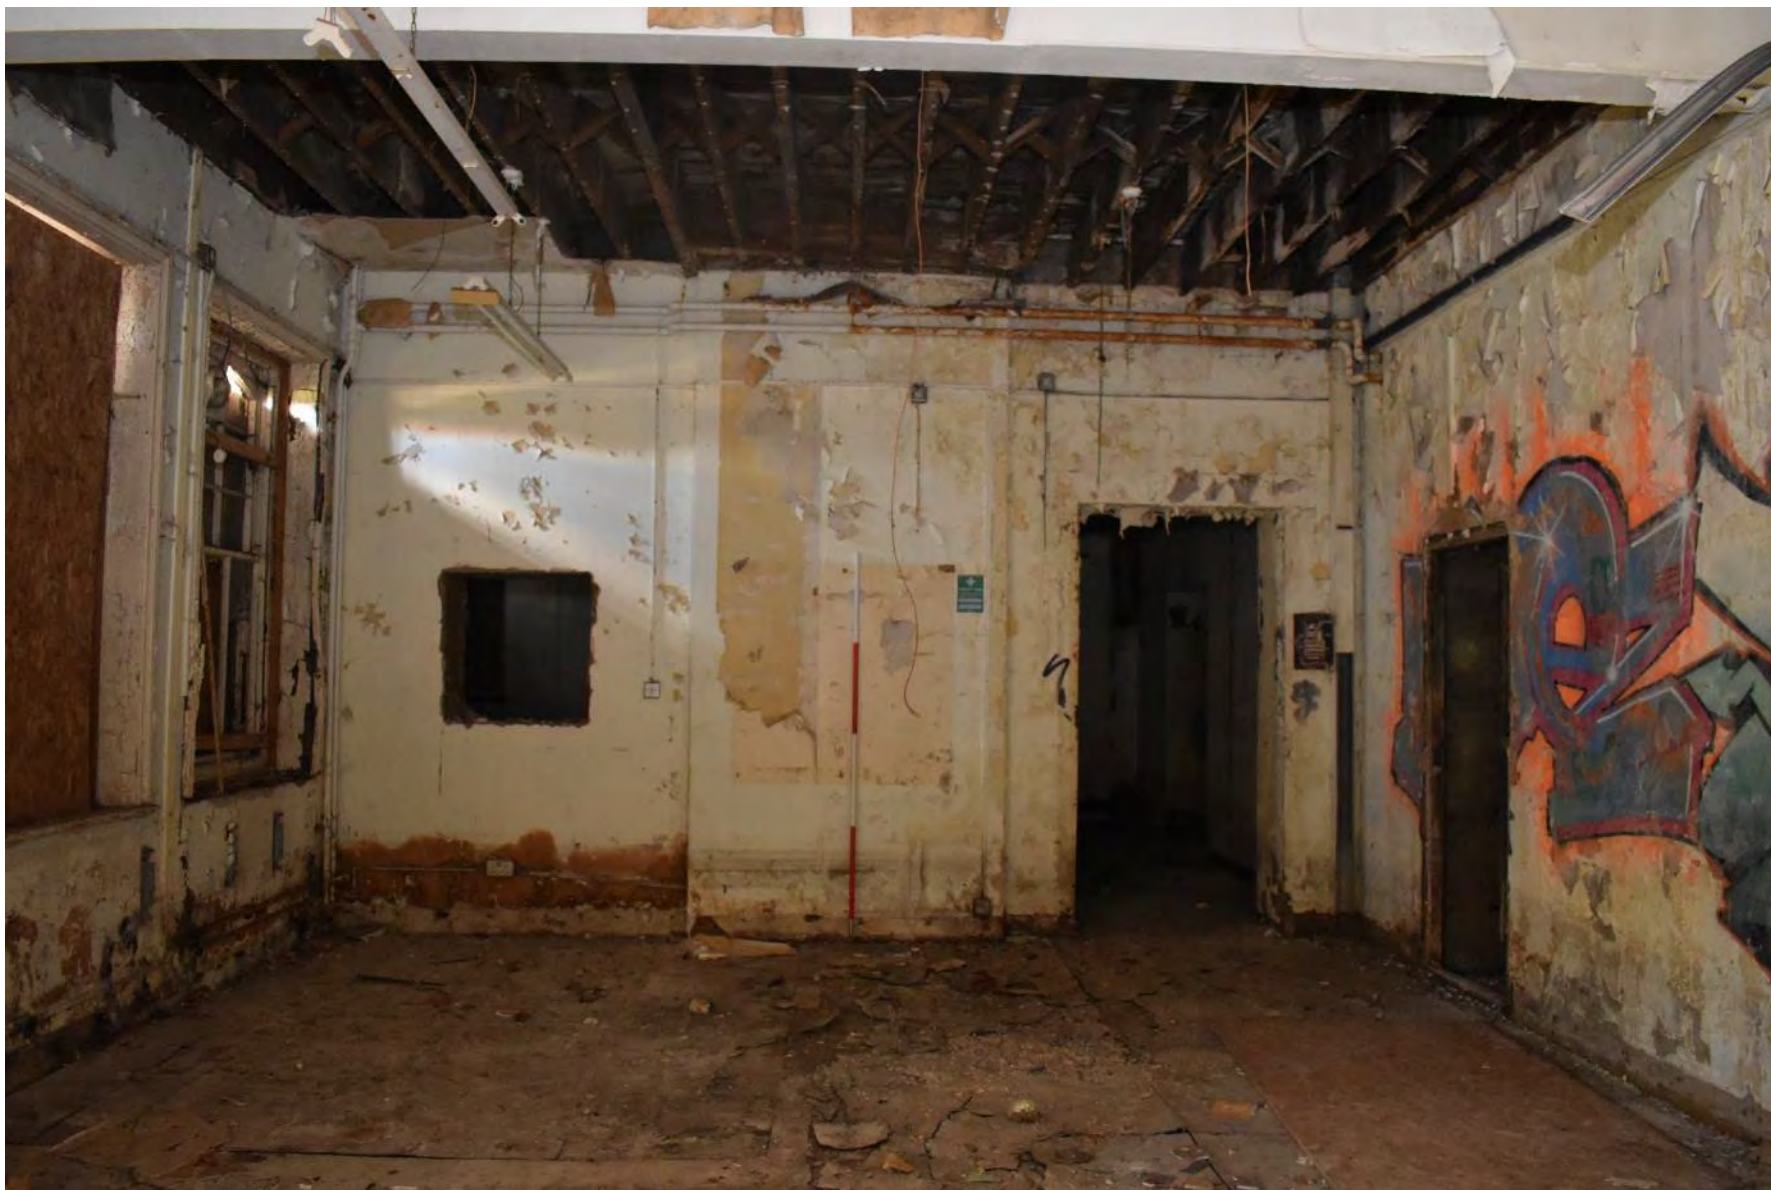
*Plate 67: Room D (August 2021 facing E)*

- 5.1.5 Room D had in the north western corner the doorway to the rear exit which was arched and had a pair of wooden plank doors and square moulding surrounding the door that matched the window moulding. At the eastern end of the room, was a boarded up chimney breast. On the same wall there was a large square opening into the room to the eastern. The plaster and lath ceiling had fallen and remains of hanging strip lights were in place. The moulding around the four windows were in place although the easternmost window moulding was in poor condition.

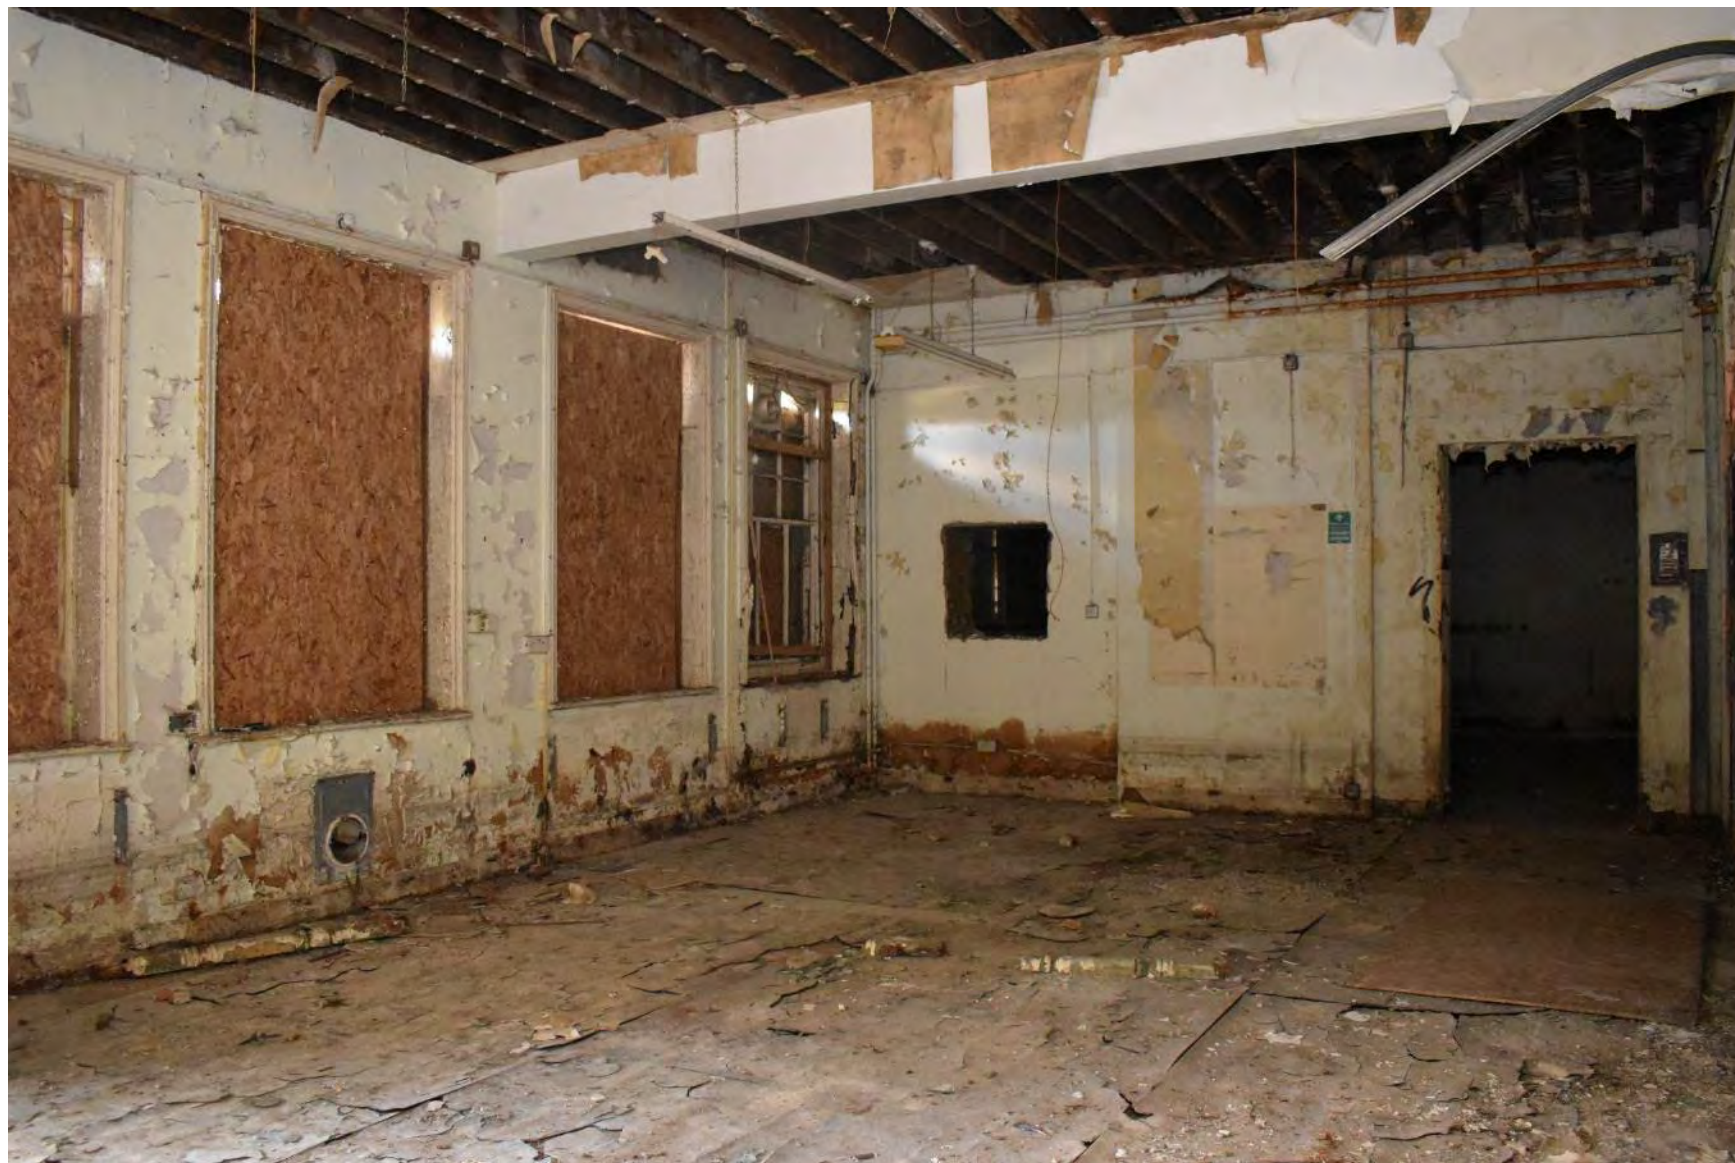
*Plate 68: Room D (August 2021 facing NE)*

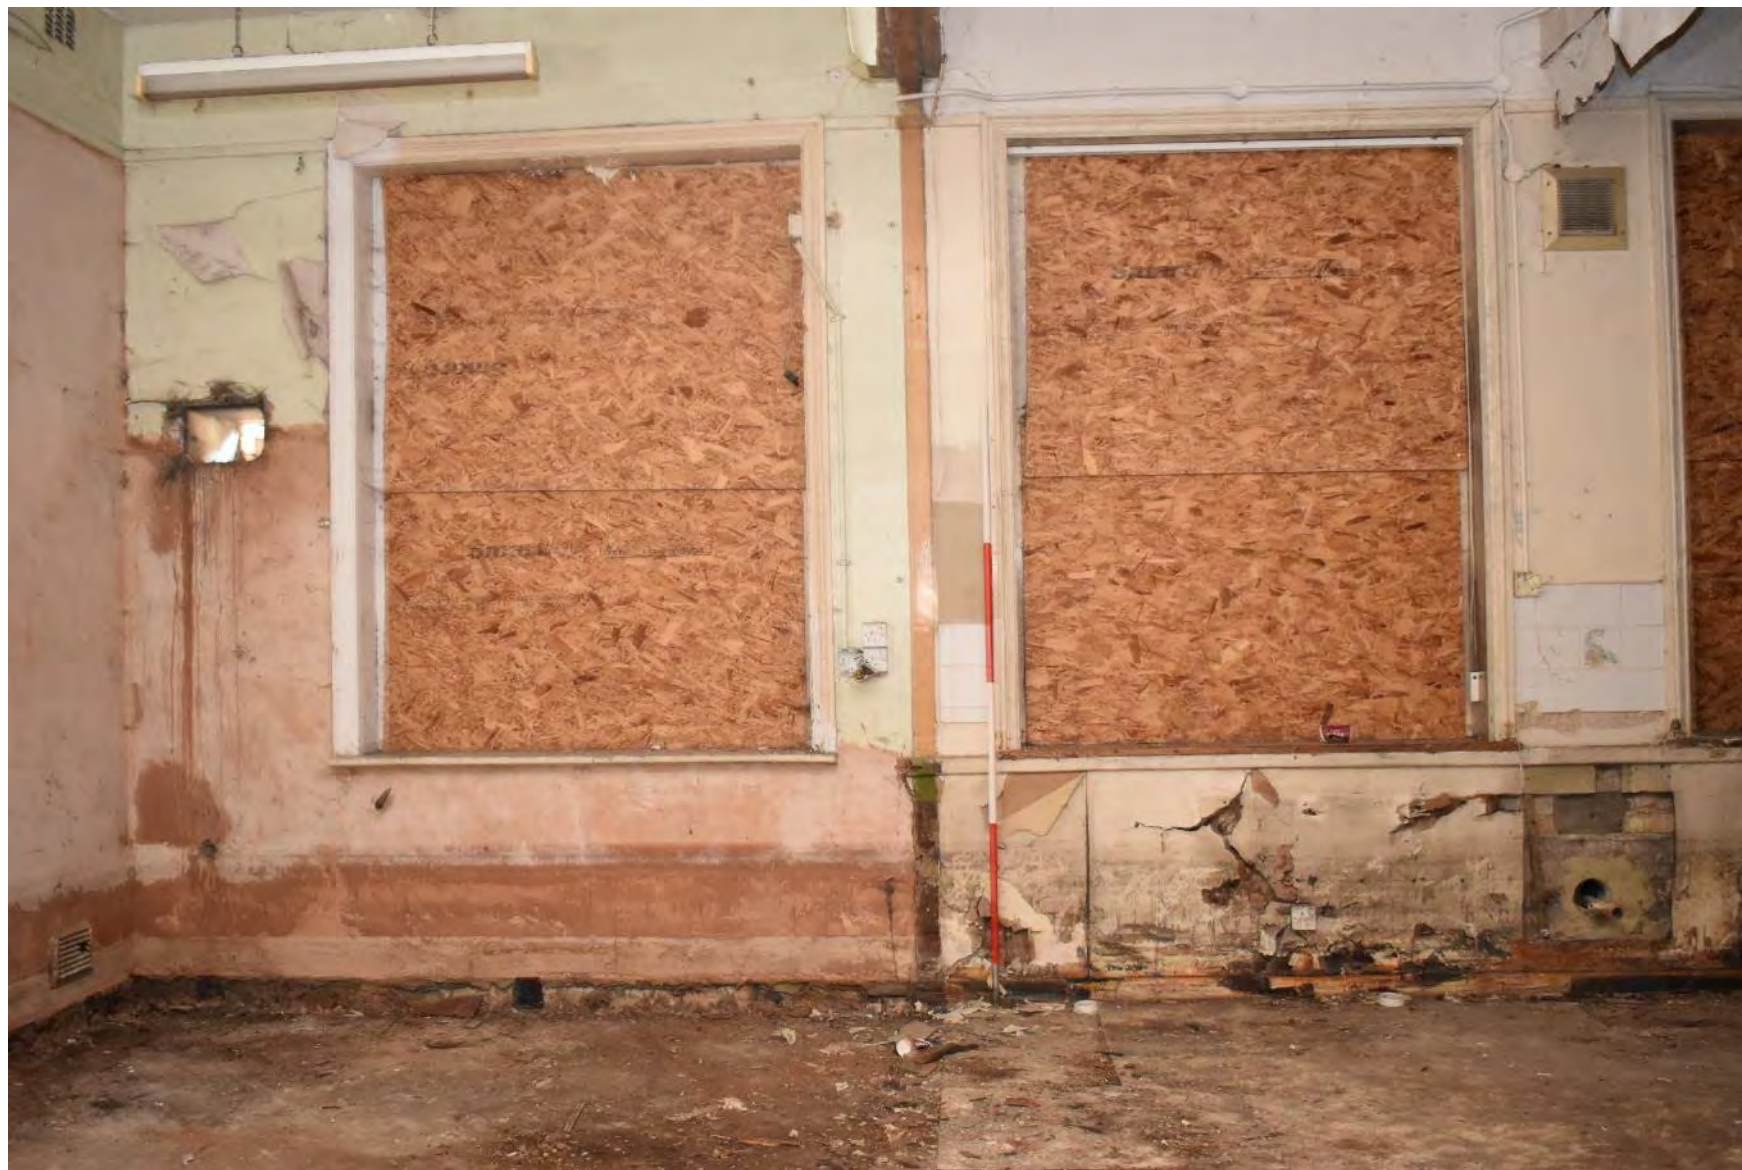
*Plate 78: Room G (August 2021 facing S)*

- 5.1.8 Room G has three windows with their surrounding mouldings. There were evidence of earlier partions within the room that had been removed. The ceiling was degraded in places.

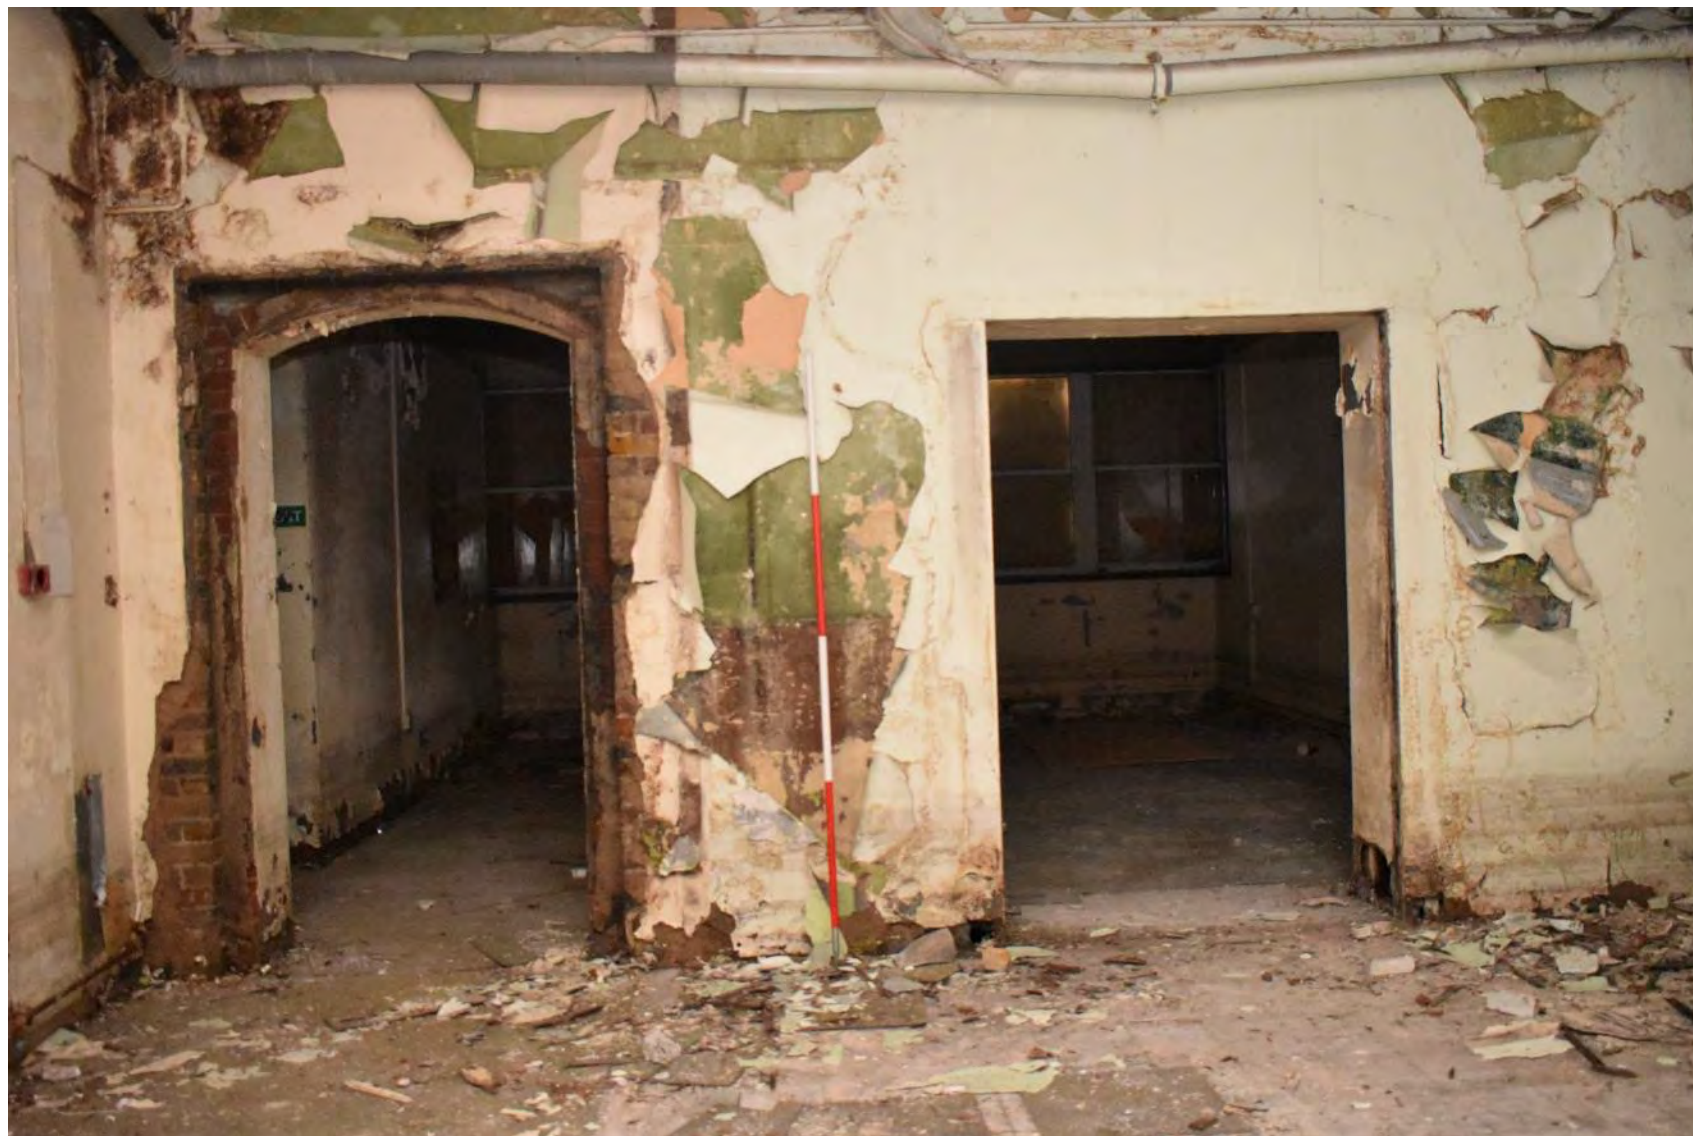
*Plate 79: Room G (August 2021 facing N)*

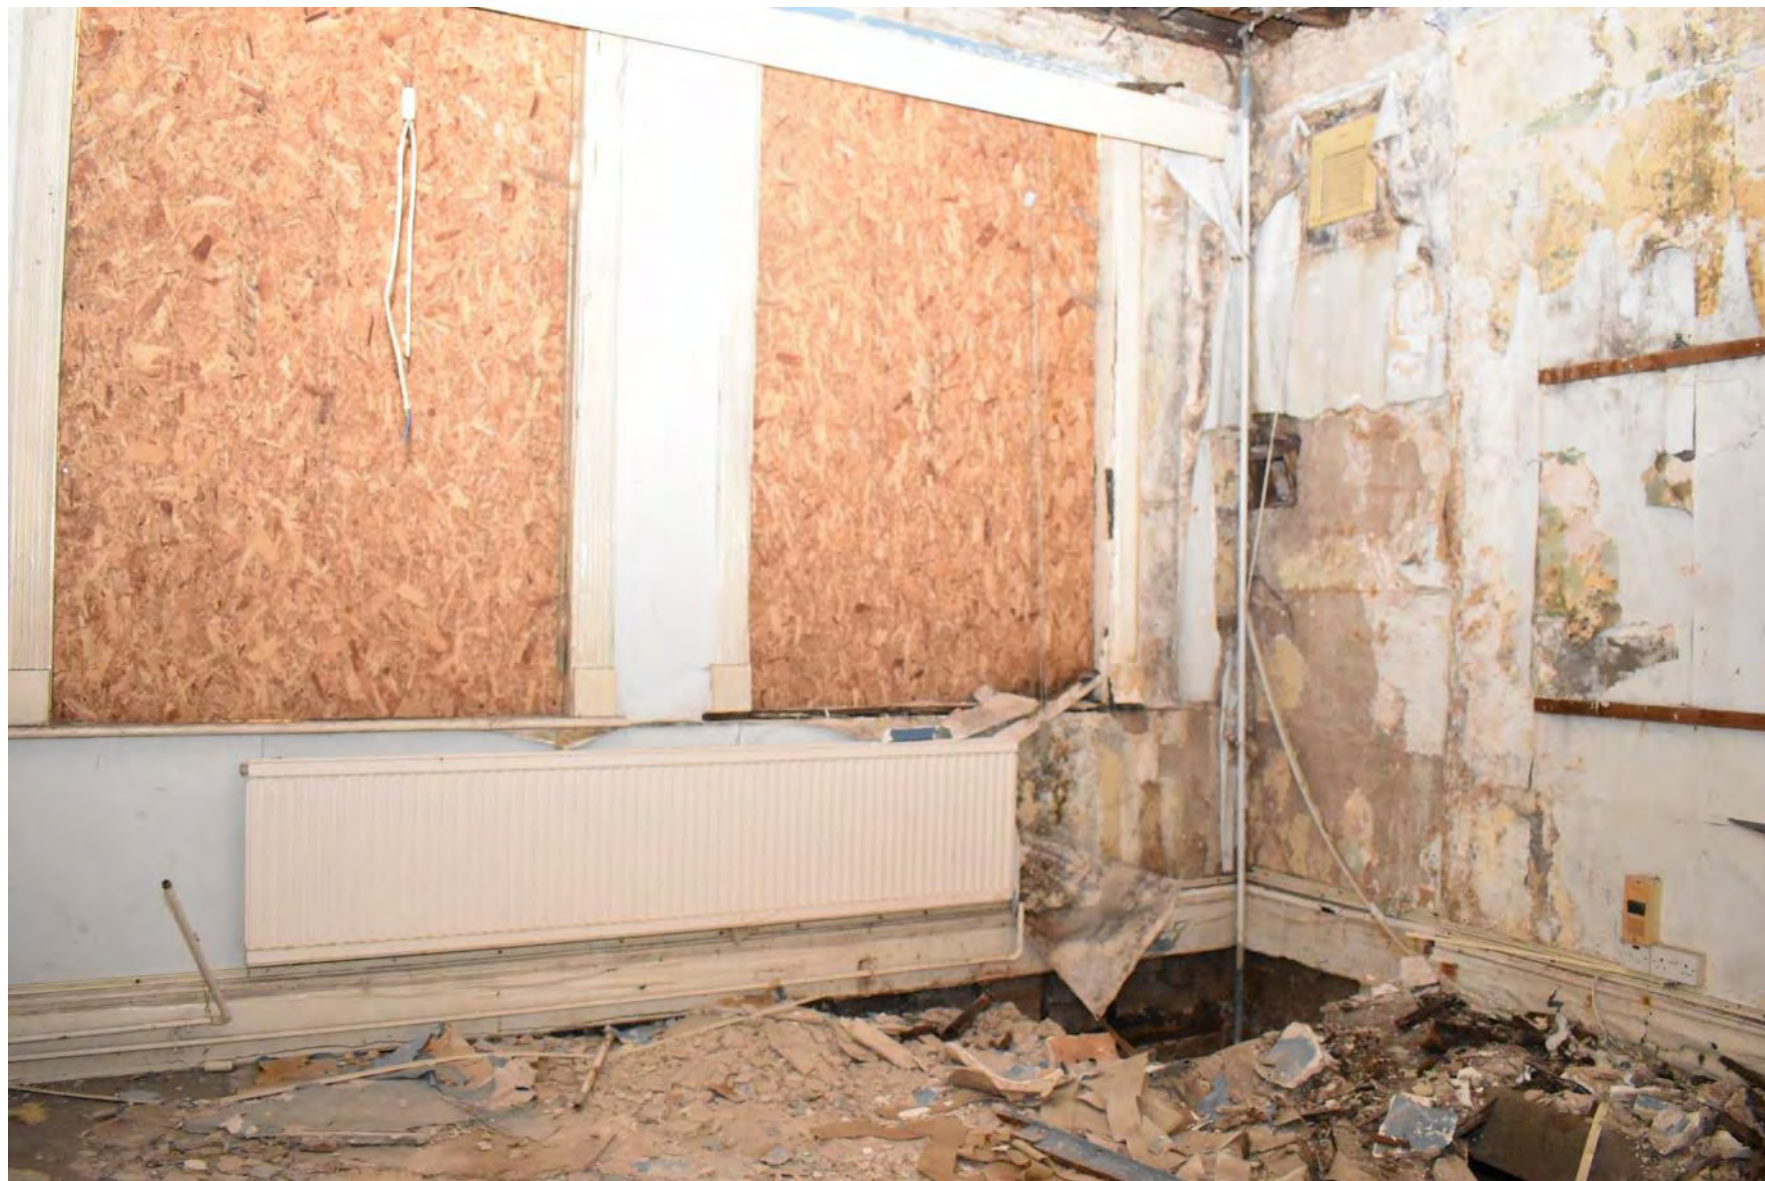
*Plate 91: Room K (August 2021 facing SW)*

- 5.1.12 Room K was viewed from the doorway due to the poor condition of the floor. The room contains two windows with more elaborate moulding surrounds than seen in the basement windows. The skirting remained in this room.

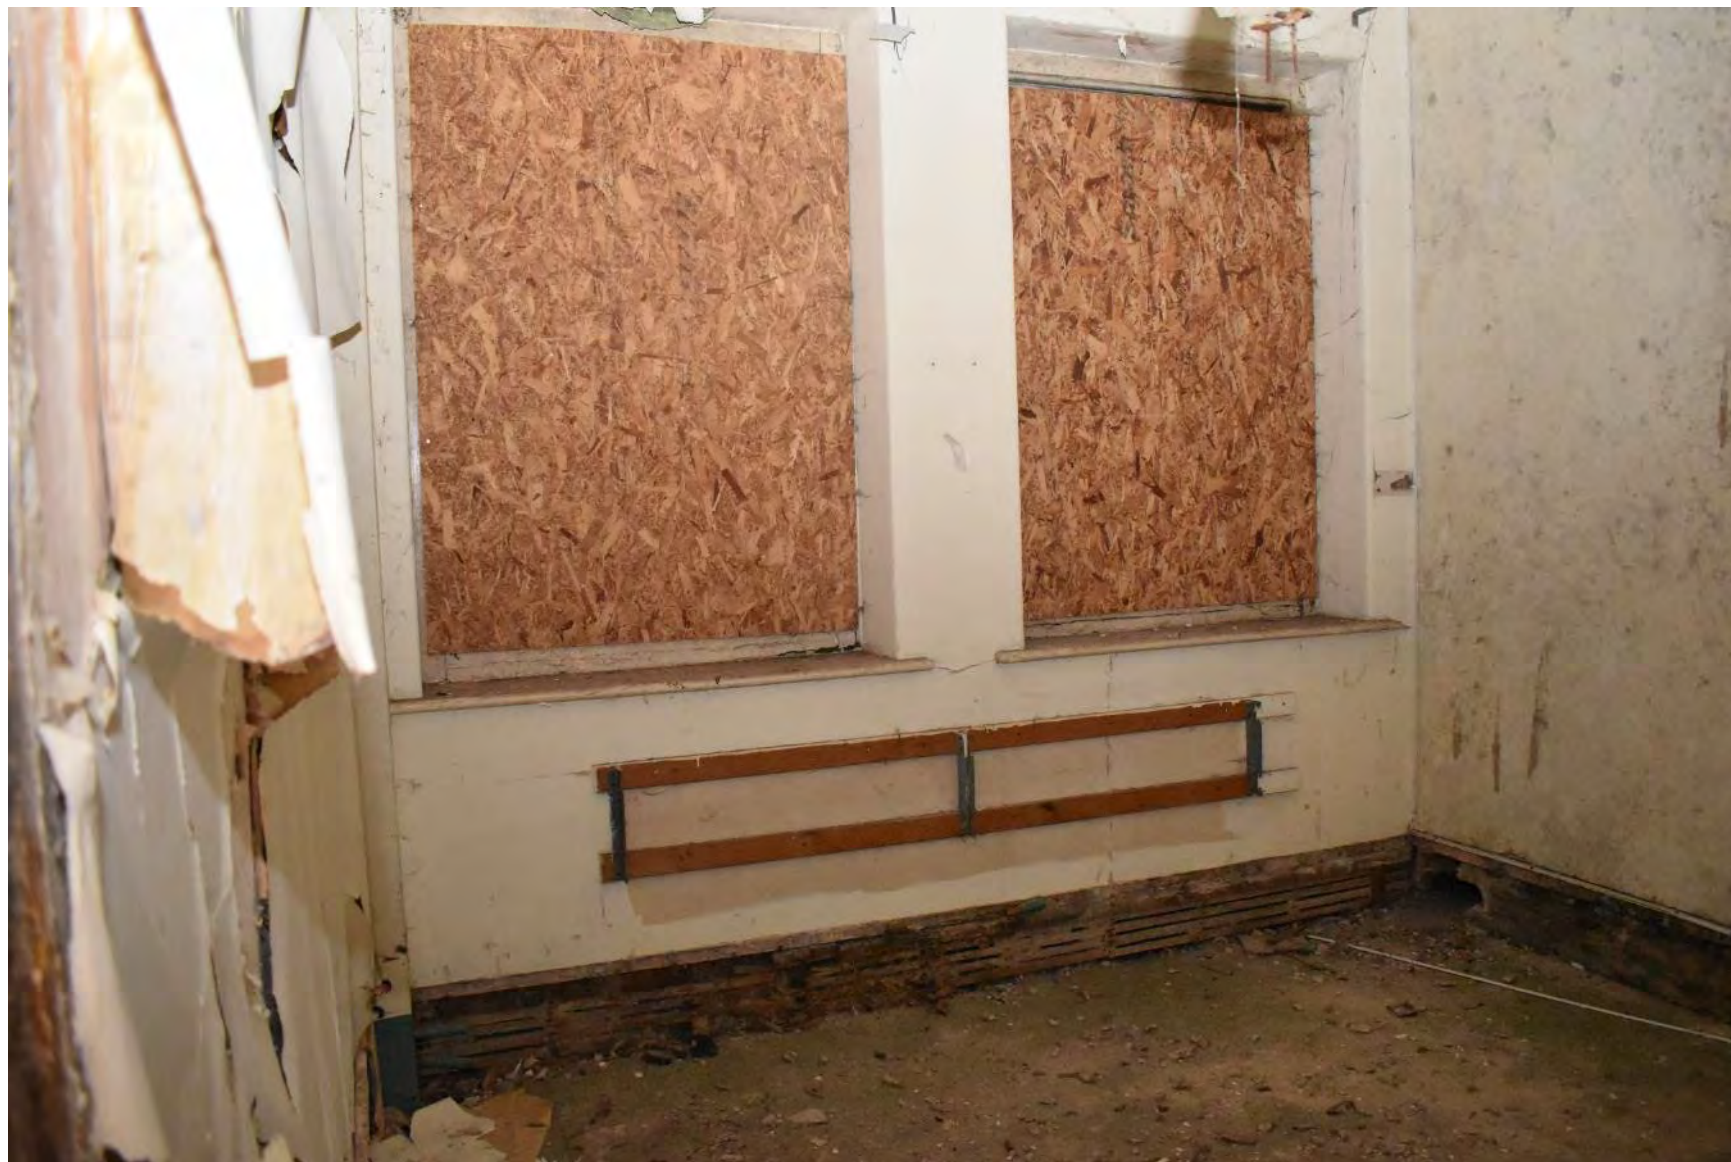
*Plate 93: Room L (August 2021 facing NW)*

- 5.1.13 Room L was also viewed from the door due to the poor condition of the floor. Two windows were in place but did not have any moulding surrounds. Plaster had been lost from the ceiling exposing the lath, although the ceiling rose remained. The skirting was not in situ, but a picture rail was. A blocked up chimney breast was on the eastern wall. It was not possible to view the room beyond to the north of this room. However, given the floor plans in this area in other floors it is likely that the dividing wall in Room L and the room beyond is a later addition.
