## HISTORIC BUILDING RECORDING OF THE OLD GAS WORKS, BOUNDARY ROAD, RAMSGATE, KENT

September 2021, updated December 2022

Report for Blueberry Development Estates Ltd

## **SWAT ARCHAEOLOGY**

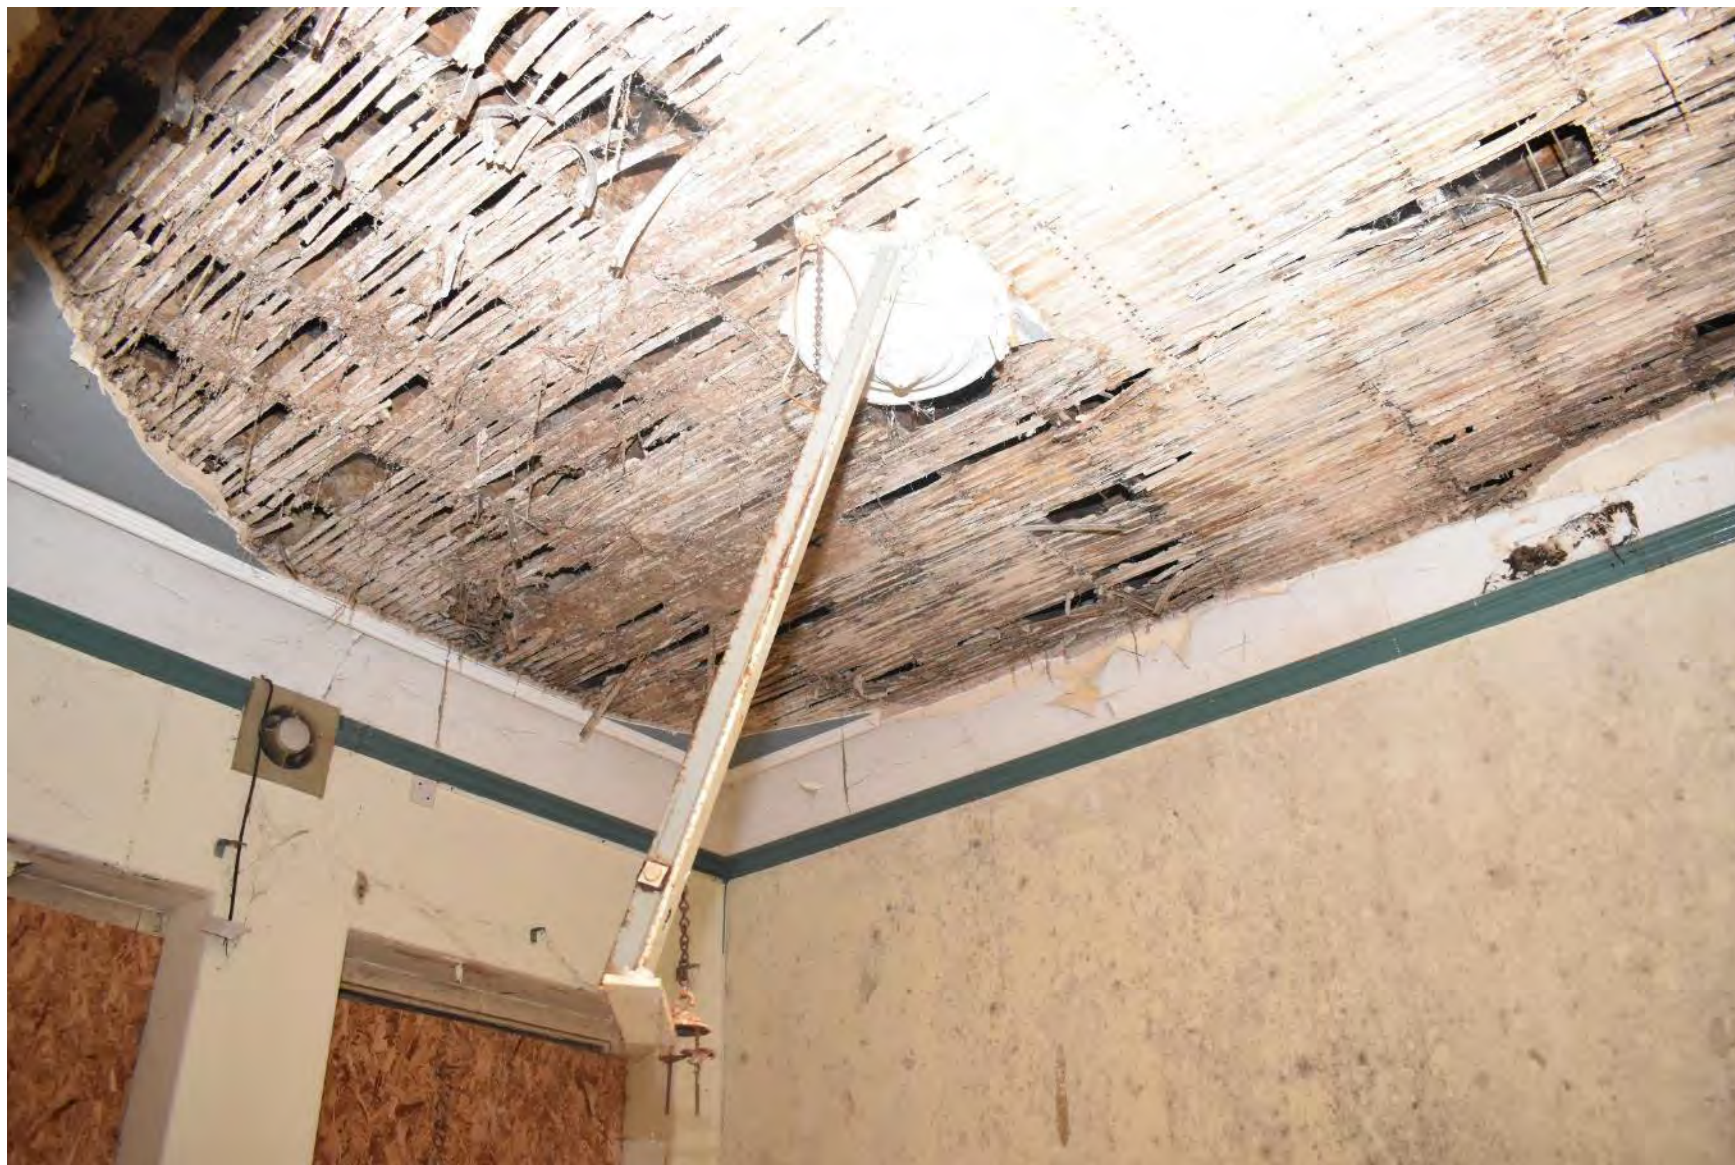
*Plate 94: Room L ceiling (August 2021)*

- 5.1.13 Room L was also viewed from the door due to the poor condition of the floor. Two windows were in place but did not have any moulding surrounds. Plaster had been lost from the ceiling exposing the lath, although the ceiling rose remained. The skirting was not in situ, but a picture rail was. A blocked up chimney breast was on the eastern wall. It was not possible to view the room beyond to the north of this room. However, given the floor plans in this area in other floors it is likely that the dividing wall in Room L and the room beyond is a later addition.

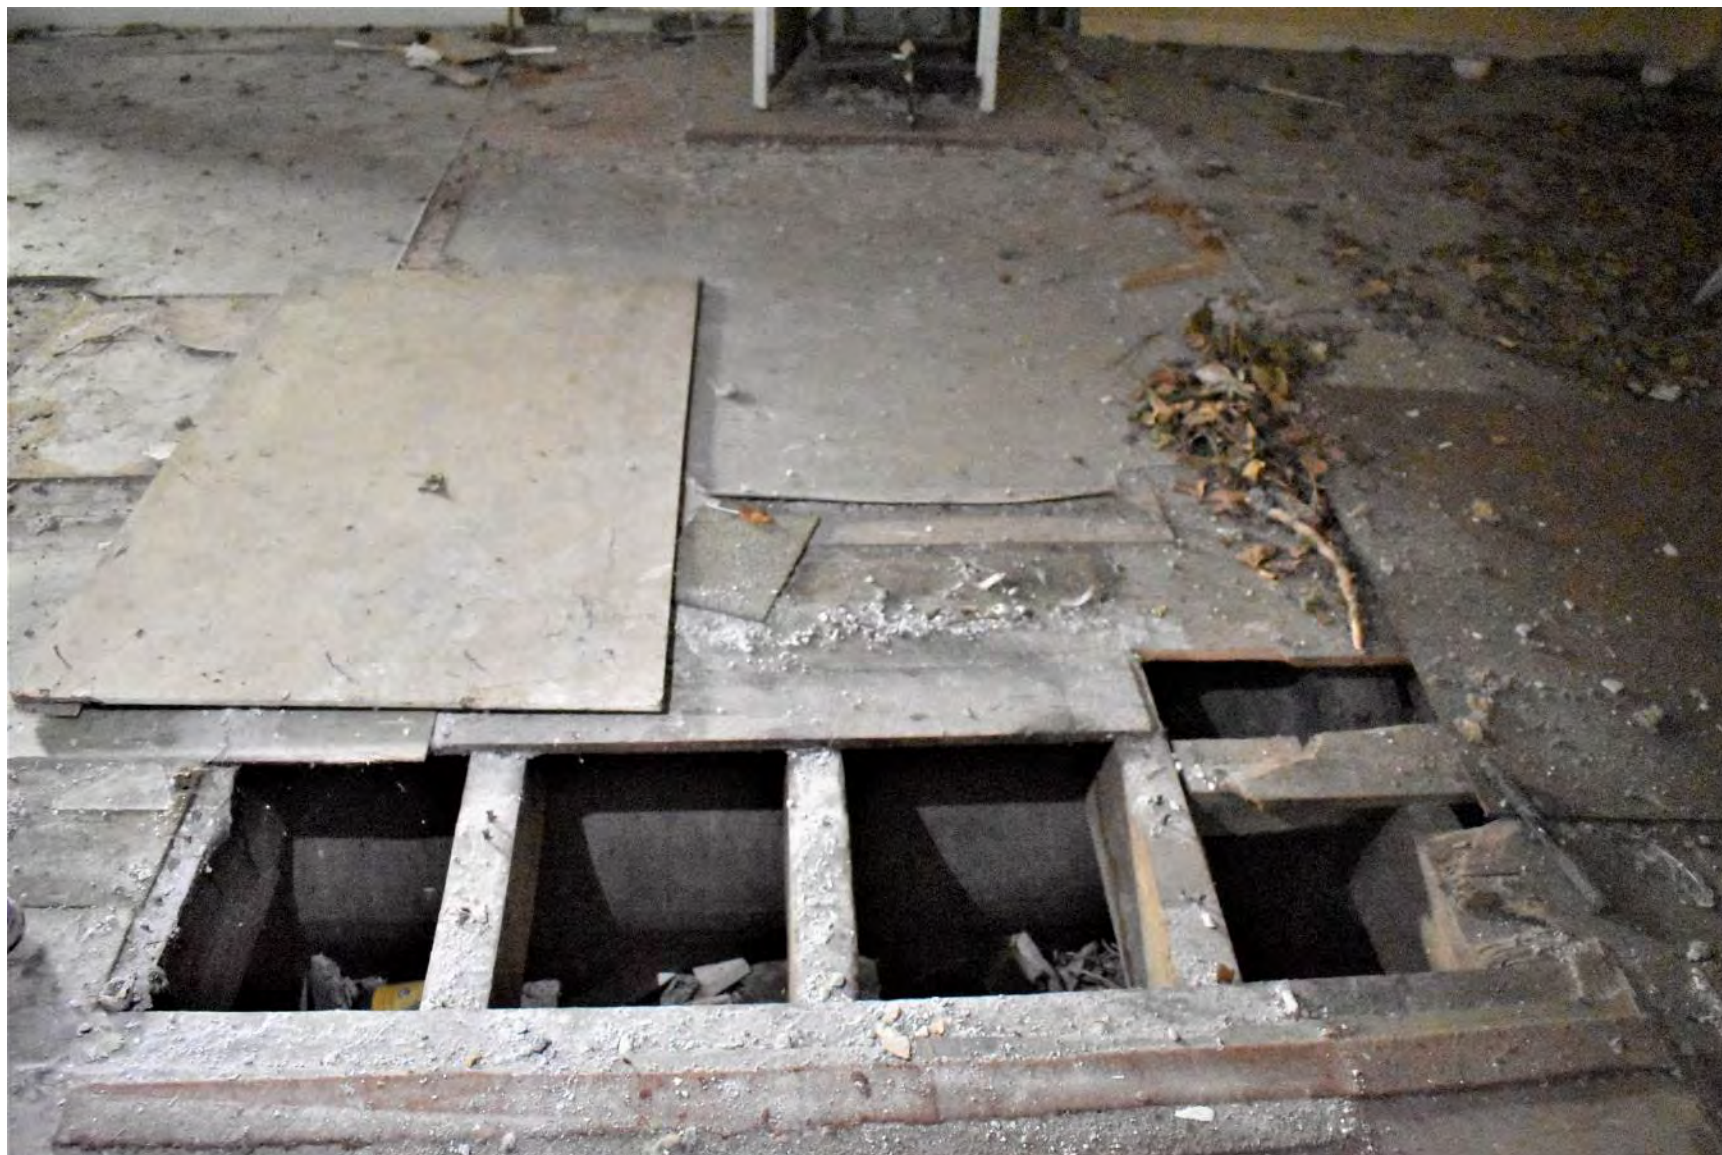
*Plate 131: Remains of a 2m stretch of mains gas pipe underneath the ground floor.*

- 5.1.27 The ground floor was accessed via the door opening in the eastern elevation. The ceiling is modern concrete supported on RSJ. The floor is wooden floorboards on wooden joists which is rotten in places. Plate 15 shows historically the wooden floorboards in place at the time in 1926. There is on the eastern elevation another doorway this is later as above the doorway can be identified the remains of a window arch (Plate 126). On the eastern elevation there are three original arched windows south of the doorway (Plate 126). North of the doorway the windows have been replaced with modern ones smaller in size than the original arched windows of which the original arch opening can be seen above the modern windows (plate 133). On the eastern elevation four modern windows have been added. Within the modern extension area (Plates 128-129), there is a single space also with window openings on the eastern and western elevations and one window in the northern elevation on the eastern side. On the southern elevation are two boarded up arched window opening. Along the eastern elevation internally it is not clearly possible to identify the attributes of what was originally the incorporated boundary wall. In the south eastern corner are tiled remains of a restroom and a modern boiler. Located underneath the floor boards in the northern half of the ground floor are the partially uncovered remains of a 2m section of large diameter gas pipe (Plate 131). The area of the underfloor pipe is not shown in the historical photograph of 1926 in Plate 26 being just off the photograph to the right. It is possible that the location of this section of pipe is depicted in red line on the 1951 plan (Plate 13) and is all that remains.

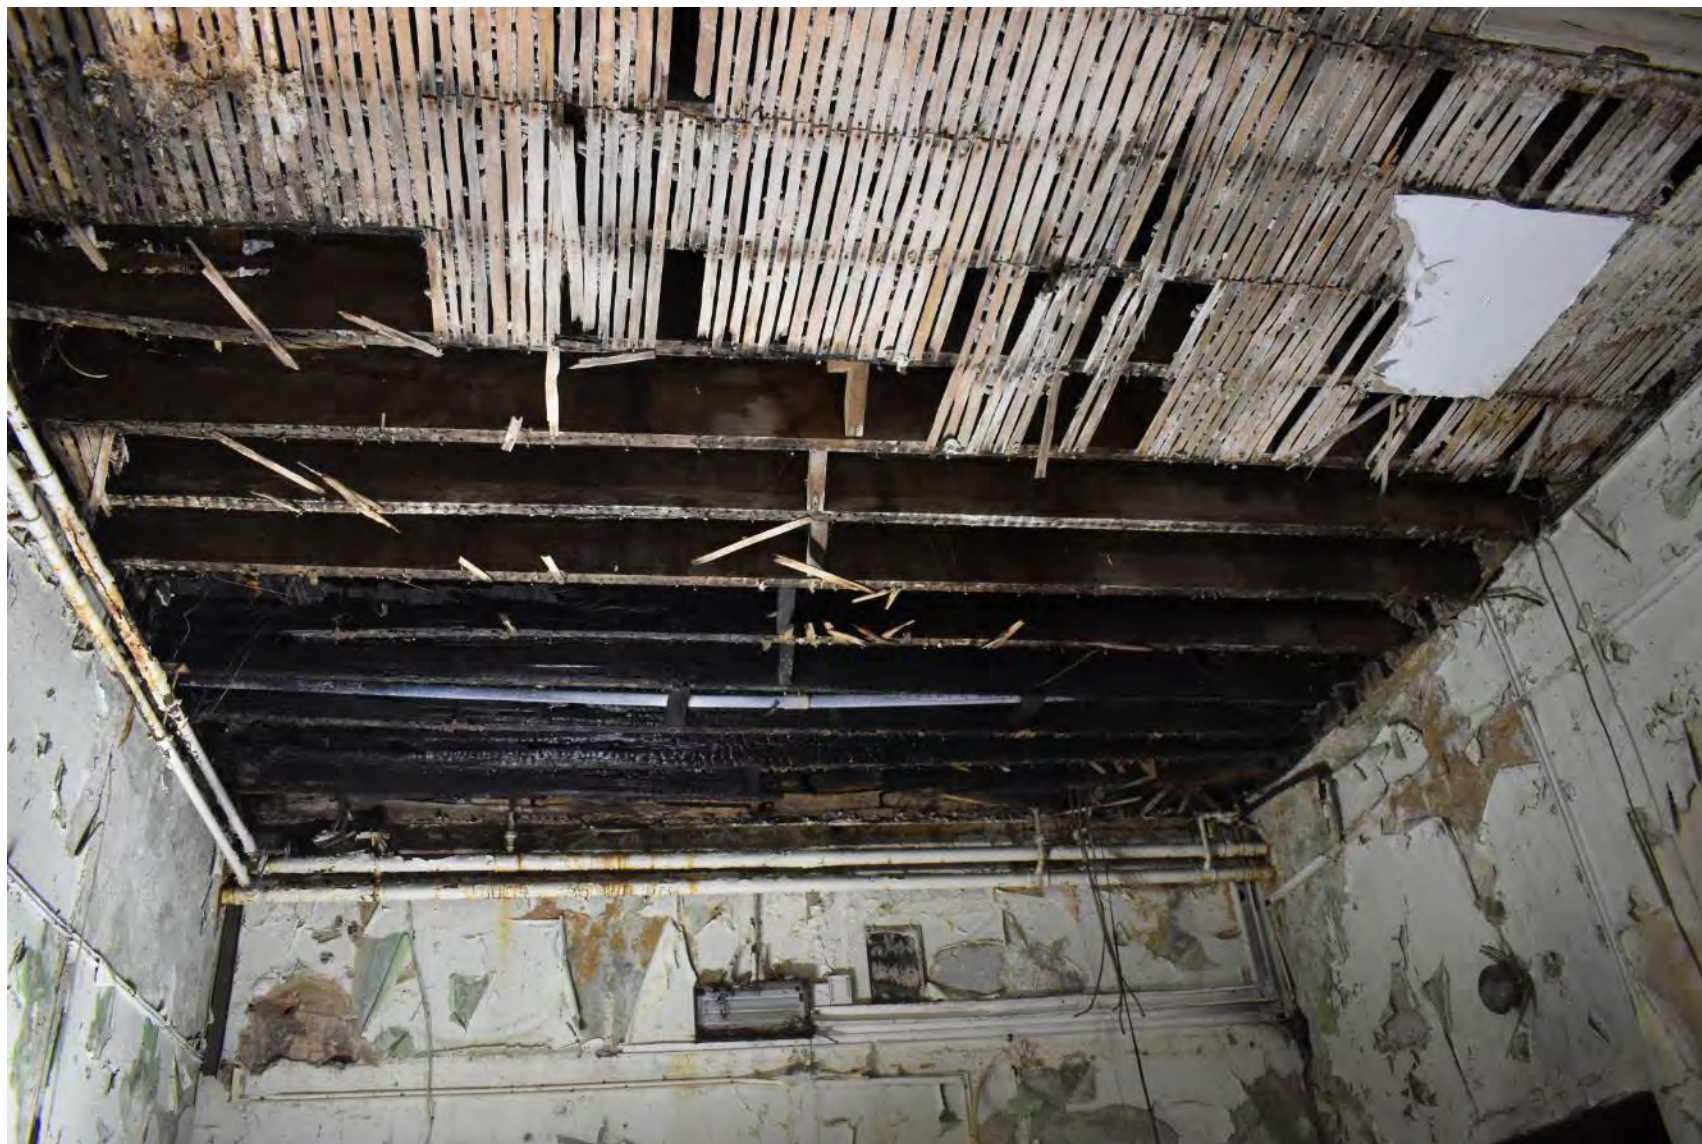
*Plate 137: Main Office, Basement, Room C ceiling*

- 5.1.24 The updated images are shown in plates 136 - 142. The applicant was informed by the fire brigade that the seat of the fire was on the ground floor at the bottom of the main stairs in Room I (Plate 140) and was caused by a portable bar-b-que. This had the effect of causing smoke and water damage as well as burning a number of flooring timbers of those between the basement ceiling and the floor of ground floor across a number of rooms as the fire travelled internally eastwards along the floor/ceiling area as seen in Plates 136 -140, where the charred beams can be seen.

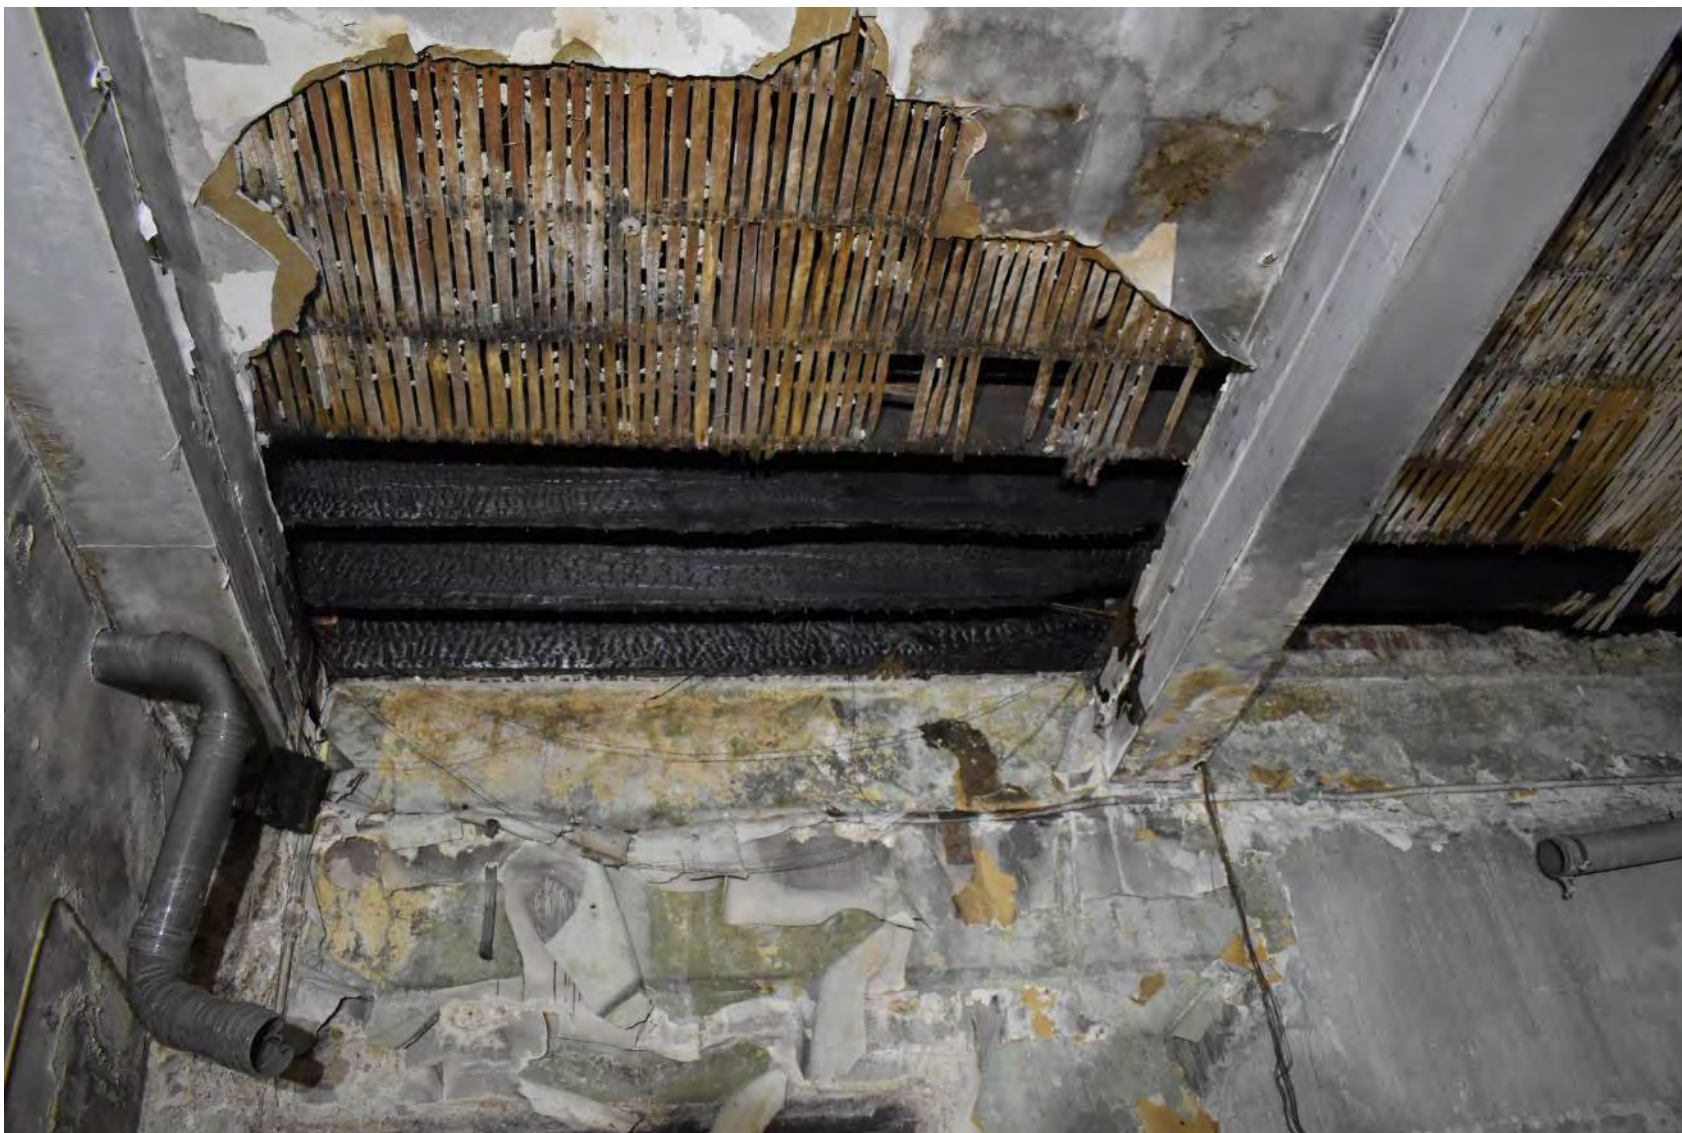
*Plate 138: Main Office, Basement, Room G ceiling*

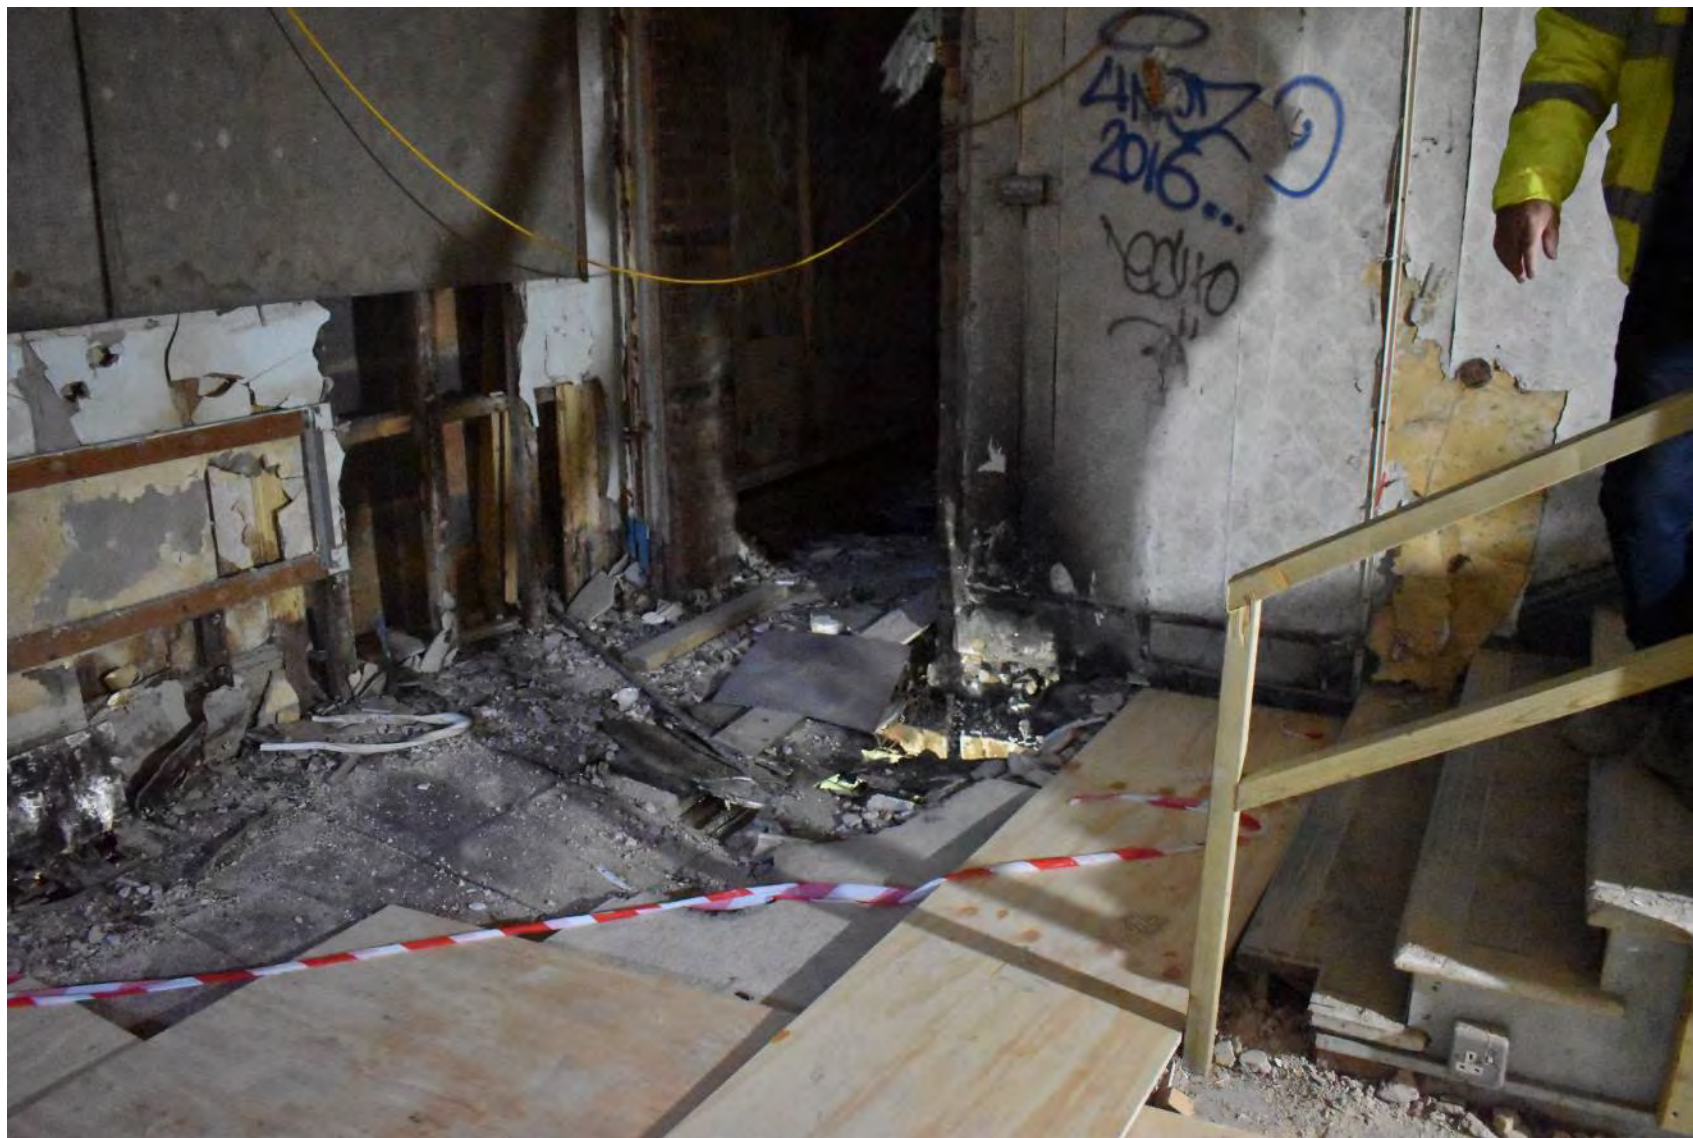
*Plate 140: Main Office, Ground Floor, Room I, source of fire (December 2022, facing NE)*
