Archaeological Watching Brief at MAIDSTONE GRAMMAR SCHOOL, BARTON ROAD, MAIDSTONE, KENT ME15 7BT

NGR: 576608 154743 Site code: MGS-WB-22 Planning reference: MA/21/502002

Date of report: 13 April 2022 Revision **1.0**

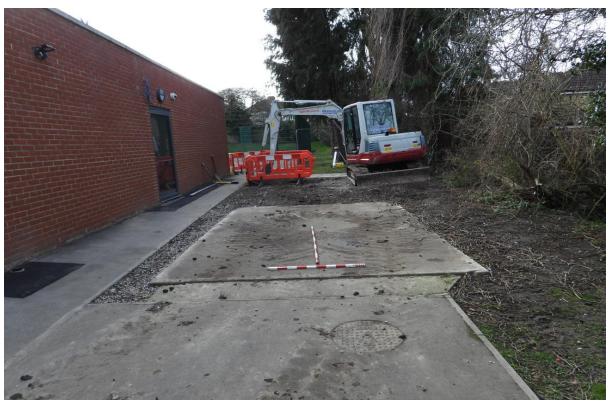
Plate 3: Excavations at western side of the pavilion. Looking south with one- and two-metres scales.

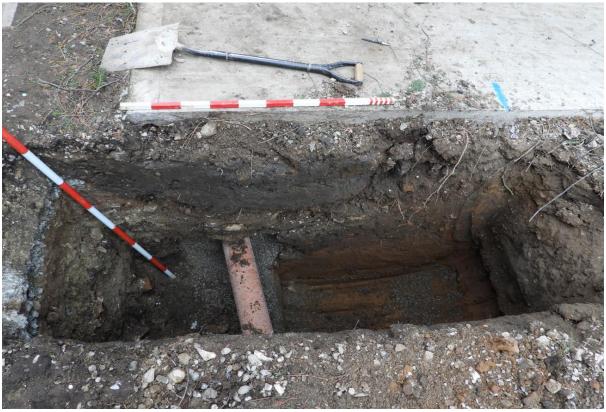
- 9.3 Trenches excavated at the western side of pavilion to the depth of 1.9metres has exposed a sequence of modern made-up deposits contained large plastic pipe laid on the shingle. Natural geology was exposed below 1.6-1.7metres bgl.

Plate 4: Showing plastic drain exposed in foundation trench at western side of the pavilion. Looking south with one- and two-metres scales.

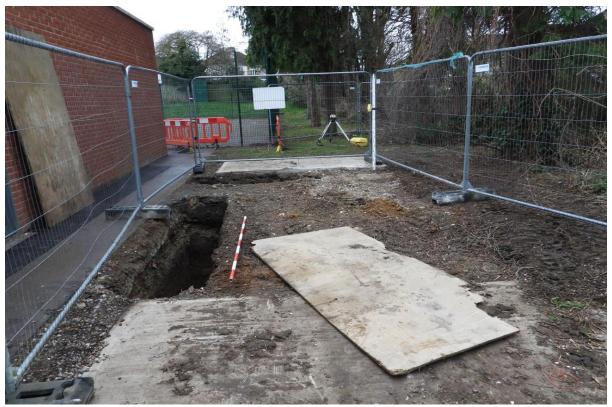
Plate 5: Further foundation trench excavated at western side of the pavilion. Looking south with two-metre scale.

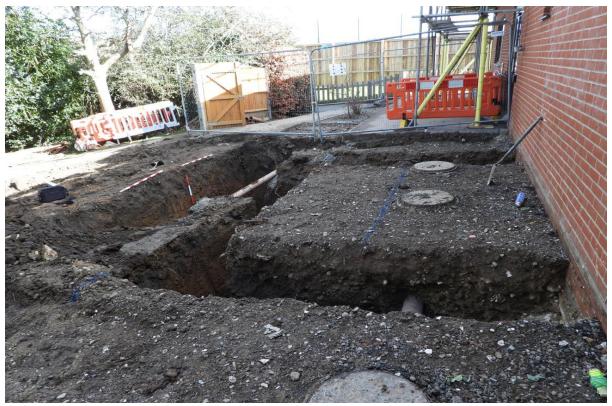
Plate 6: Showing staircase foundations at northern side of the pavilion. Looking east with one two-metres and two one-metres scale bars.

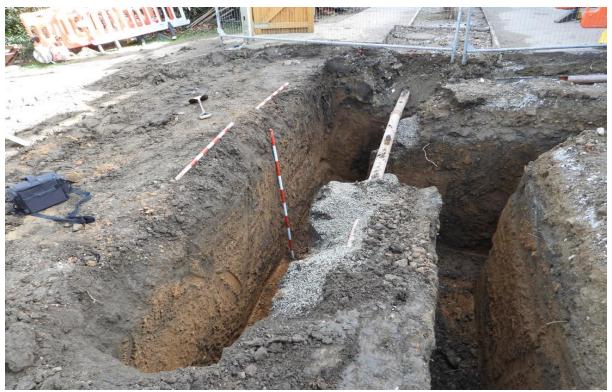
- 9.4 Trenches at the northern side of the pavilion were excavated to the depth of 2.05metres and exposed natural geology from the depth of 0.5metres bgl. Four large plastic pipes were exposed during archaeological monitoring.

Plate 7: Showing exposed geology and plastic pipe in foundation trenches excavated at northern side of the pavilion. Looking northeast with one two-metres and two one-metre scales.

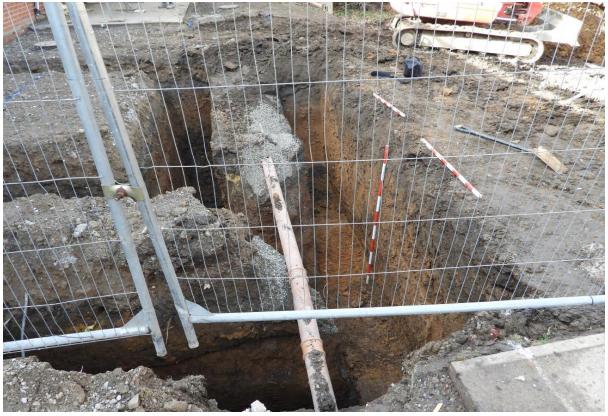
Plate 8: Viewing northern foundations from the east. One two-metres and two-one metre scales.
