**HISTORIC BUILDING RECORDING AT 81 LONDON  
ROAD, MAIDSTONE, KENT**

Date of report 29<sup>th</sup> May 2023

The site has a planning application 23/500244/FULL for conversion of main (2/3-storey) building to 14(no) self-contained flats, including fenestration alterations; conversion of outbuildings to 2(no) dwellings including fenestration alterations and alterations to roof of existing storage building; and rearrangement of parking area and associated works.

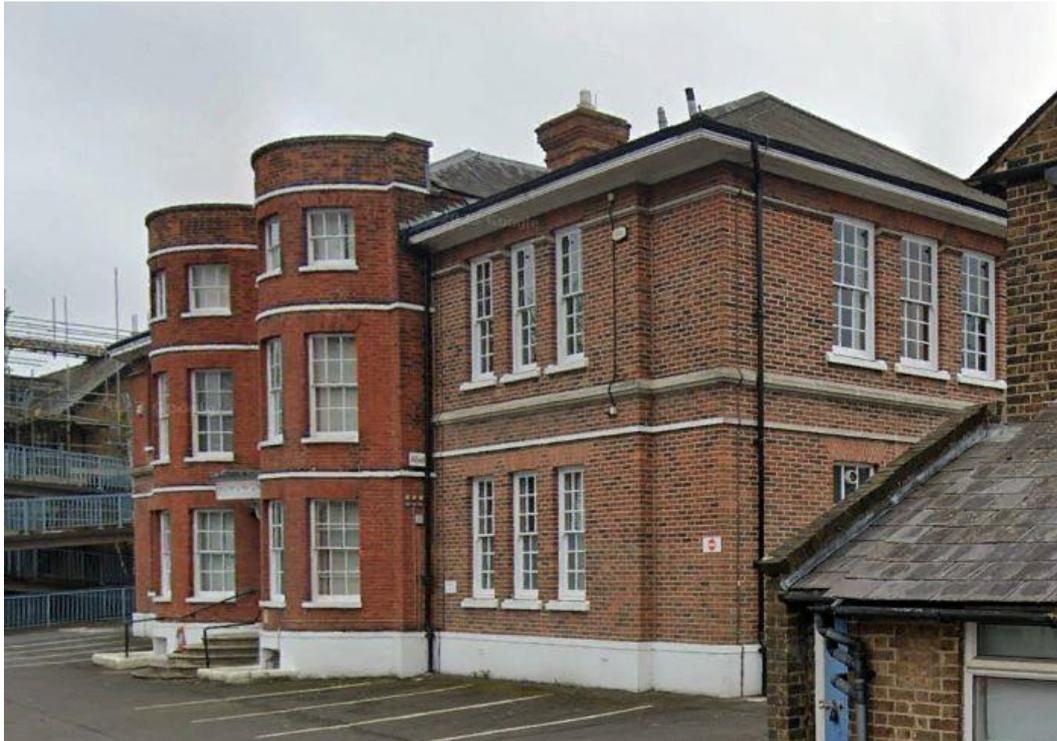
The original building is a brick built three storey building with cellars. Built of red brick laid in a stretcher bond the frontage is architecturally impressive with a ground floor central doorway accessed by five stone semi-circular steps to a four-panel double door with a deep round timber hood with frieze and above a glazed rectangular fanlight. Above the doorway a round headed first floor timber window with glazing bars and above the white painted string course a second floor circular timber window within a circle of ornamental bricks in the tympanum capped with a pediment shaped moulding painted white (Plates 2-13).

Plate 3. Front facade and later build to the right (May 2023)

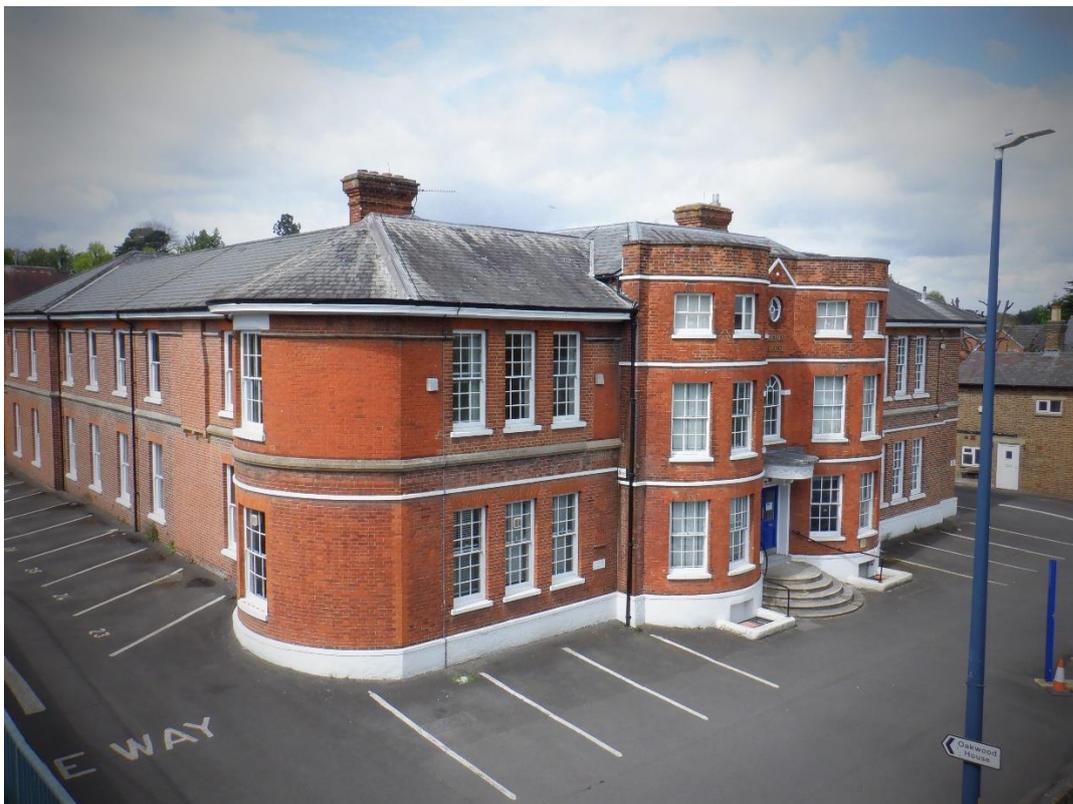
3.7 The south facing two storey modern build is an office block built after 1936 (MAP 7) and before 1940 (AP1). The north and west facing office blocks are of the same build with a modern staircase in the north-west corner (Figures 3-4. Plates 4, 16, 17, 18, 19).

Plate 4. North-east facade and to the left the later two storey build

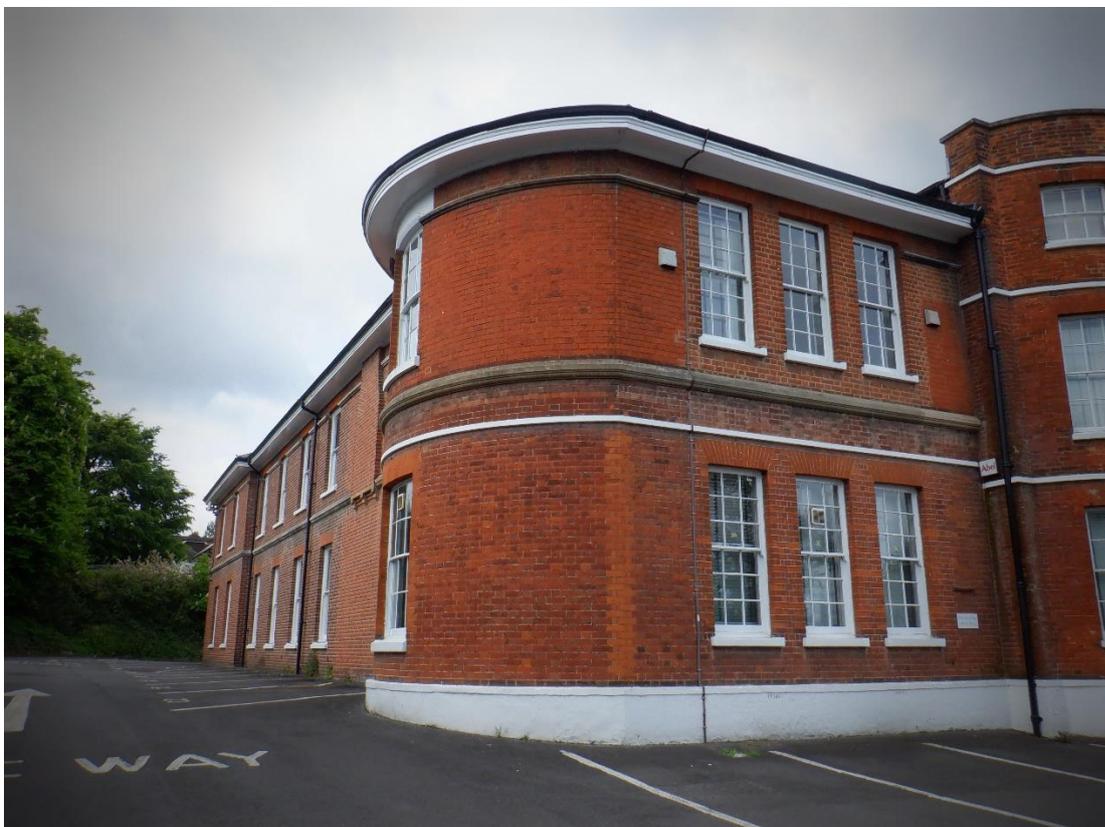
3.5 The façade to the left is part of the original build as an additional bay with six double hung sash windows to the front, two windows to the side and built of rubbed red brick set in a Flemish bond with a stringer brick course, a white painted string course and a carved stone string course (Plates 6-9).

Plate 6. Ground view north-east facade and view of later extension (left)

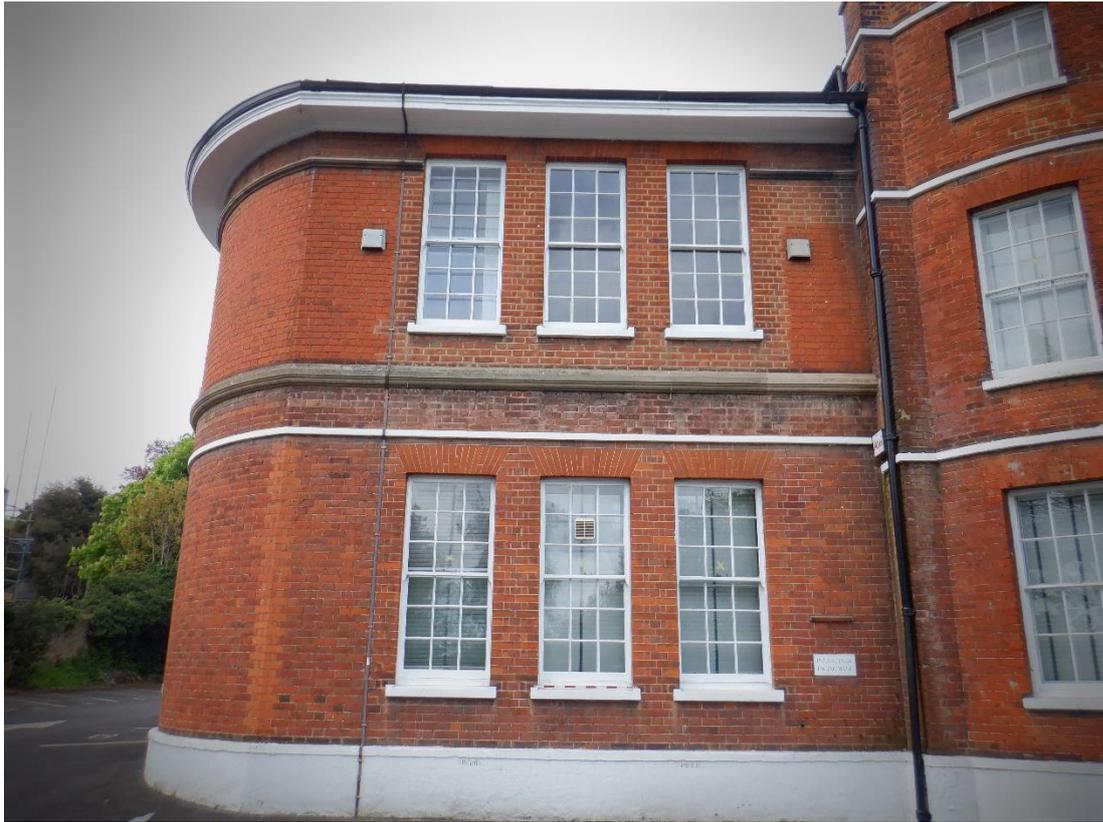
Plate 7. Ground view north-east facade

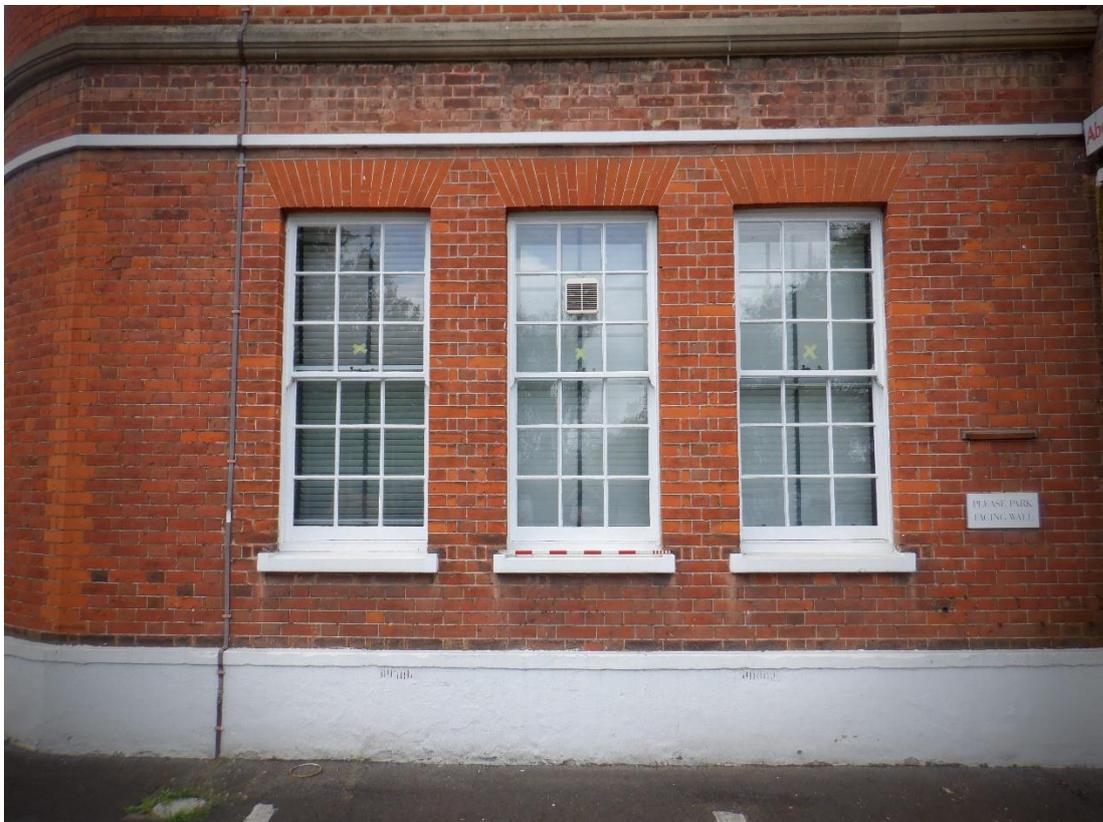
Plate 8. Sash windows north-east facade

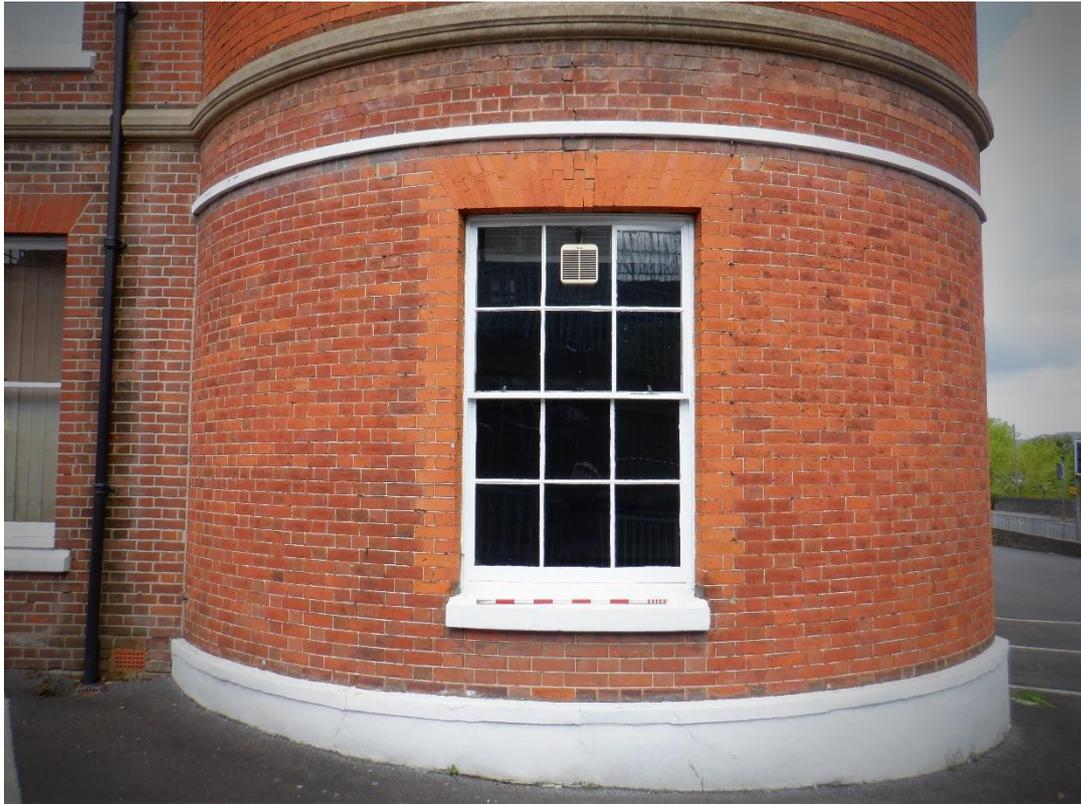
Plate 9. Detail of left corner of frontage facade

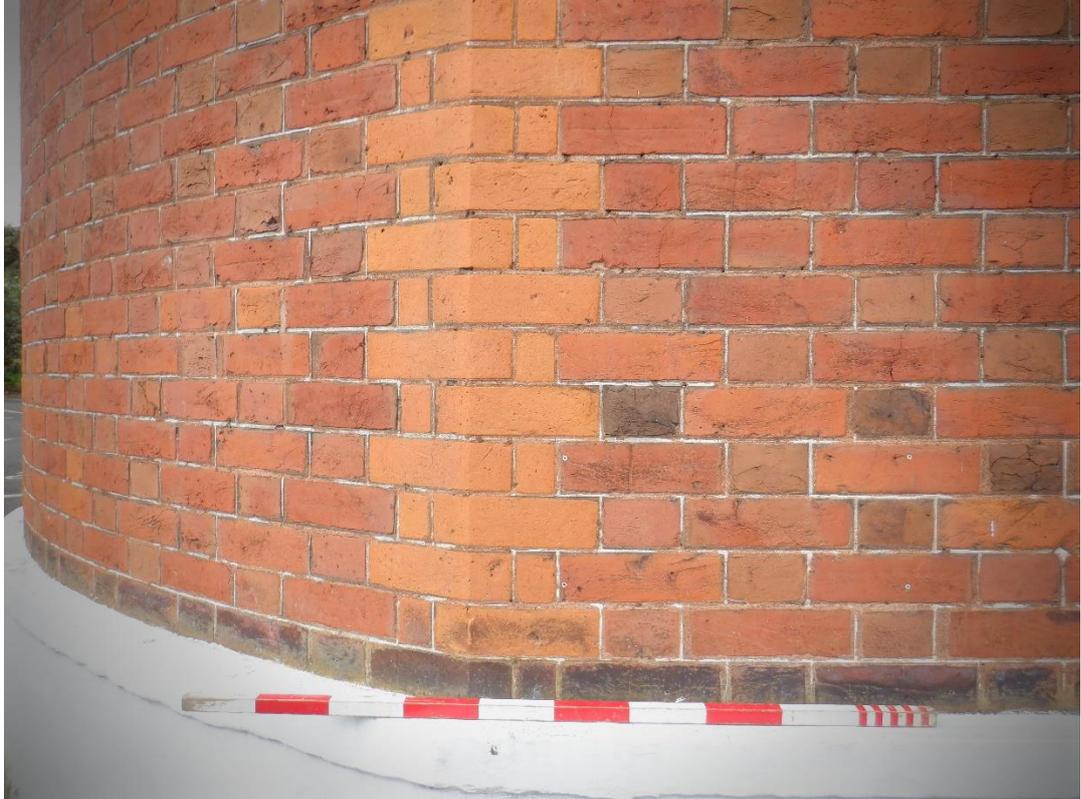
Plate 10. Brick details of corner built with splayed bricks set with Flemish Bond courses

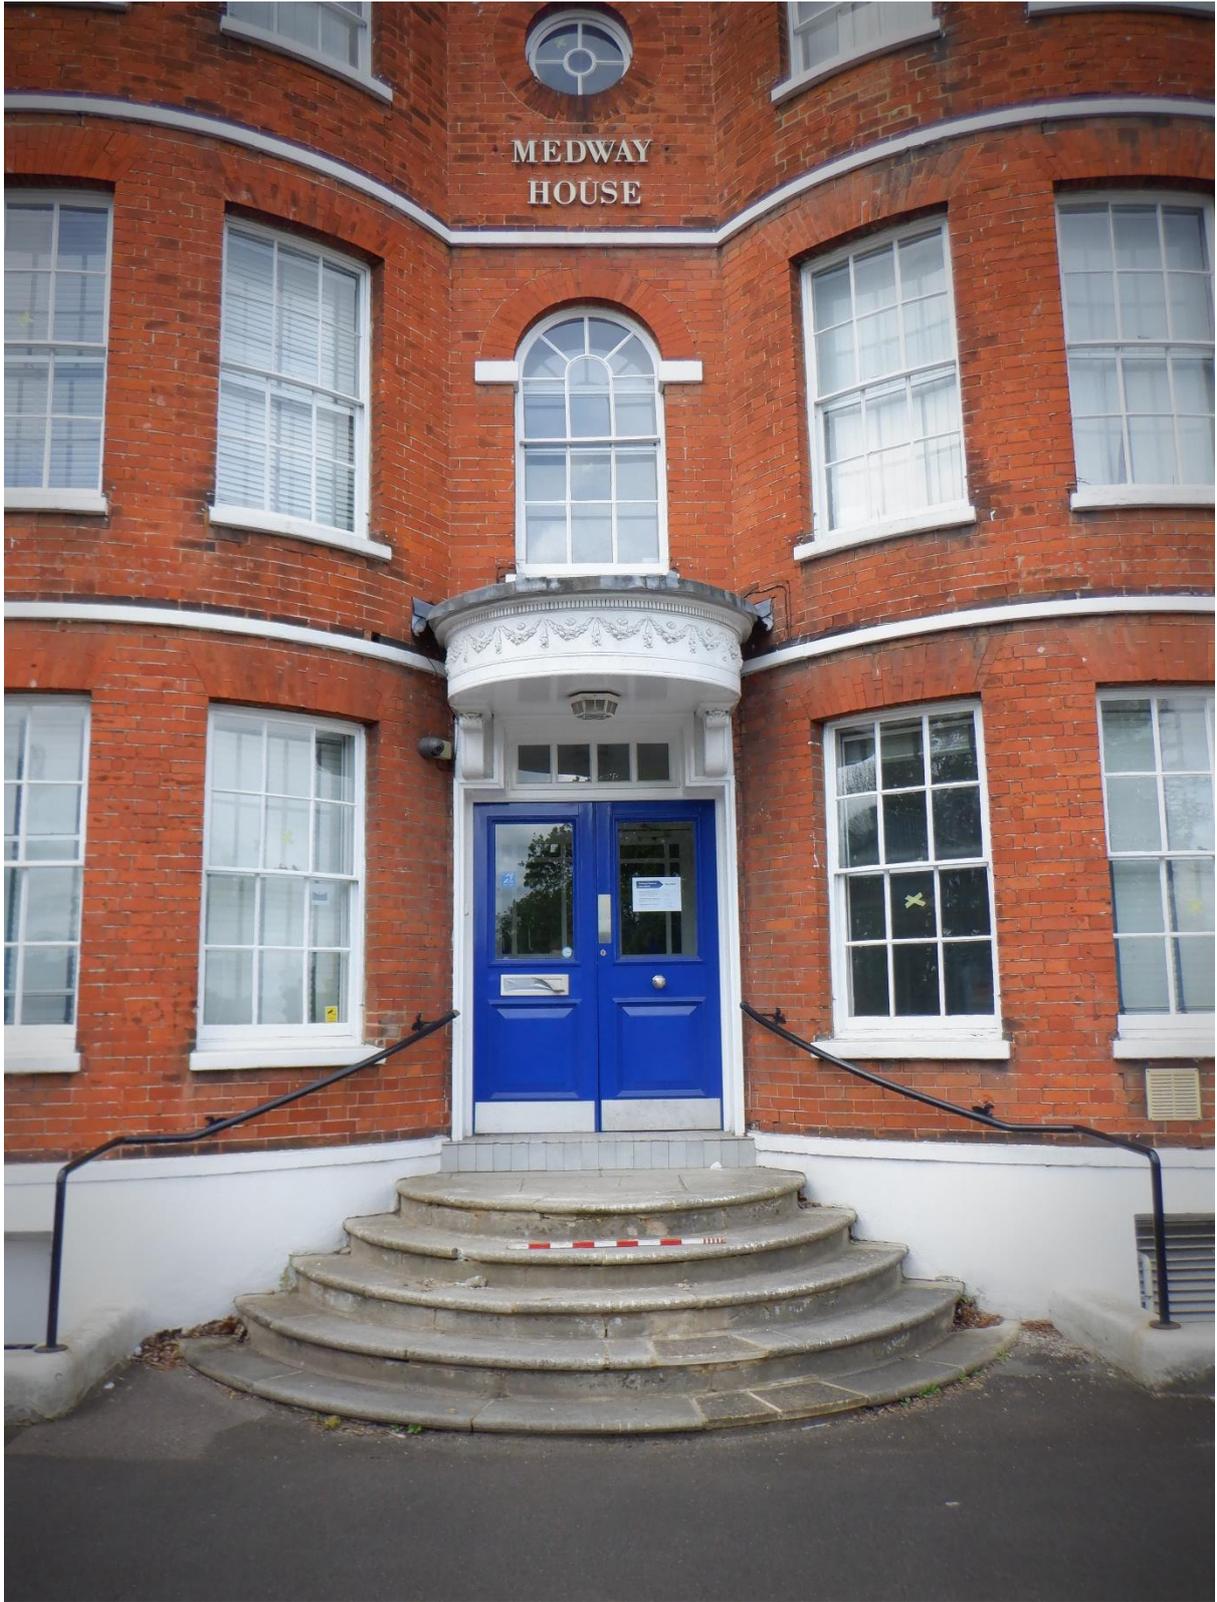
3.2 Either side of the central doorway are a three-storey curved red brick-built bay with a white painted string course above each window with three double hung sash windows with stone cill lighting each floor (Plates 11-13).

Plate 11. Front entrance (1m scale)

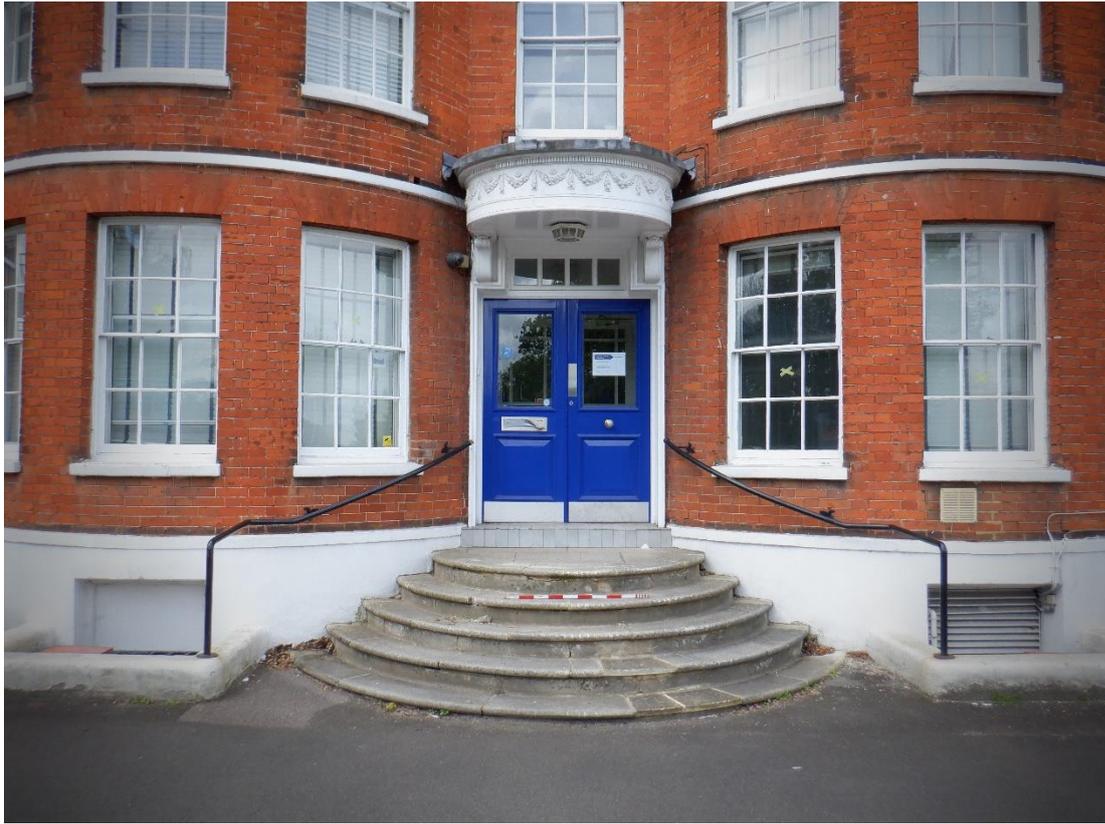
3.3 Each bay has a ground level light pit and window to light the cellars (Plate 12).

Plate 12. Frontage detail (1m scale)

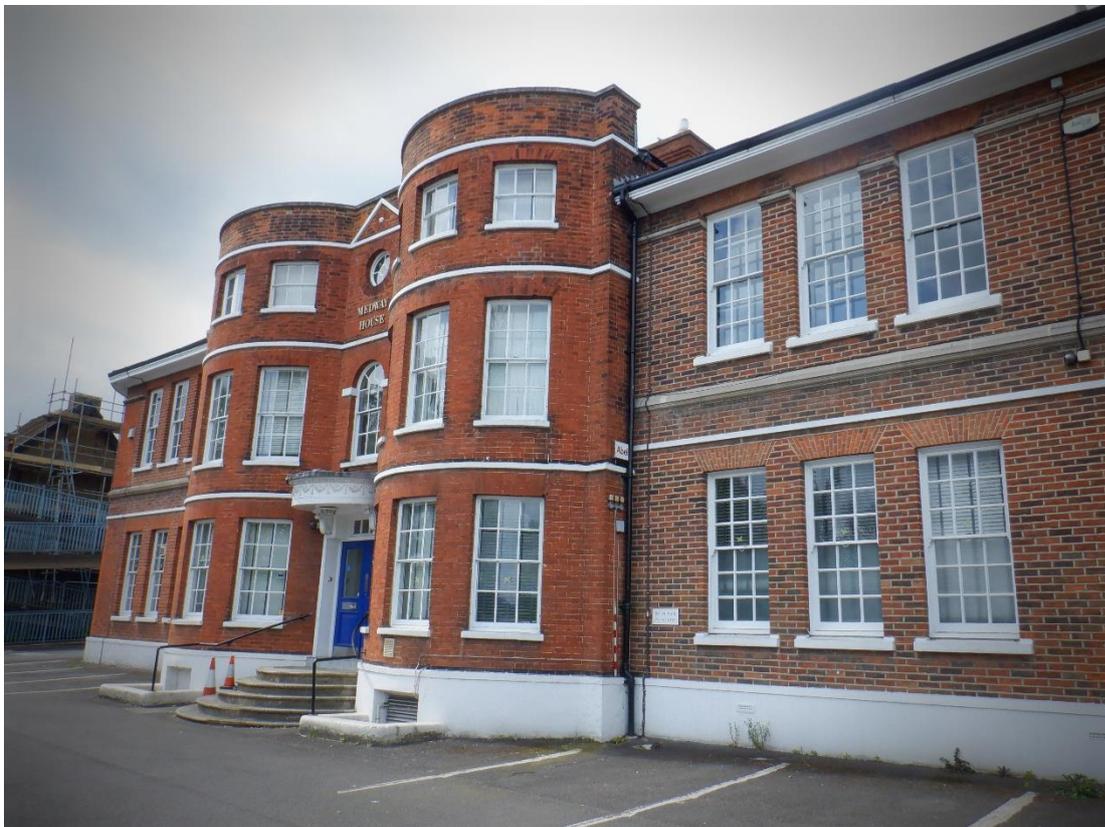
3.4 To the right of the original bay frontage is a modern extension again with a white painted plinth and built of brick in a stretcher bond with two stringer courses, six double hung sash windows and with a slate hipped roof (Plate 13).

Plate 13. Main frontage with later build to the right (1m scale)

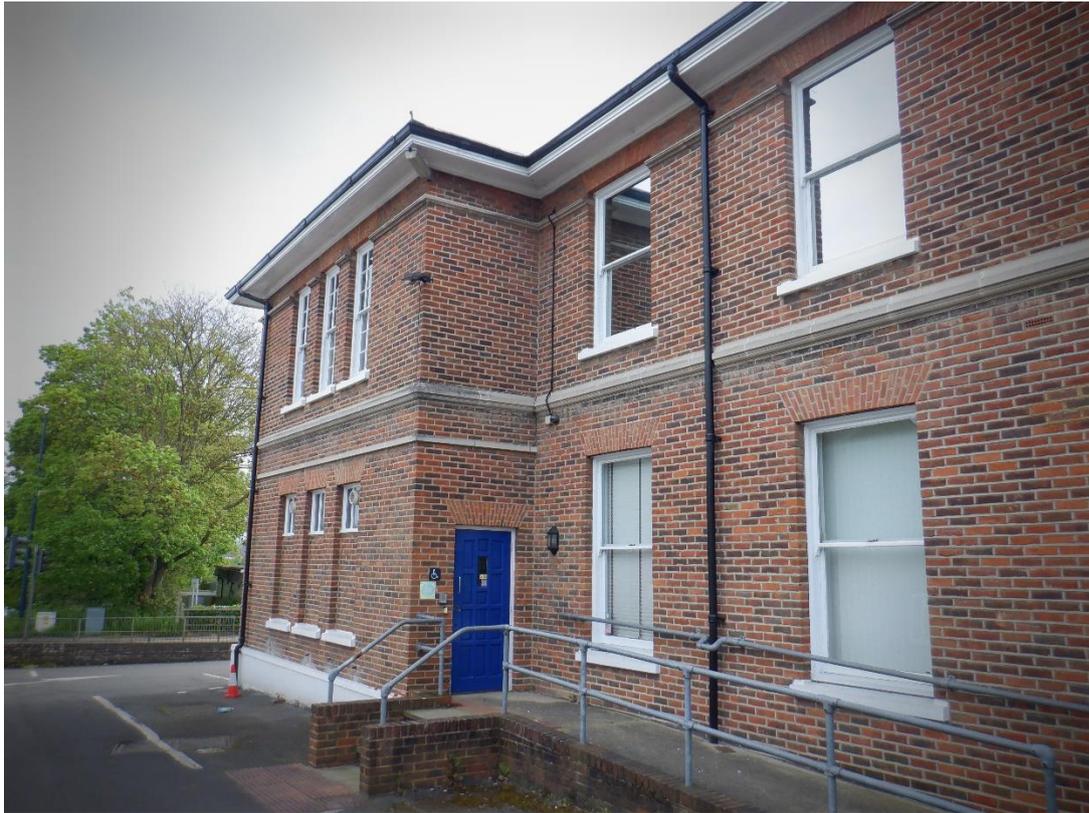
Plate 16. Later north-west build (1m scale)

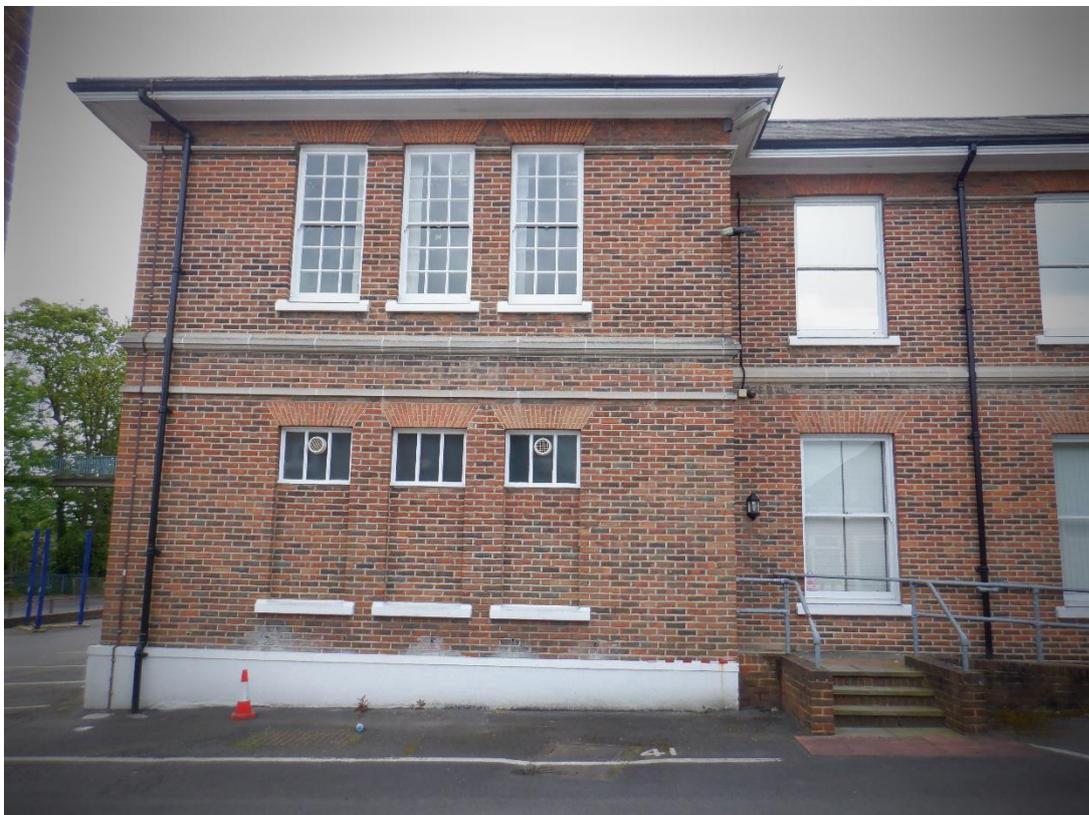
Plate 17. Detail of later north-west build (1m scale)

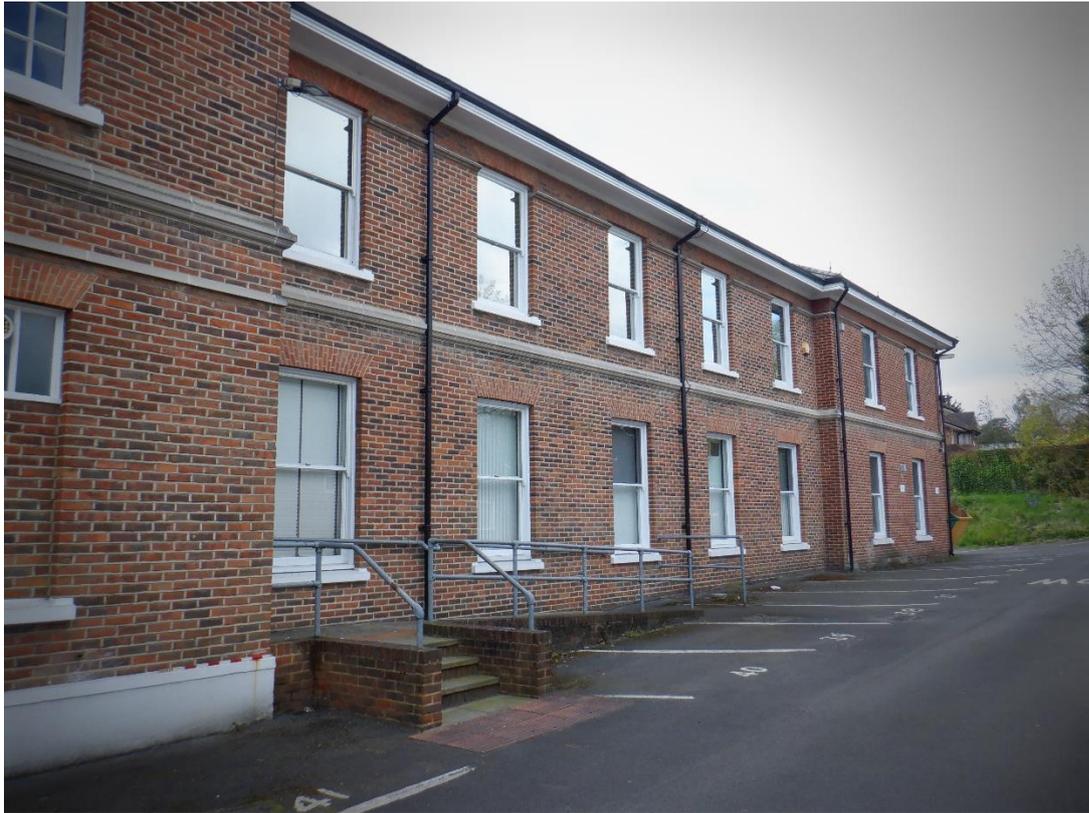
Plate 18. Later north-west build (1m scale)

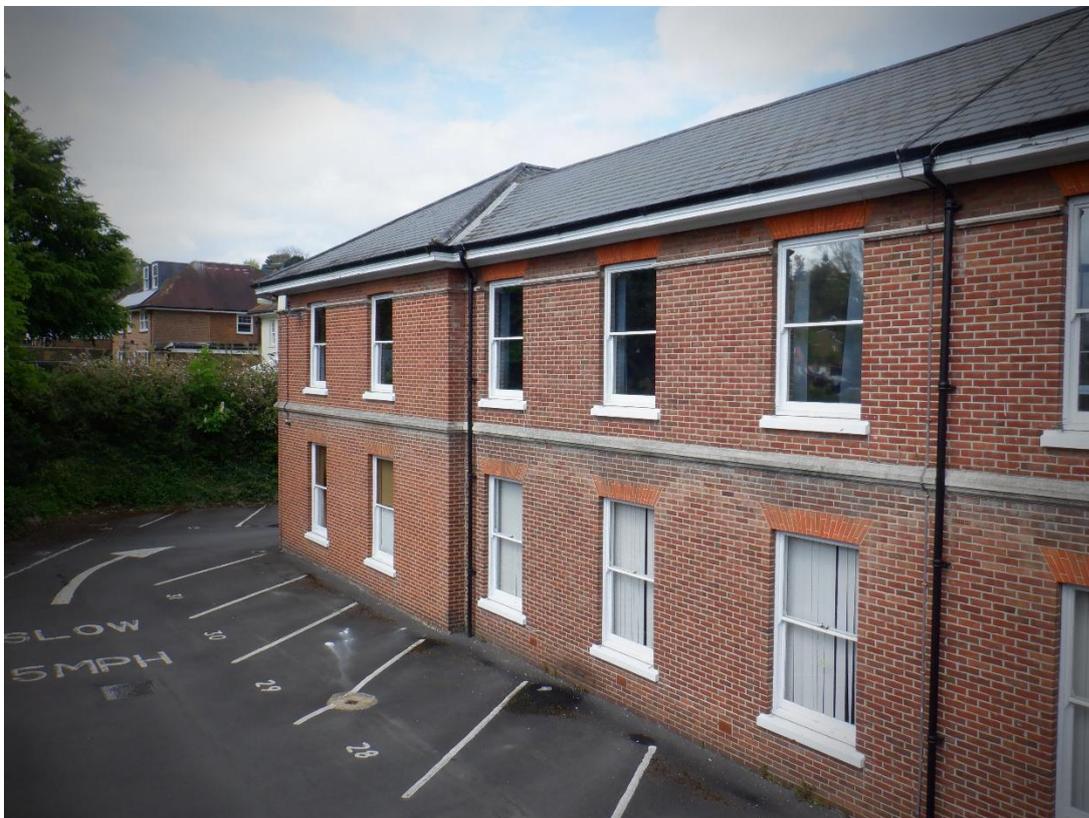
Plate 19. Later north-west build (1m scale)

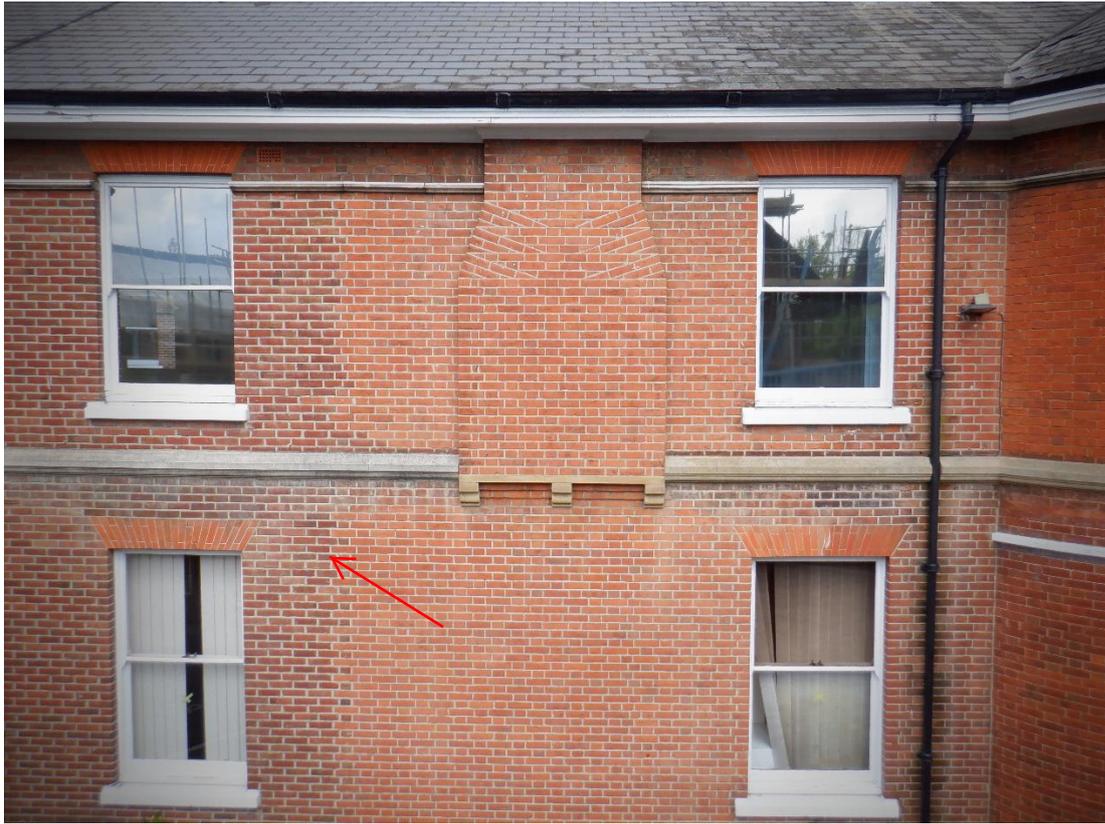
3.6. To the south facing side of the original building can be seen a brick built chimney stack set on a stone corbelled base and to the left the join with the modern extension with the original brick build set in Flemish Bond and the later extension in a different coloured brick set in a cavity wall Stretcher Bond (Plate 20).

Plate 20. Detail of later south-east build to the left and red arrow marks the join

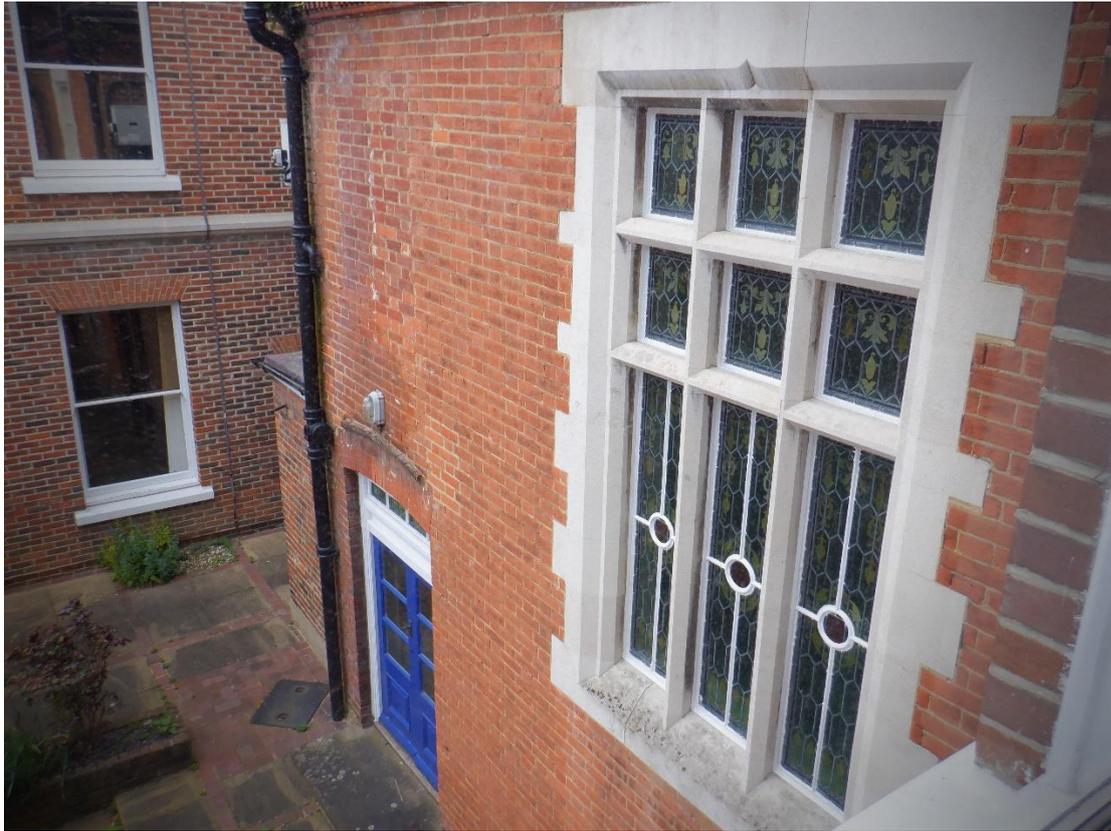
Plate 27. External view of rear facade of original build with stained glass window dated to 1902

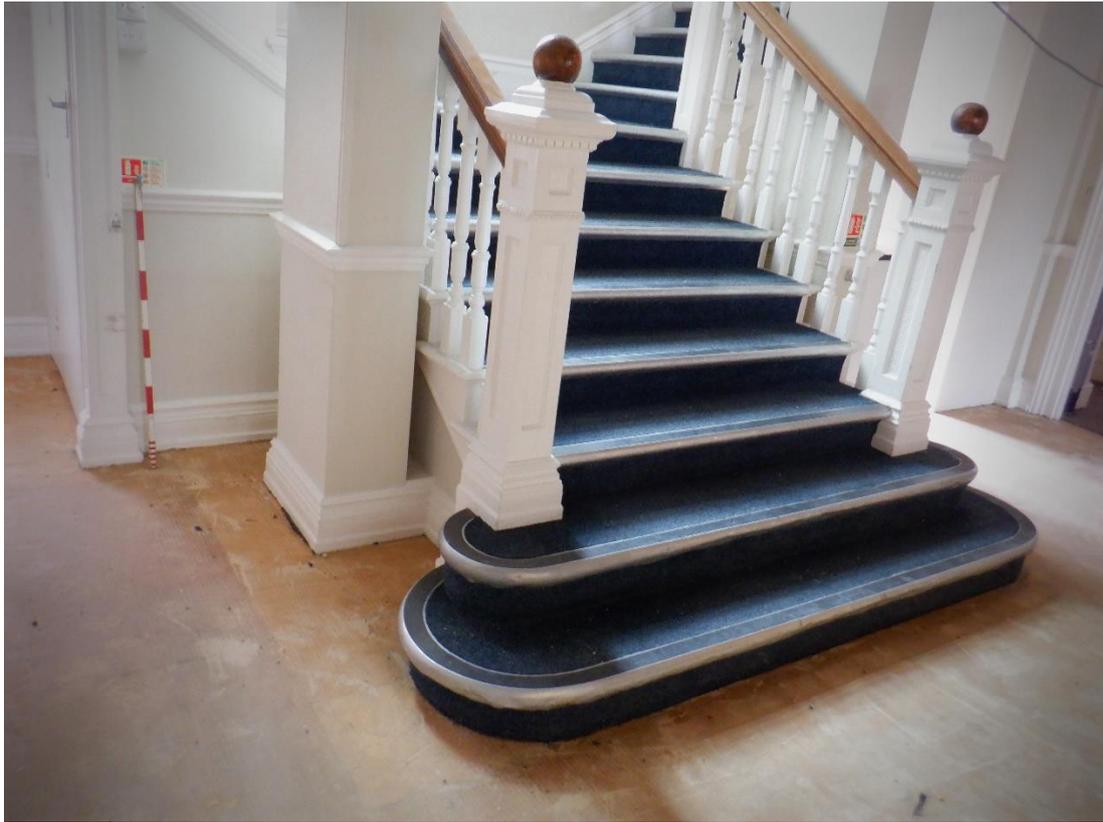
The building is accessed through the main doorway in the centre of the north-east facing elaborate façade (Plates 29, 30, 31). The main internal entrance area is dominated by a splayed timber built staircase with elaborate newel posts but somewhat marred by two square later build steel columns boxed in timber but enhanced by a 'art deco' style timber banded with centre horizontal band in Walnut Burr veneer desk (Plates 29, 30, 31). To the left a white painted four panelled door leads to a fine room with a moulded plaster ceiling (Plates 43, 44, 45) and with three sash windows looking to the north-east and a single sash window looking to the south-east and with original internal frame with white painted panelled timber shutters (Plates 41, 42, 43, 44). The other modern door located to the right of the room entrance leads to a small storeroom and another door in the storeroom leads to the attached modern office block (Plate 52).

Plate 31. View of stairs in entrance hall. 1m scale

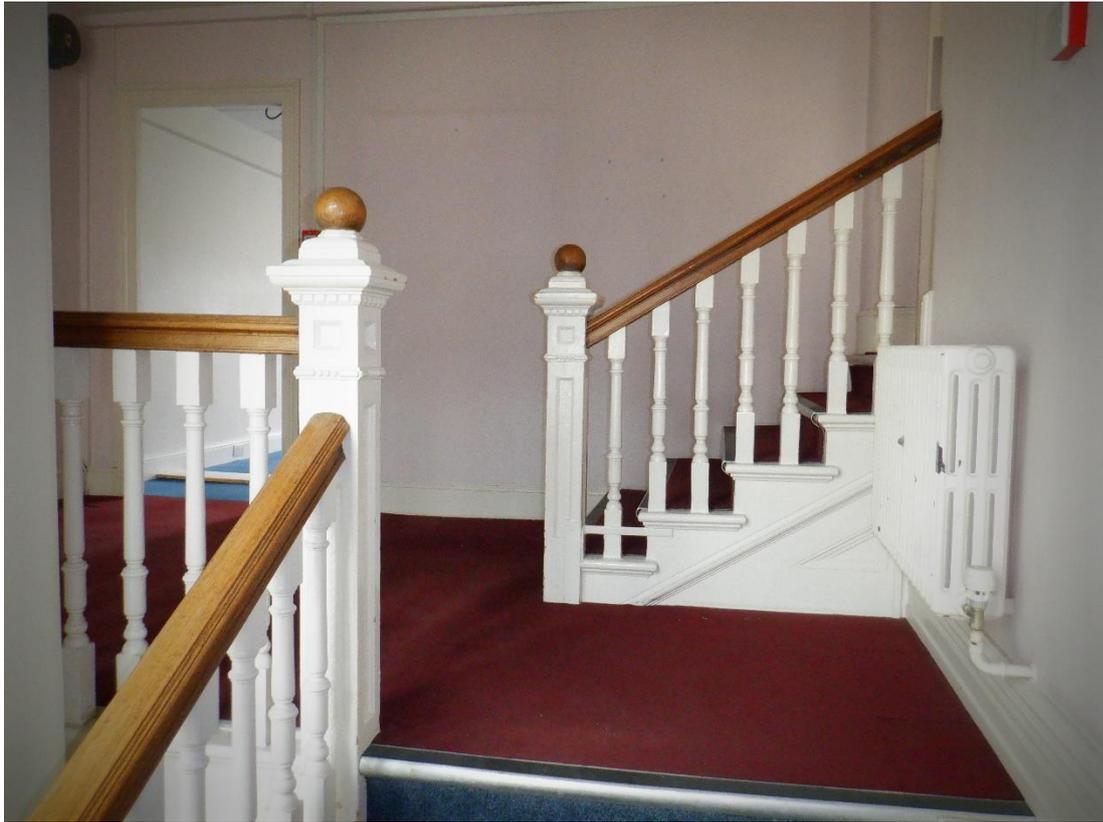
3.10 The main staircase leads to a landing with two staircases, one to the south-west and one to the north-east (Plate 35) and behind and opposite the main entrance is a fine stained glass window dating to 1902 (Plates 36-40).

Plate 35. View of stairs landing in entrance hall. 1m scale

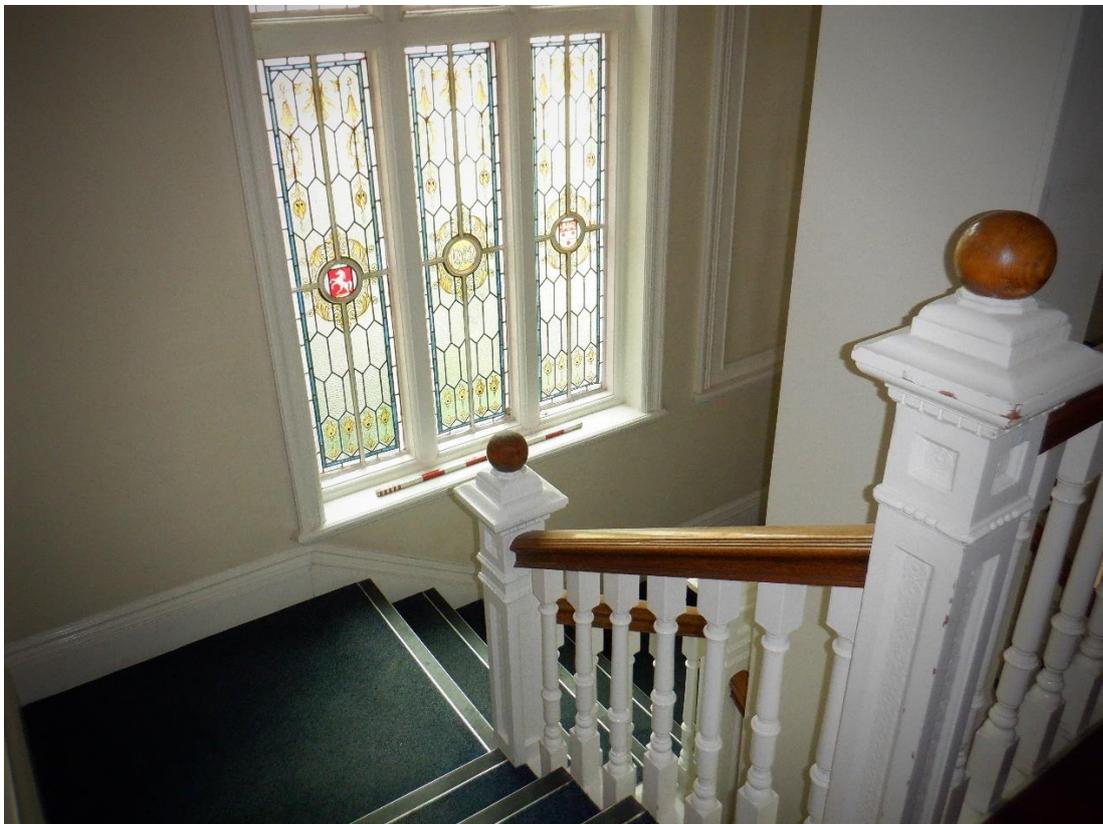
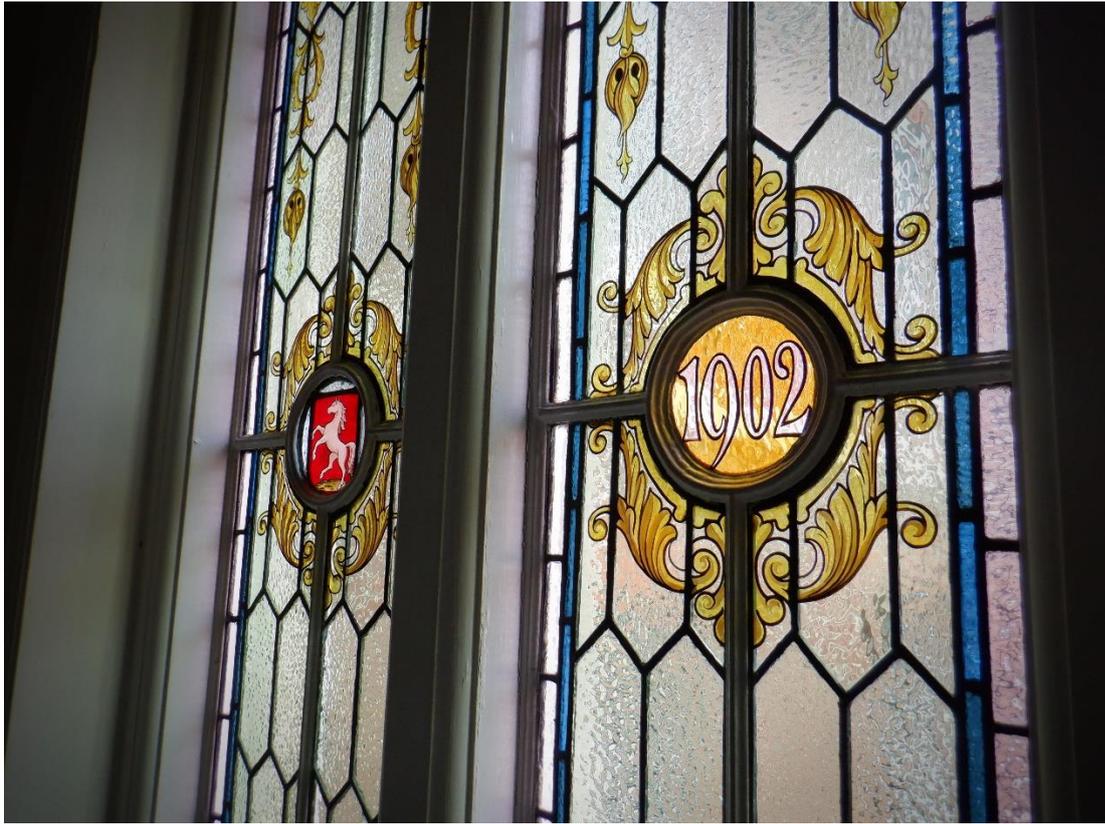
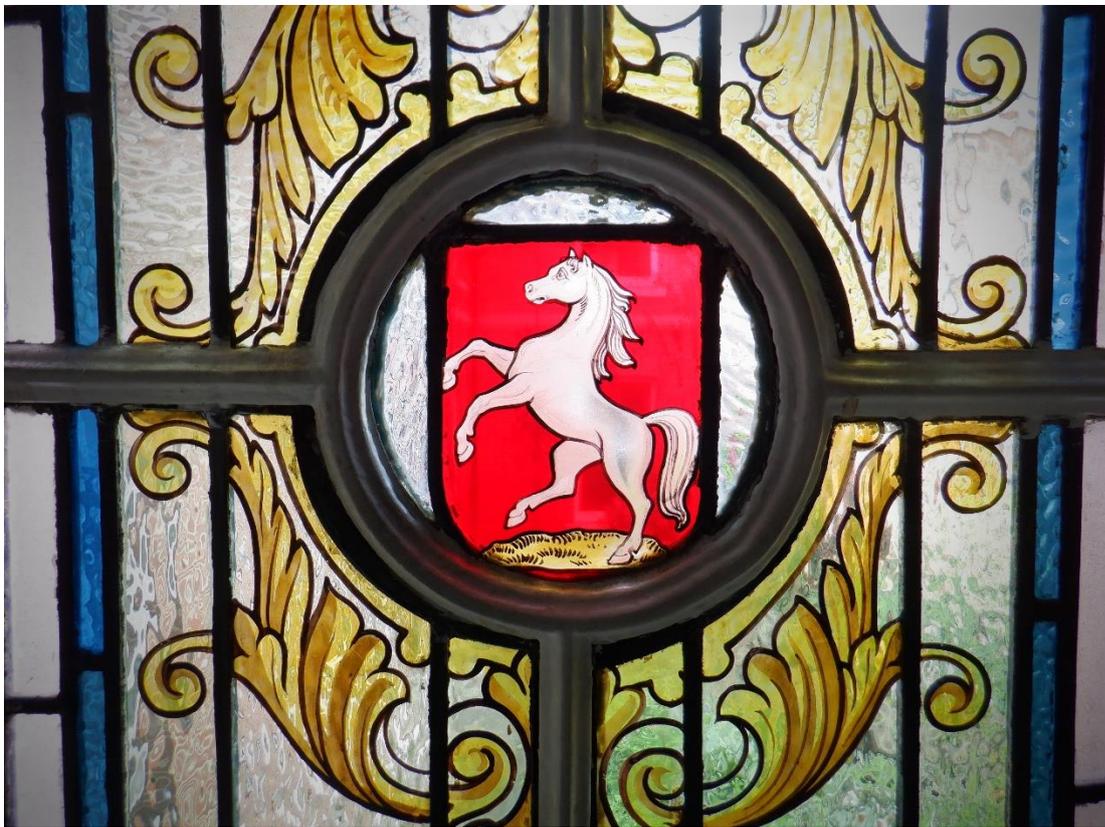
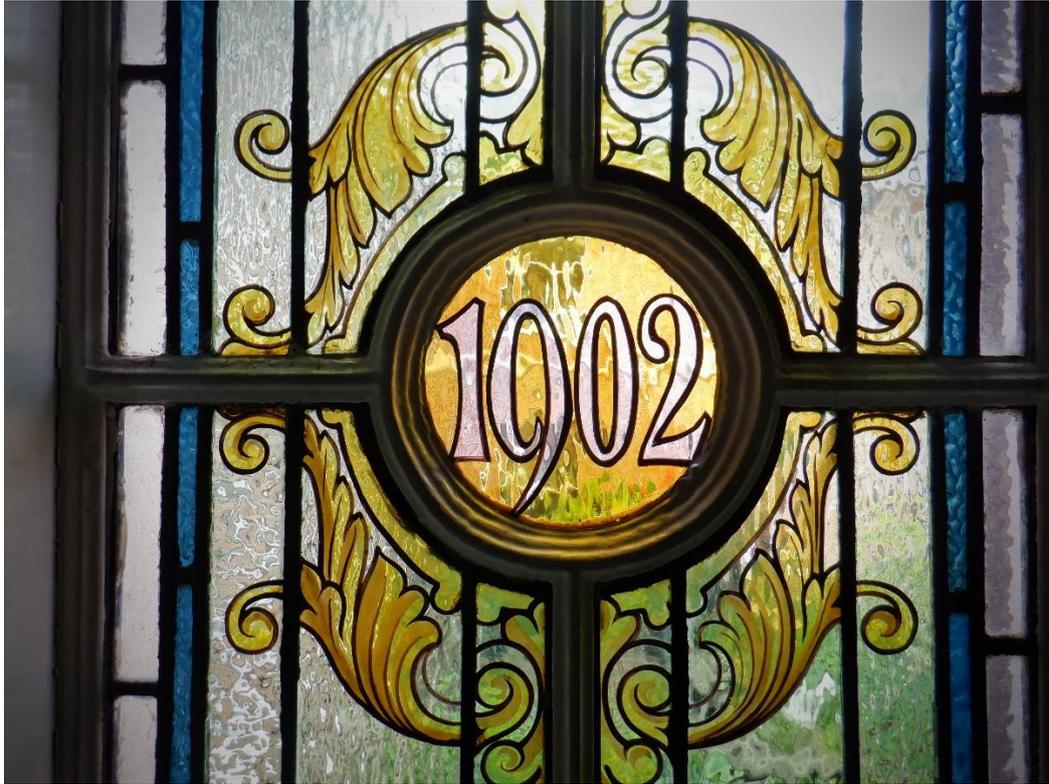
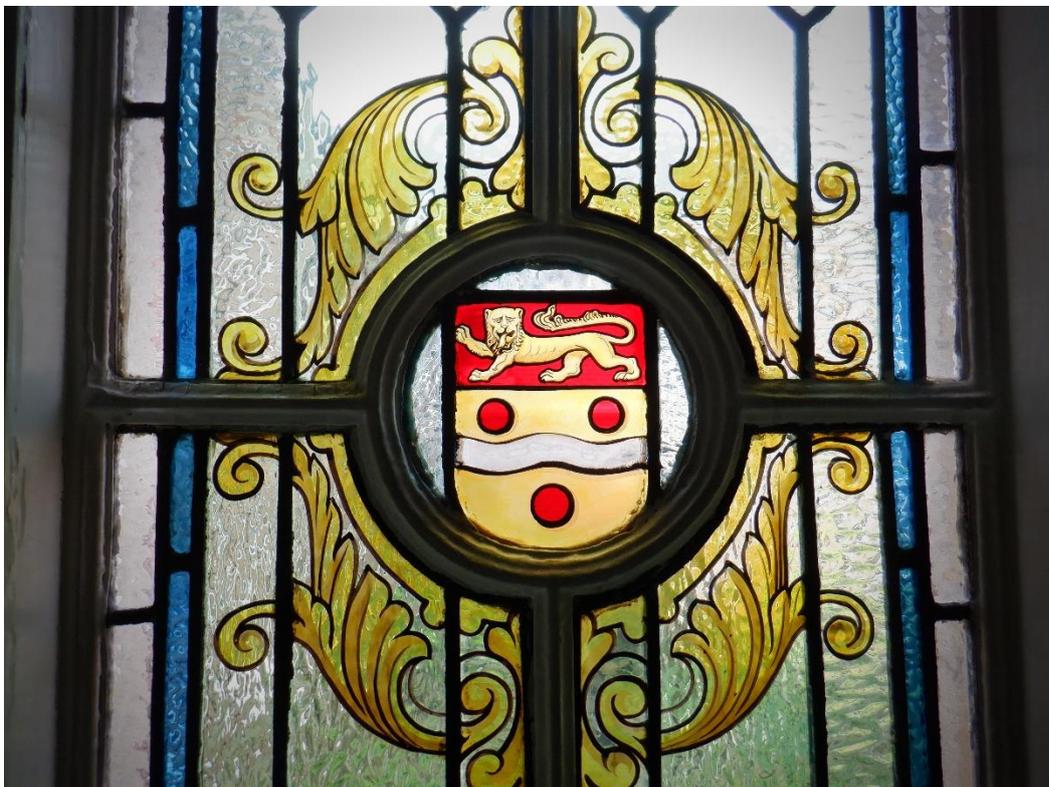
Plate 36. View of staircase leading to entrance hall and stained glass window in rear wall
