**HISTORIC BUILDING RECORDING AT 81 LONDON  
ROAD, MAIDSTONE, KENT**

Date of report 29<sup>th</sup> May 2023

The site has a planning application 23/500244/FULL for conversion of main (2/3-storey) building to 14(no) self-contained flats, including fenestration alterations; conversion of outbuildings to 2(no) dwellings including fenestration alterations and alterations to roof of existing storage building; and rearrangement of parking area and associated works.

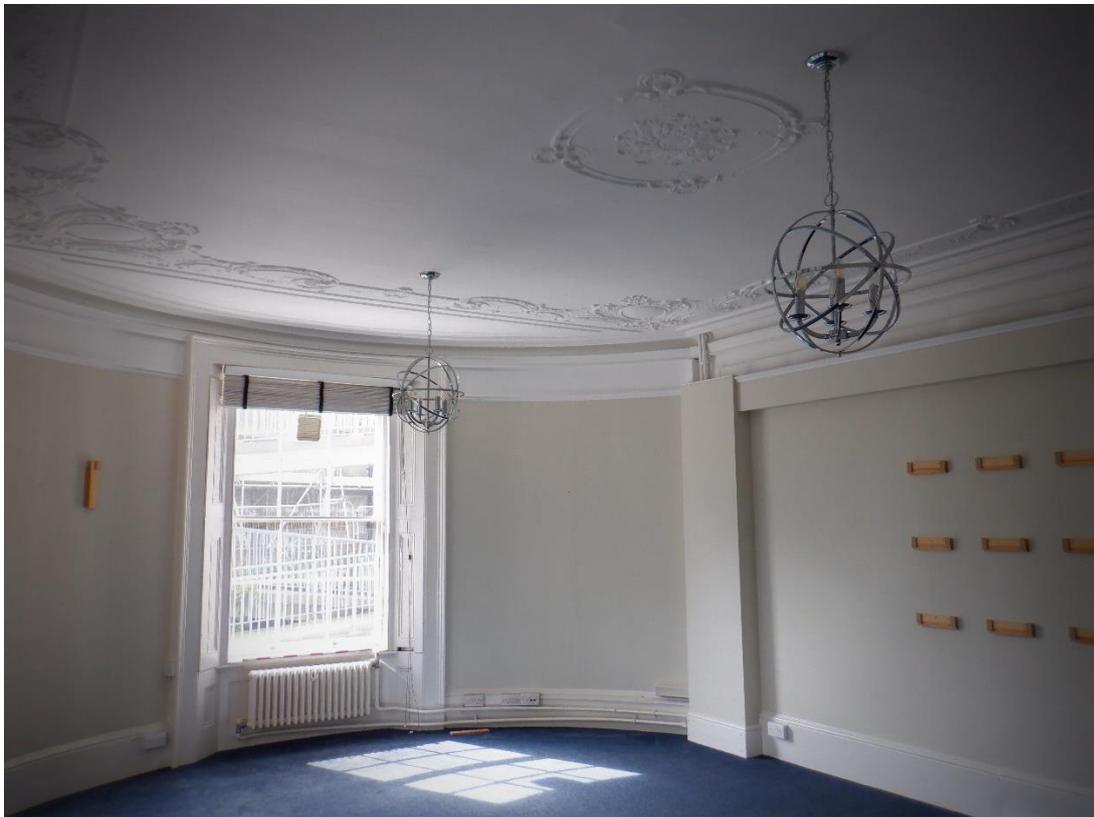
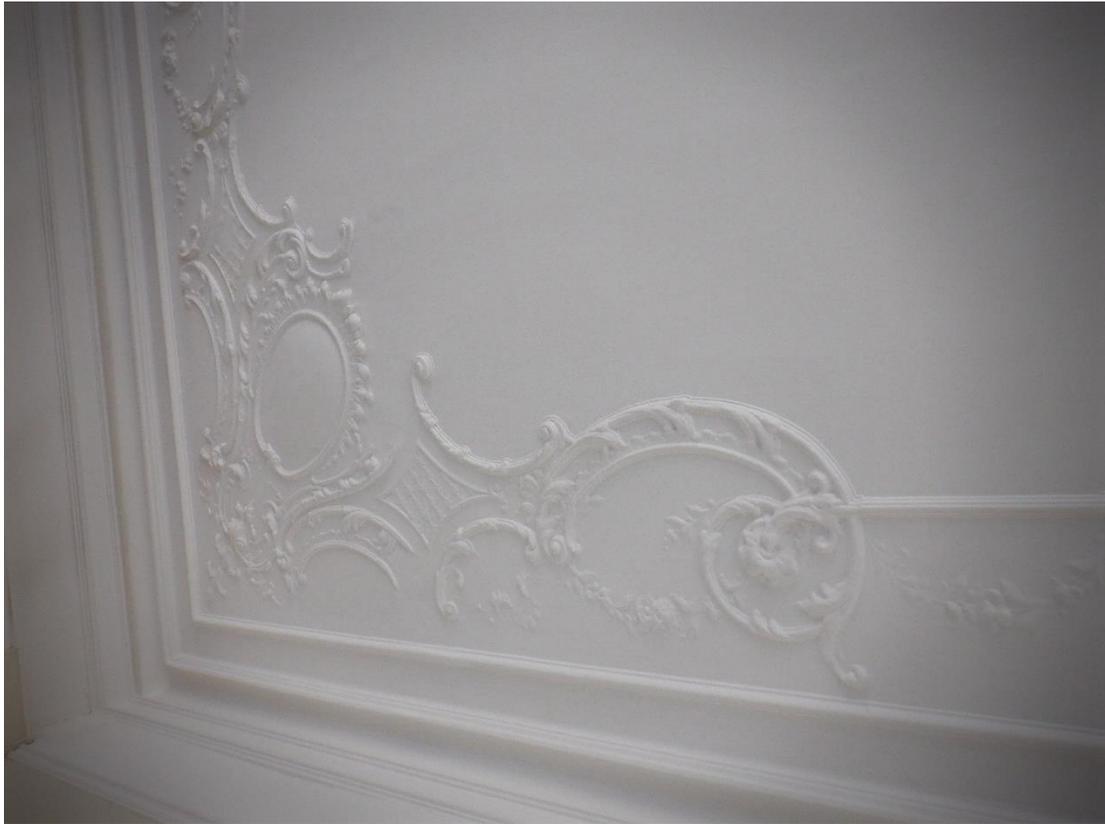
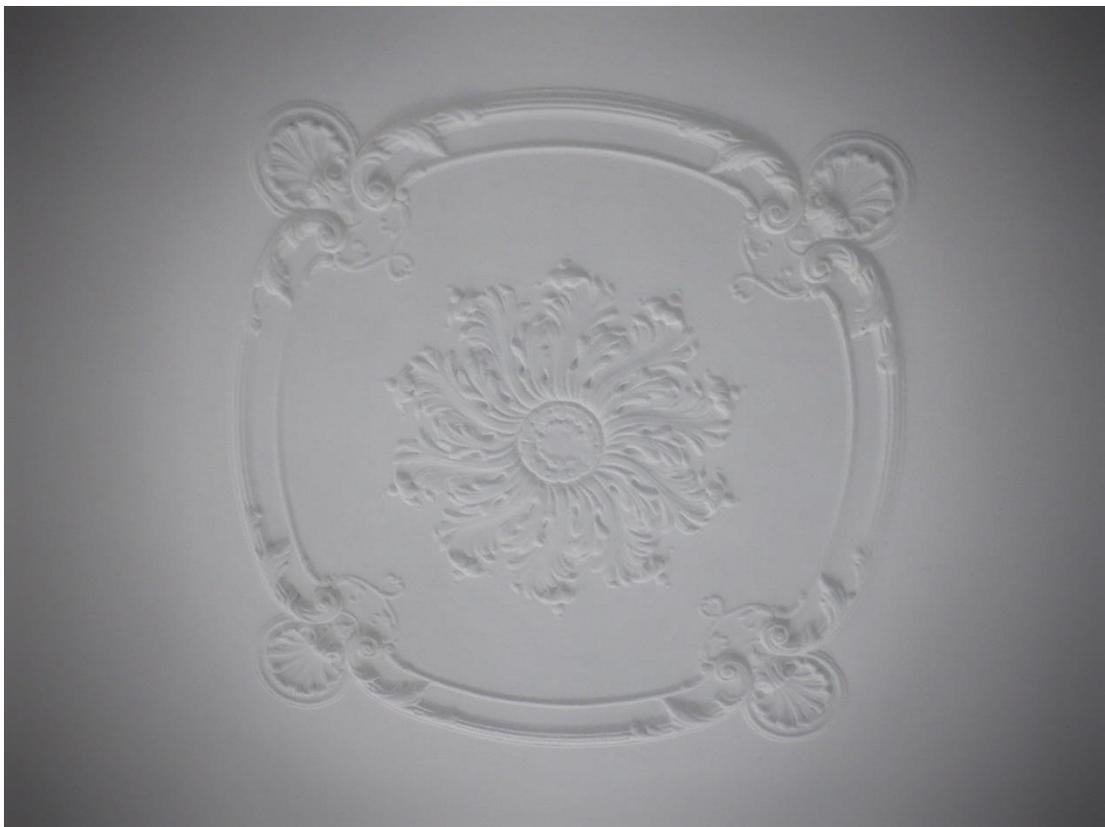
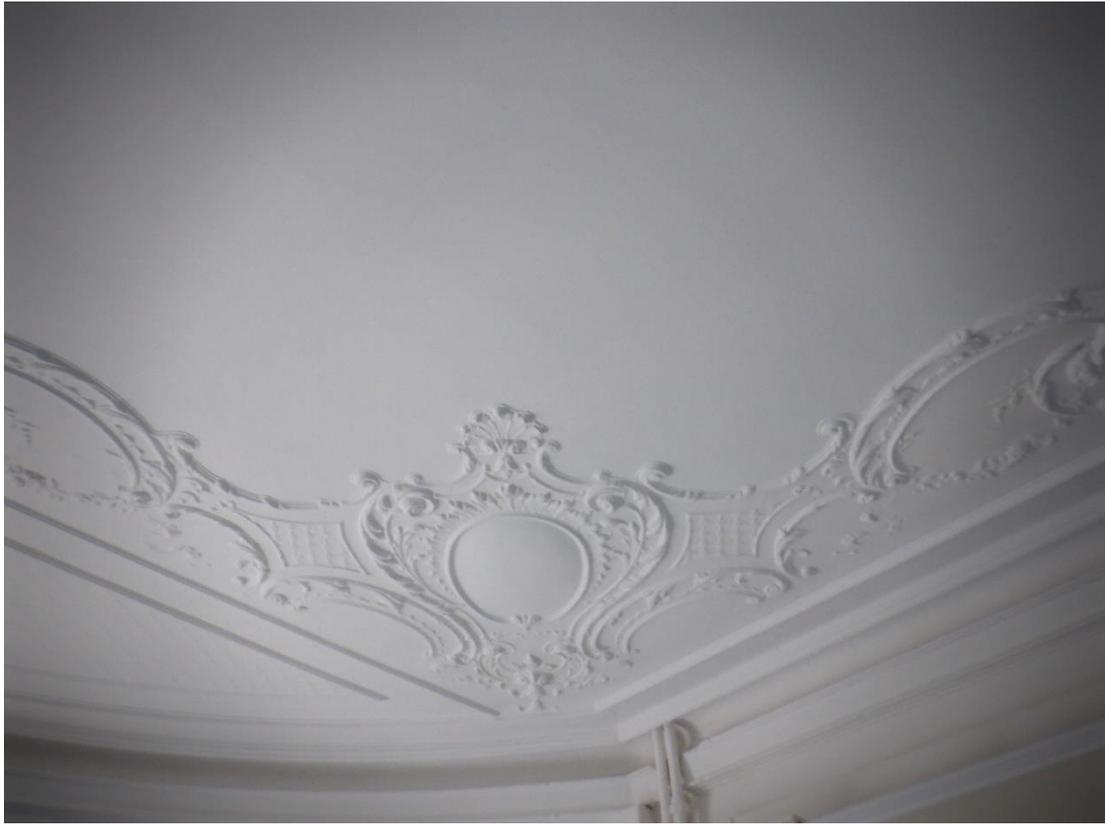
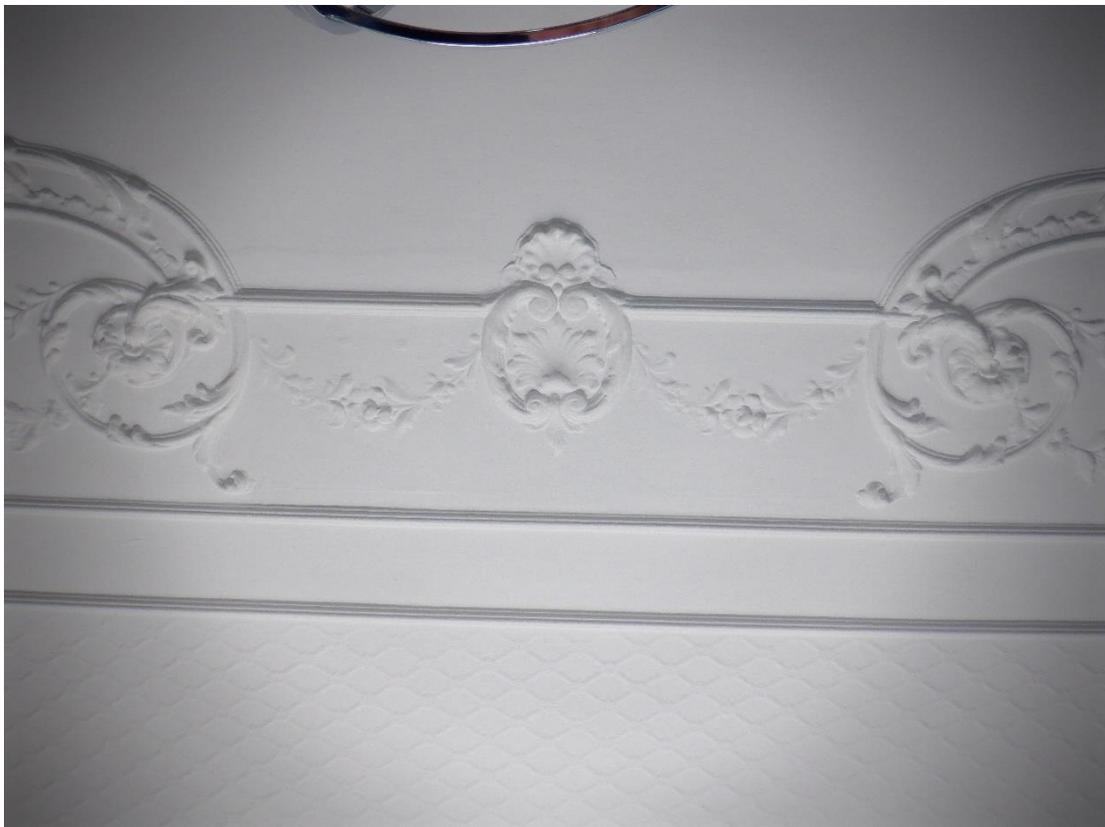
Plate 42. Plaster decoration with ceiling rose, coving, cornice and panel moulding

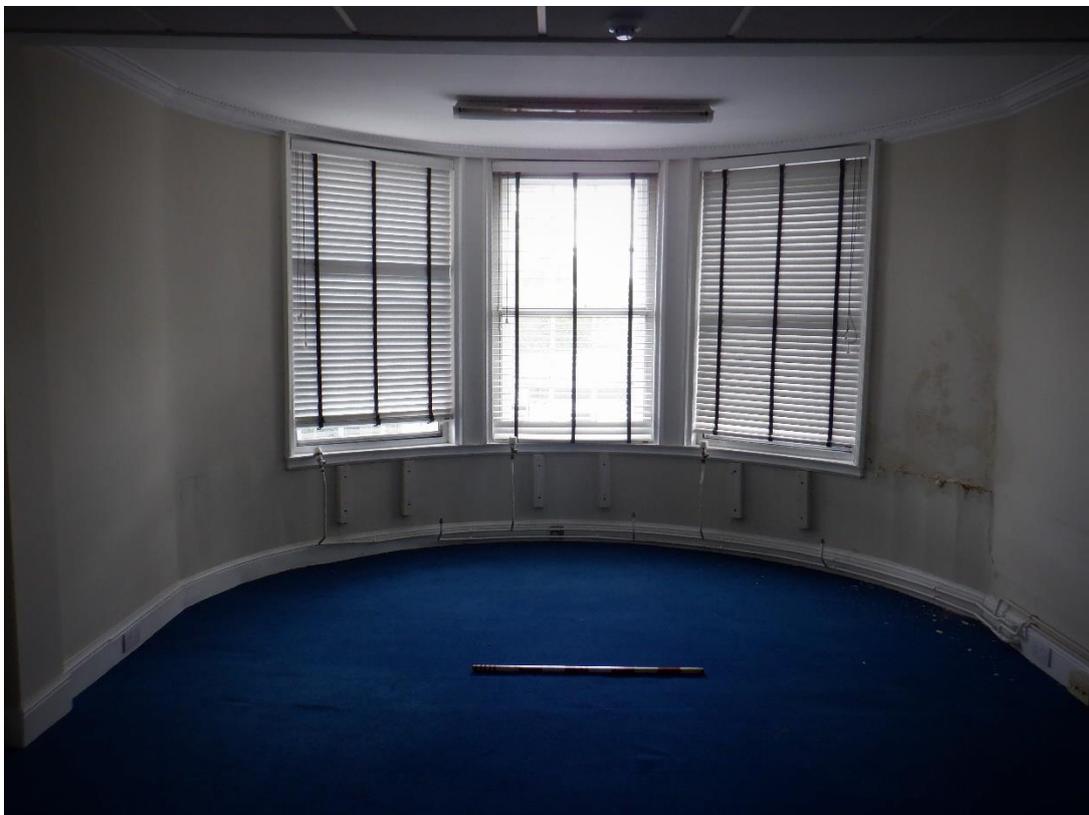
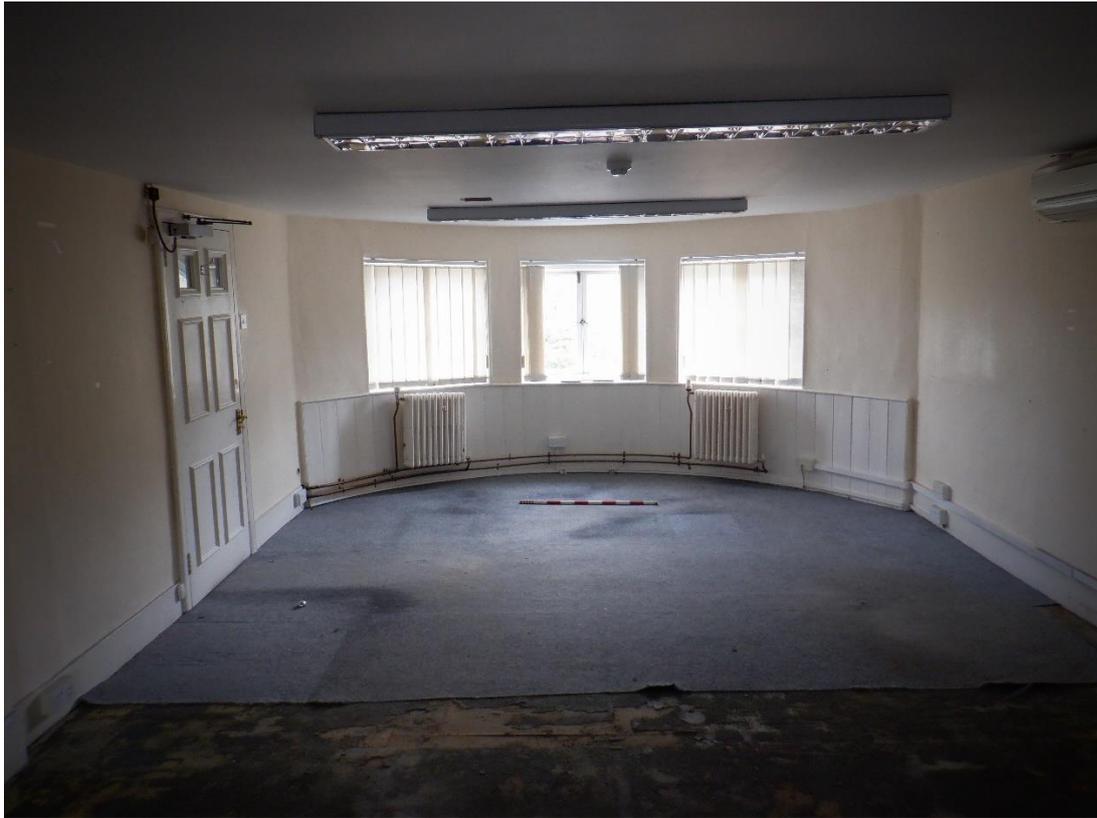
3.11. This staircase leads to the two second floor rooms of the original building both used as offices and storage areas (Plates 50-51) and another staircase leads to the third floor room in the original build (Plate 52).

Plate 50. Third floor office room (looking north-east) 1m scale

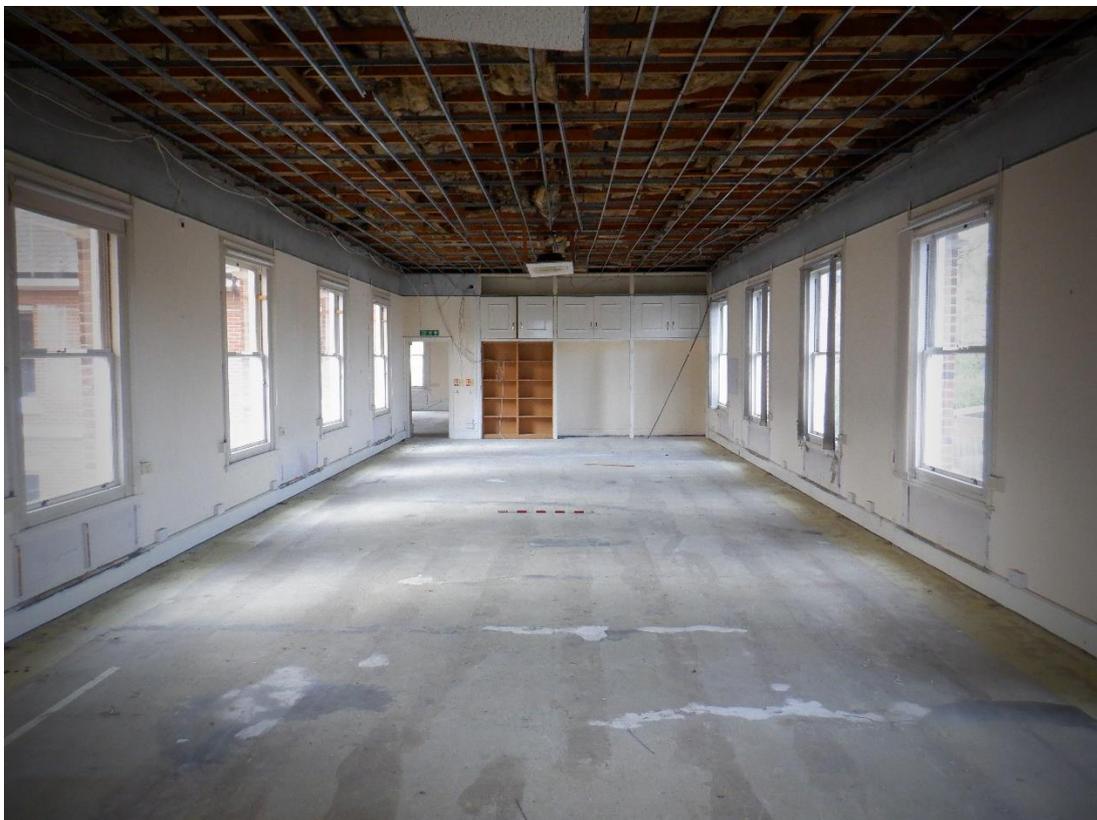
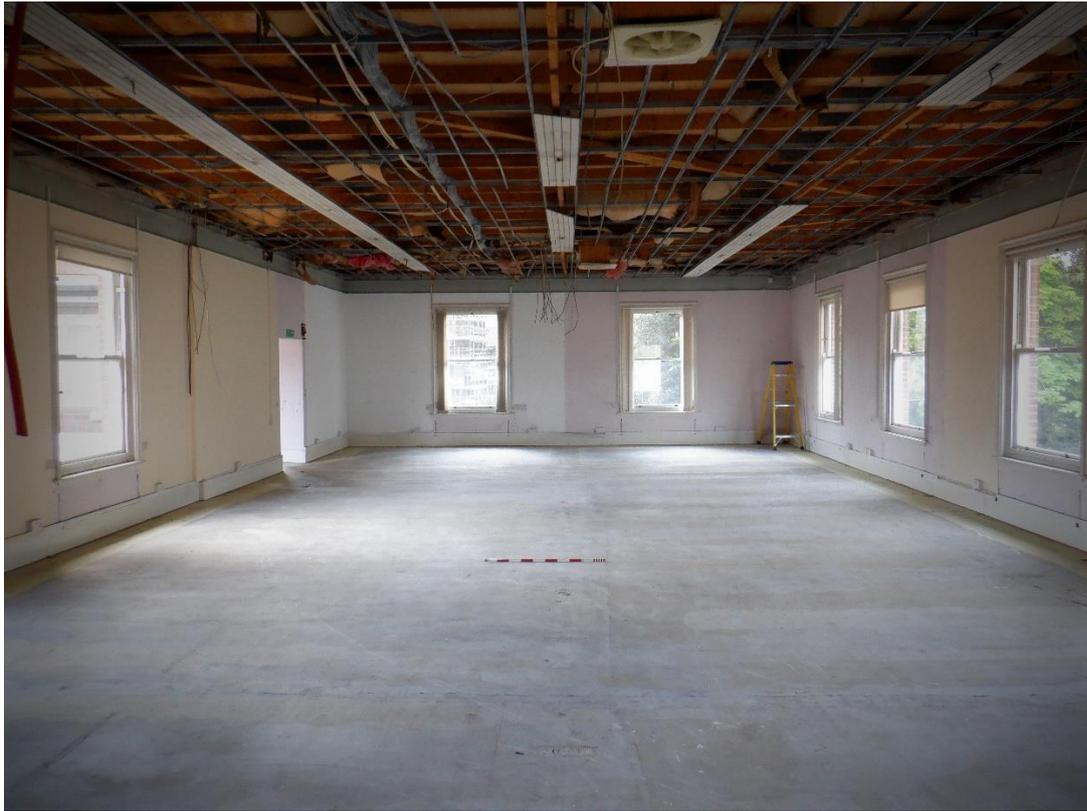
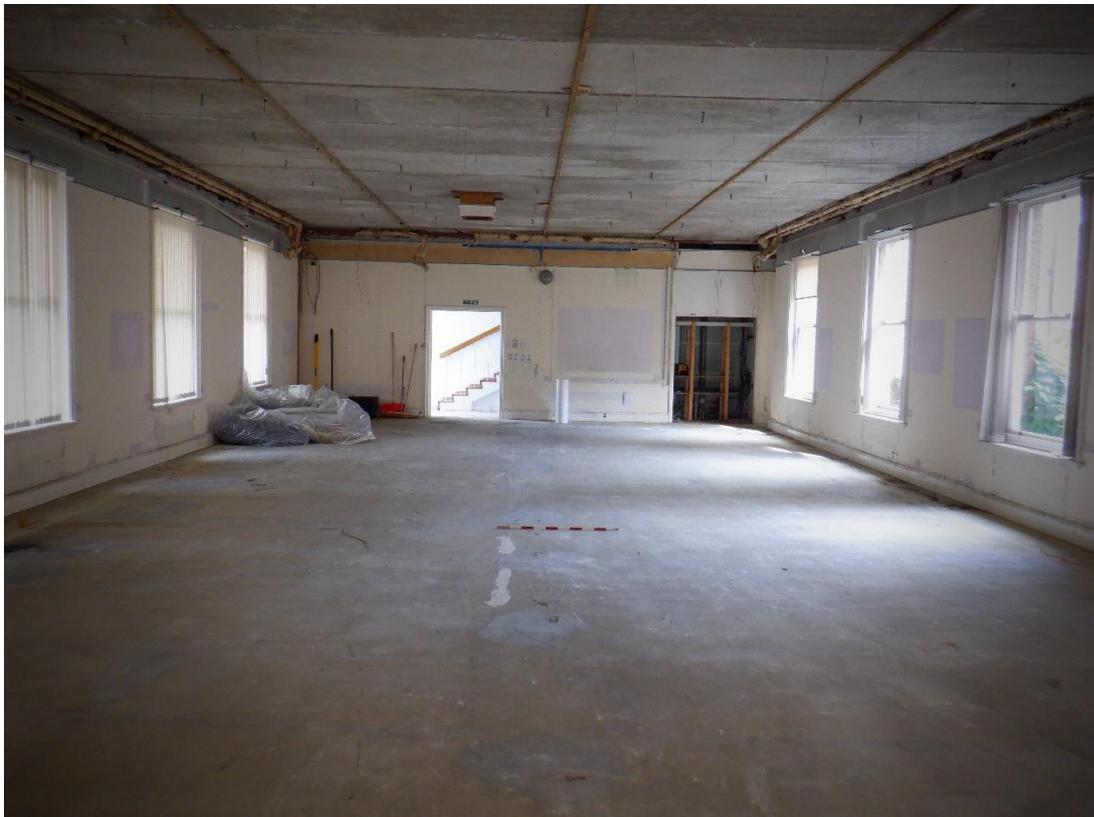
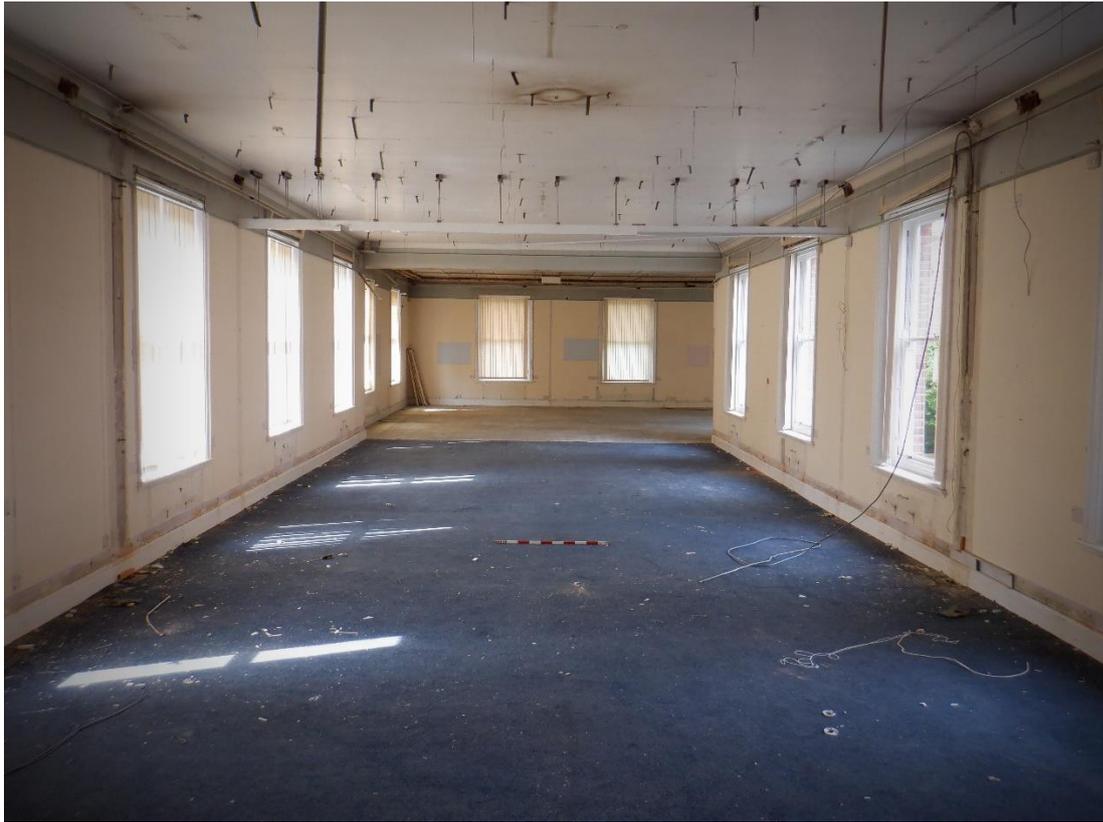
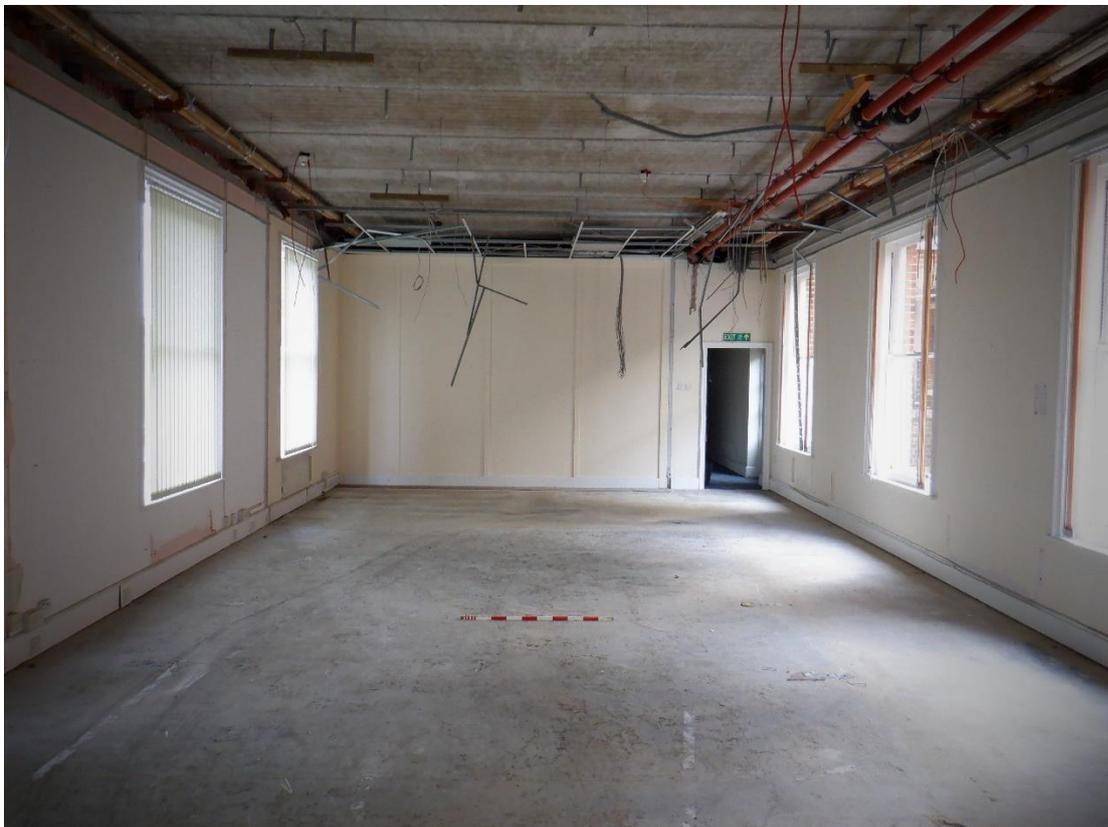
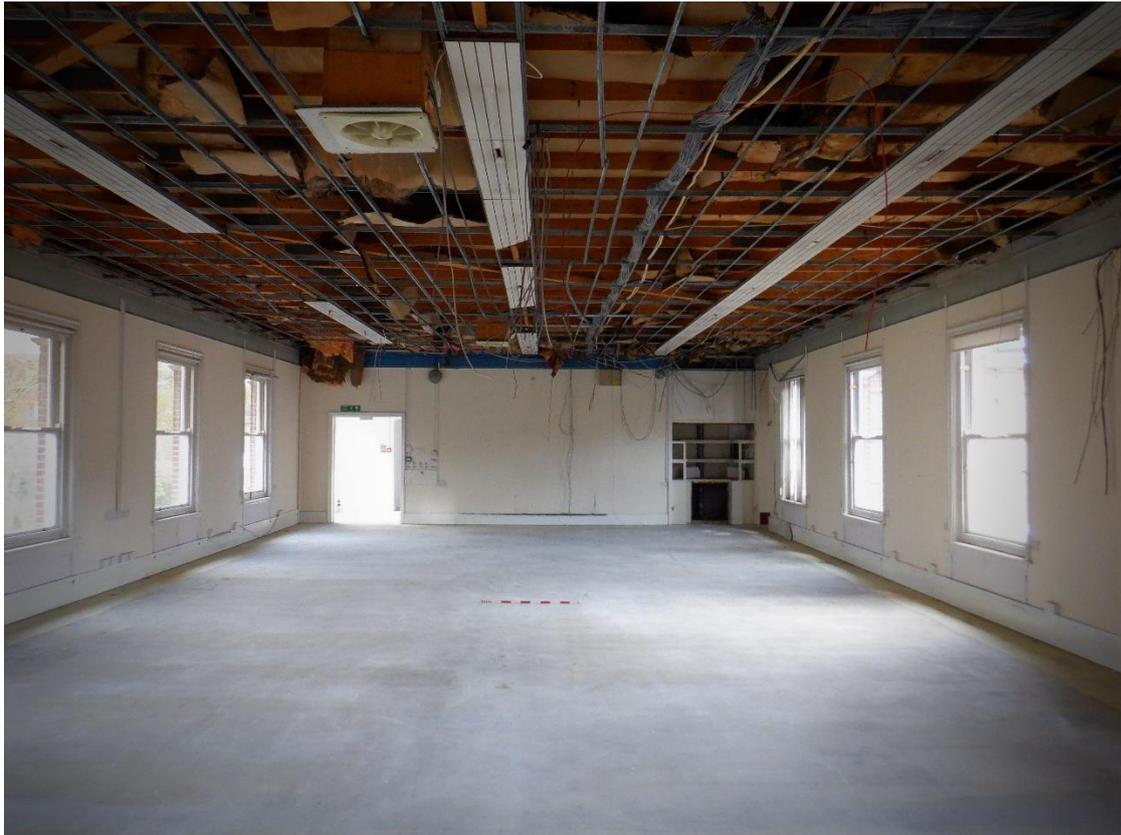
3.12 The later build office blocks are open spaces and have stripped out ready for conversion (Plates 52-57).

Plate 52. Later build office space (looking north-east)
