HISTORIC BUILDING RECORDING AT THE BLACK HOUSE, LOWER RAINHAM ROAD, RAINHAM, GILLINGHAM, KENT

January 2019

1.3 In summary the work consists of an analytic record of the infilled hearth and chimney in the western elevation accompanied by digital photographs and plans.

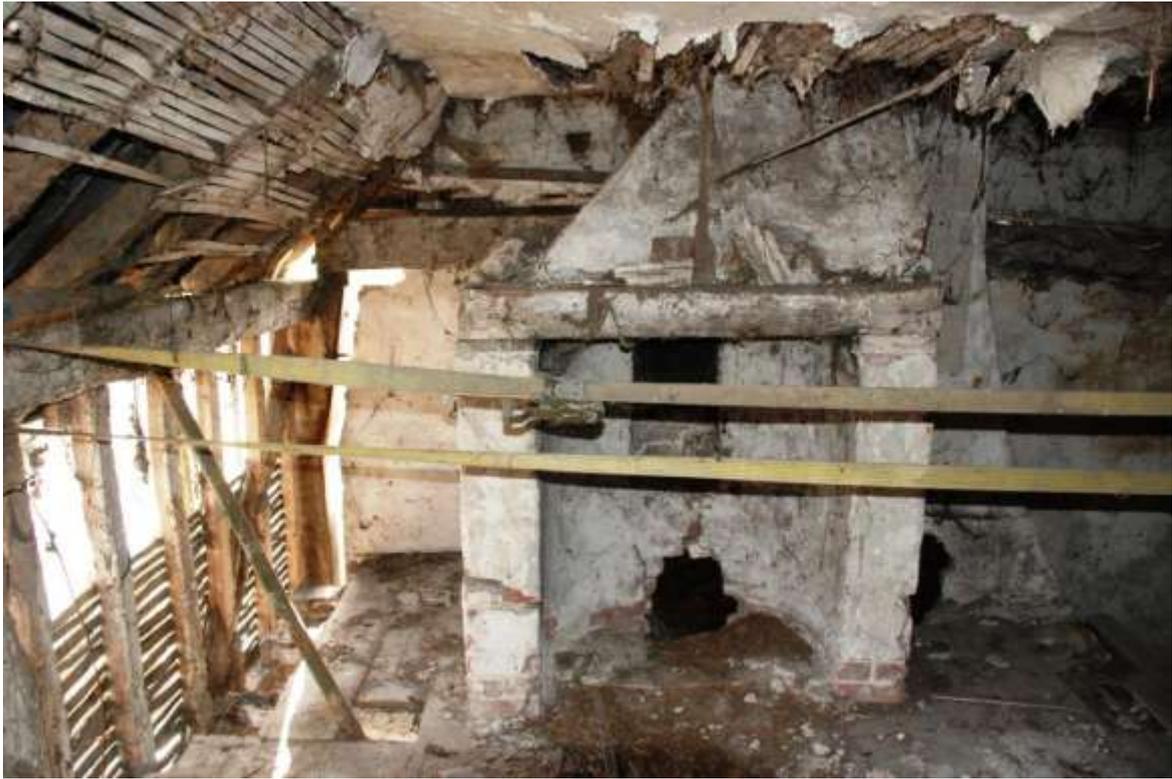
Plate 5. First Floor (looking east)

4.4 First-floor 17th century floorboards and fireplace with wooden bressumer and curved back. Roof has coupled rafters without ridge piece, collar beams with carpenter's marks and lath and plaster partition. Frame has jowled posts and diagonal tension braces (Plates 5-6).

4.7 The Phase 1 build had an arched opening springing from two brick piers with a surviving brick tilt on the upper courses. It is likely at this stage the building did not have an upper floor but the chimney stack was rebuilt as

Phase 2 with an additional fireplace on the upper floor and an additional flue (Drawing 11 and Plates 5-6).

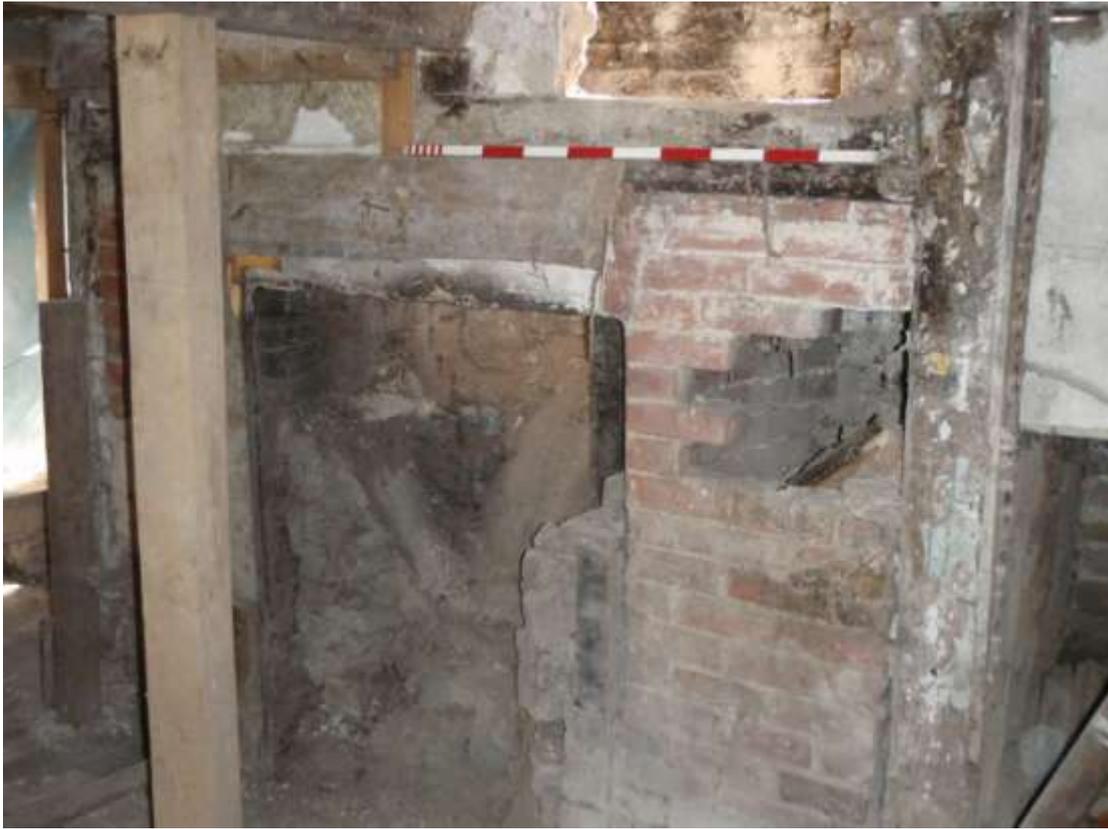
Plate 7. Ground Floor – close up fireplace

4.6 The fireplace is built of red to pink slightly frogged clay bricks measuring 220mm in length and width of 100mm and height of 70mm laid in a Flemish Bond and set in a pale creamy yellow brown fine sandy lime mortar mix of about 18mm thick (Drawing 11 and Plates 7-10).

4.8 As part of the Phase 2 rebuild the arched opening on the ground floor was dismantled and replaced by a 19th century brick soldier course sitting on iron bars. In addition two side walls were added, ground floor levels reduced and a winding staircase added and the access closed with machine cut timber T & G boarding fitted vertically with a later Victorian panelled door (Drawing 11 and Plates 7-10).

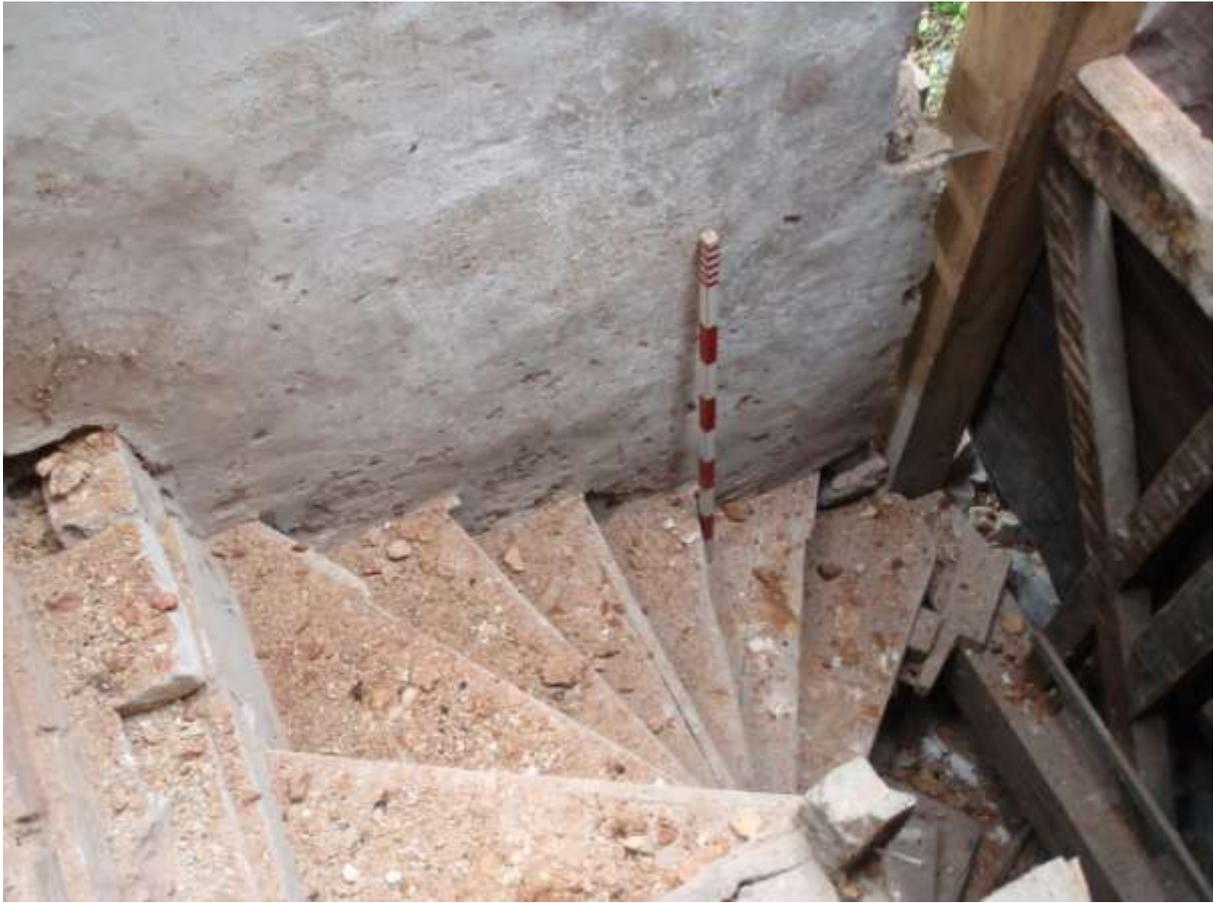
Plate 13. Stairs to the right of chimney

4.3 Eighteenth century wooden winder stair (Plates 13-14).

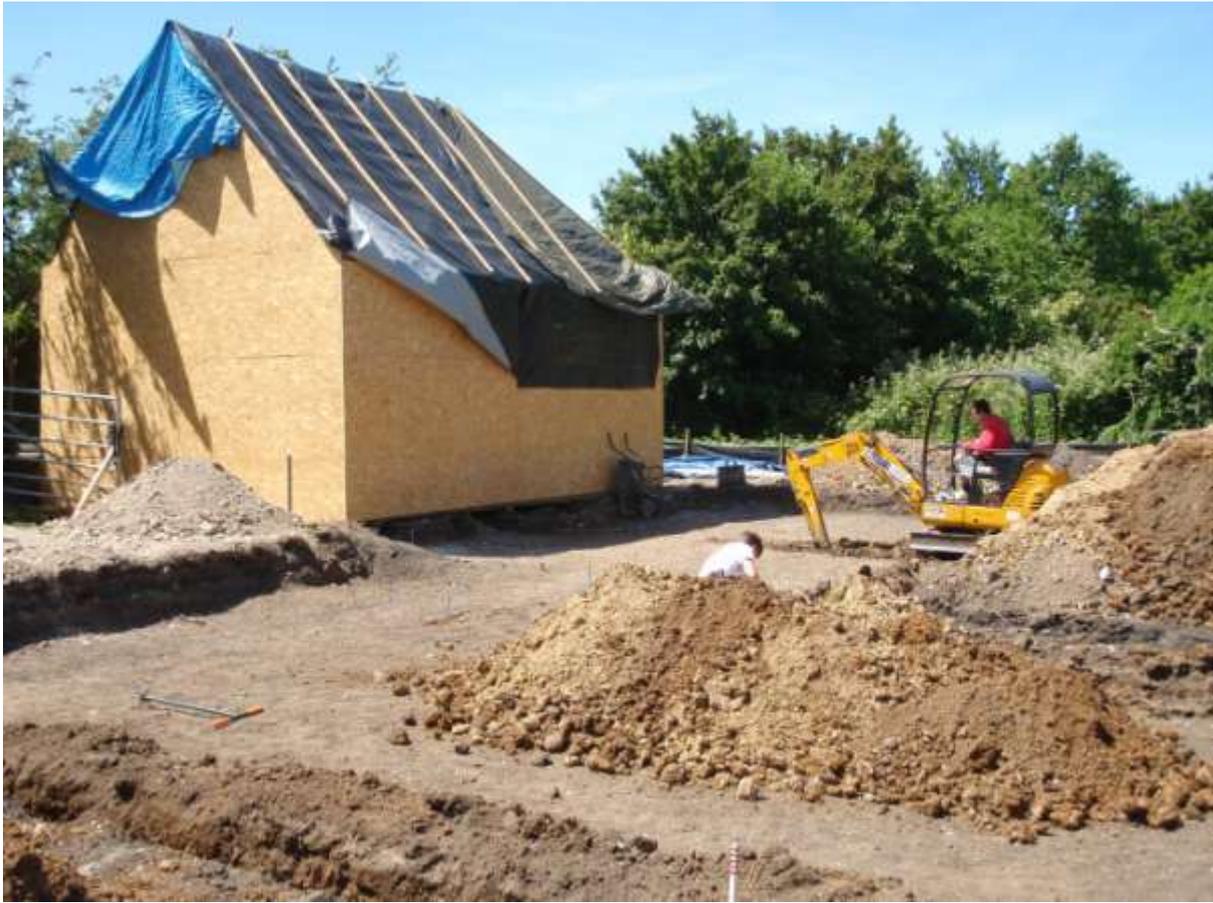
Plate 15. Plate 16 (below) The Black House under preparation for moving and view of trenches being watched

5.1 Behind the weatherboarding is the substantially intact frame of a three-bay 17th century farmhouse which will be moved to a new location. The brick internal fireplace will need to be numbered and de-constructed in a recorded manner to enable reconstruction at the new location site (Figure 1 & Plate 15).

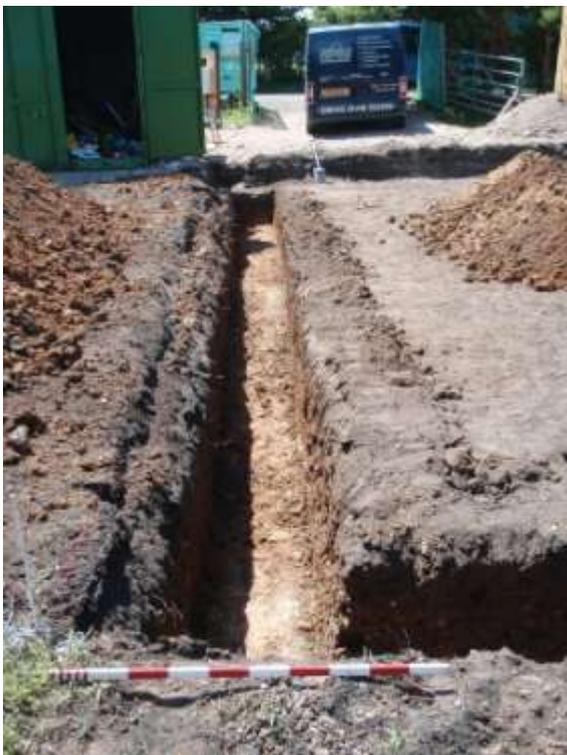
No archaeological features or remains were revealed by the trenching (Plate 16).

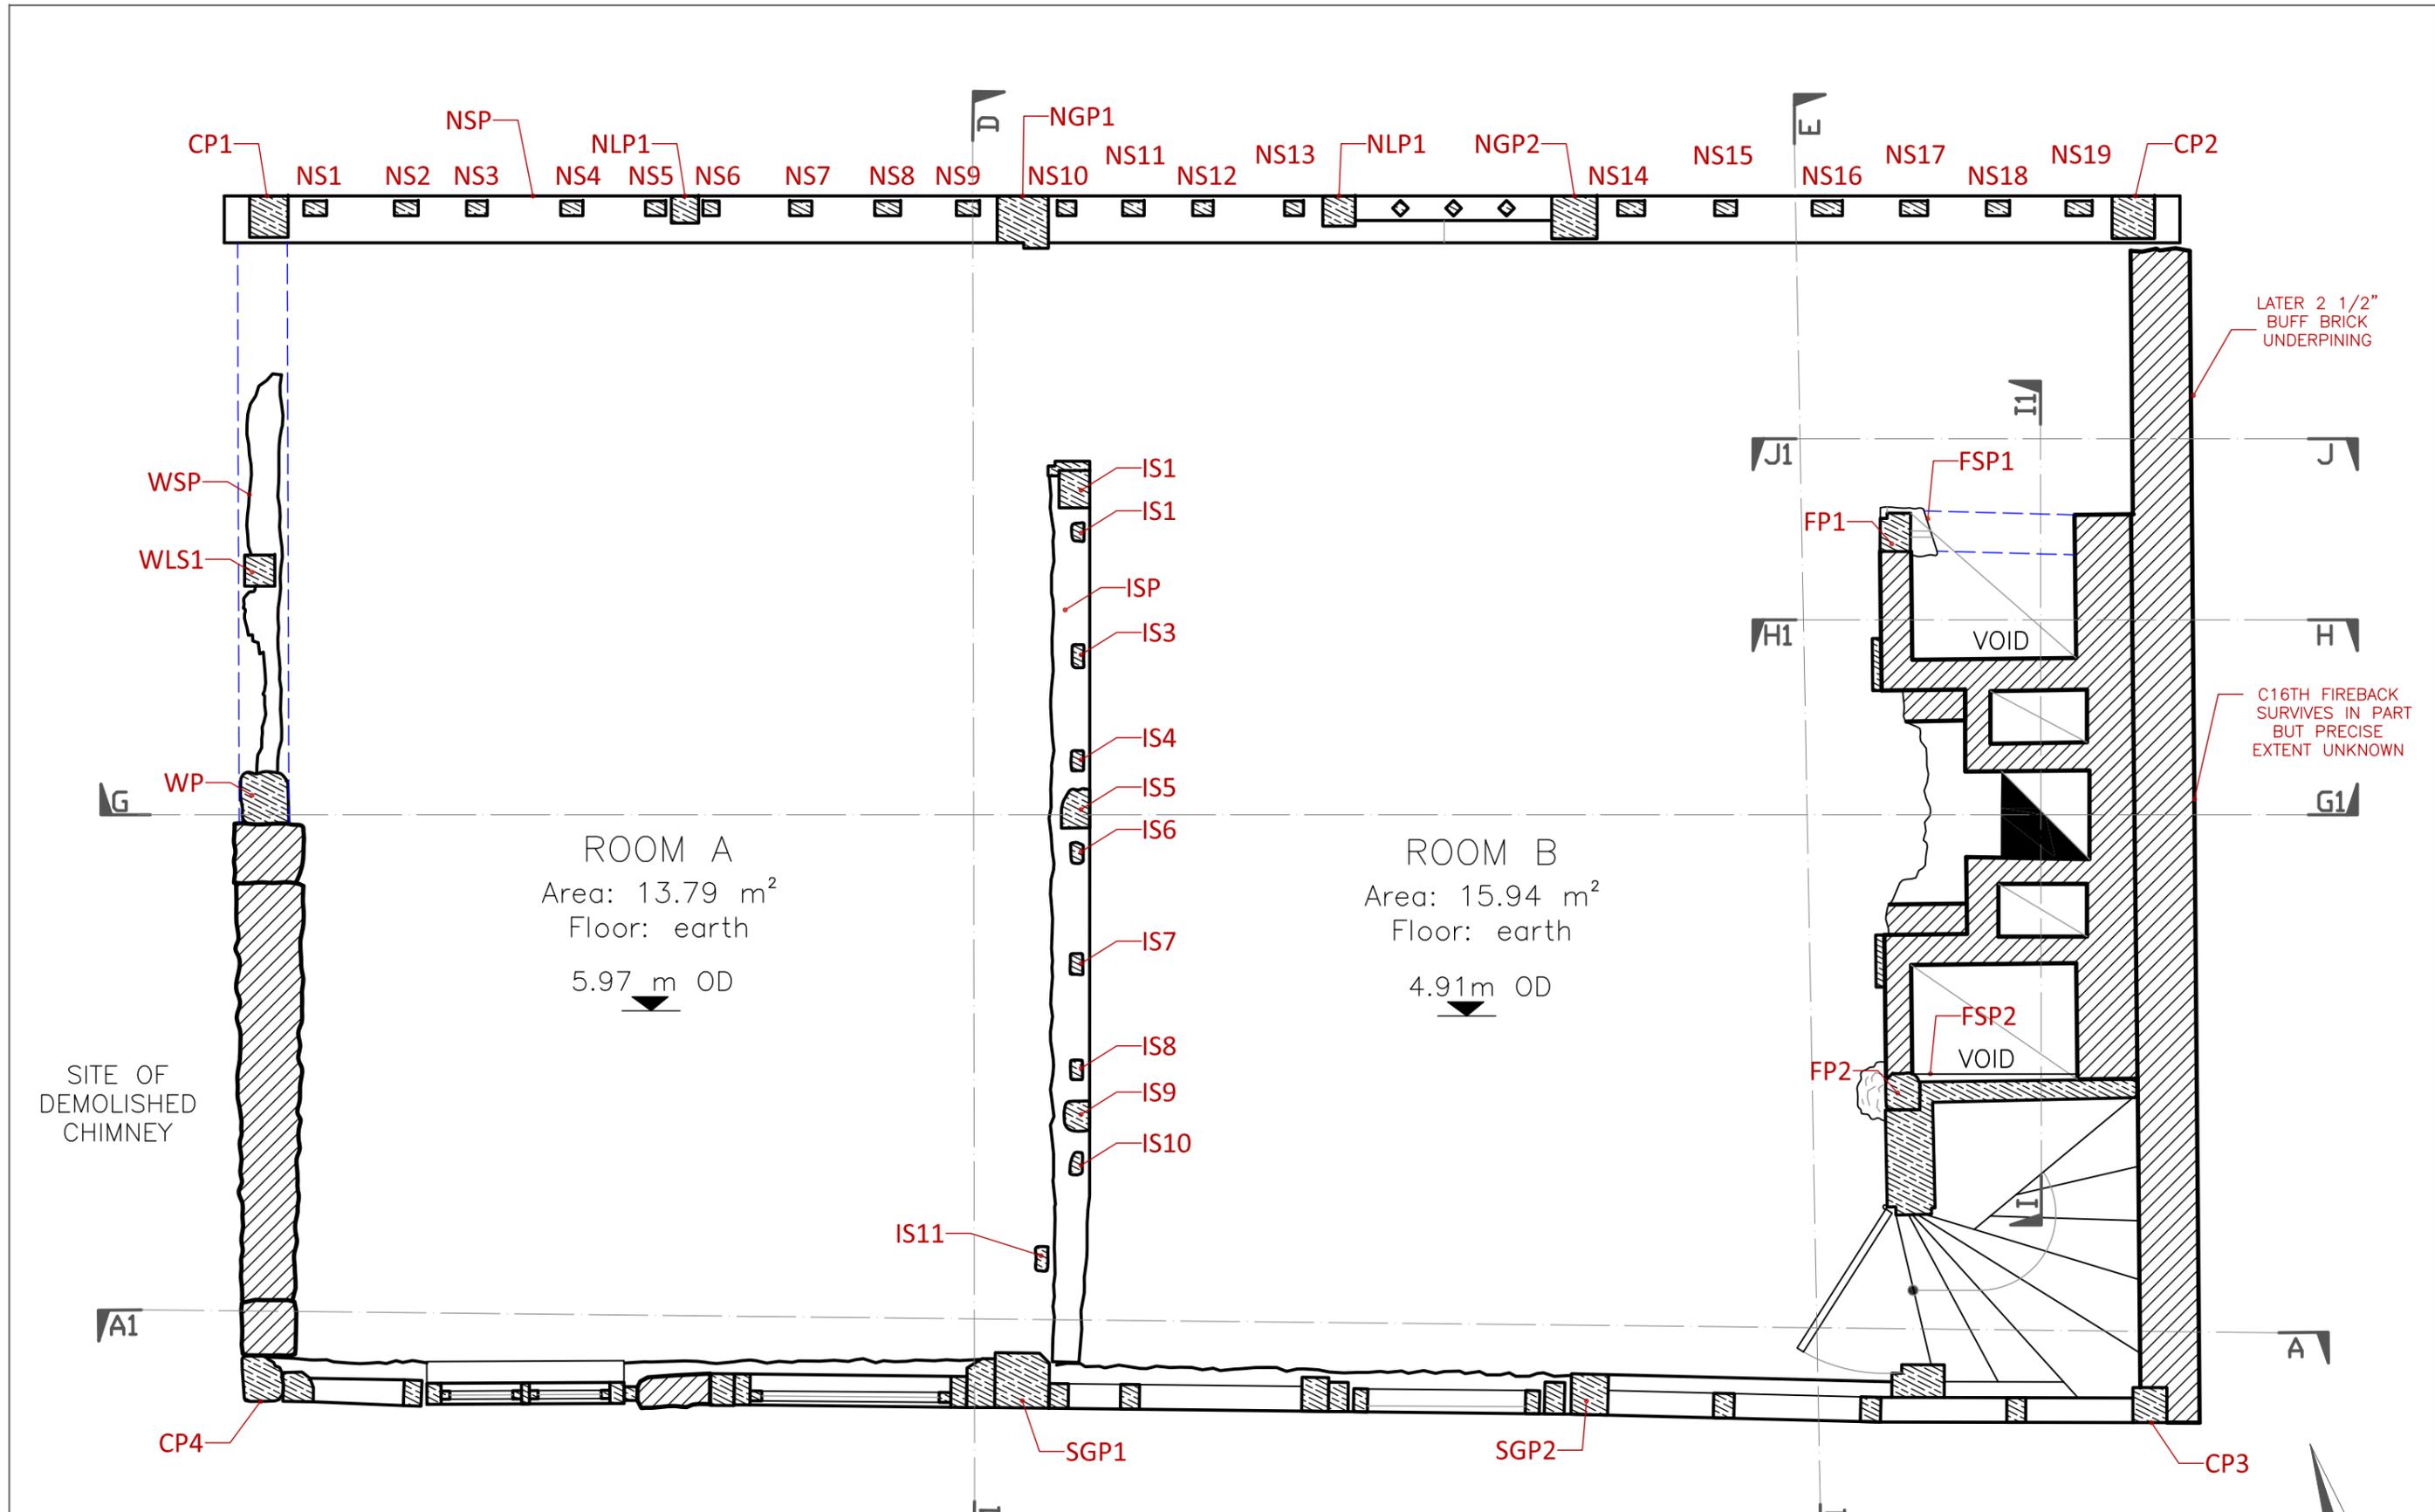
GROUND FLOOR PLAN

4.1 The interior of the building has a complete frame except for east wall, which was rebuilt in brick when former lath and plaster smoke bay was converted to a chimney (Drawings 1-5).

4.2 Ground-floor east room has chamfered spine beam with lamb's tongue stop, west room has chamfered floor hoists.

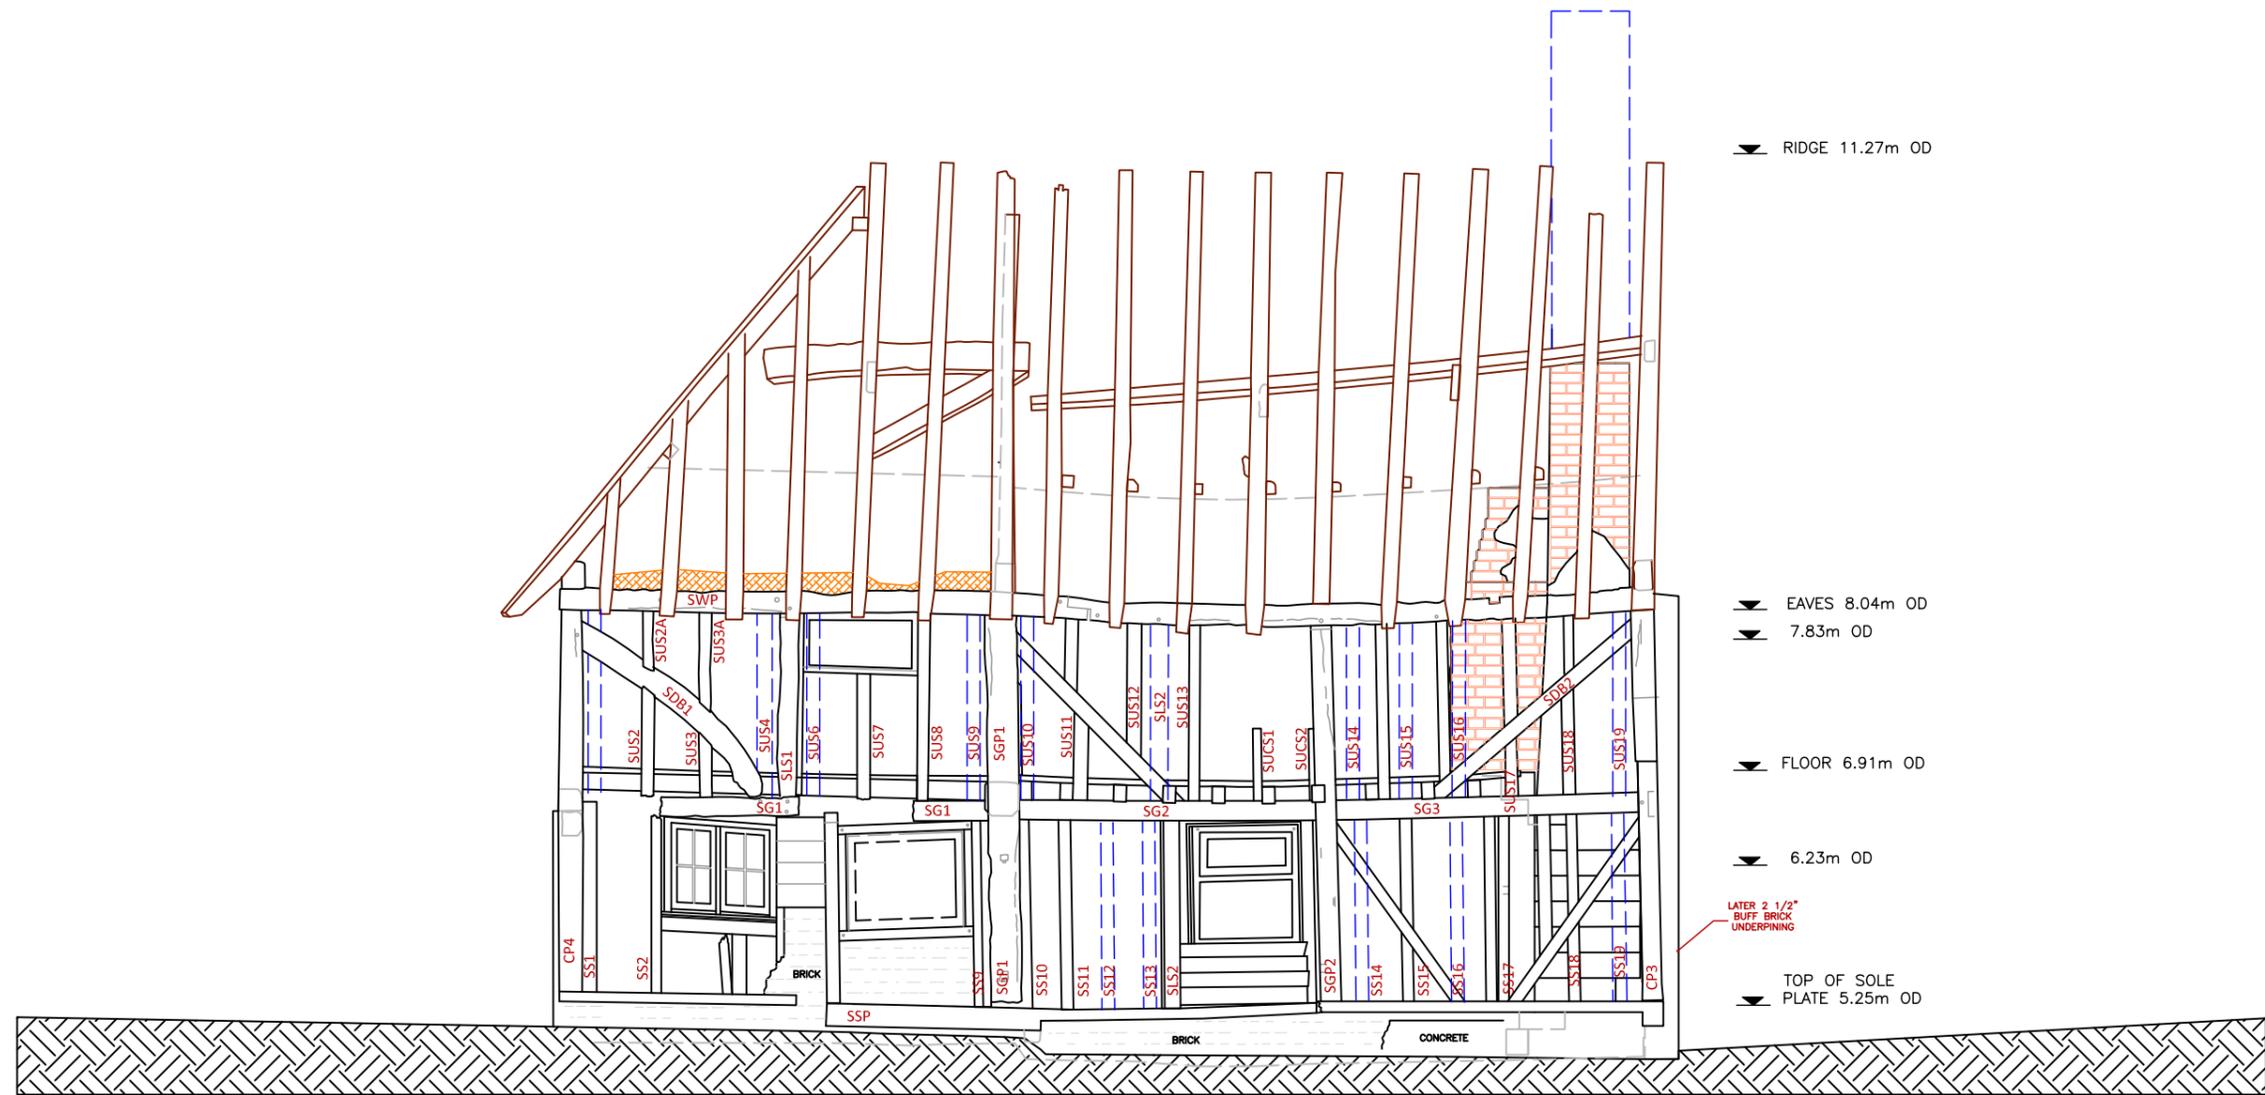
SOUTH ELEVATION

3.3 Two-bay hall house, originally with smoke bay at east end. North front has one mid 19th century square casement window but others are concealed by weather boarding. The structure appears to be the two surviving bays of a three-bay house. Opening at first-floor level on north front indicates that the west first-floor room was used for storage (Drawings 6-10).
