Archaeological Evaluation of Land at the former Lipscomb Cars Site, Bridge House, Chart Road, Ashford, Kent TN23 3HZ

Site Code: BHA-EV-24

Report for;
Betteridge & Milsom
08/09/2024

Document Reference: 34340.01

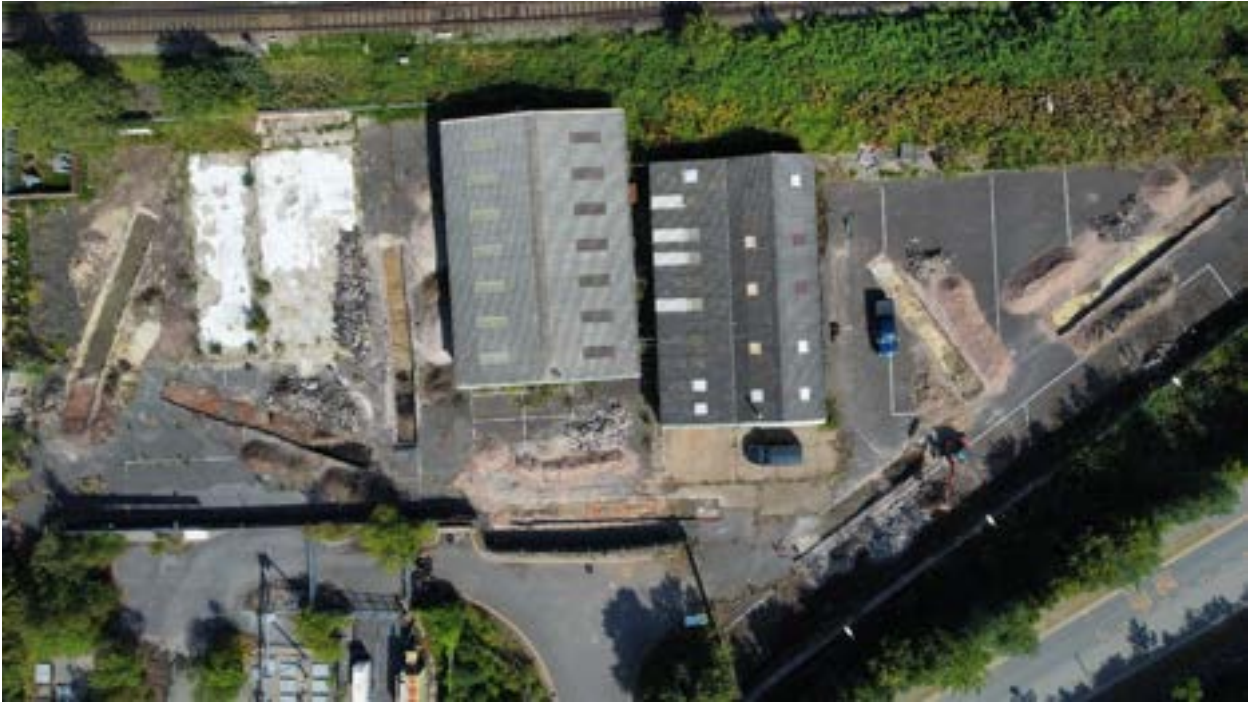
Plate 1 Aerial photograph of the site following excavation of the archaeological trenches

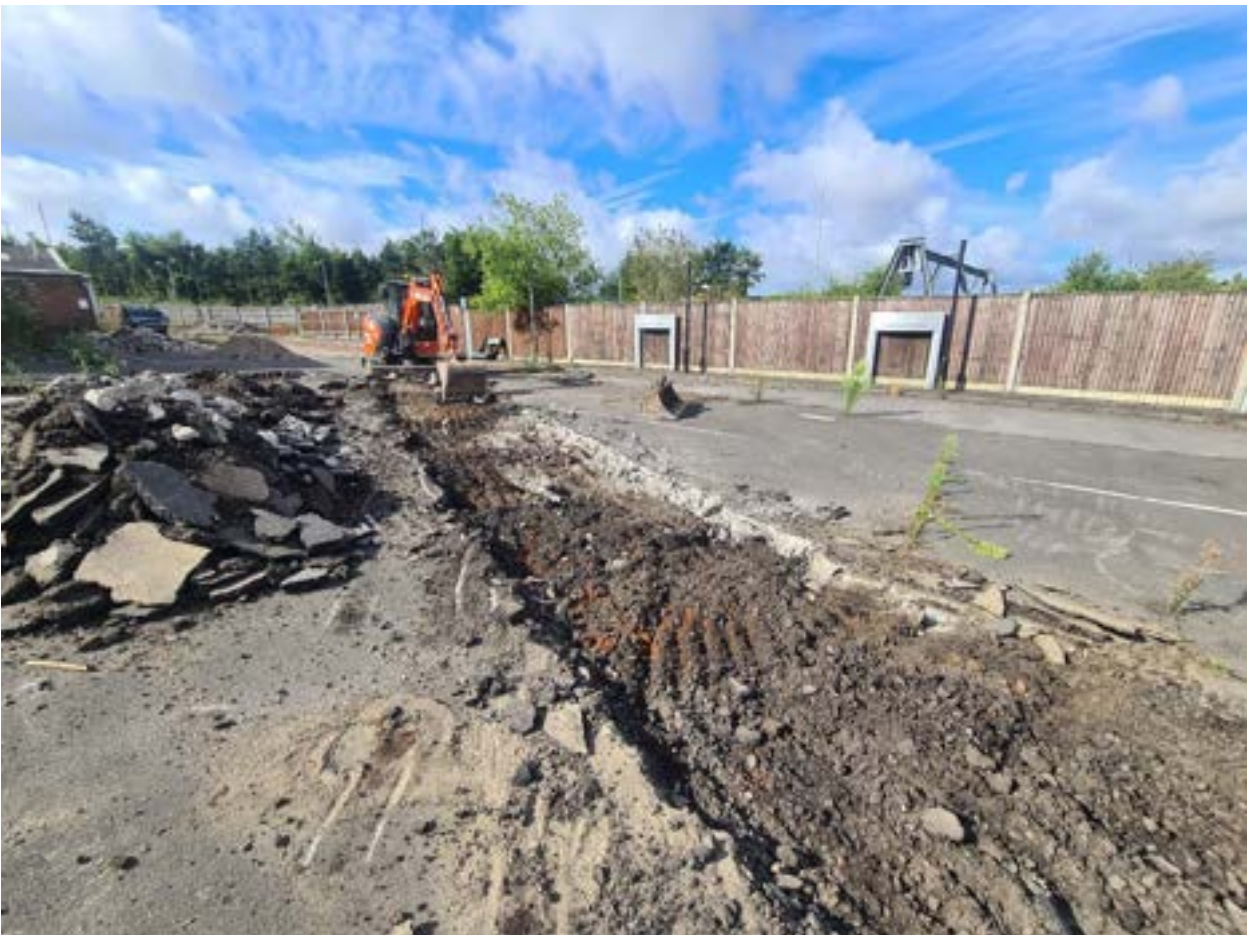
- 5.2.2 The trenches were excavated in two phases with the upper concrete slab being removed (Phase 1) prior to removal of any further overburden (Phase 2) to the upper archaeological horizon (Plate 2).

Plate 2 Archaeological trenches were excavated in two phases; removal of concrete surface followed by excavation to upper archaeological horizon

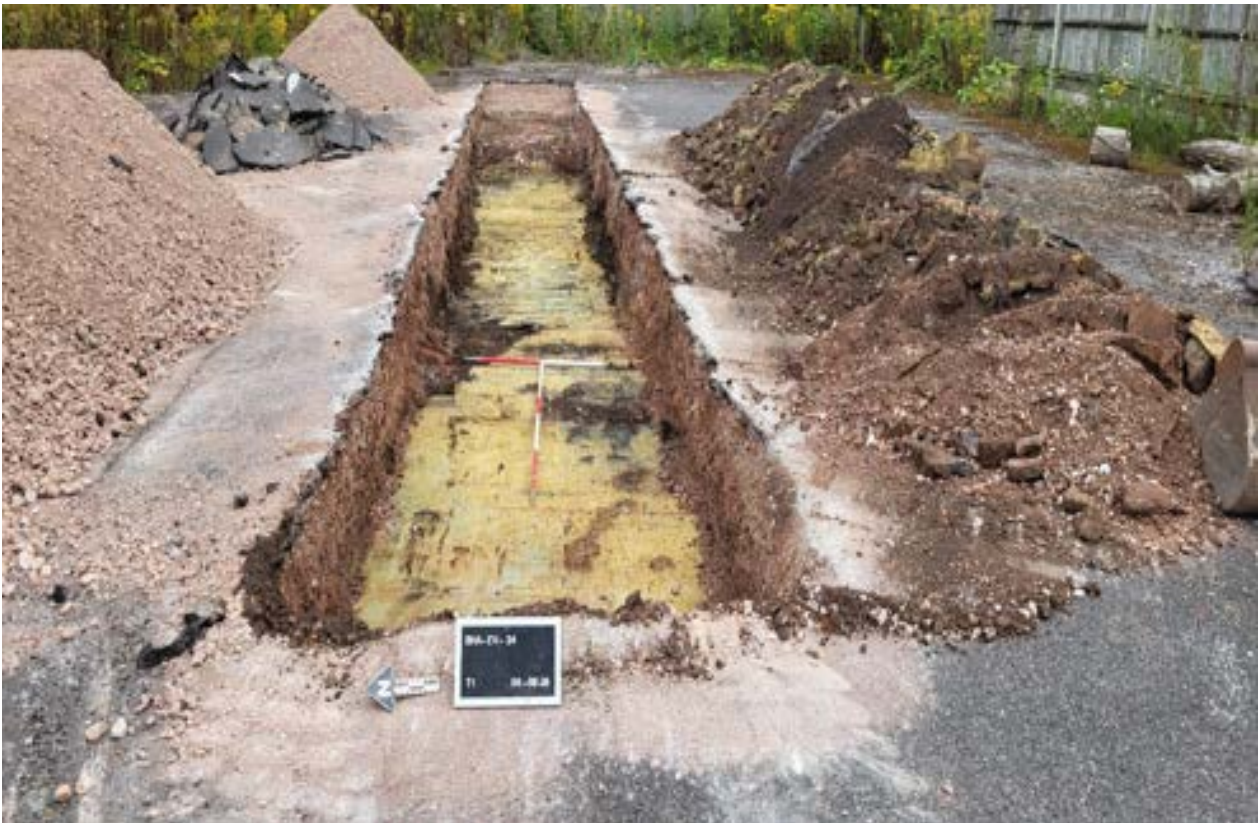
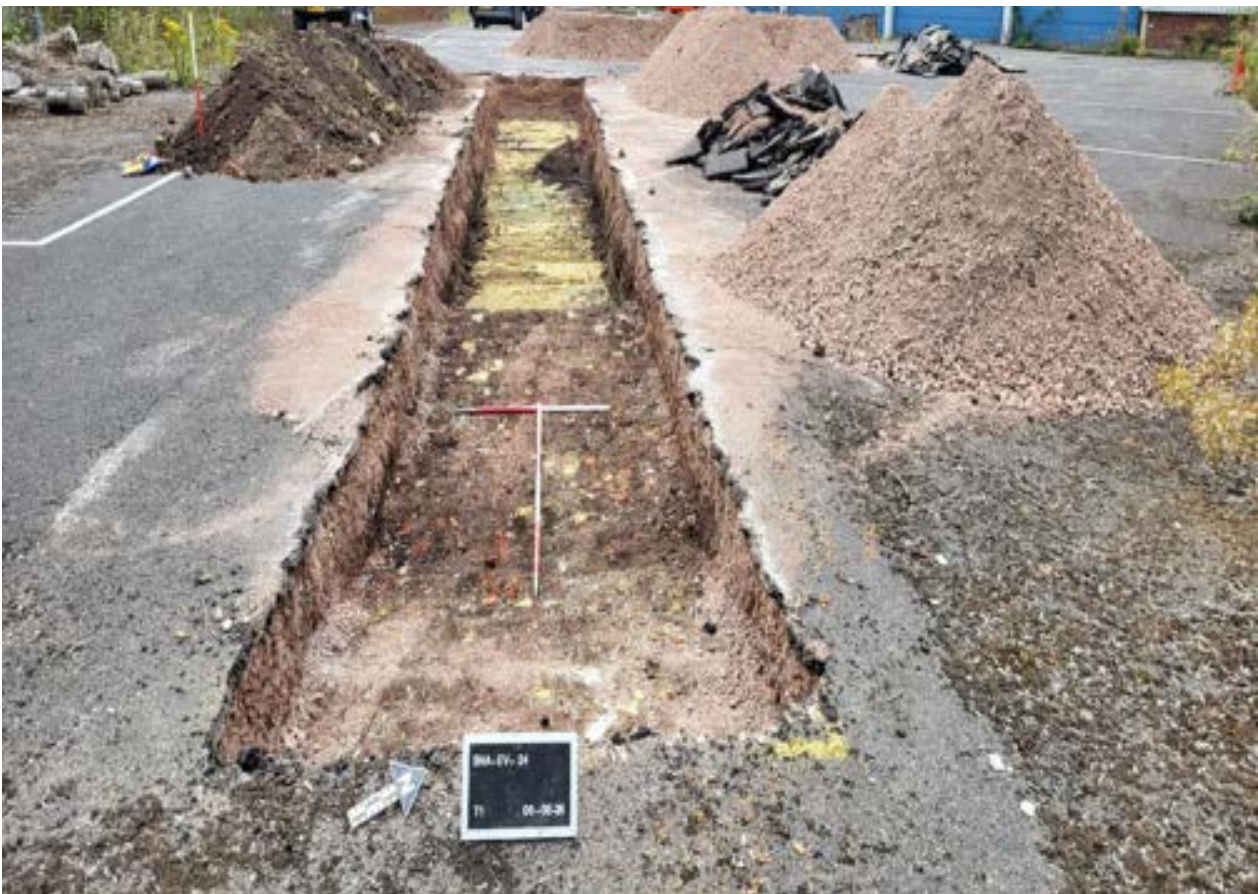
- 5.3.1 Within the southern extent of the site (Figure 2), Trench 1 was excavated on a NE-SE alignment and measured approximately 20m in length, 1.8m in width with a maximum depth of 0.64m (Figure 3). Natural geological deposits (104) were recorded at levels ranging from 3.95m OD and 4.10m OD, below a tarmac surface (101) that sealed Type I reject stone (102) which overlay made ground (103) sealing the natural clay (104).

- 5.3.2 No archaeological finds or features were present in Trench 1.

Plate 3 Trench 1, viewed from the northwest

Plate 4 Trench 1, viewed from the southeast

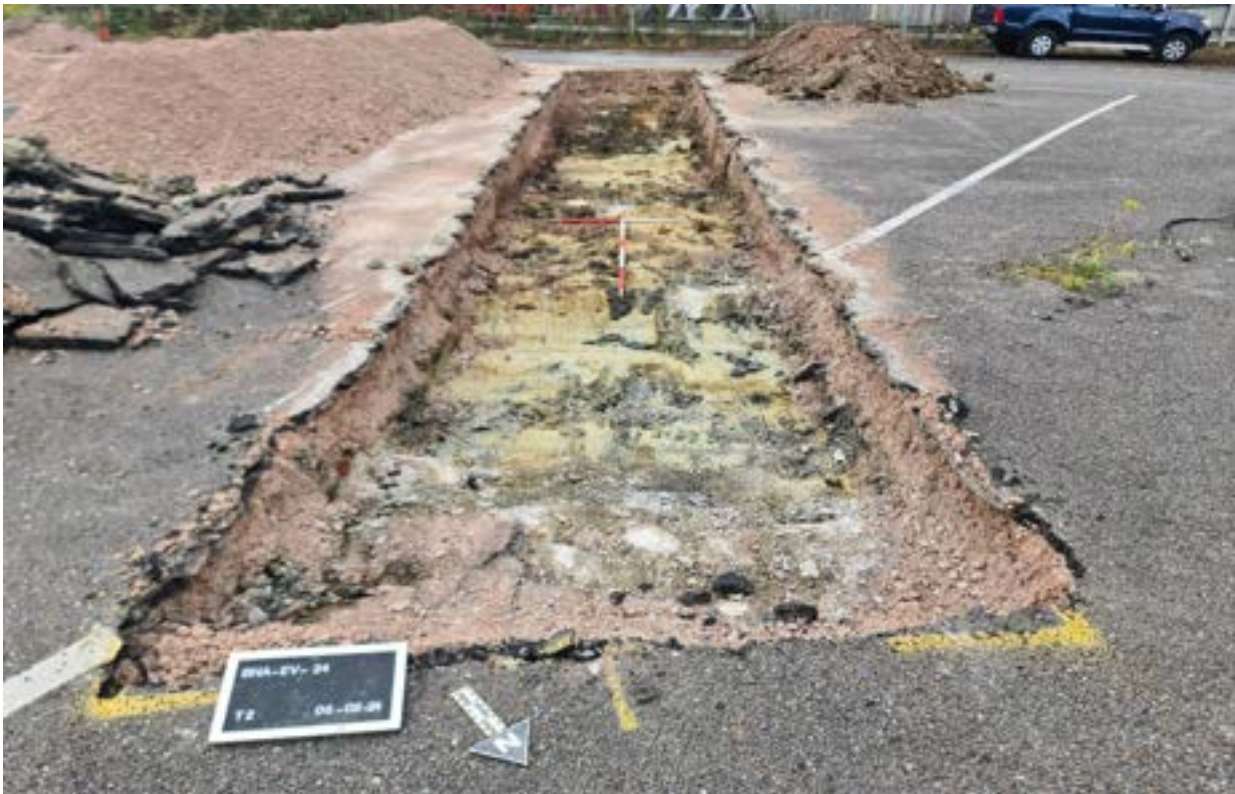
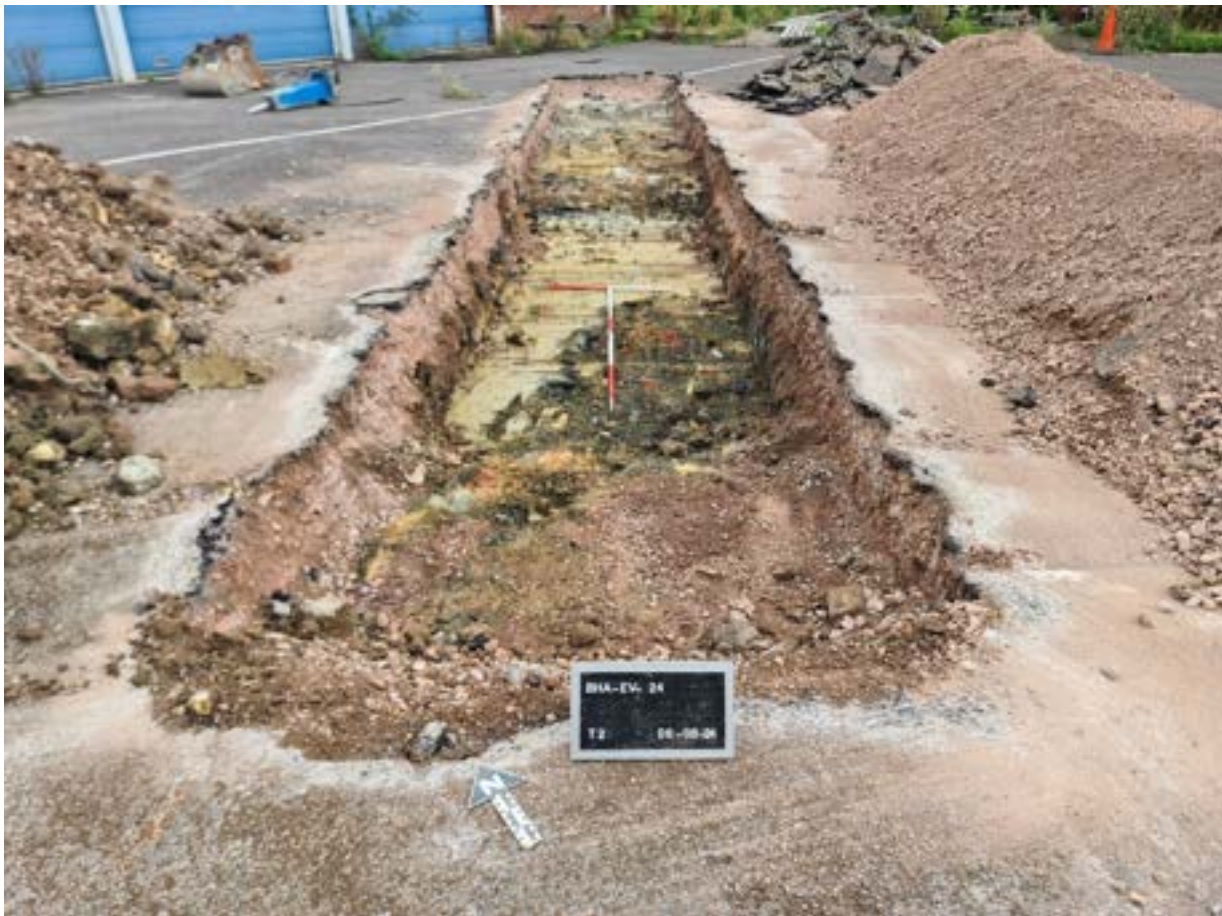
- 5.3.3 Trench 2 was located within the southern extent of the site, north of Trench 1. This trench was excavated on a NE-SW alignment and measured 20.6m in length (Figure 4) with an average depth of 0.62m. Natural geological horizons (203) were recorded at a level of approximately 3.78m OD, sealed below made ground (203) which was topped by Type 1 stone (202) and a tarmac surface (201).

- 5.3.4 Two areas of modern disturbance included a pit filled with hardcore and plastic sheeting, and a ceramic soakaway drain. No archaeological finds or features were recorded within Trench 2.

Plate 5 Trench 2, viewed from the northeast

Plate 6 Trench 2, viewed from the southwest

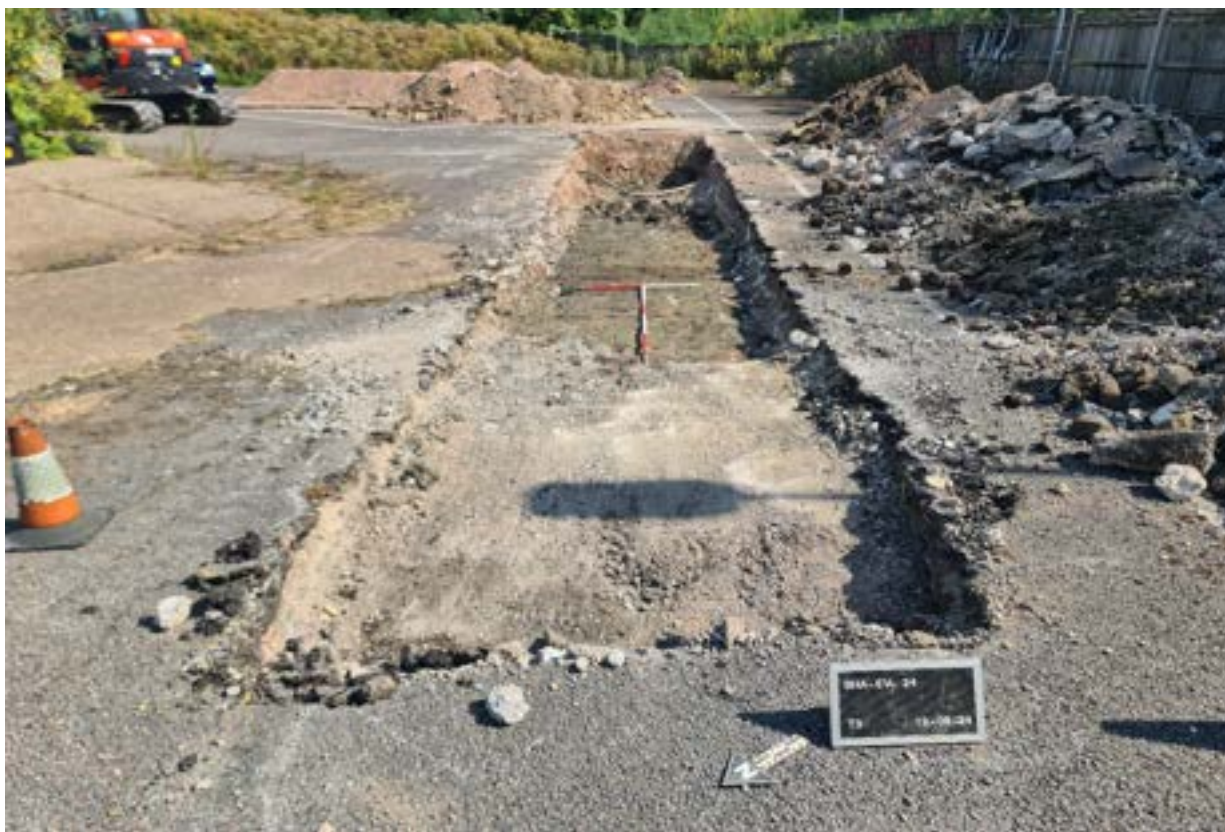
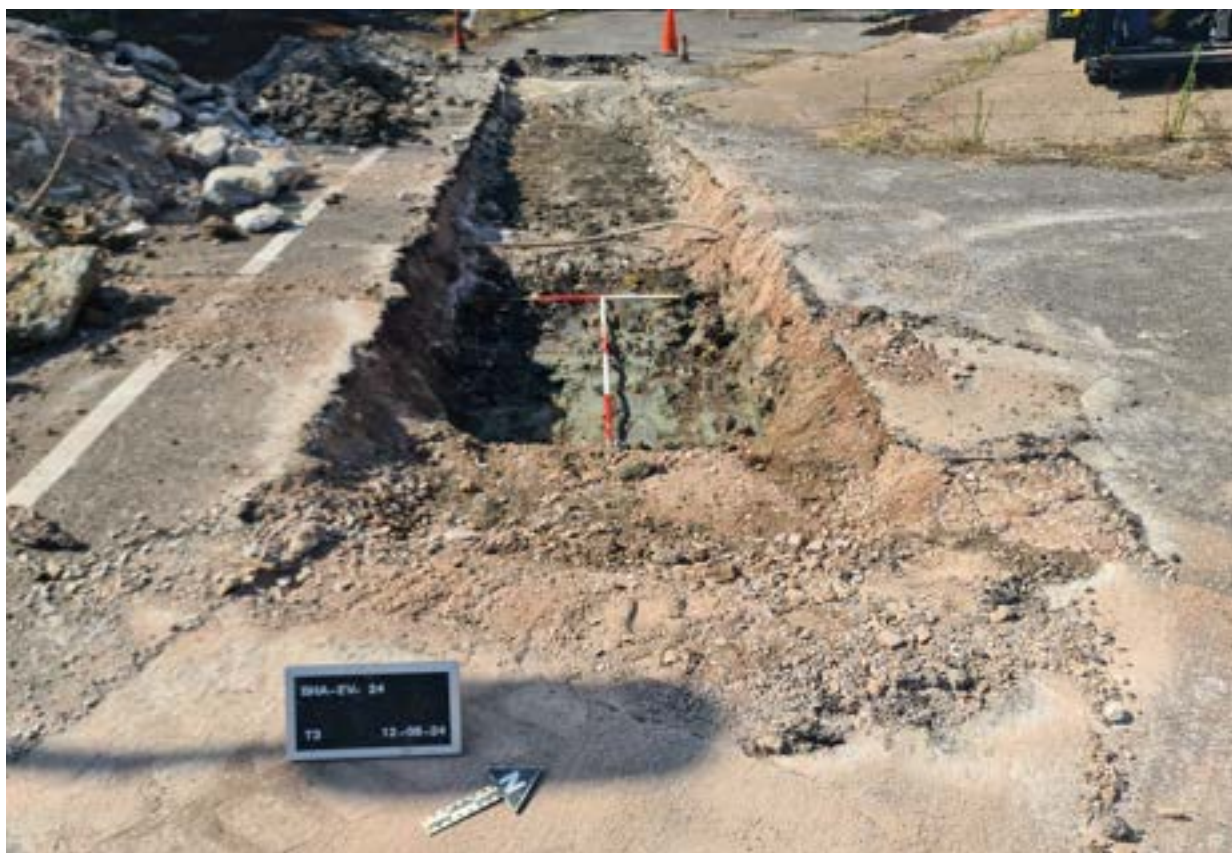
- 5.3.5 Within the southern area of the site (Figure 2) adjacent to the western boundary, Trench 3 was excavated on an NW-SE alignment and measured approximately 16.4m in length, 1.8m in width with a maximum depth of 0.62m (Figure 5). This trench was reduced in length so that access could be maintained to the site. As with the two former trenches, steps were cut into the ends of the trench to provide safe access/egress.
- 5.3.6 Natural geological deposits (305) were recorded at a level of approximately 2.88m OD, below a stratigraphic sequence that comprised a tarmac surface (301) over Type 1 reject stone (302) which sealed a reinforced concrete slab (303). Direct made ground (304) sealed the natural clay.

- 5.3.7 A live electric surface was recorded within this trench (Figure 5). No archaeological finds or features were present.

7.2.3 To the south Trench 3 was heavily disturbed during the construction of a modern reinforced concrete slab and services, and so it is suggested southernmost building shown on the historical mapping may have been completely removed.

Plate 7 Trench 3, viewed from the northwest

Plate 8 Trench 3, viewed from the southeast

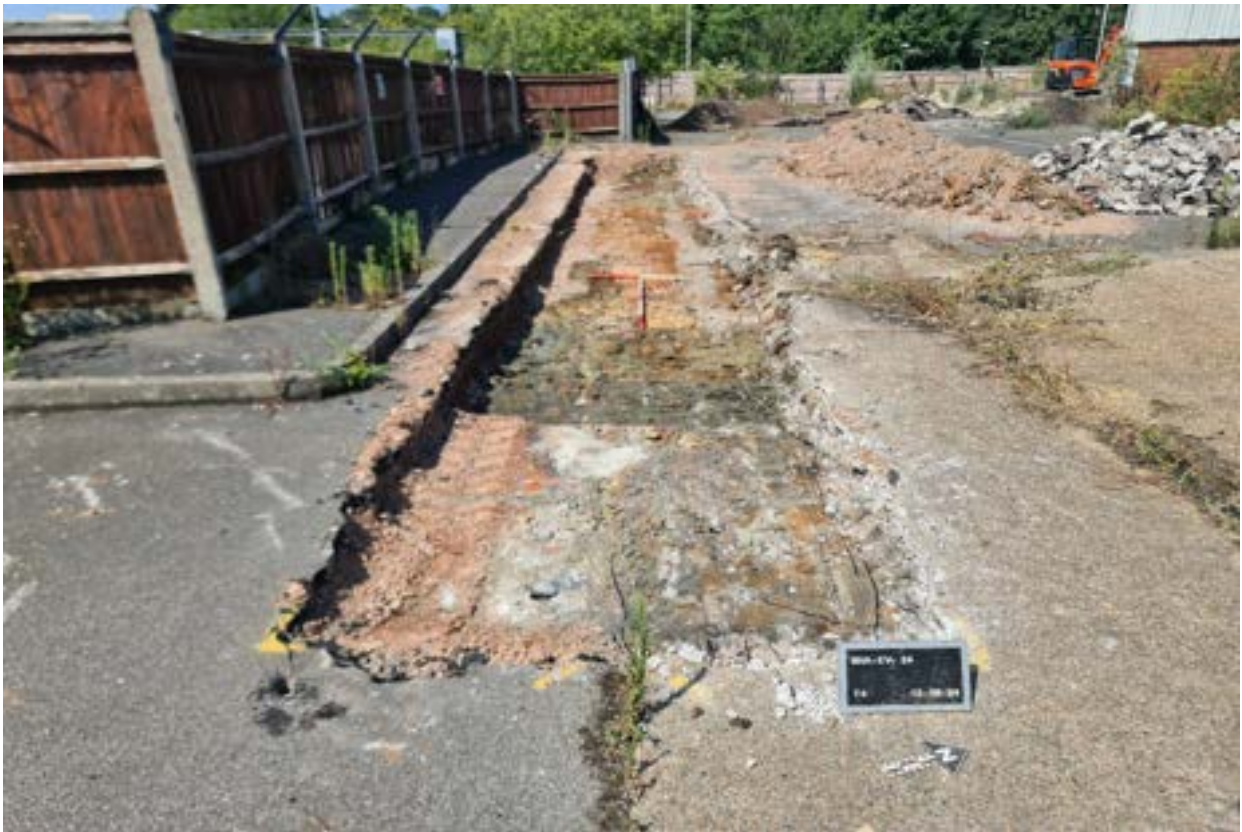
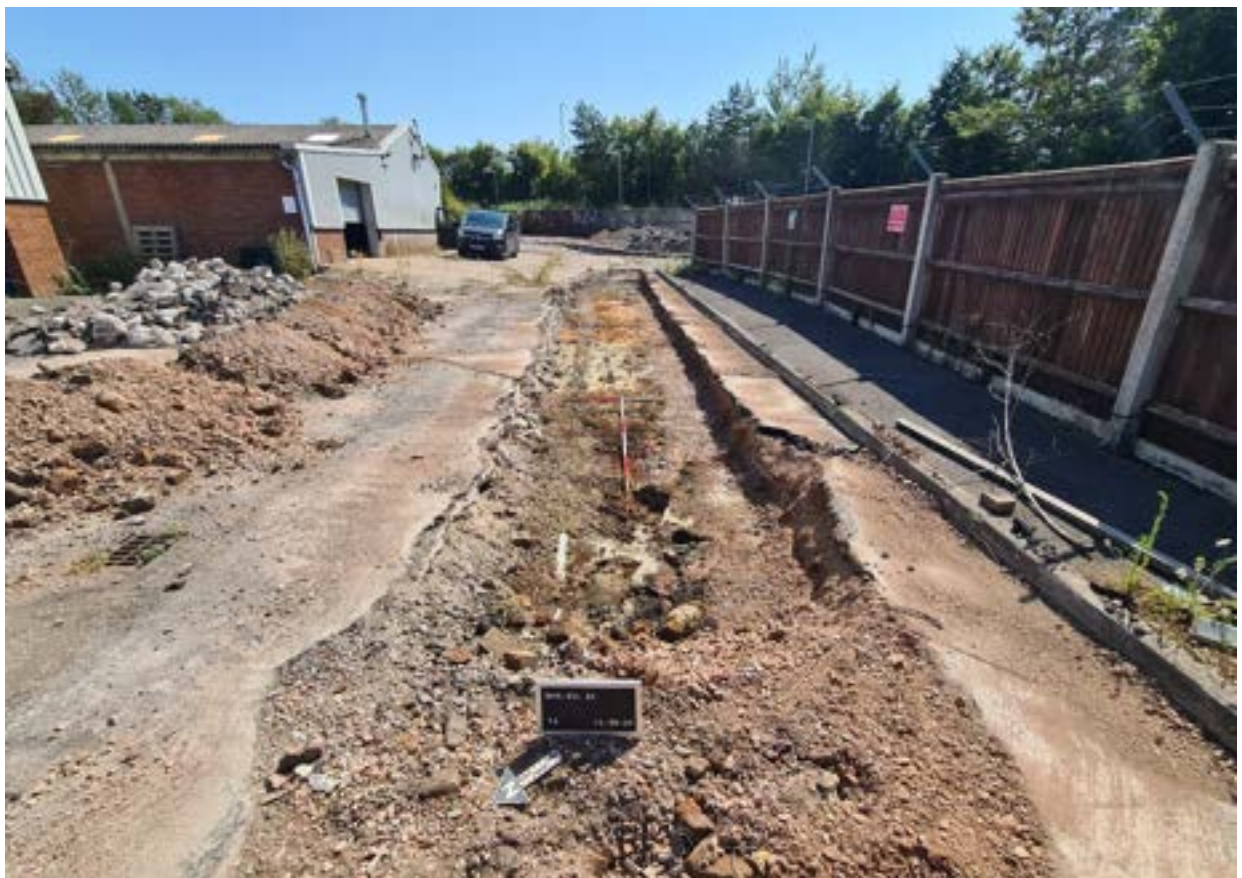
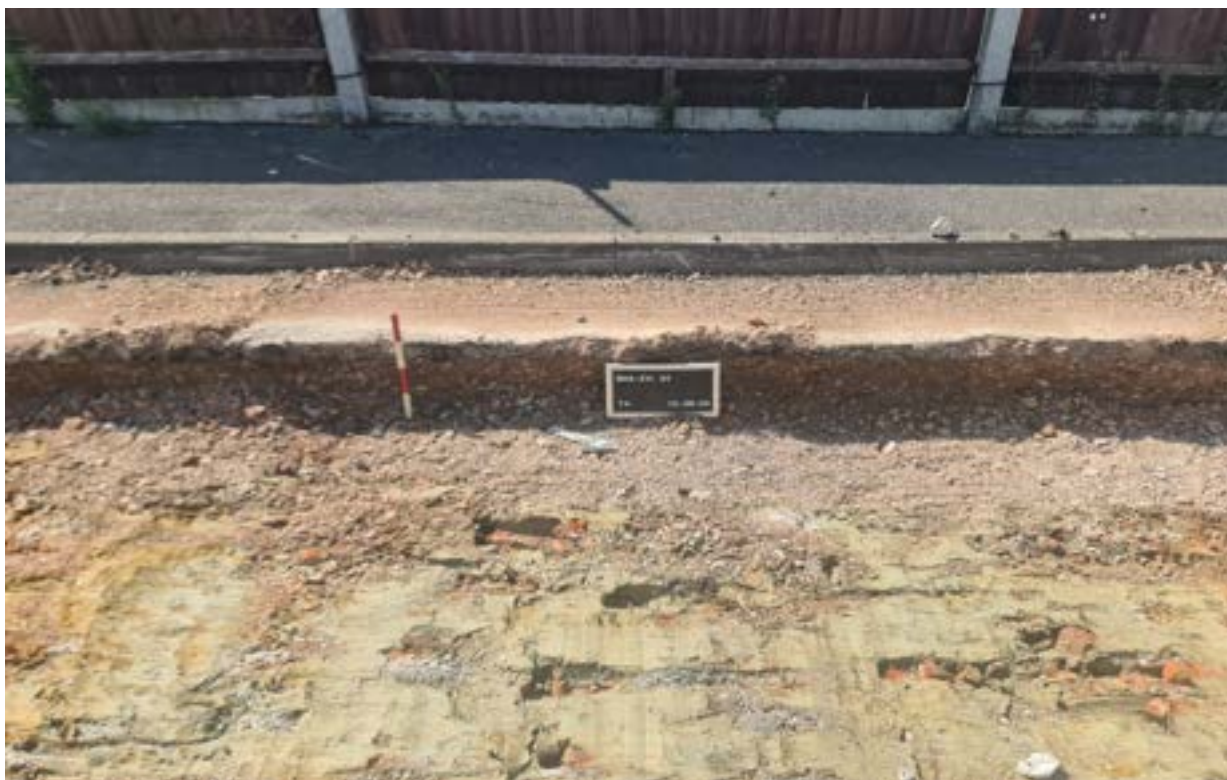
- 5.3.8 Within the central western extent of the site (Figure 2), Trench 4 was excavated on a NW-SE alignment and measured approximately 20m in length, 1.8m in width with a maximum depth of 0.64m (Figure 3). Natural geological deposits (403) were recorded at a level of approximately 3.14m OD, c. 0.29m below the existing ground surface (Plate 11). The upper horizon of the natural clay was heavily truncated along the full extent of the trench by modern service trenches.
- 5.3.9 Within the central area of the trench the faint remains of a former building was recognised. The fill of the structure comprised pulverised brick dust and small fragments of mortar (405), which formed the linear remains of what appeared to be a former building. Although now demolished, it is considered possible that this building may have been related to the former brickworks present on the site.

Plate 9 Trench 4, viewed from the southeast

Plate 10 Trench 4, viewed from the northwest

Plate 11 Trench 4, Representative Section RS4/1

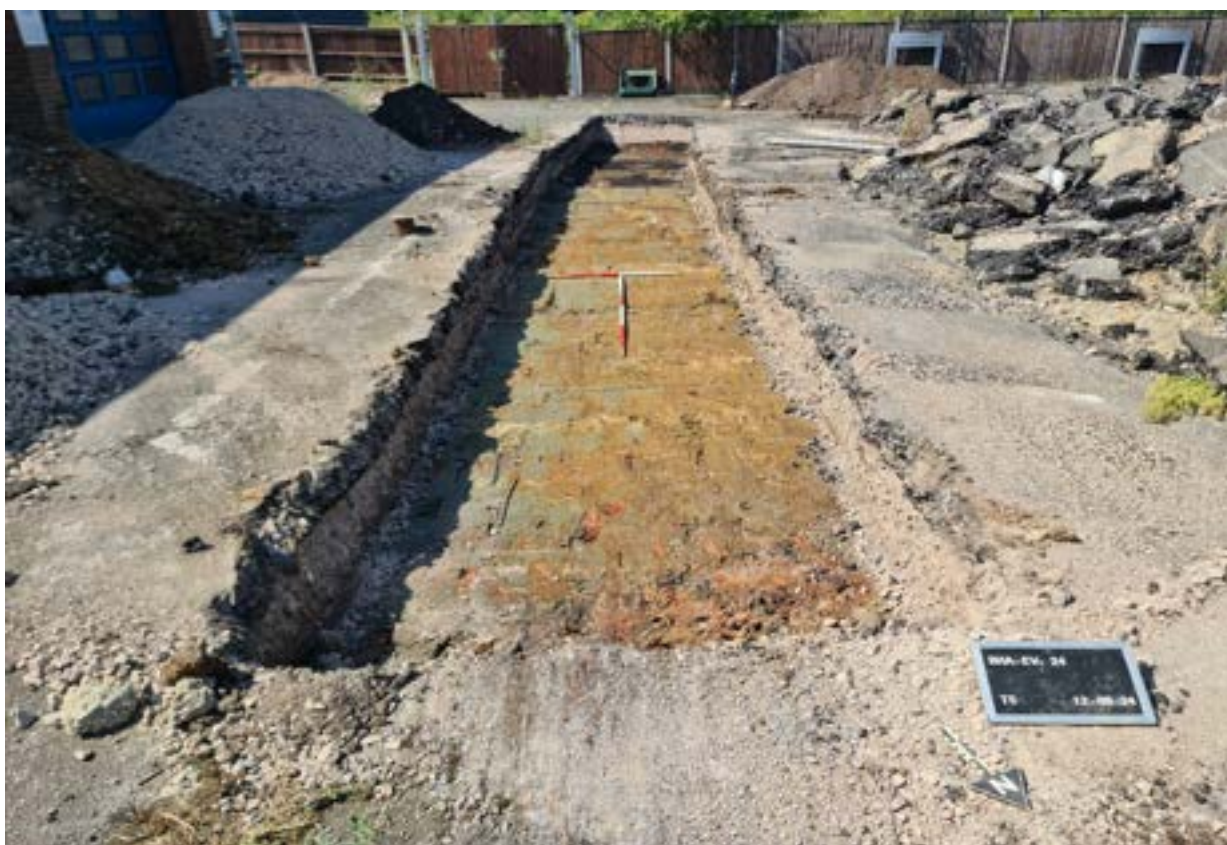
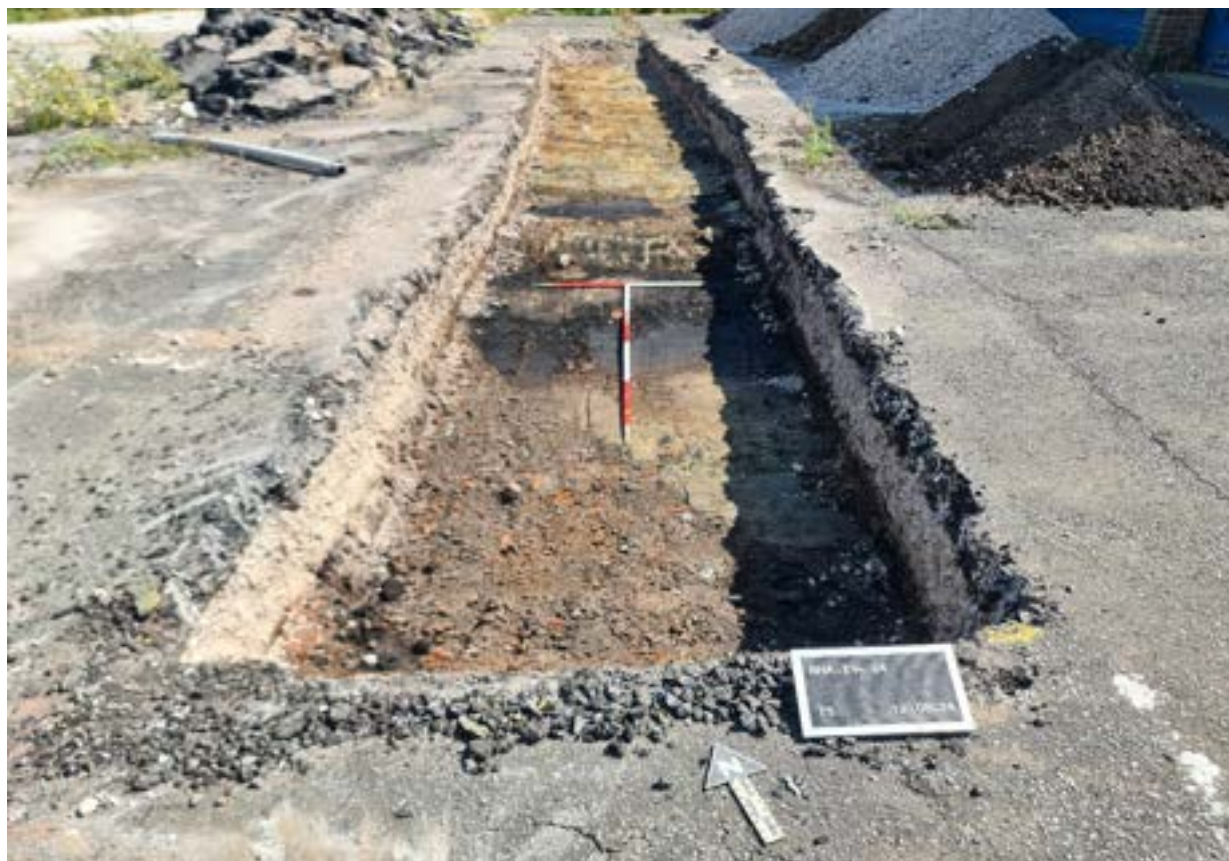
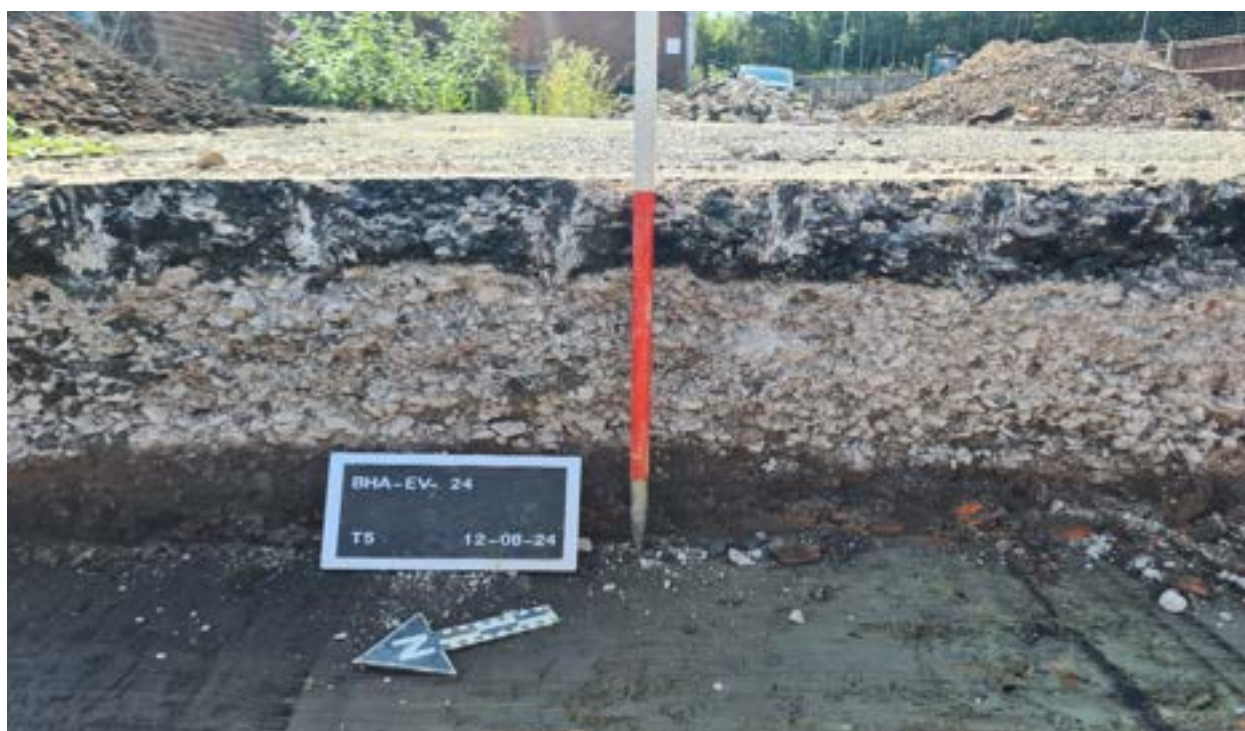
- 5.3.10 Within the central northern extent of the site (Figure 2), Trench 5 was excavated on an E-W alignment and measured approximately 21m in length, 1.8m in width with a maximum depth of 0.59m (Figure 7). Natural geological deposits (503) were recorded at a level of approximately 2.69m OD, below a tarmac surface (501) that sealed compact deposited chalk (502) (Plate 14). The upper horizon of the natural clay was truncated by modern drains, with a large, contaminated pit present at the western extent.
- 5.3.11 No archaeological finds or features were present in Trench 5.

Plate 12 Trench 5, viewed from the northeast

Plate 13 Trench 5, viewed from the southwest

Plate 14 Trench 5, representative Section RS5/1

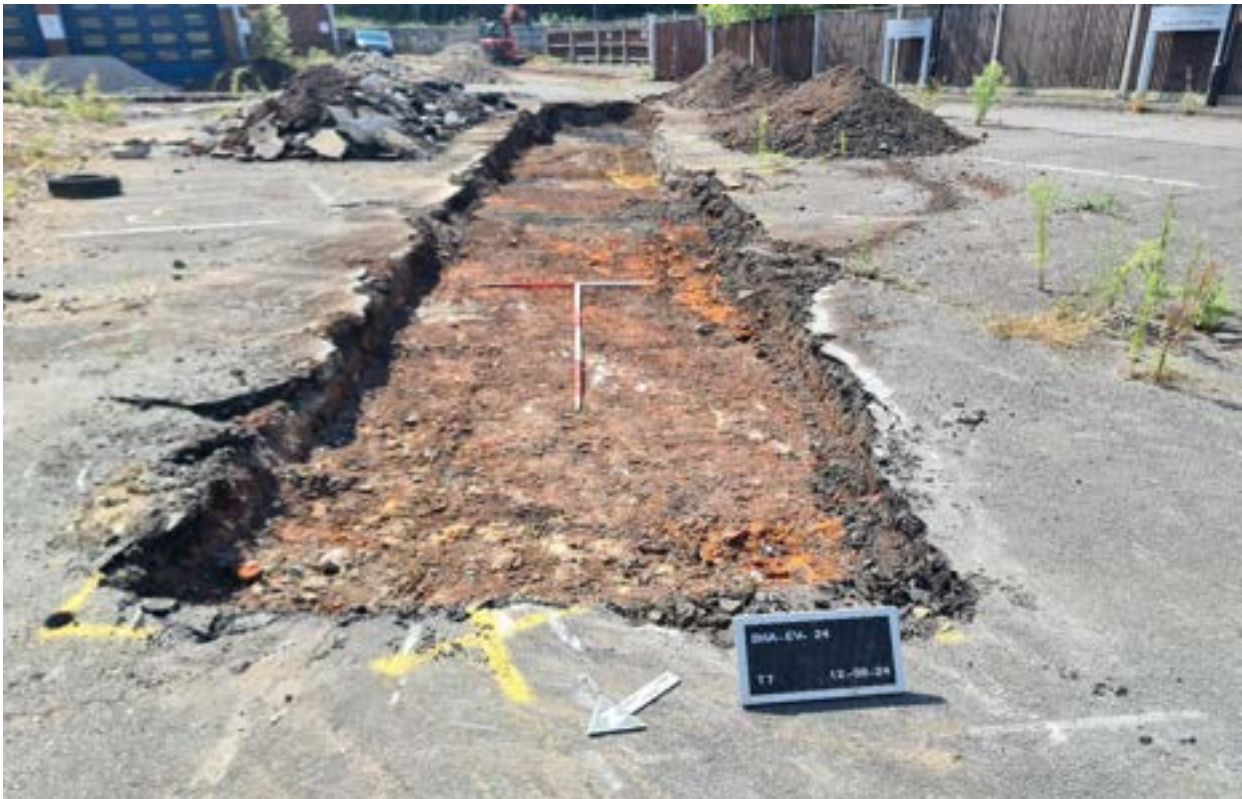
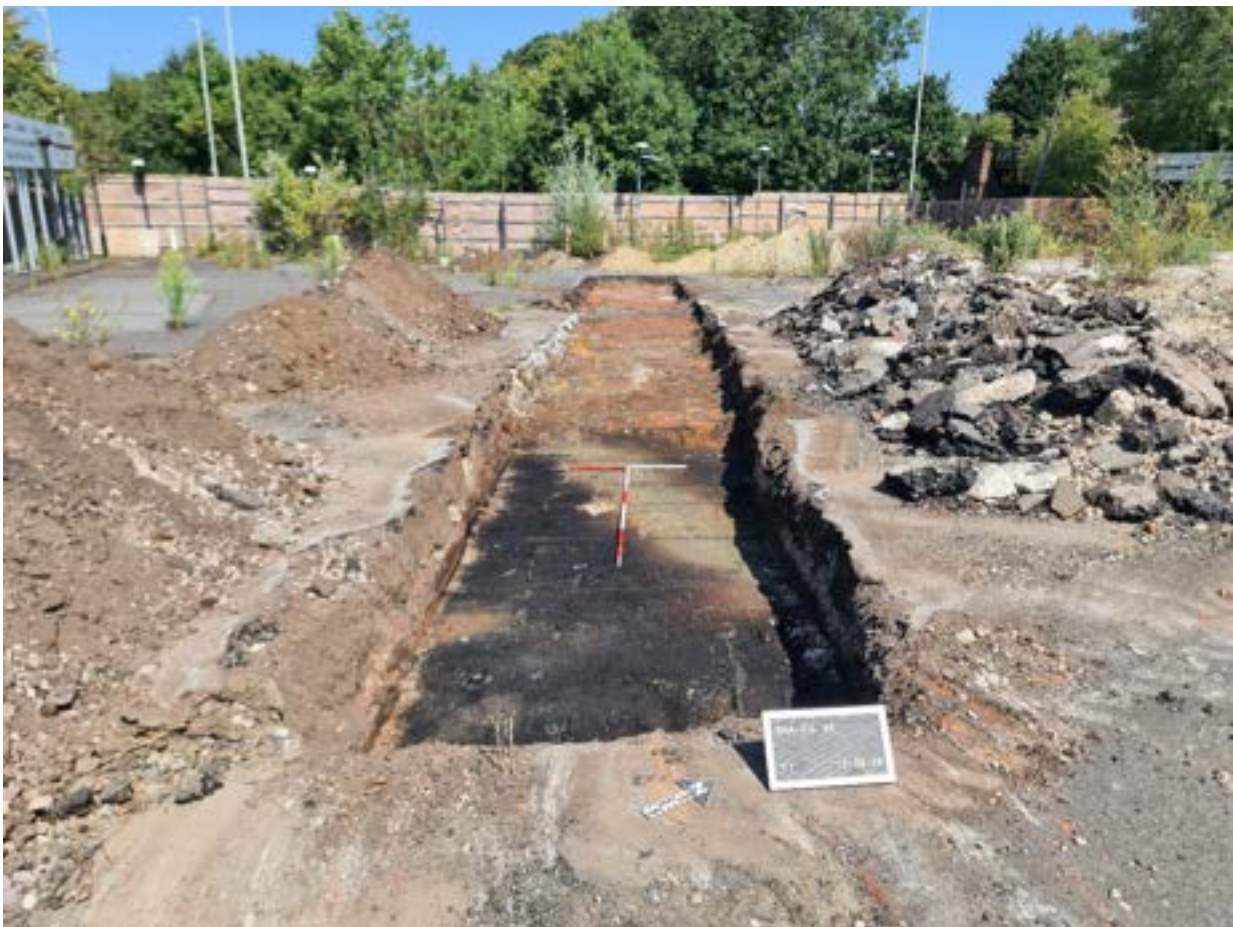
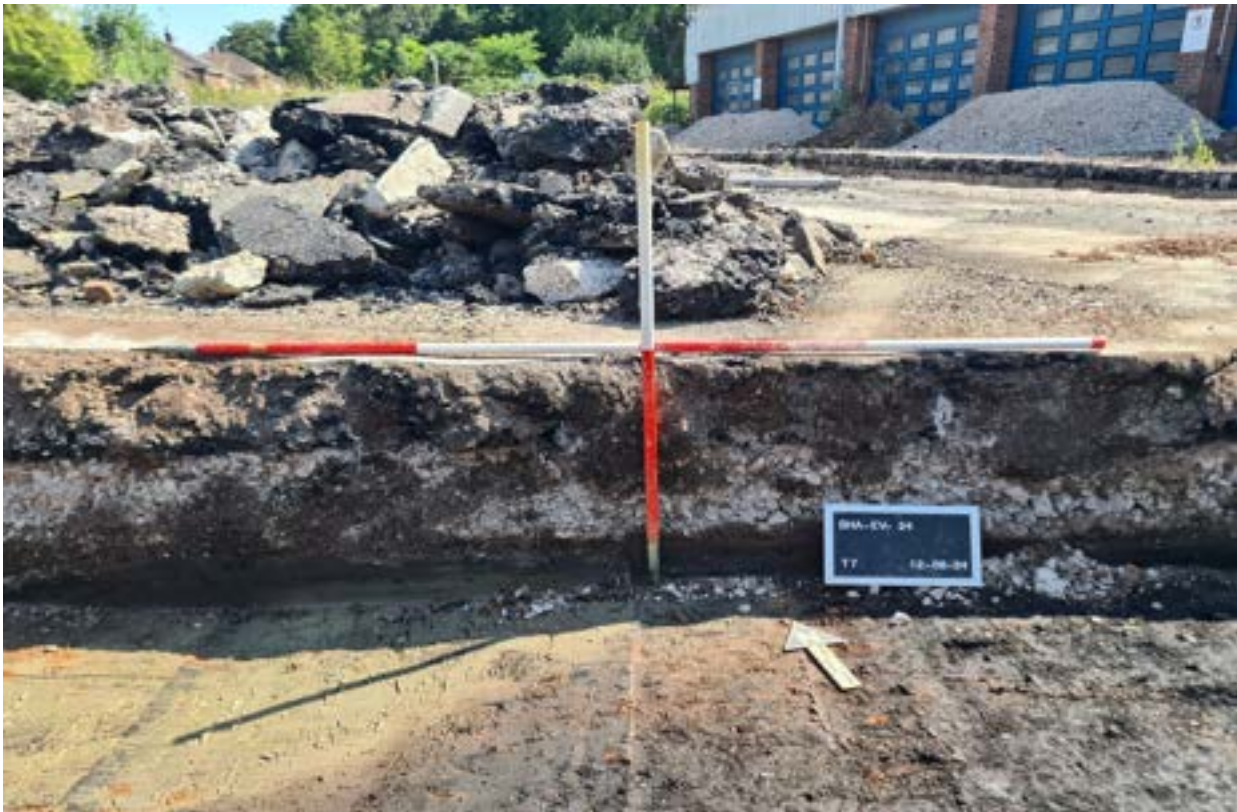
- 5.3.13 Within the northern extent of the site (Figure 2), Trench 7 was excavated on a N-S alignment and measured approximately 21m in length, 1.8m in width with a maximum depth of 0.58m (Figure 8). Natural geological deposits (704) were recorded at a level of approximately 3.14m OD, c. 0.29m below the existing ground surface (Plate 17). The upper horizon of the natural clay was heavily truncated by modern service trenches and a contaminated pit.
- 5.3.14 With the northern area of the trench faint remains of a former building were once again recognised. As with Trench 4, the fill of a possible structure comprised pulverised brick dust and small fragments of mortar (705), with layers of reject buff red stone (706) surrounding a seam of compact grey stone (707). It is possible that this building is also related to the former brickworks present on the site.

Plate 15 Trench 7, viewed from the northwest

Plate 16 Trench 7, viewed from the southeast

Plate 17 Trench 7, representative Section RS7/1

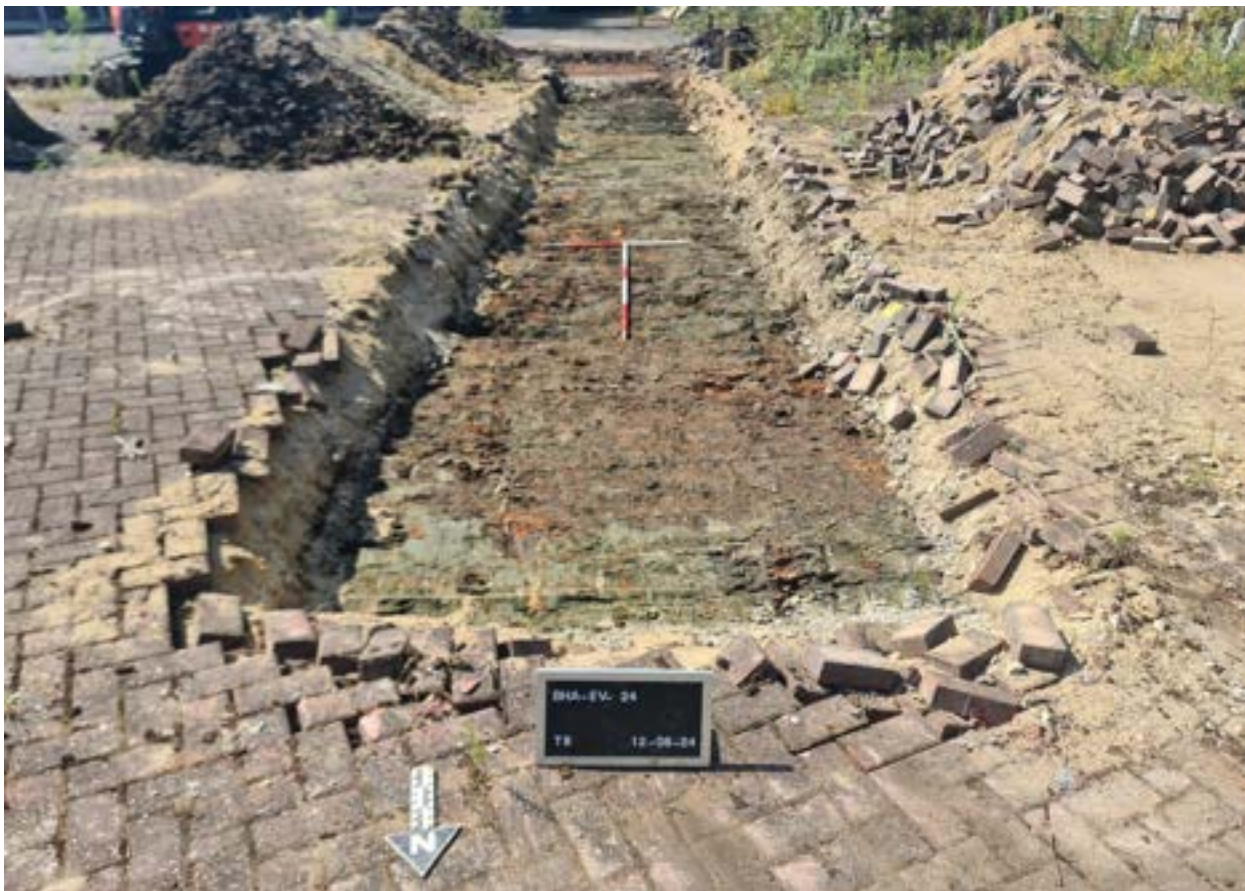
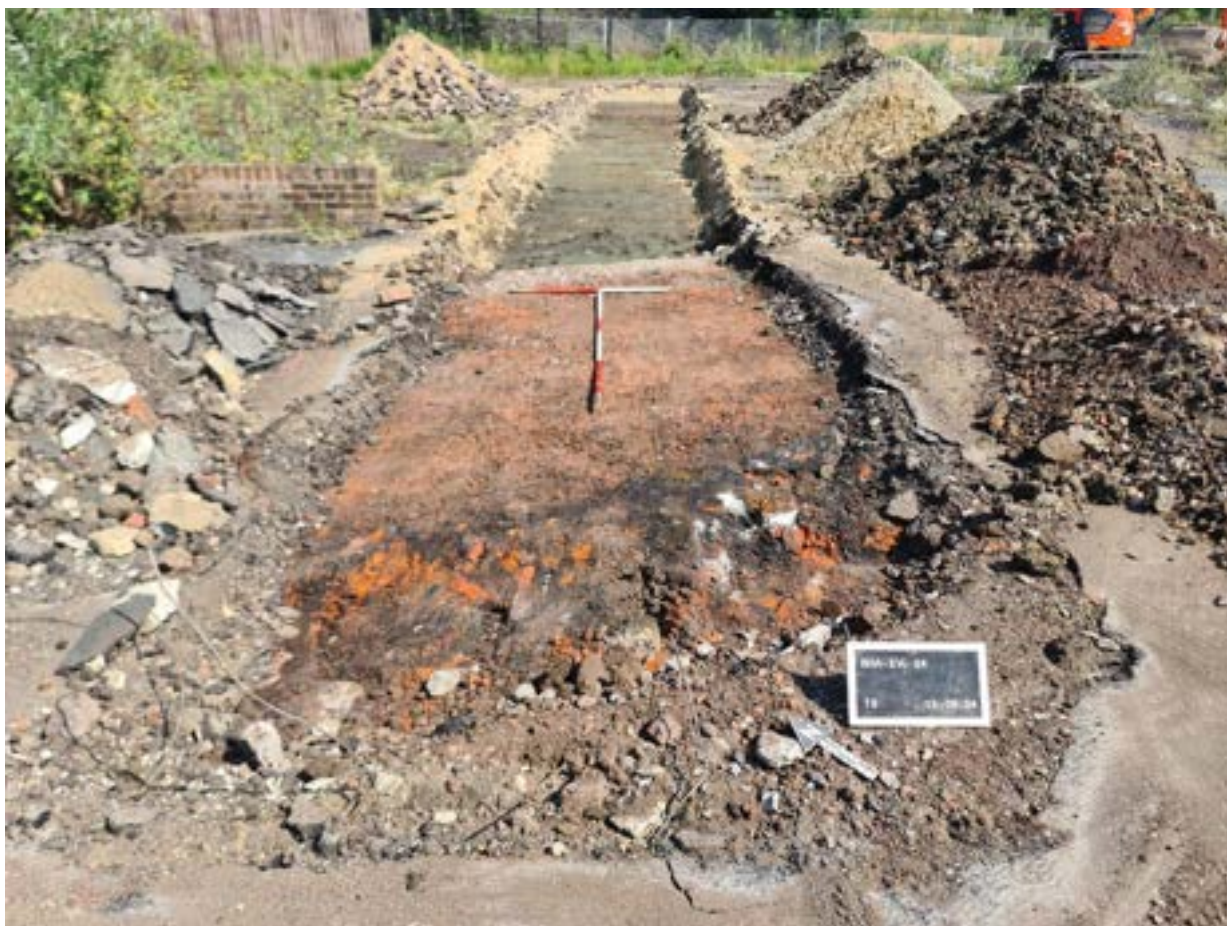
- 5.3.15 Trench 8 was located within the northern extent of the site and measured 20.9m in length with a maximum depth of 0.41m. This E-W orientated trench contained a stratigraphic sequence comprising block paving (801) overlying a mixed layer of fine grey sand and stone (802) which was sealed by a thin layer of modern made ground (803). Natural clay was recorded at a level of approximately 2.42m OD along the majority of the trench.
- 5.3.16 Within the western extent of the trench angular layers of buff red crushed brick (807) and grey stone (806) were present on a similar alignment to comparable deposits within Trench 7. Black contaminated sand silt with fragments of concrete and broken brick filled what may represent a robbed/demolished foundation/wall (808 and 809).

Plate 18 Trench 8, viewed from the northeast

Plate 19 Trench 8, viewed from the southwest

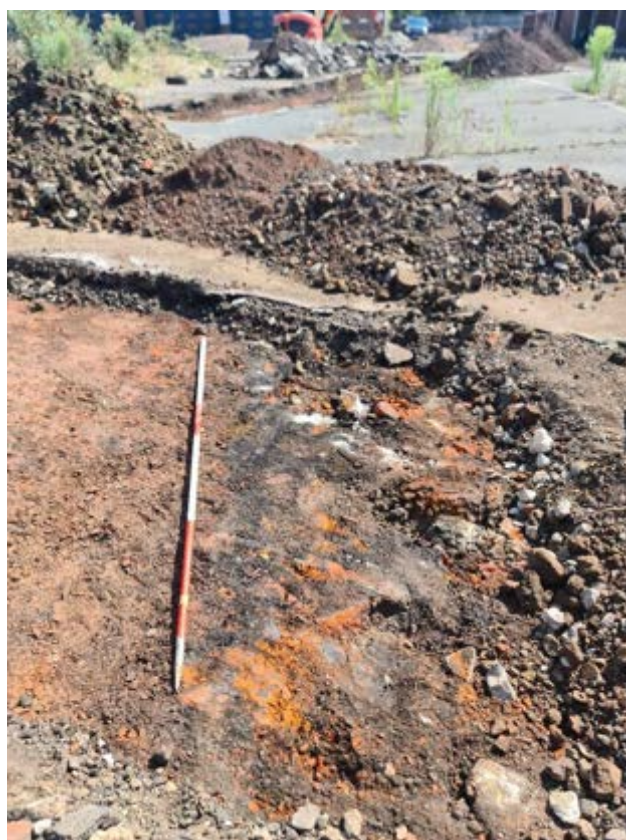
7.2.2 That said, the remains of what are believed to represent the former 19th century Brickworks could be seen within three of the seven trenches excavated where the shadows of either walls and/or foundations were visible, albeit relatively vague. Plotting of the archaeological survey over an historical map has been provided as Figure 10. From this we can suggest that feature (405) within Trench 4 may be the remains of one of the larger Brickworks buildings within the central area of the site, and that feature (809) within Trench 8 may represent the remains of a foundation trench robbed of its original brick fabric (Plate 20).

Plate 20 Robbed wall (809) within Trench 8, viewed from the north
