Archaeological Evaluation of Land at the former Lipscomb Cars Site, Bridge House, Chart Road, Ashford, Kent TN23 3HZ

Site Code: BHA-EV-24

Report for;
Betteridge & Milsom
08/09/2024

Document Reference: 34340.01

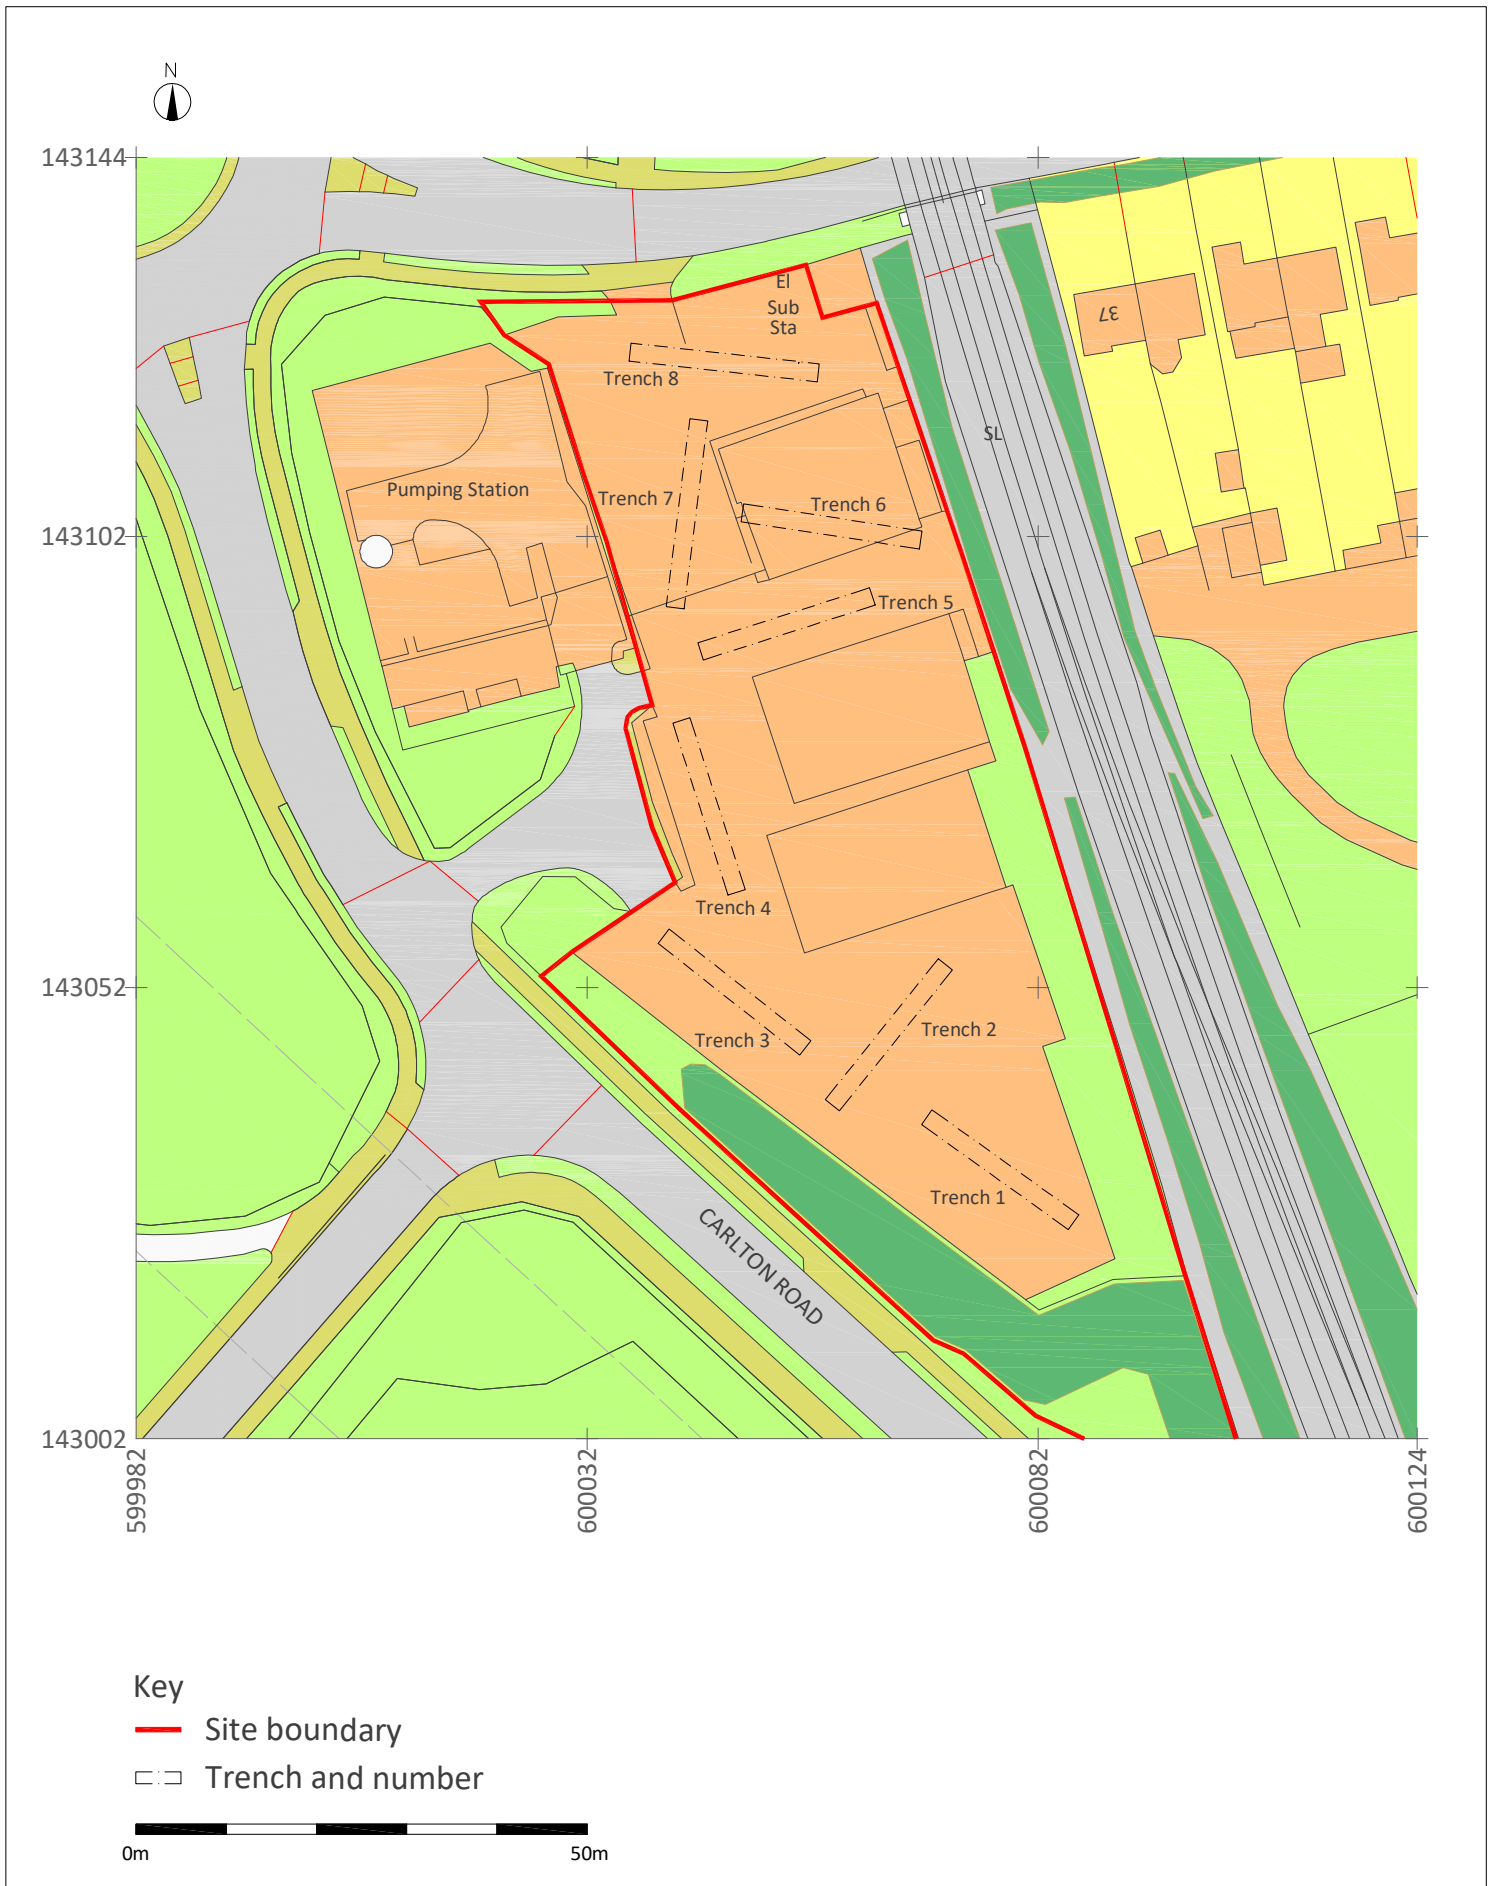
Figure 2 Site Plan

- 4.2.1 A total of seven evaluation trenches were excavated, as shown on Figure 2, and Plate 1, out of the eight proposed. Excavation was carried out using a mechanical excavator fitted with a toothless ditching bucket, removing the overburden to the top of the first recognisable archaeological horizon (Plate 2), under the constant supervision of an experienced archaeologist. Additional time was allowed for the breaking up of existing tarmac surfaces which, in most trenches, overlay reinforced concrete slabs.

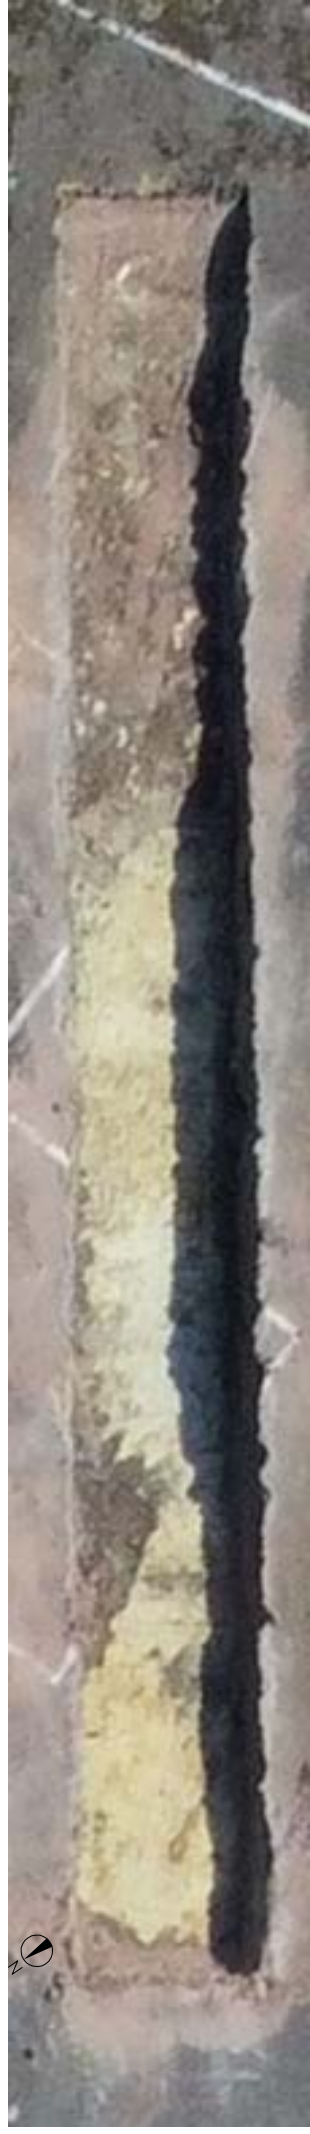
Figure 3 Trench 1 Details

- 5.3.1 Within the southern extent of the site (Figure 2), Trench 1 was excavated on a NE-SE alignment and measured approximately 20m in length, 1.8m in width with a maximum depth of 0.64m (Figure 3). Natural geological deposits (104) were recorded at levels ranging from 3.95m OD and 4.10m OD, below a tarmac surface (101) that sealed Type I reject stone (102) which overlay made ground (103) sealing the natural clay (104).

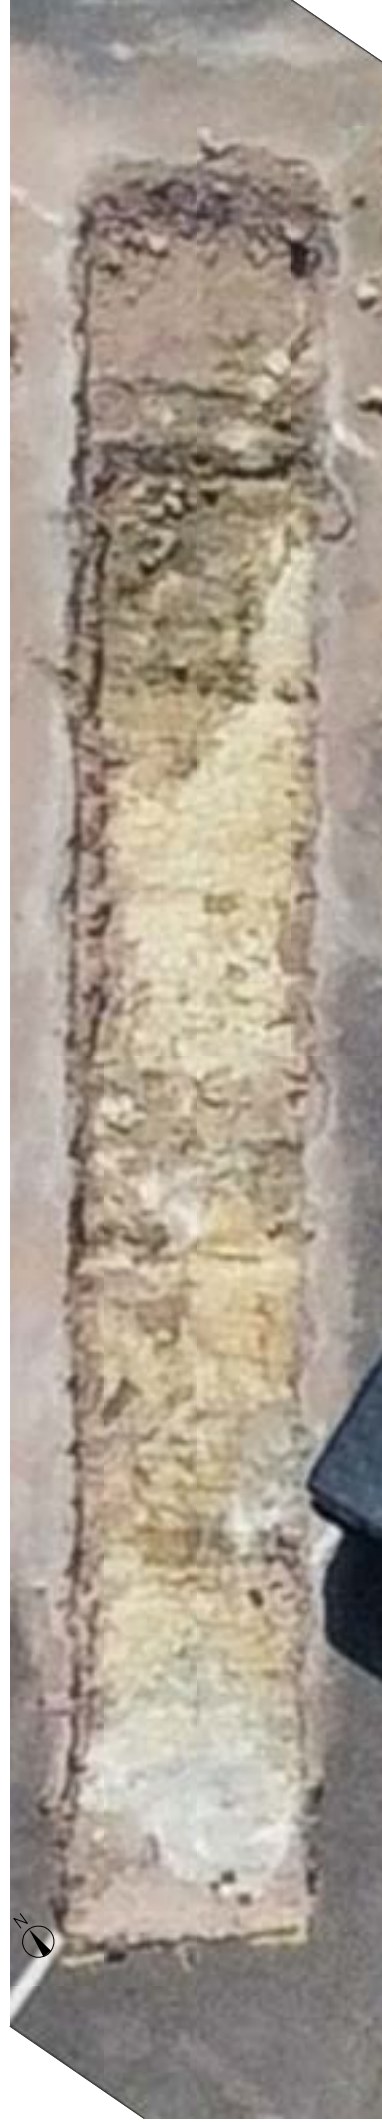
Figure 4 Trench 2 Details

- 5.3.3 Trench 2 was located within the southern extent of the site, north of Trench 1. This trench was excavated on a NE-SW alignment and measured 20.6m in length (Figure 4) with an average depth of 0.62m. Natural geological horizons (203) were recorded at a level of approximately 3.78m OD, sealed below made ground (203) which was topped by Type 1 stone (202) and a tarmac surface (201).

- 5.3.4 Two areas of modern disturbance included a pit filled with hardcore and plastic sheeting, and a ceramic soakaway drain. No archaeological finds or features were recorded within Trench 2.

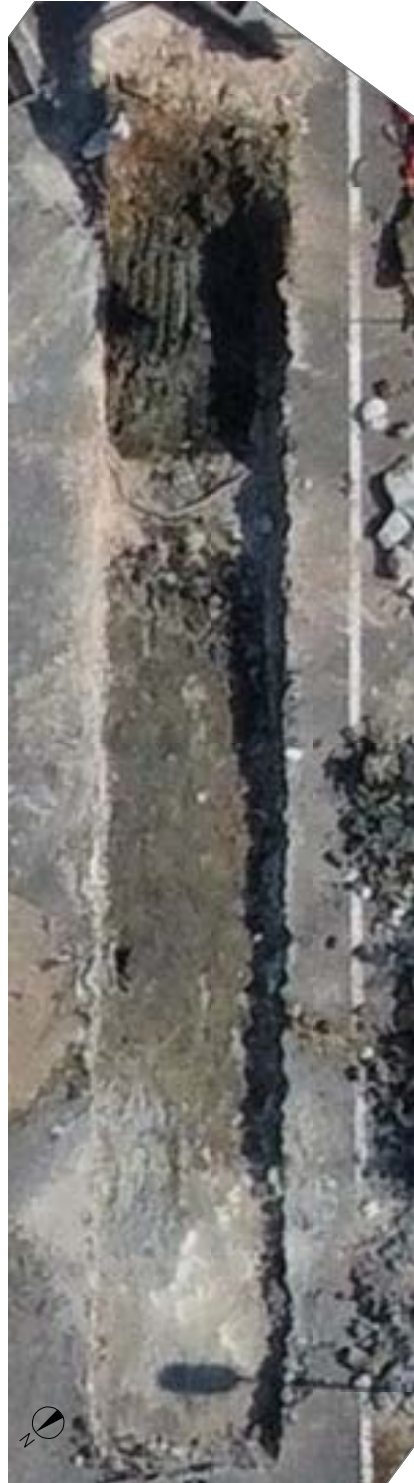
Figure 5 Trench 3 Details

- 5.3.5 Within the southern area of the site (Figure 2) adjacent to the western boundary, Trench 3 was excavated on an NW-SE alignment and measured approximately 16.4m in length, 1.8m in width with a maximum depth of 0.62m (Figure 5). This trench was reduced in length so that access could be maintained to the site. As with the two former trenches, steps were cut into the ends of the trench to provide safe access/egress.
- 5.3.6 Natural geological deposits (305) were recorded at a level of approximately 2.88m OD, below a stratigraphic sequence that comprised a tarmac surface (301) over Type 1 reject stone (302) which sealed a reinforced concrete slab (303). Direct made ground (304) sealed the natural clay.

- 5.3.7 A live electric surface was recorded within this trench (Figure 5). No archaeological finds or features were present.

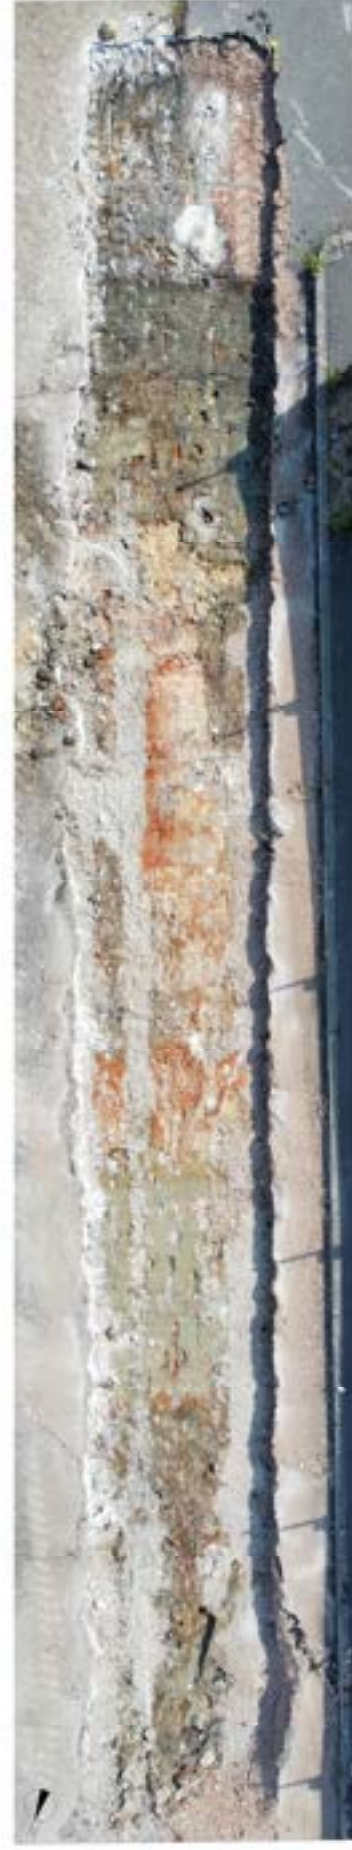
Figure 6 Trench 4 Details

- 5.3.8 Within the central western extent of the site (Figure 2), Trench 4 was excavated on a NW-SE alignment and measured approximately 20m in length, 1.8m in width with a maximum depth of 0.64m (Figure 3). Natural geological deposits (403) were recorded at a level of approximately 3.14m OD, c. 0.29m below the existing ground surface (Plate 11). The upper horizon of the natural clay was heavily truncated along the full extent of the trench by modern service trenches.
- 5.3.9 Within the central area of the trench the faint remains of a former building was recognised. The fill of the structure comprised pulverised brick dust and small fragments of mortar (405), which formed the linear remains of what appeared to be a former building. Although now demolished, it is considered possible that this building may have been related to the former brickworks present on the site.

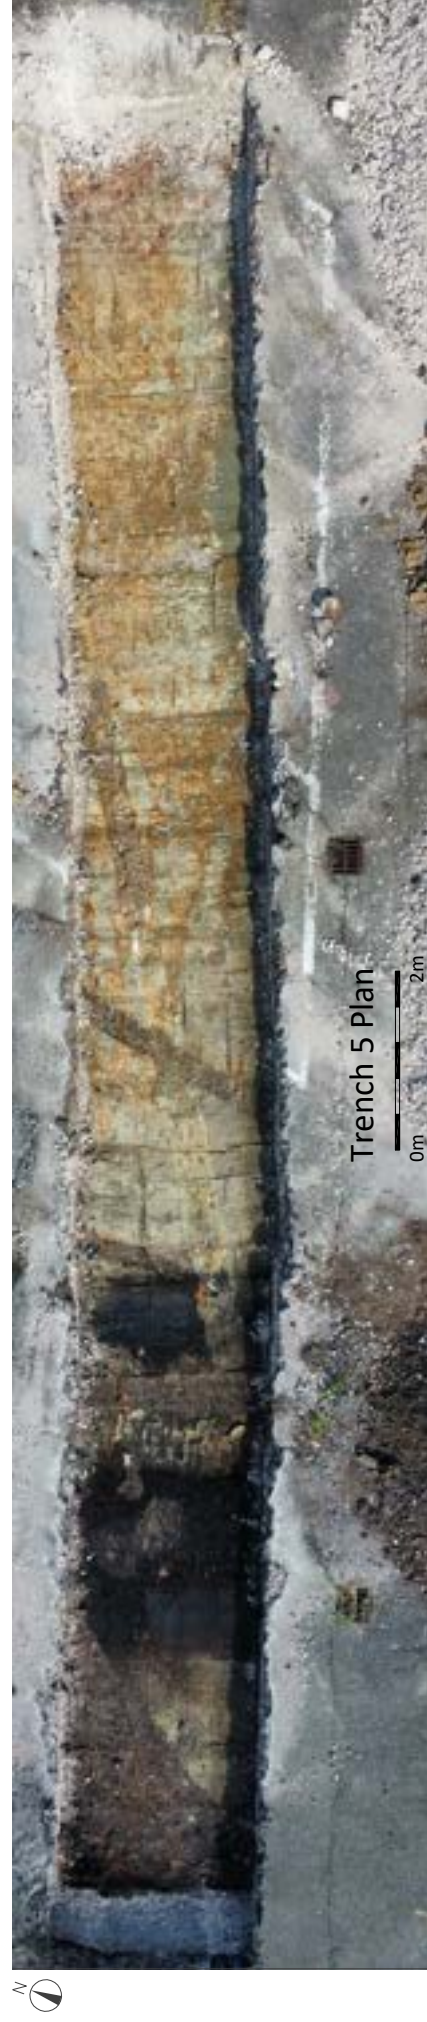
Figure 7 Trench 5 Details

- 5.3.10 Within the central northern extent of the site (Figure 2), Trench 5 was excavated on an E-W alignment and measured approximately 21m in length, 1.8m in width with a maximum depth of 0.59m (Figure 7). Natural geological deposits (503) were recorded at a level of approximately 2.69m OD, below a tarmac surface (501) that sealed compact deposited chalk (502) (Plate 14). The upper horizon of the natural clay was truncated by modern drains, with a large, contaminated pit present at the western extent.
- 5.3.11 No archaeological finds or features were present in Trench 5.

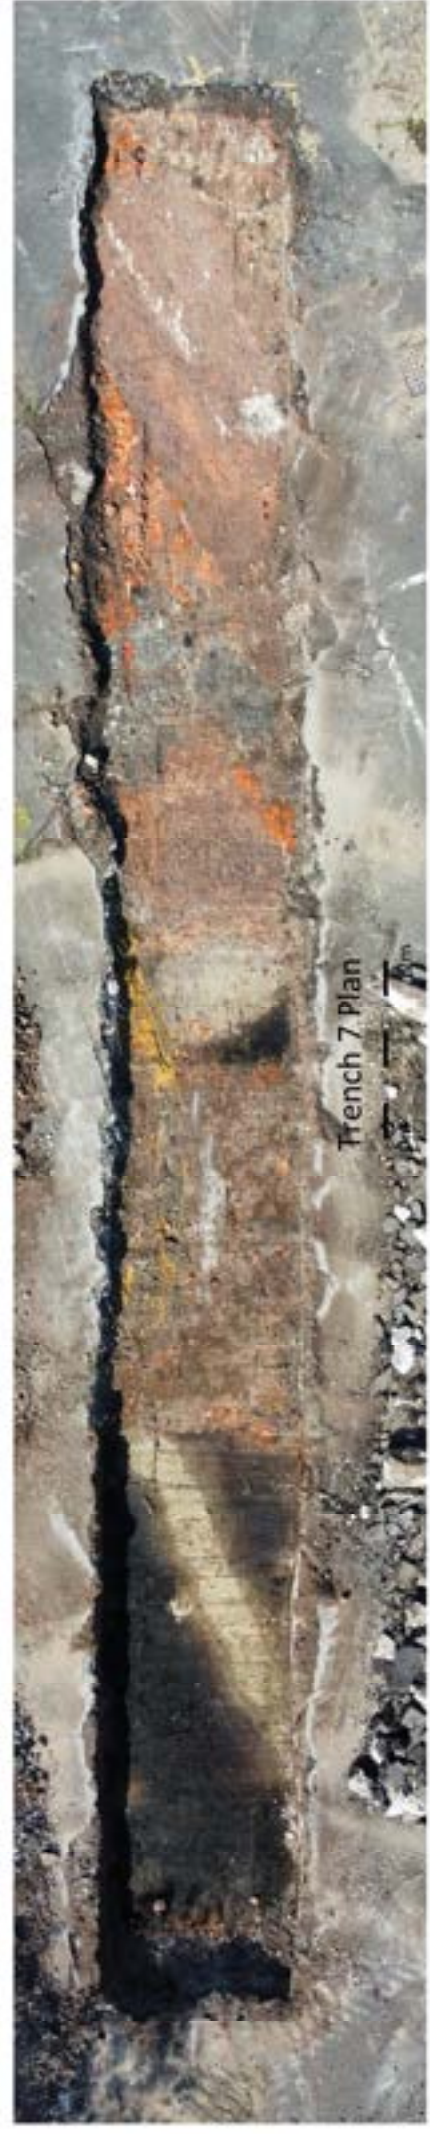
Figure 8 Trench 7 Details

- 5.3.13 Within the northern extent of the site (Figure 2), Trench 7 was excavated on a N-S alignment and measured approximately 21m in length, 1.8m in width with a maximum depth of 0.58m (Figure 8). Natural geological deposits (704) were recorded at a level of approximately 3.14m OD, c. 0.29m below the existing ground surface (Plate 17). The upper horizon of the natural clay was heavily truncated by modern service trenches and a contaminated pit.
- 5.3.14 With the northern area of the trench faint remains of a former building were once again recognised. As with Trench 4, the fill of a possible structure comprised pulverised brick dust and small fragments of mortar (705), with layers of reject buff red stone (706) surrounding a seam of compact grey stone (707). It is possible that this building is also related to the former brickworks present on the site.

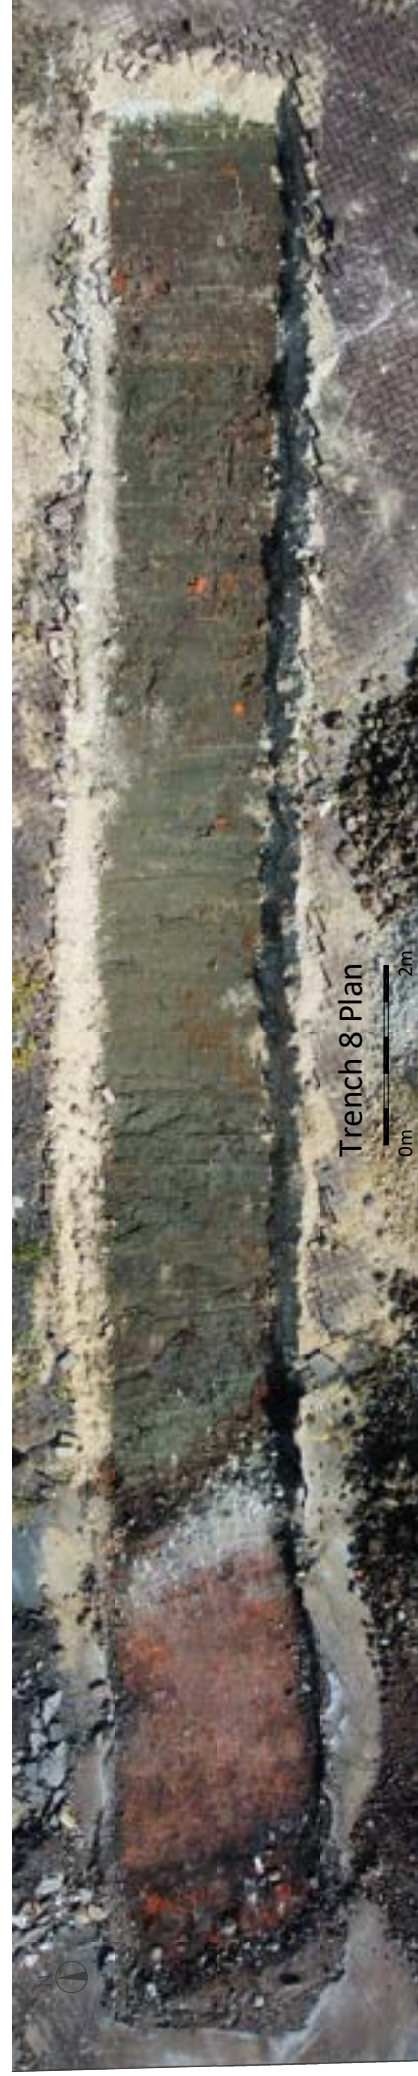
Figure 9 Trench 8 Details

- 5.3.15 Trench 8 was located within the northern extent of the site and measured 20.9m in length with a maximum depth of 0.41m. This E-W orientated trench contained a stratigraphic sequence comprising block paving (801) overlying a mixed layer of fine grey sand and stone (802) which was sealed by a thin layer of modern made ground (803). Natural clay was recorded at a level of approximately 2.42m OD along the majority of the trench.
- 5.3.16 Within the western extent of the trench angular layers of buff red crushed brick (807) and grey stone (806) were present on a similar alignment to comparable deposits within Trench 7. Black contaminated sand silt with fragments of concrete and broken brick filled what may represent a robbed/demolished foundation/wall (808 and 809).
