# Historic Building Recording at St Lawrence College, College Road, Ramsgate, Kent

Report dated 21<sup>st</sup> April 2021

## **SWAT Archaeology**

# Historic Building Recording at St Lawrence College, College Road, Ramsgate in Kent

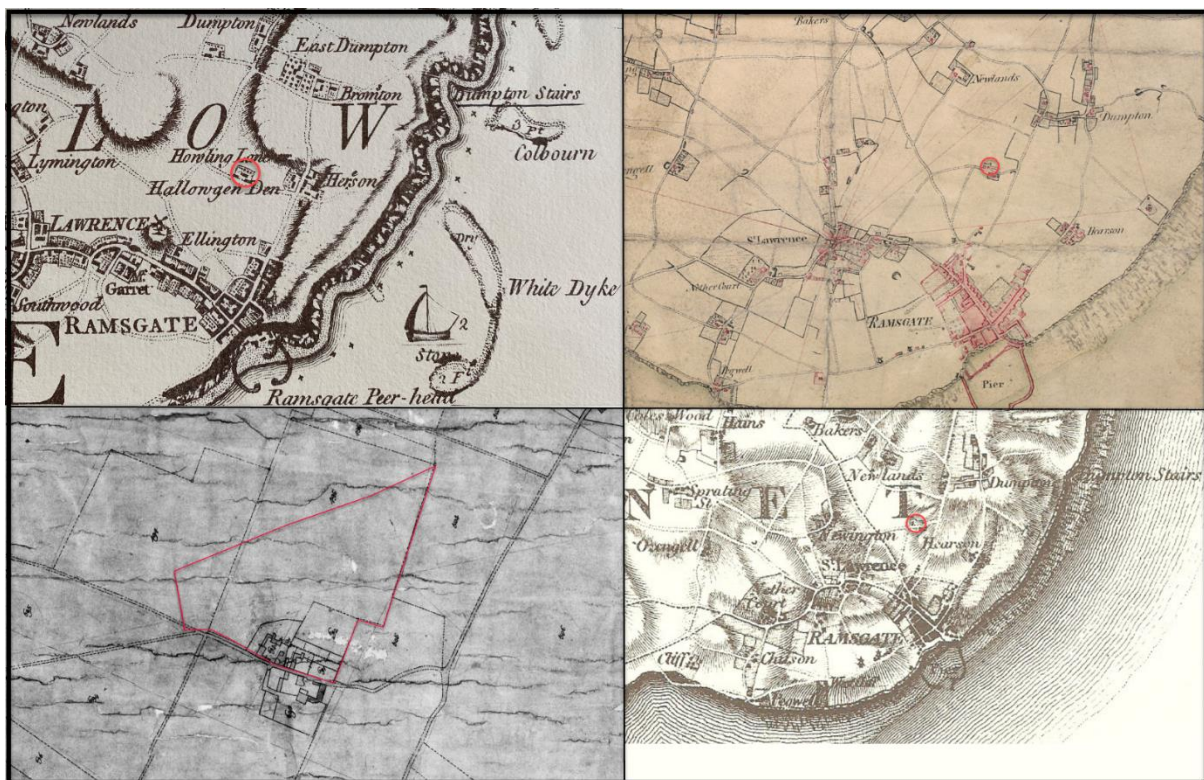
Figure 1: Clockwise from top left: Andrews and Dury, 1869; Ordnance Surveyors Drawing, 1797; Mudge, 1801; St Lawrence Tithes 1840.

Historical mapping shows the PDA on the northern side of a trackway labelled Howling Lane and Hallogen Den, to the east of Hereson. There are already three buildings located on the PDA set within a rectangular enclosure.

The area is one of small scattered hamlets with the main settlement area of St Lawrence to the south west and the harbour at Ramsgate to the south. The Ordnance Surveyors Drawing shows three buildings still within the site on the northern side of the road. There

are now also buildings on the southern side of the road opposite. The area around is still sparsely populated and the map also shows a field boundary to the east.

The Mudge Map shows little additional information. The tithes shows far greater detail. The buildings fall within an area designated 693 and recorded as 'buildings' and owned and occupied by William Goodson. They appear to be arranged around a yard with buildings on all four sides and are likely to be barns or other outbuildings. It does not appear that there are any residential buildings in this portion. To the east of the yard is a small area designated 691 owned and occupied by Henry Gisby and is a cottage and garden. To the north is a larger area designated 692 also belonging to William Goodson that is a meadow used for pasture. To the north of all these areas is a larger field designated 494 and 495 also owned and occupied by William Goodson that are arable fields. On the southern side of the road are the buildings designated 690 which is referred to as a homestead for Captain Henry Hodges and occupied by Henry Gisby.

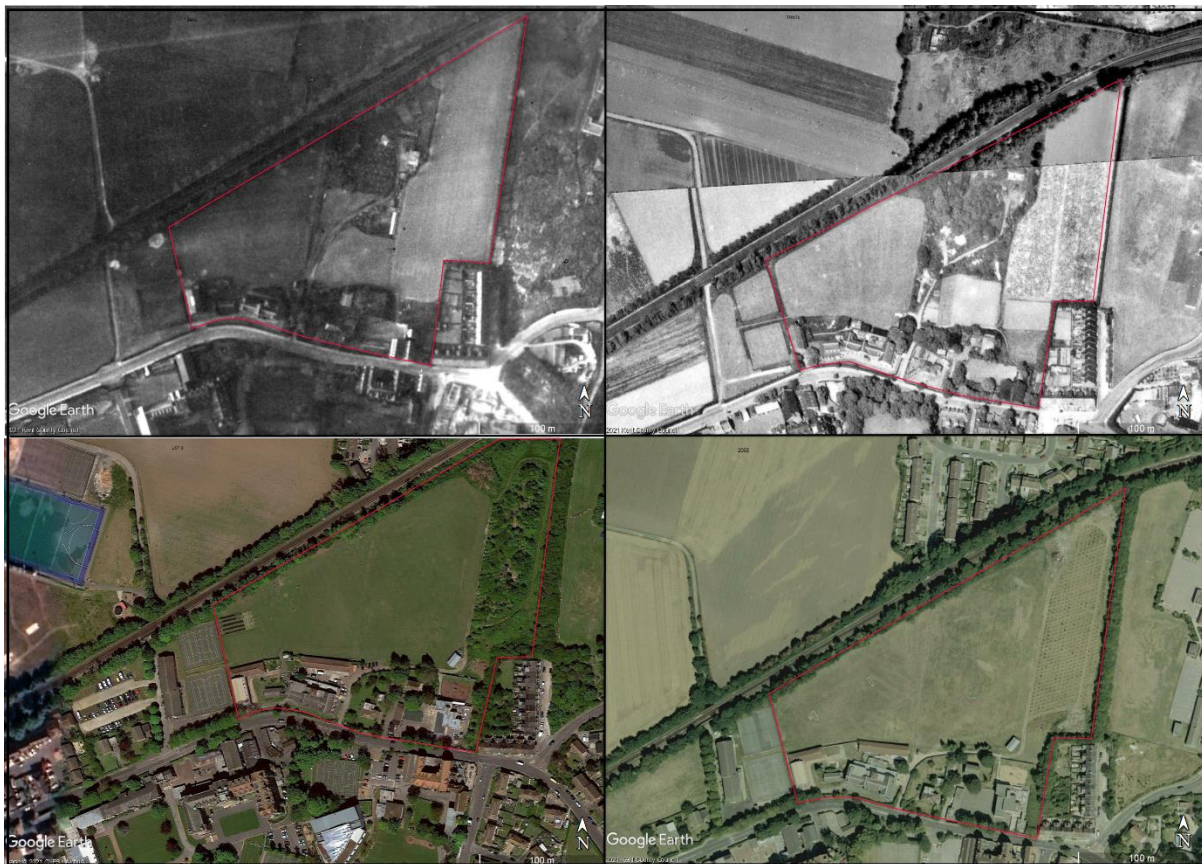
*Figure 4: Aerial photographs, clockwise from top left 1940s, 1960s, 2003 and 2019 (Google Earth)*

The 1940s photograph shows the main school buildings to the west of the trackway. A single building is located alongside the western boundary and to the north are playing fields. Eastern of the trackway can be seen two buildings. A larger one facing the road in what appears to be gardens and a smaller one to the rear. In the south eastern corner is a square building with two pitched roofs. The central trackway leads northwards towards an orchard area.

In 1960, to the north of the main building are now a number of smaller buildings. A hedge surrounds this area along the boundary with the road. The square building in the south eastern corner with two pitched roofs is now surrounded by lawn and mature trees.

By 2003, there have been a number of changes to the school buildings. The smaller buildings at the rear of the main building have been replaced by a single rectangular building. In addition, the main building has been extended on the northern side. There is another new building in the north western corner. In the central portion, the building facing the road has been replaced but the building at the rear has disappeared. Only a small building to the east is from the original pre-school period. In the south eastern corner, the building with the pitched roofs has been replaced entirely by a new flat roofed building on the western side of which is a playground. Just north of the playground is a new detached building.

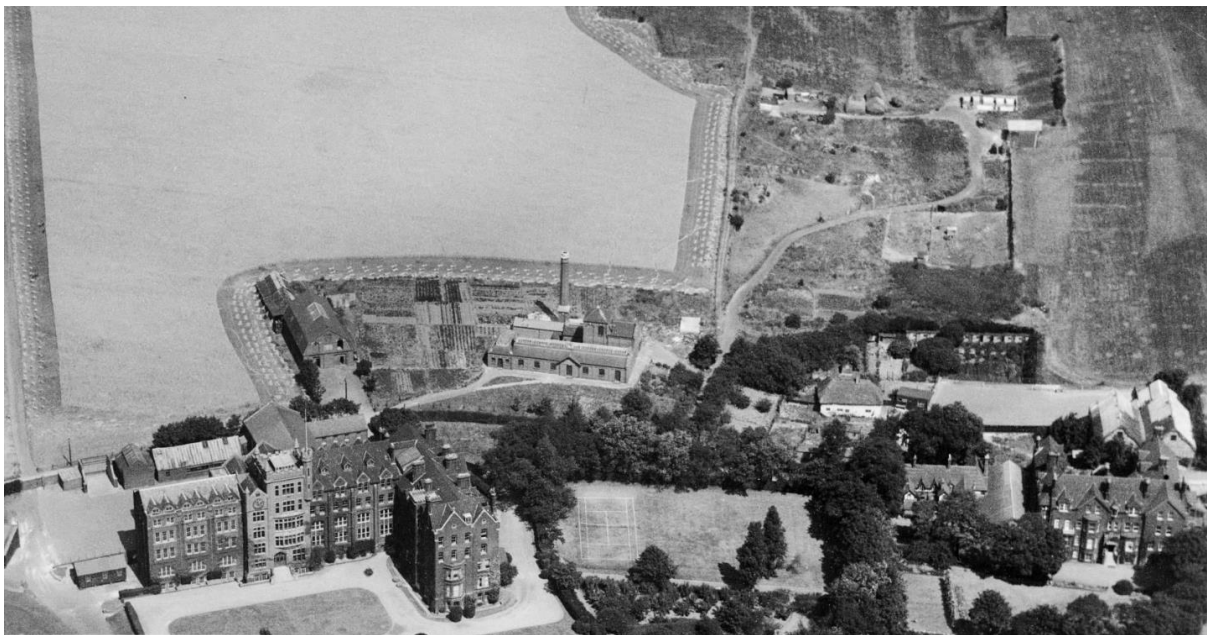
*Figure 5: 1923 Aerial photograph (Britain from Above)*

This photograph provides a clear shot of the school on both sides of College Road before it was widened. On the northern side from the western end can be seen the existing school building from 1898, with a low shed to the rear (since demolished). To the east of this is the main school building, comprising of a building of different heights, roofs, pitches as well as a tall chimney. This stands alone surrounded by vegetable fields. East of this building is the trackway that travels northwards towards what appears to be an agricultural area. East of

the trackway is a large building that appears to be an old house, which is no longer in existence. Immediately east of this is a small two storey building. To the far east of the photograph is a building with a double pitch roof, also since demolished

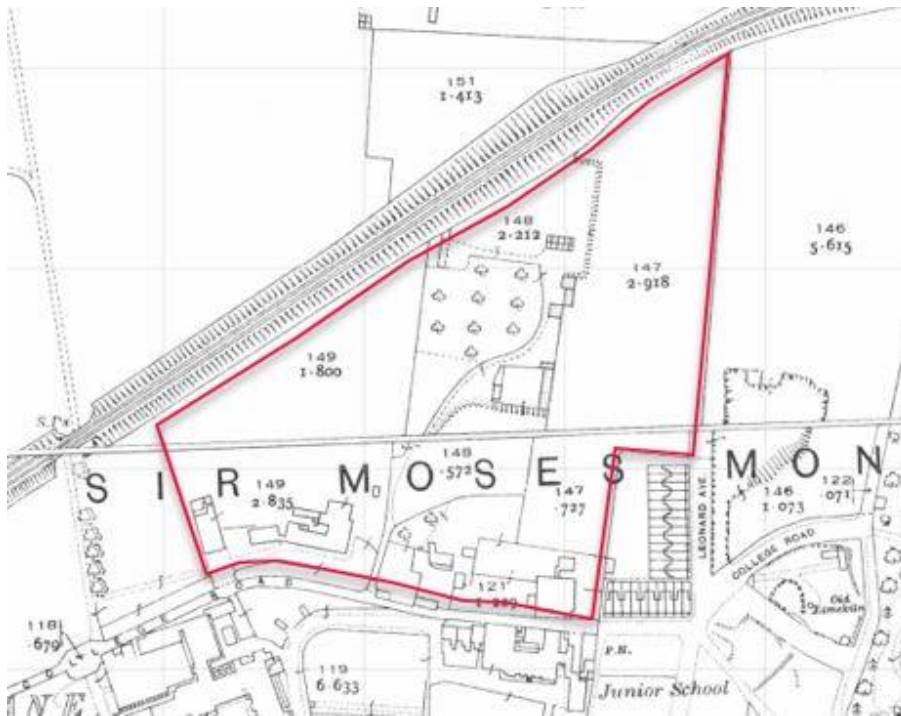
The OS map of 1932 (below) shows brickearth extraction to the north of the College buildings in an area that is now (April 2021) turfed playing fields.

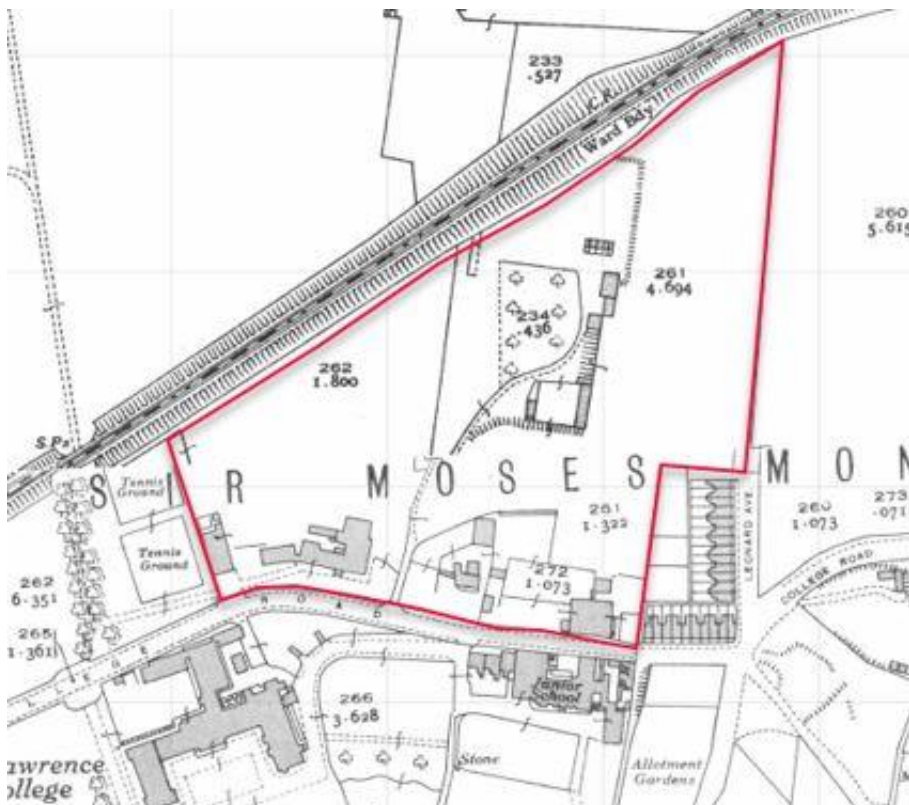
The OS map of 1939 shows more of the orchard has been taken for brickearth extraction.

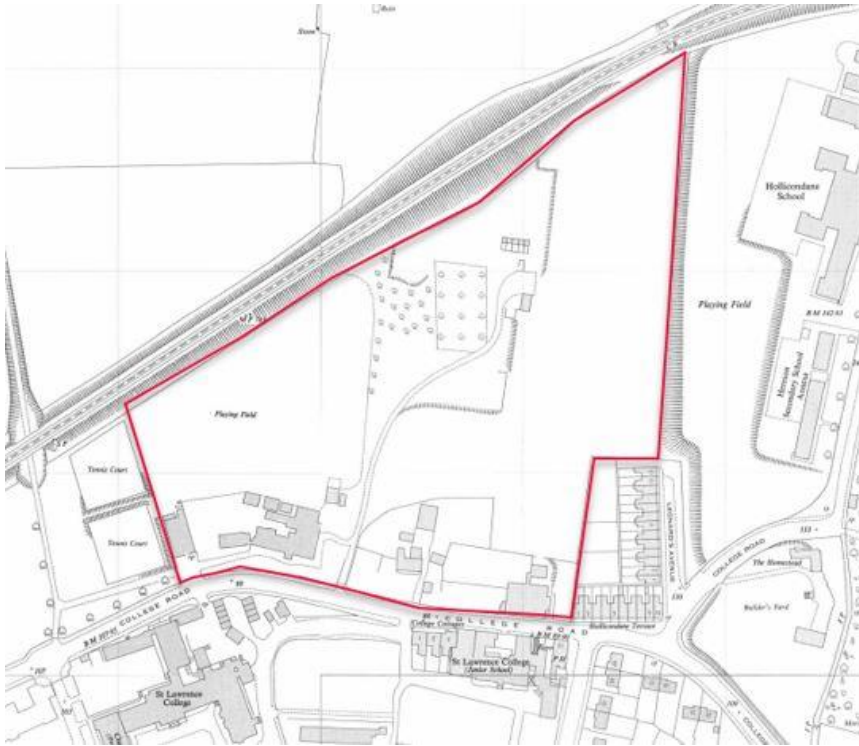
The OS map of 1955 shows that more of the site has had brickearth extracted

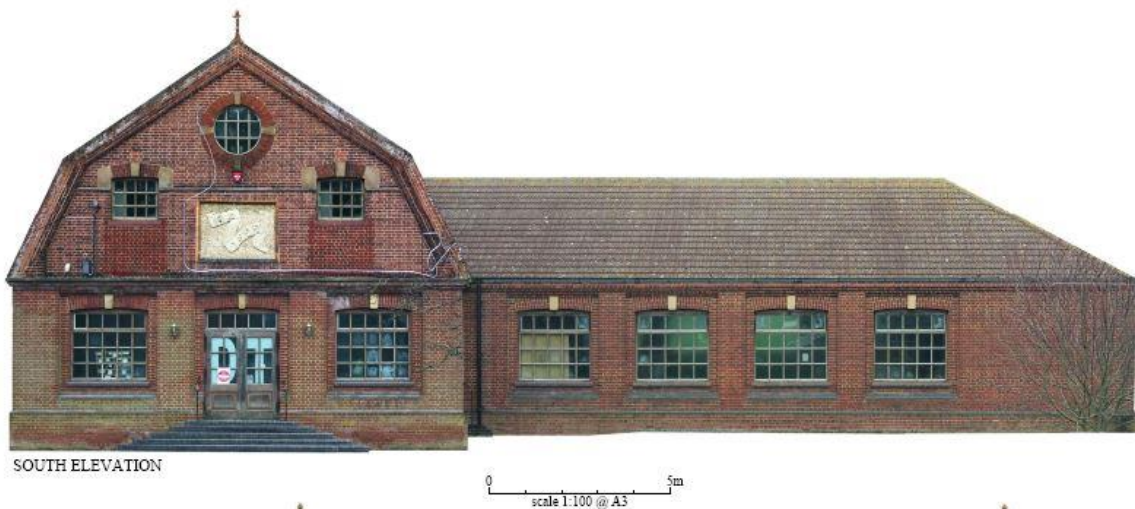
The Design and Technology Building (above) comprises a rectangular-shaped structure which measures 23.75m in length and 10.80m in width and is orientated NNW along its long axis (Figures 4a-4f).

The building is located on the western side of the PDA and is adjacent to the tennis courts which are set on a raised terrace to the west of the building. The original Design Technology Building was completed in 1897 as commemorated by a date stone above the entrance (Plate 16) but is also shown on the 1896 Historic Ordnance Survey mapping of the Site.

The building is constructed of soft red brick laid in an English Bond with smooth jointing and has a gambrel roof with terracotta finials at each end with a row of roof lights either side (Plate 17). On the north gable end is a circular window whilst on the south gable is the inset carved date stone with a circular window above and two casement windows- both the same dimensions and built with a cambered rubbed brick and gauged lintel with central key stone and two larger arch stones (Plate 15, HP 1). The front access towards College Road is through a single storey extension with steps and a double door (Plates 1, 2, 3, 4).

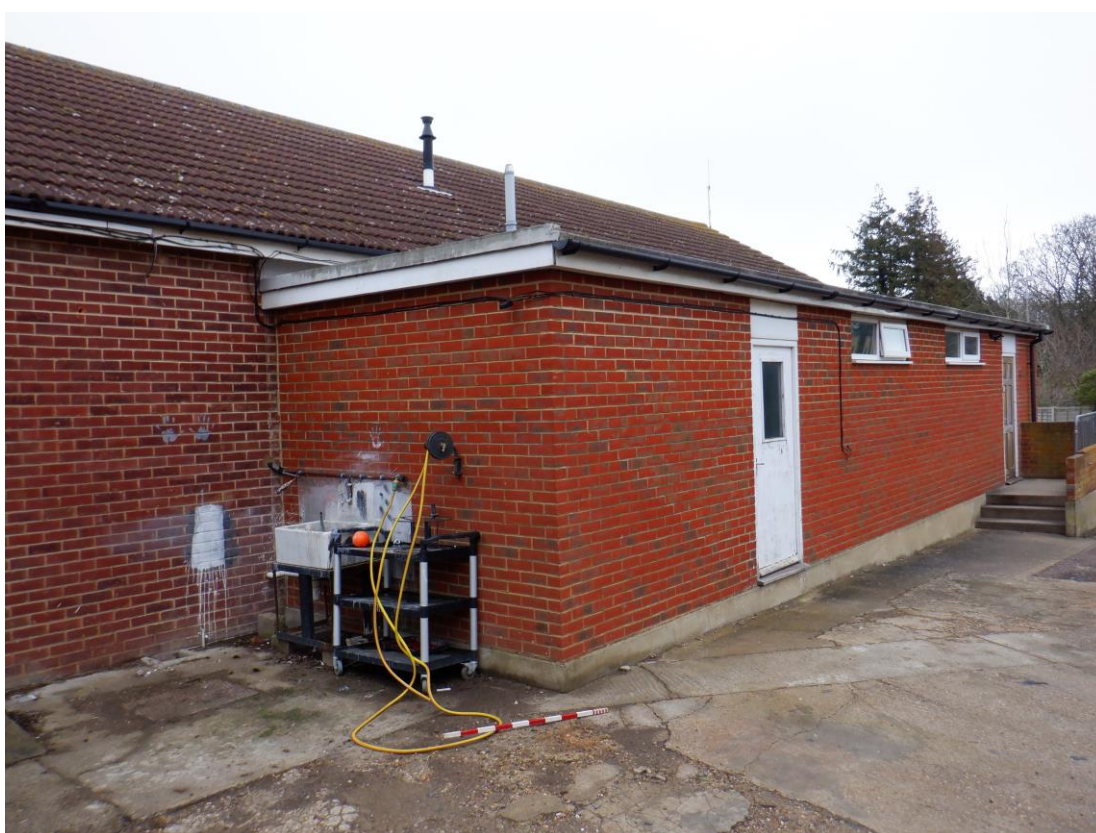
Plate 33. View of south elevation (looking north)

To the east of the Science Building (4) is a steeply sloping access into the site along the western edge of which is a substantial concrete retaining wall (Plate 28). This access can be traced on OS Historic mapping at least as early as the 1890's when it was also used to access the brickfields located in the rear area of the site. The access leads to the playing fields to the rear of the Science Building and also to a yard area and a 20<sup>th</sup> century built single story yellow brick workshop which is used by the college maintenance staff. The Grounds and Maintenance Building is constructed on sloping ground and on a concrete plinth that levelled the footprint of the building. Built of red brick in two phases (Plate 33) the first phase with a gable concrete tiled roof and the second phase a single storey flat roofed extension (Plate 34). Windows and doors are modern and the building has little architectural significance (Figure 2b).

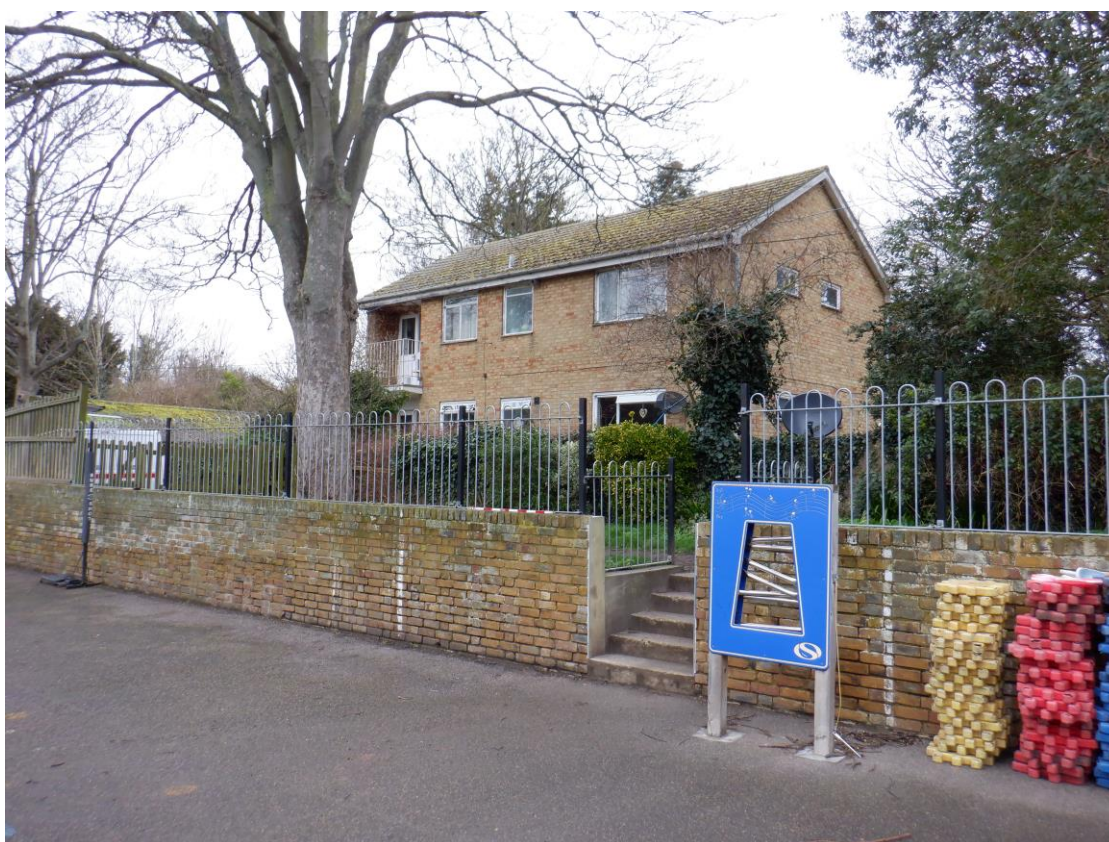
Plate 35. No.36 College Road (6) view of south elevation

36 College Road is constructed of yellow brick with a small first floor balcony and is located at the end of the driveway within an open plot (Plates 35, 36). Its appearance suggests that it was constructed sometime around the mid to late 1970's although its footprint appears to have been laid out on the OS map of 1973/4 and is now divided into two flats (Figure 2b).

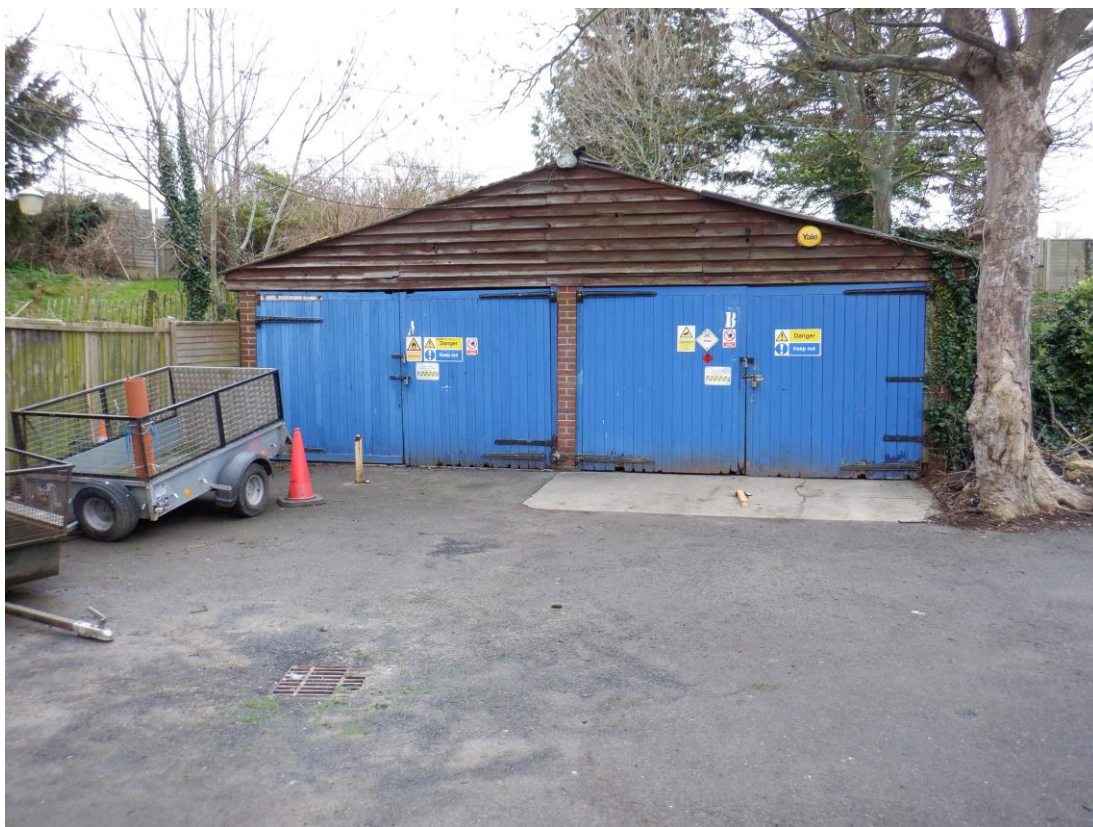
Plate 37. Grounds Store (9)

To the north-east of 36 College Road and to the west of 38 College Road is a two bay single storey timber outbuilding (9) which first appears on the 1956 maps of the site and is now used to store mowing tractors and associated machinery (Plate 37). The garage block (10) of six bays is of 20<sup>th</sup> century build (Plate 38).

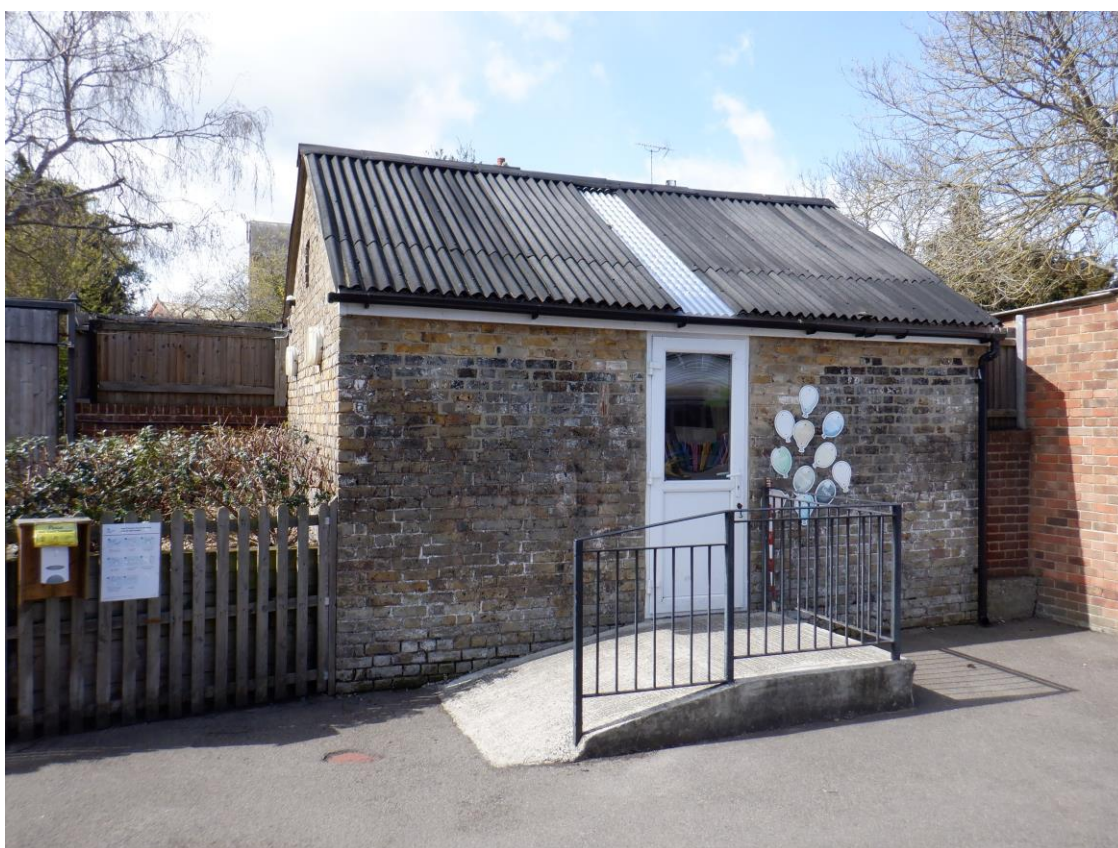
Plate 39. Store (11) east elevation (looking west)

Close to the entrance from College Road on the eastern side of the driveway is a small brick building which is identified on the 1898 historic mapping of the site (Plates 39-41). The single storey building is constructed of yellow stock bricks and originally had small rectangular openings on the upper parts of both gable ends. A blocked window opening is visible on the northern gable end (Plate 40) and tiles set on end have been used to infill narrow gaps on the southern, western and eastern faces of the building (Plate 40). The pitch of the original roof has been raised at some time in the past (Plates 40, 41). The building is currently in use as a store accessed from the SLC Pre-Prep School playground via a new doorway and concrete ramp and metal railings (Plate 39).

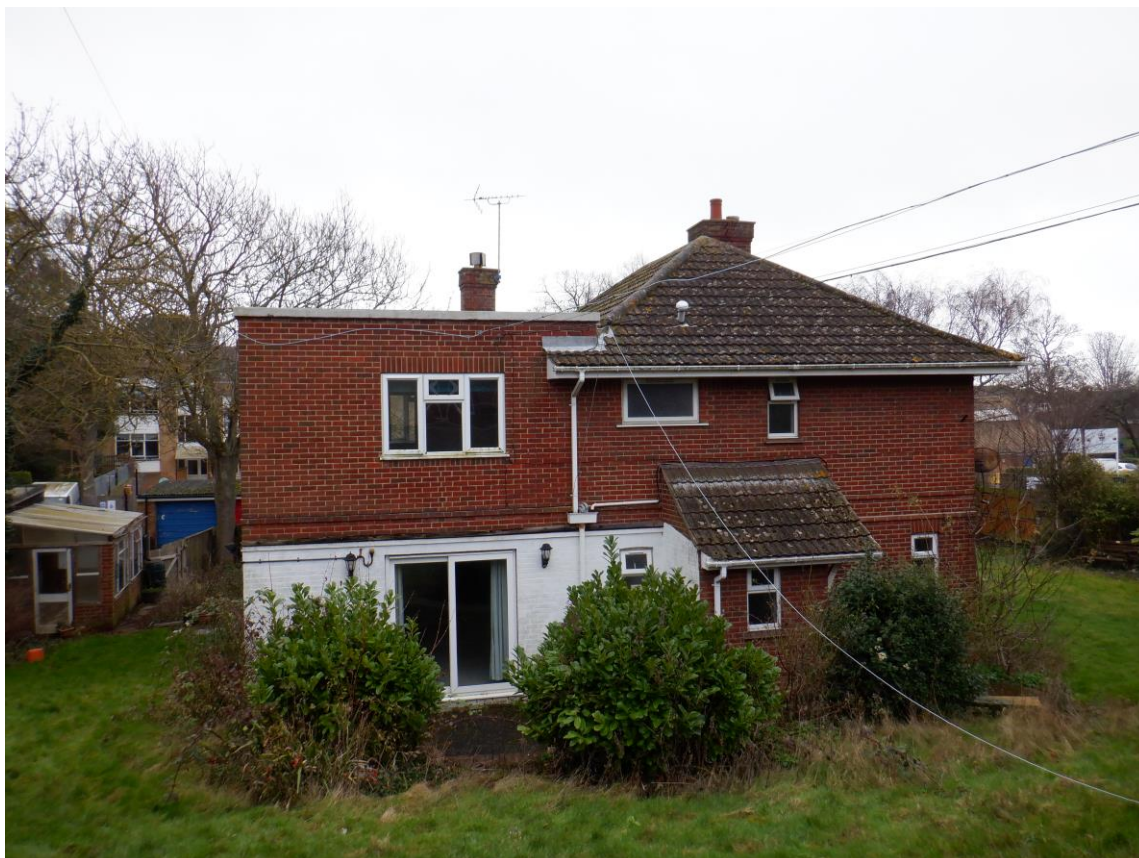
Plate 42. No.38 (Upper and Lower) College Road (12) looking south

roughly in the centre of a curvilinear plot. The boundaries of the plot can be traced on OS Historic Mapping from at least the Tithe map of 1839. Access to the property is gained via a wooden gate on College Road and a driveway leading to the garage on the eastern side of the plot. This driveway appears to have developed from an access into a yard area that can be traced on historic mapping from at least the first Edition Ordnance Survey maps of 1872/3. The 20<sup>th</sup> century building is a two storey gable roofed building with part of the ground floor rendered and painted white (Plate 42).

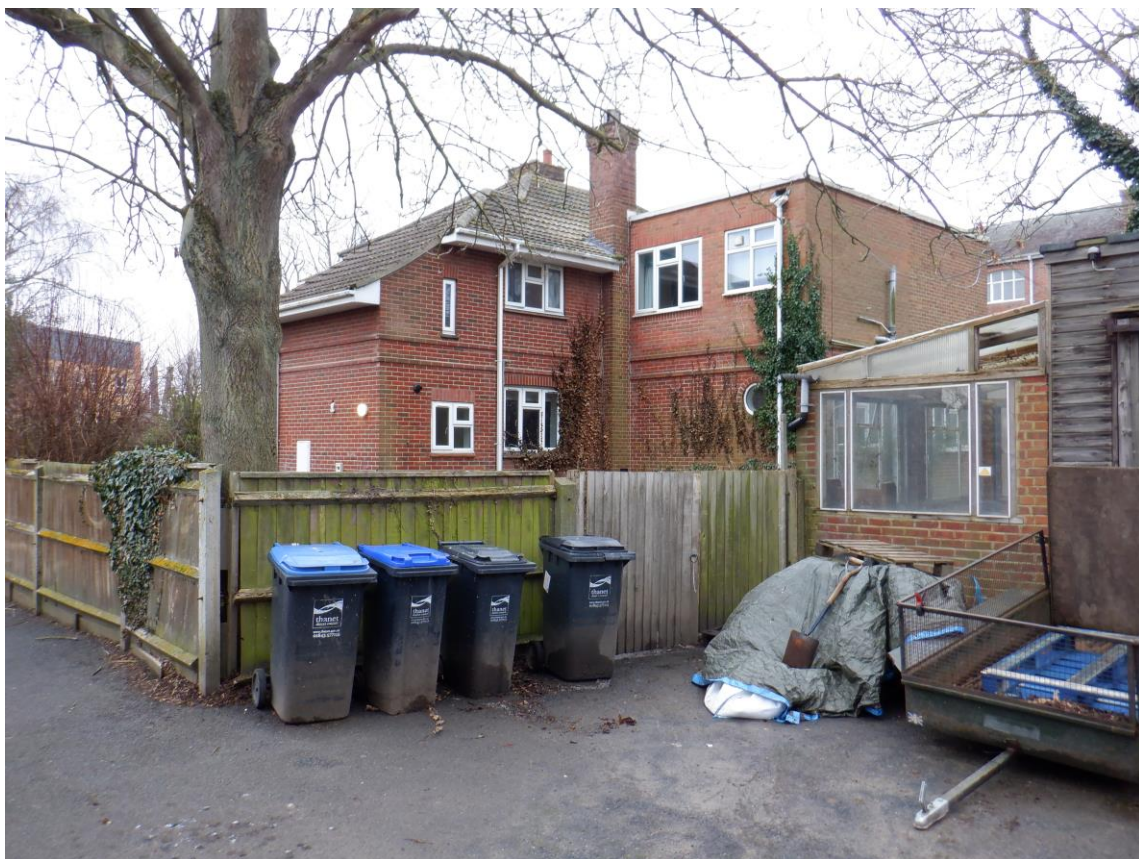
Plate 43. No.38 (Upper and Lower) College Road (12) looking NW

This building (Plate 43) is situated on the eastern side of the school and is divided from the school areas by a wooden panelled fence. 38 College Road is a two storey house built for Master's accommodation, set in open gardens with a garage and greenhouse to the rear

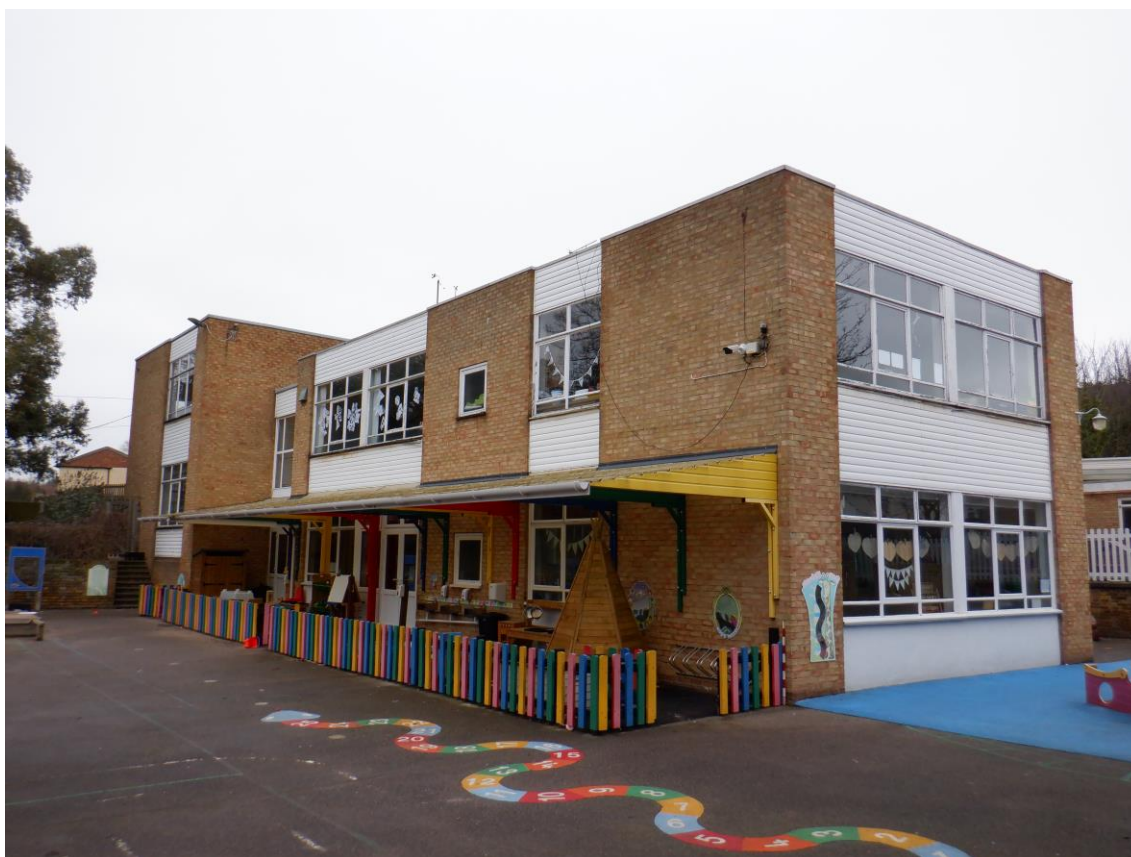
Plate 44. SLC Pre-Prep Building (13) looking SW

The Lower School or Infants school is constructed on the eastern side of the site. This building was probably constructed around the same time, in the 1970's, as 38 College Road, as similar building materials have been used in its construction (Plate 44). The building is mainly of two storeys, with a single story projection on its southern side, facing on to College Road (Plate 46). This single storey building is raised on a platform above the playground level by approximately 1.3 metres and is retained by a brick wall approximately 1.3 metres high. The platform is accessed from the playground (Plate 48) by a set of steps next to the main building entrance. The single storey building incorporates a cellared element which may lead to the subway tunnel which links the Junior School to the Lower School.

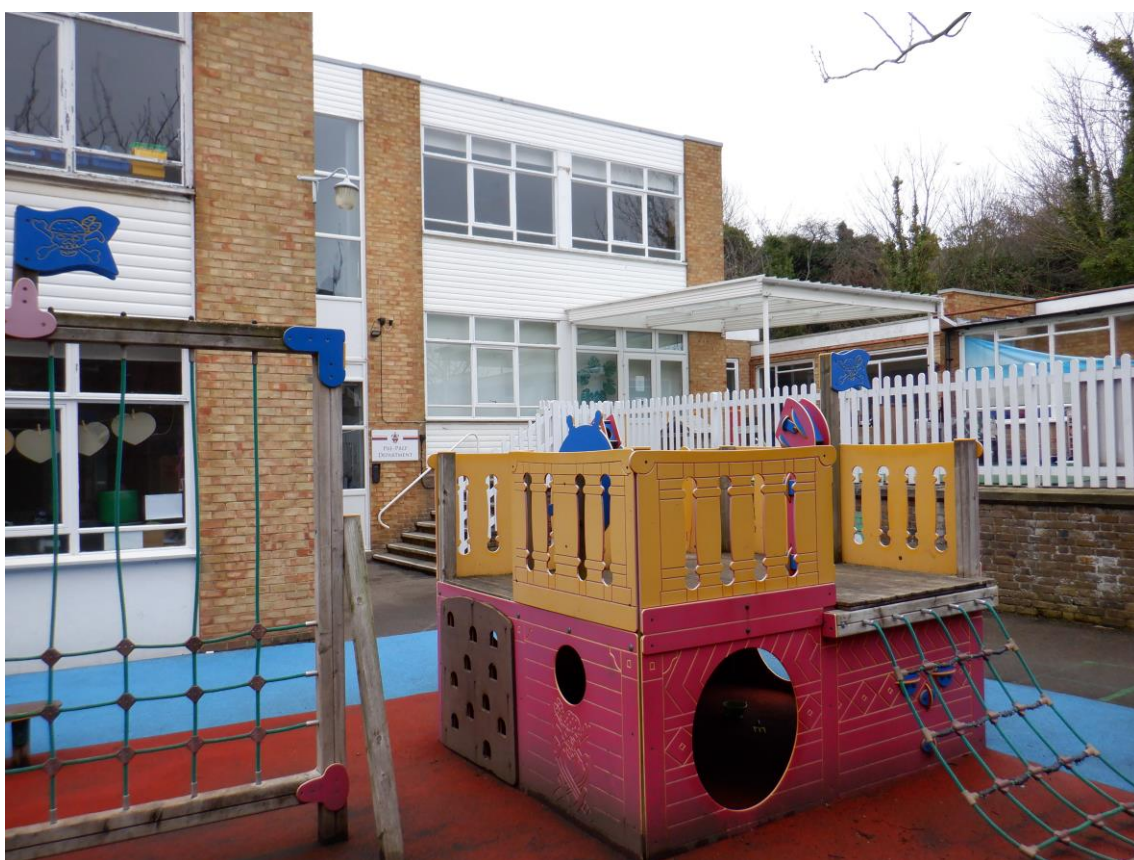
Plate 47. SLC Pre-Prep Building (13) looking SE

The playground area to the east of the building is relatively level and has been tarmacked. There is a multi-use games surface laid on the western part of the playground (Plate 48). To the north of the lower school building the ground levels rise in a series of terraces cut to accommodate the natural sloping ground of the site and incorporate gardens and play equipment areas (Plate 47).

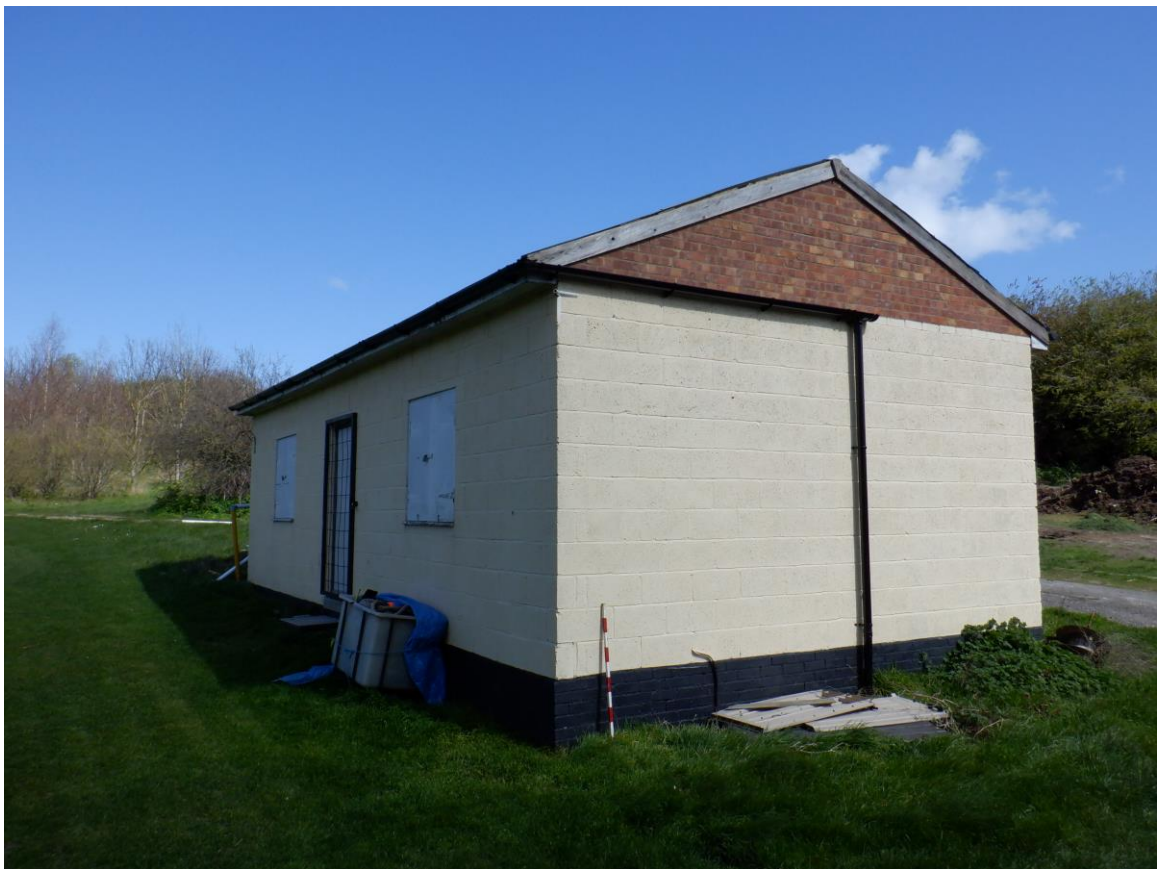
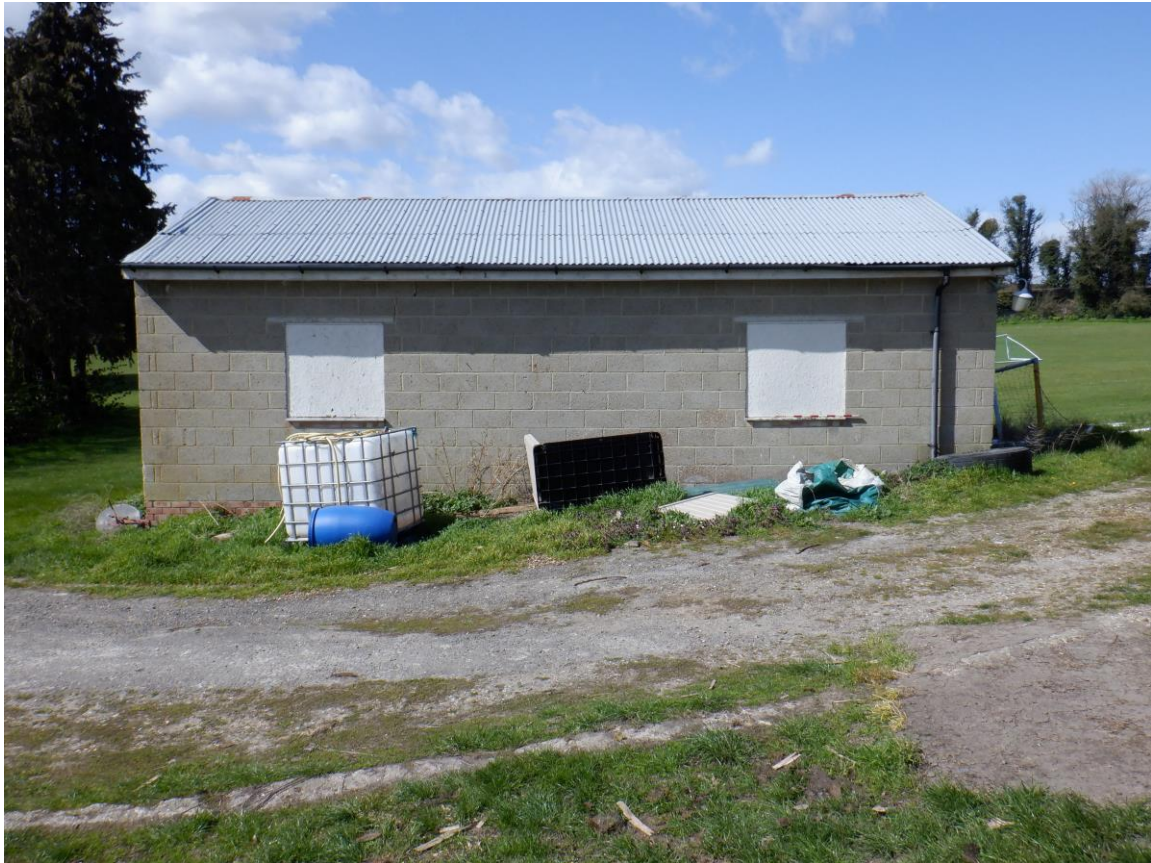
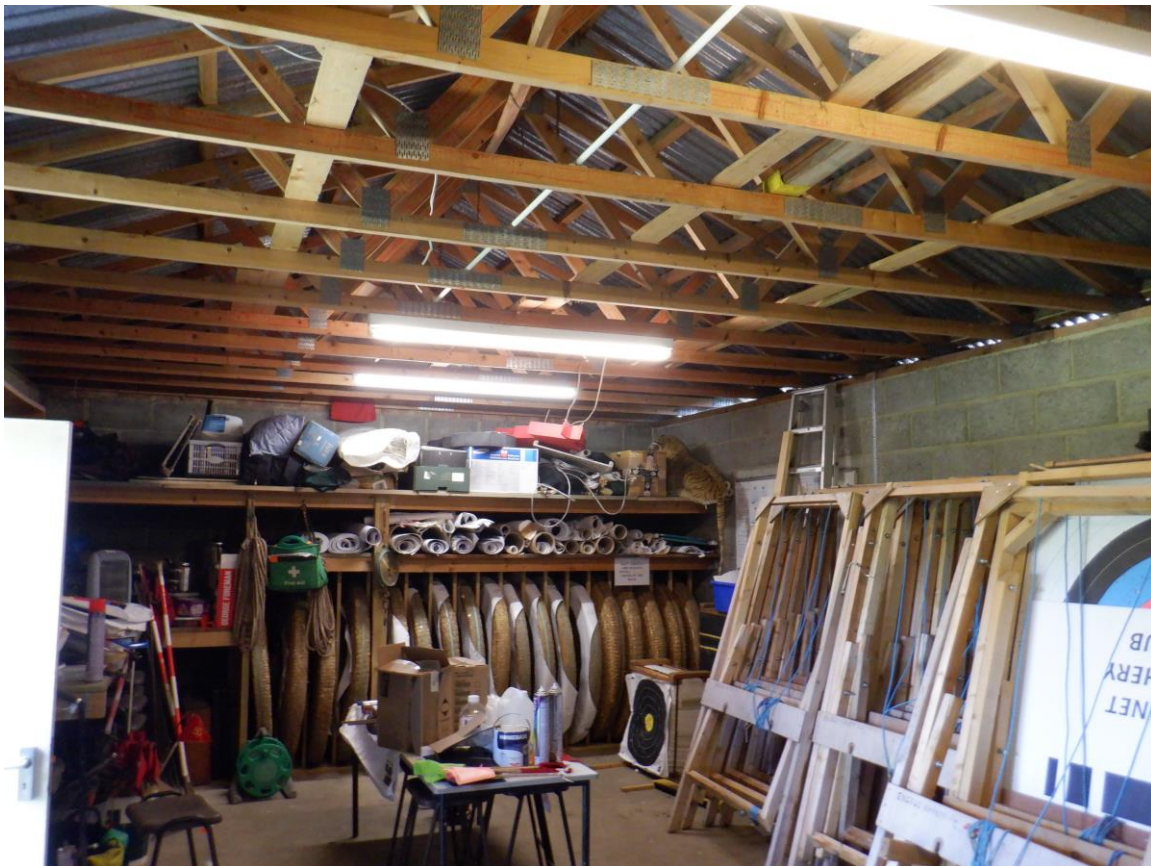
To the west of the bank is a gently sloping playing field, falling from the north western corner of the site down towards the base of the valley to the south east. The north eastern corner of the site is occupied by an area of cricket practice nets with the rest of the site in use as open playing fields. A metalled trackway extends from the access from College Road around the southern and eastern edges of the playing field (Plate 52). At the corner of the bend on the eastern side of the site is a painted breeze block constructed store-archery shed with a modern truss gable roof (Plates 51, 52, 53)

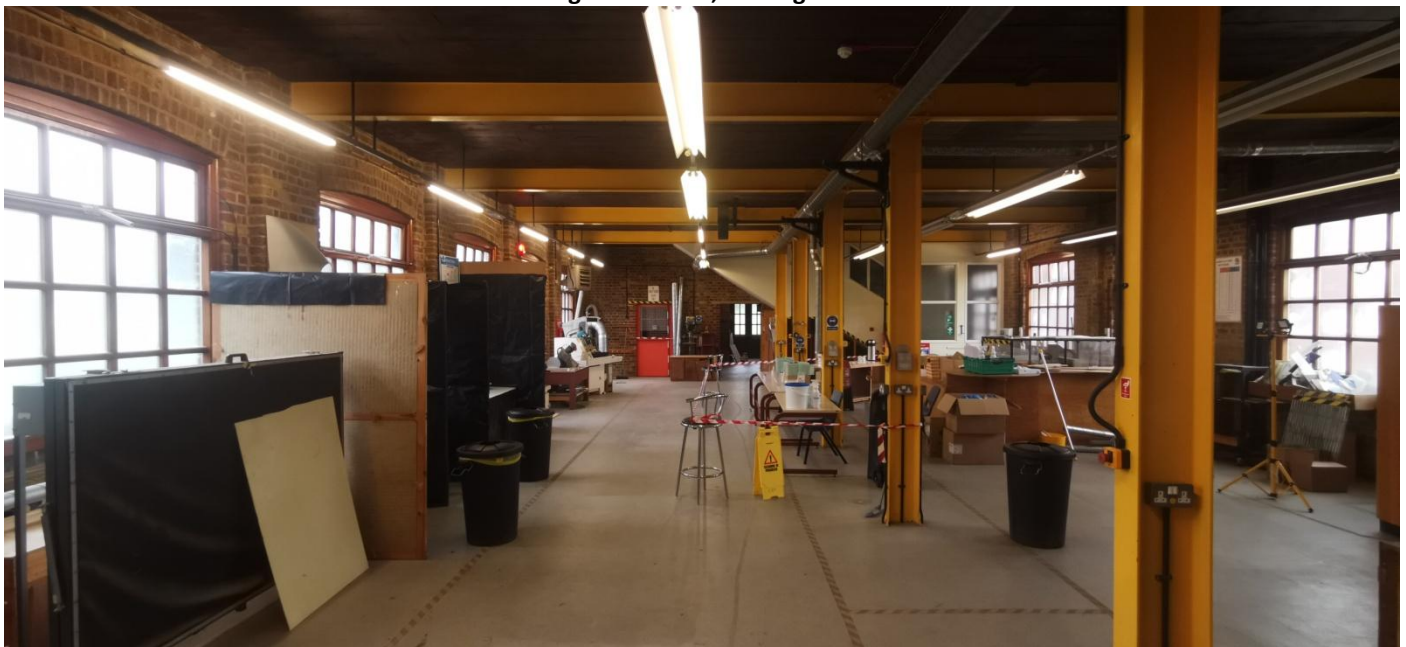
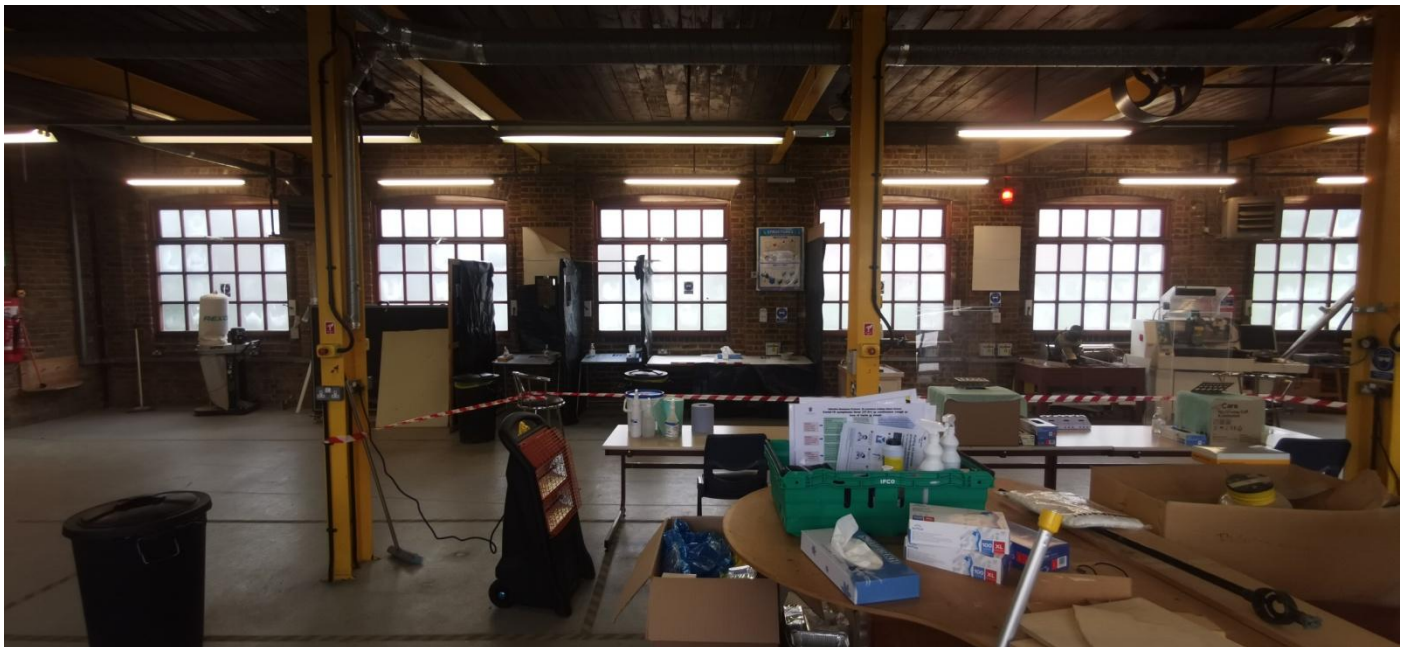
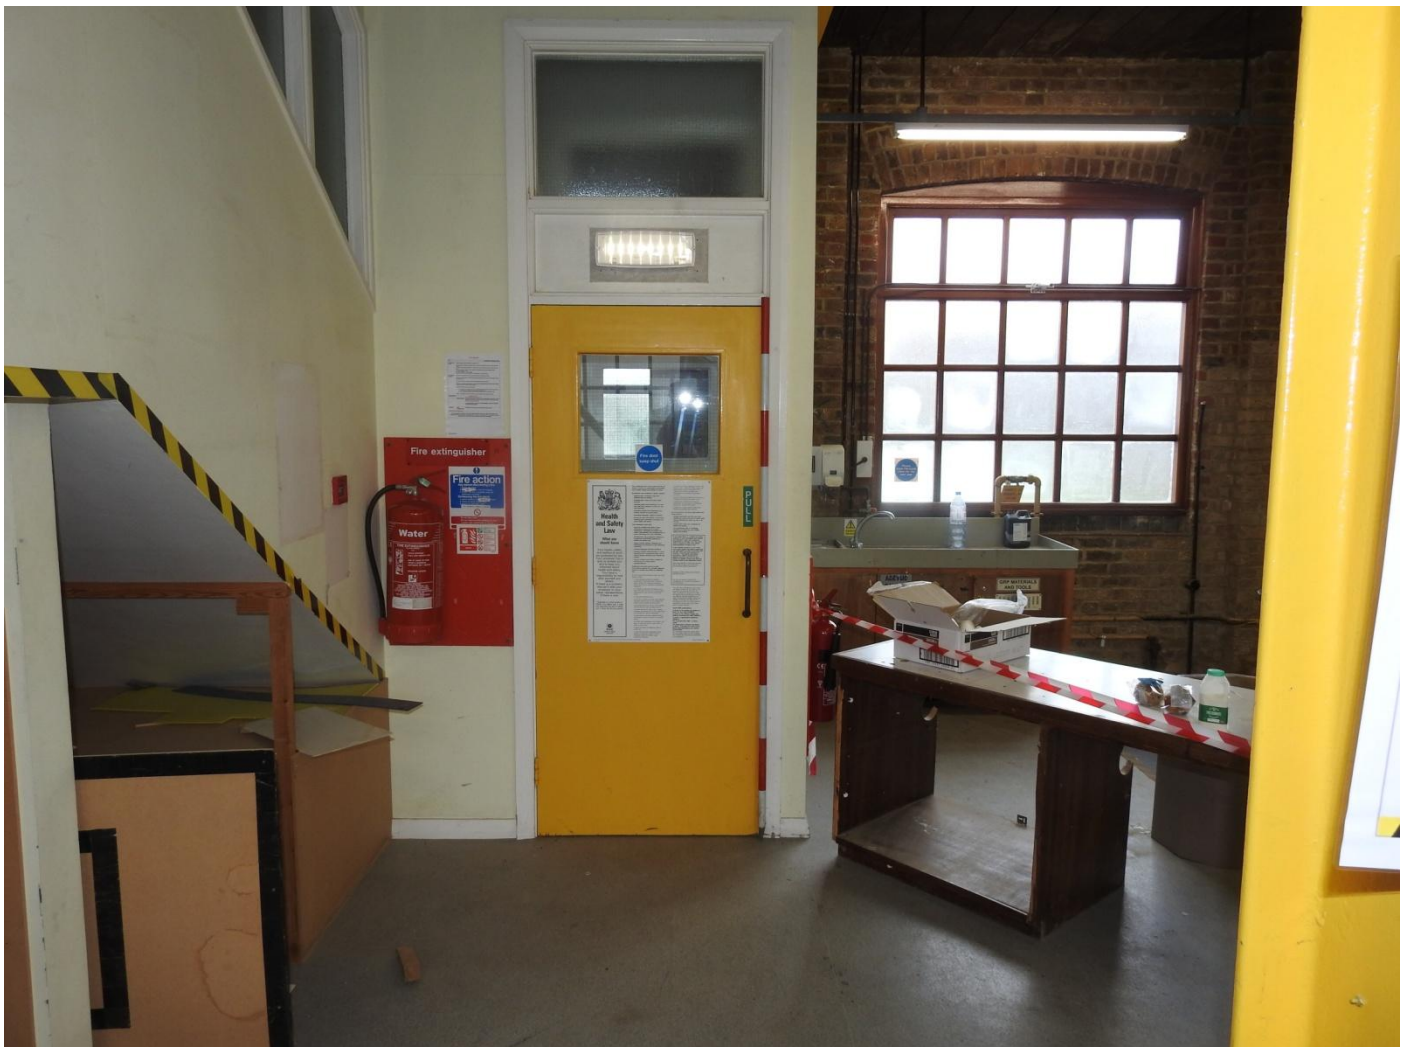
Room 8 is the main ground floor hall in the main building (Plates 63, 64, 65, 66) with a steel framework painted yellow (Plate 68) and the main entrance situated at the south end of the building is located within a entrance hall (Plate 69). A modern staircase (Plates 70, 71) leads to an upper space (Room 15, 16) with modern partitions and the original timber roof (Plates 72-81).
