# Historic Building Recording at St Lawrence College, College Road, Ramsgate, Kent

Report dated 21<sup>st</sup> April 2021

## **SWAT Archaeology**

# Historic Building Recording at St Lawrence College, College Road, Ramsgate in Kent

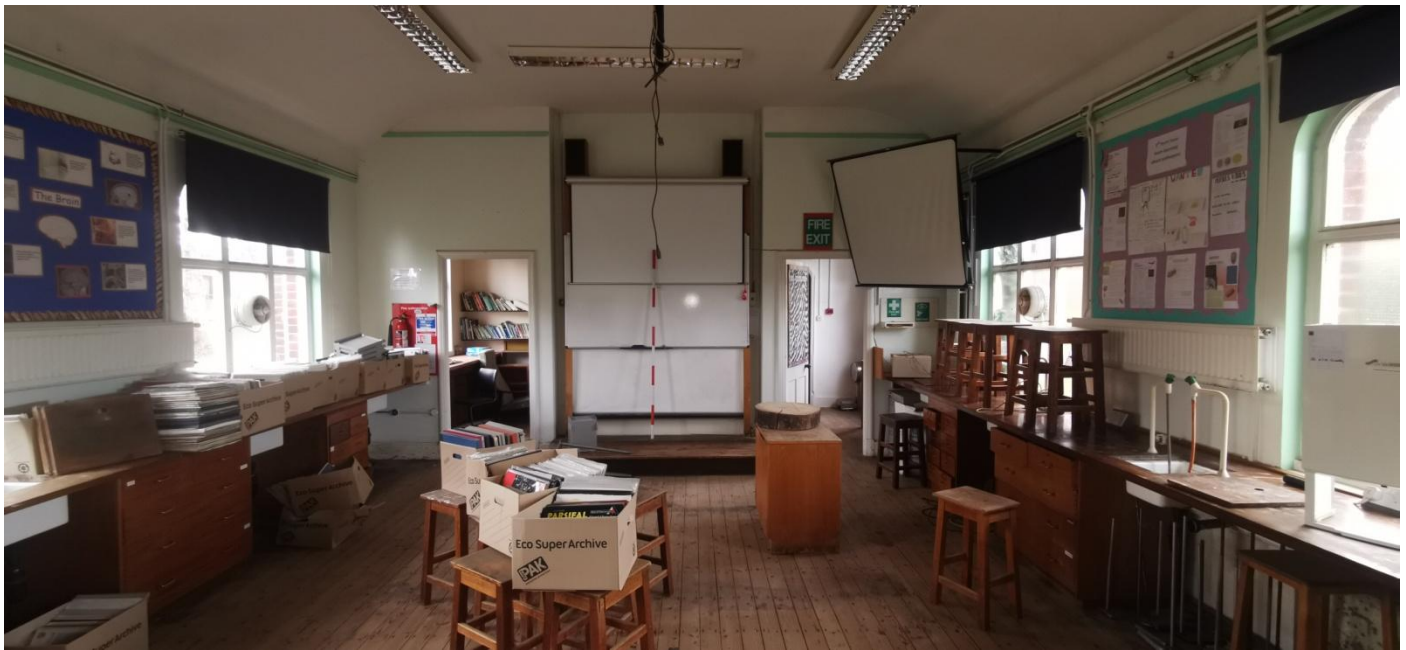
Plate 82: Building 3 – Room 1; looking west-south-west.

The main room (1) is open plan and holds modern science equipment (Figure 5. Plate 82) with three windows on each of the two outside walls (Plates 83, 84). Room 2 situated in the SW corner of the building is fitted out with modern bookshelves and desk (Plate 86). The adjoining room to the north is again fitted out with modern bookshelves and an original Gothic exterior door (Plate 87). Access to the adjacent Science Building (4) is through a corridor and stairs (Plates 89, 90).

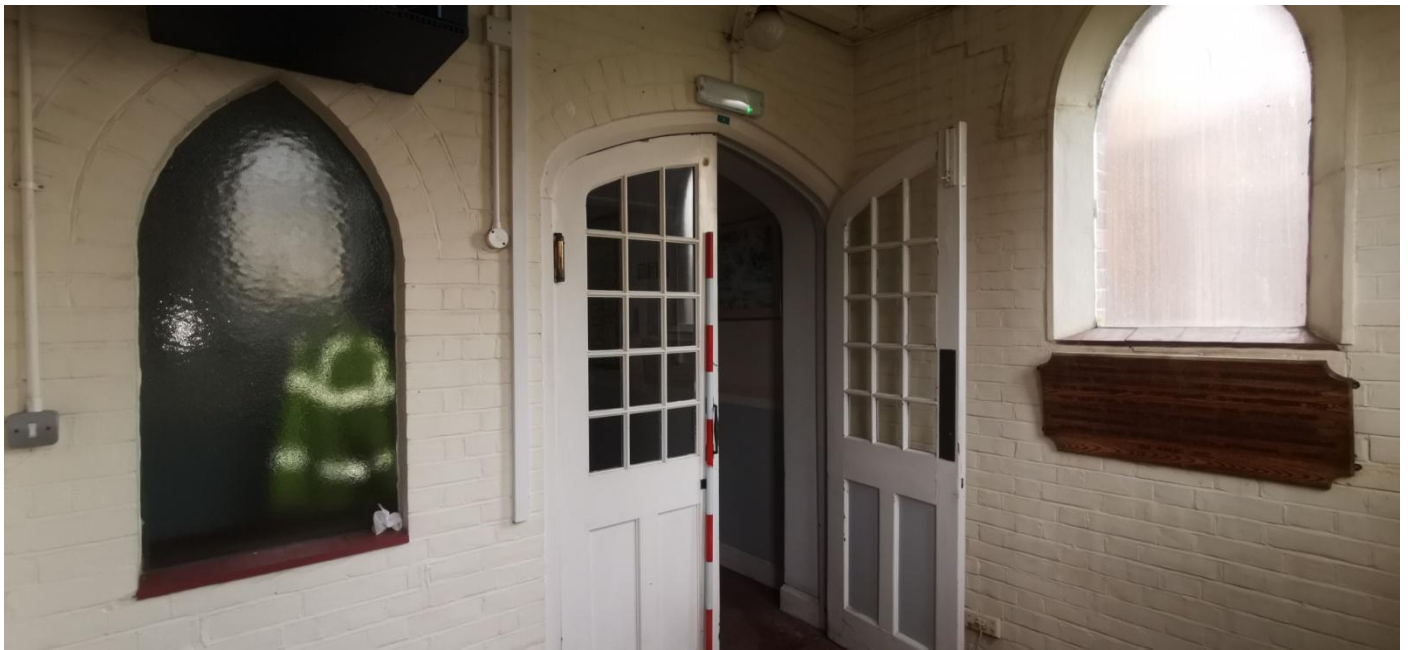
Plate 97: Building 4 – Room 8; looking north-east.

The main access to the building is through the Gothic style timber double doors situated on the west frontage of the single storey brick built vestibule (Room 8. Plates 19, 96). The interior of the vestibule houses the electric supply boxes (Plate 96) and access to the interior of the building through a set of half glazed white painted Gothic style doors (Plates 97, 98) into a corridor with staircase (Room 9. Plates 98, 99, 100). The corridor turns right (10) and

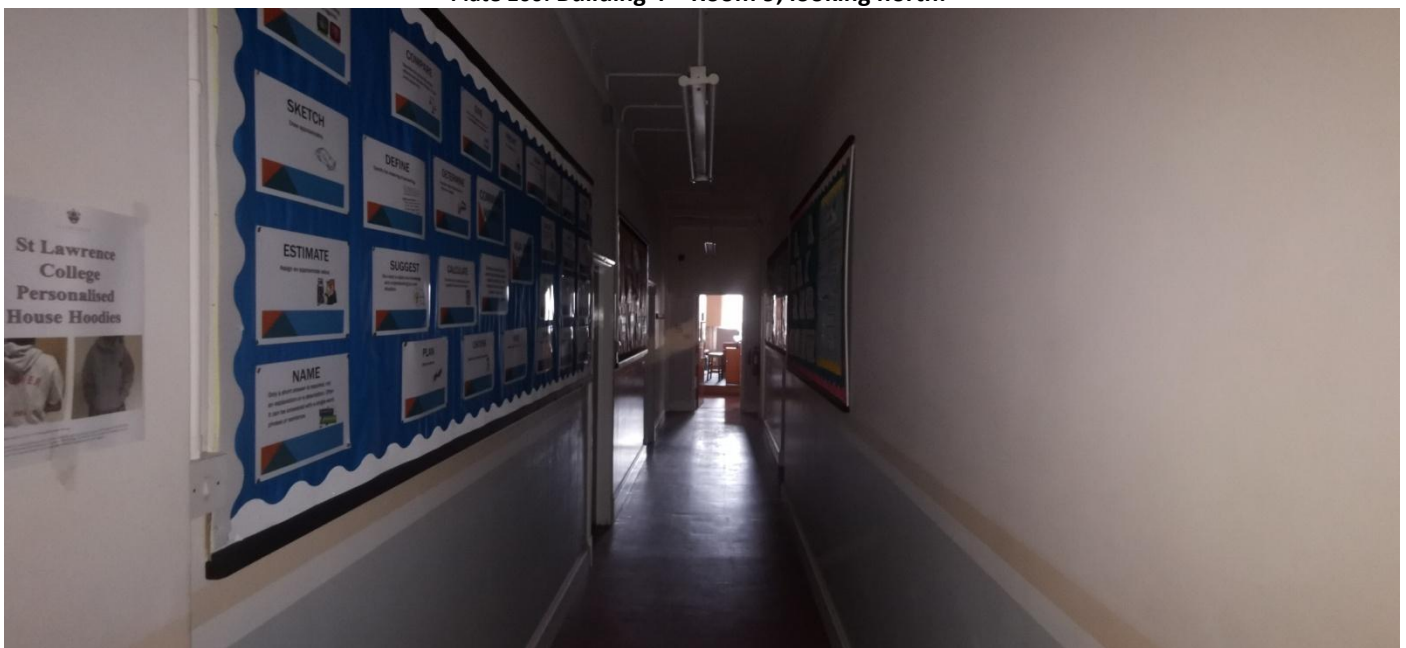
Plate 101: Building 4 – Room 10; looking east-south-east.

the far door on the right (Plate 101) leads into Room 11 which is furnished with modern school desks and green baize pin boards (Plates 102, 103).

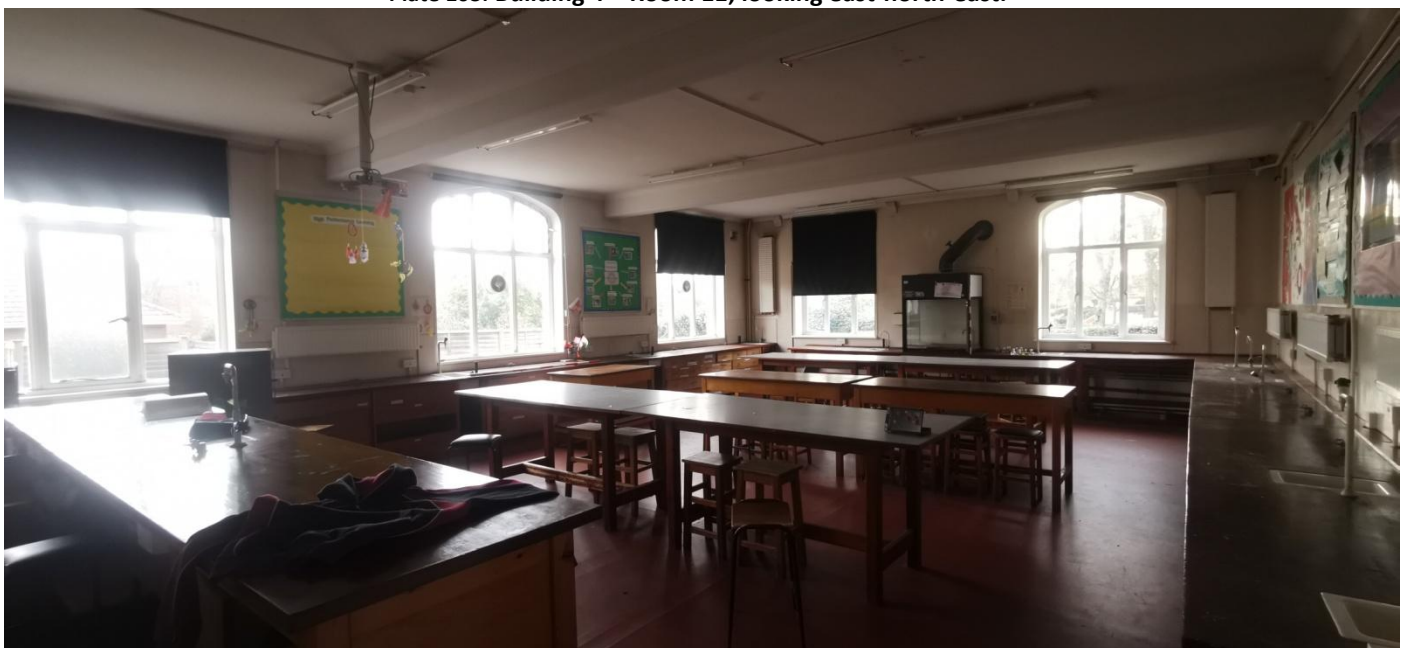
Plate 104: Building 4 – Room 12; looking south-south-east.

The adjacent room to the east (Figure 5. Room 12) is also furnished with modern school desks (Plates 104, 105) and to the north and accessed from Room 12 a small store cupboard (Room 13. Plate 106).

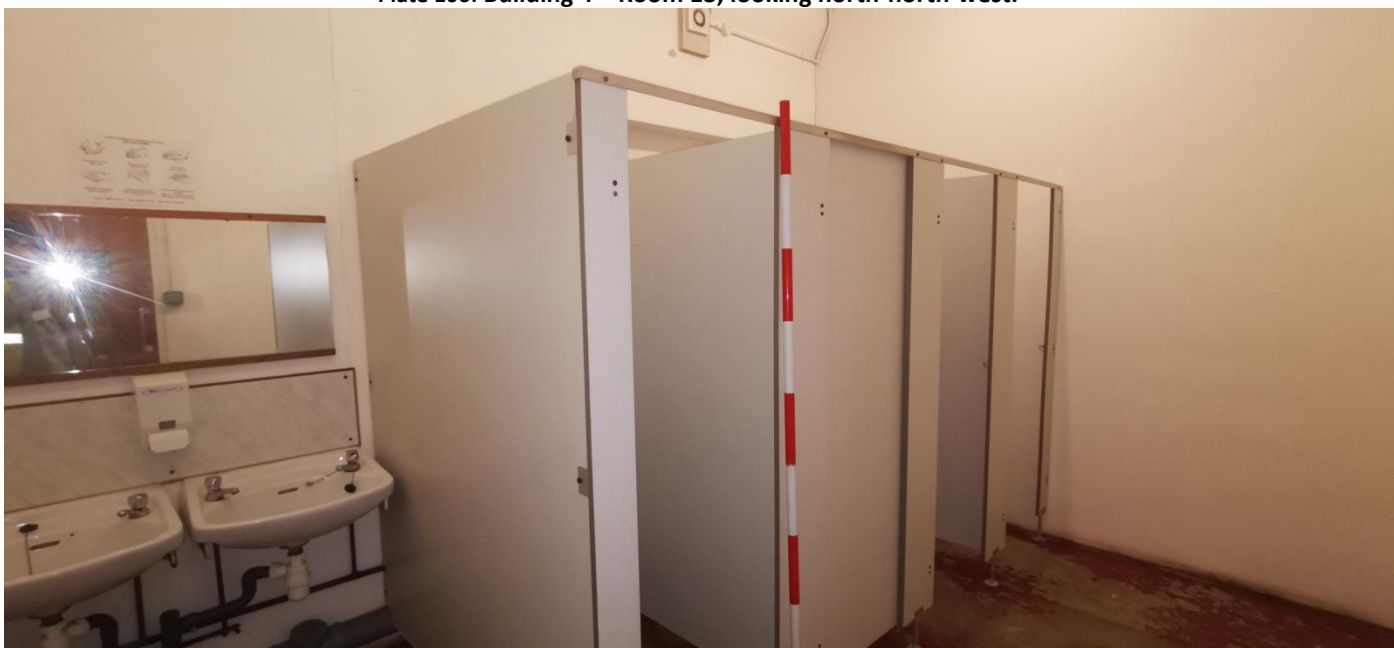
Plate 107: Building 4 – Room 14; looking east.

Room 14 to the right is a modern washroom (Plate 107) and to the left (Plate 108) the staircase leading to the first floor (Figure 7b). Room 23 is another large classroom fitted out with modern tables (Plates 109, 110). The adjacent classroom (Room 24) is another classroom (Plates 111, 1120 and Room 25 next door is fitted out with sofa's and bookshelves (Plate 113). Room 22 is the corridor (Plate 114) which leads to Room 20 which is fitted out as a lecture theatre (Plates 117,118).

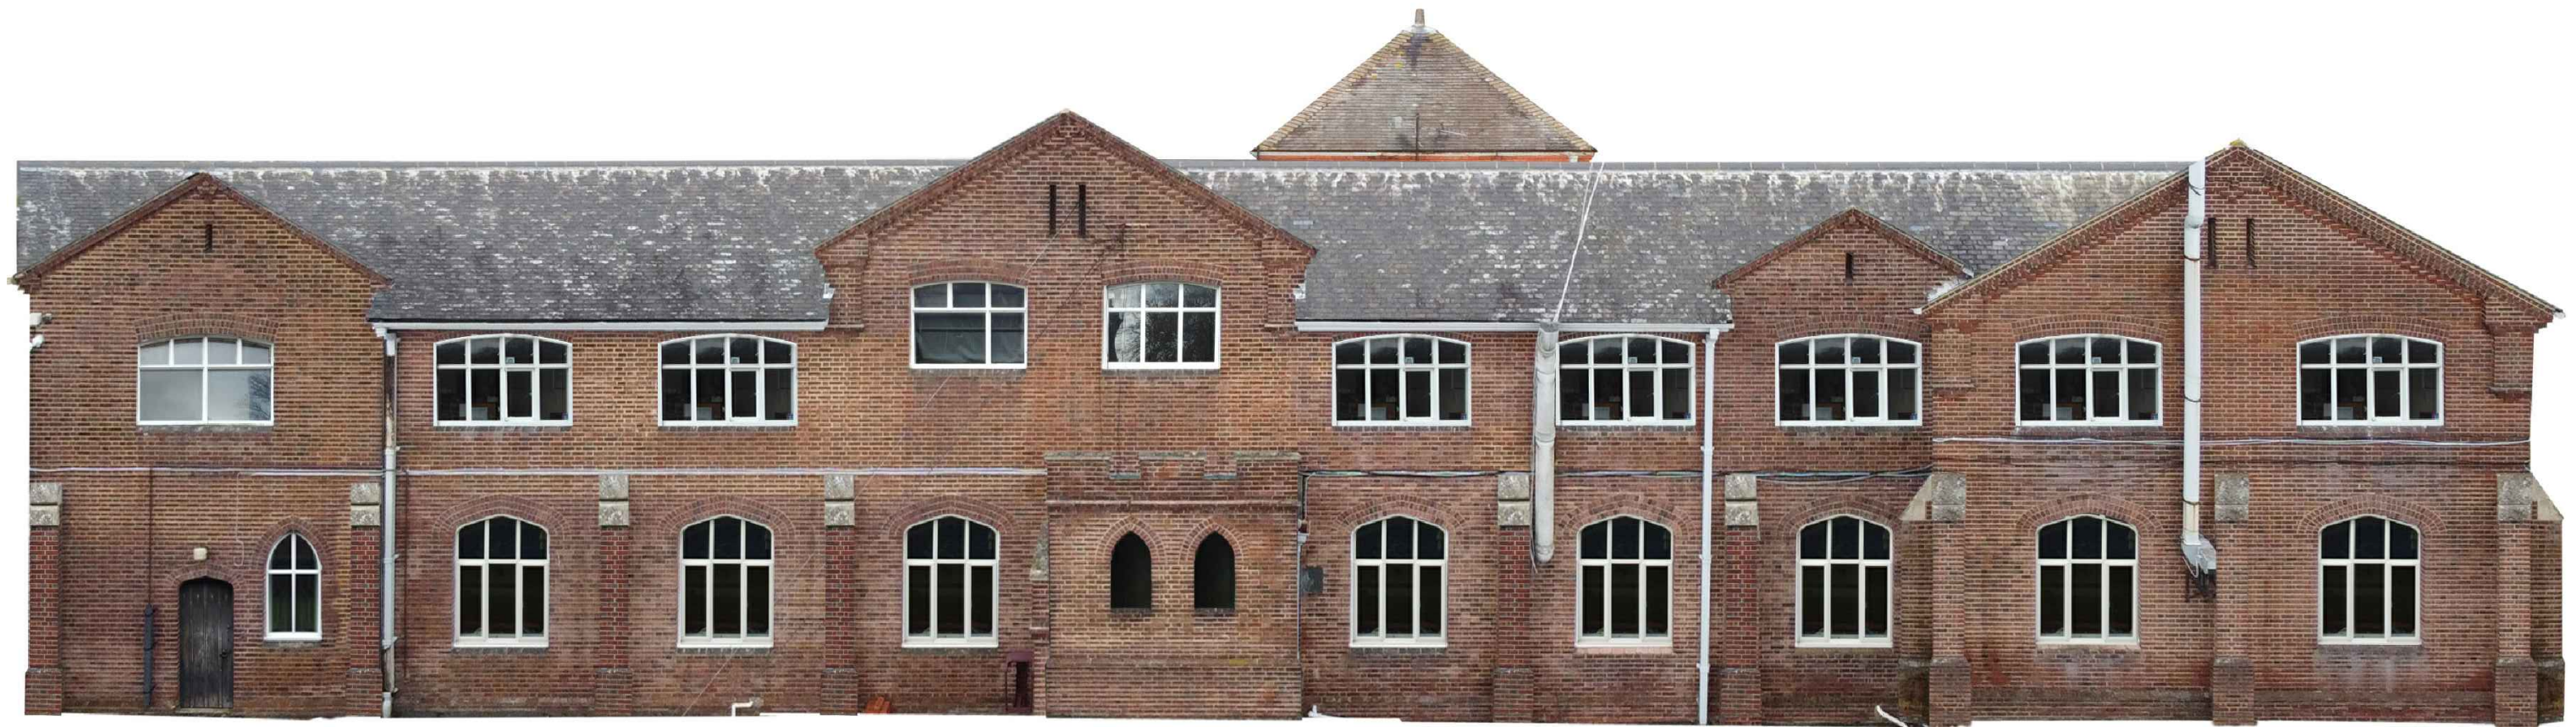
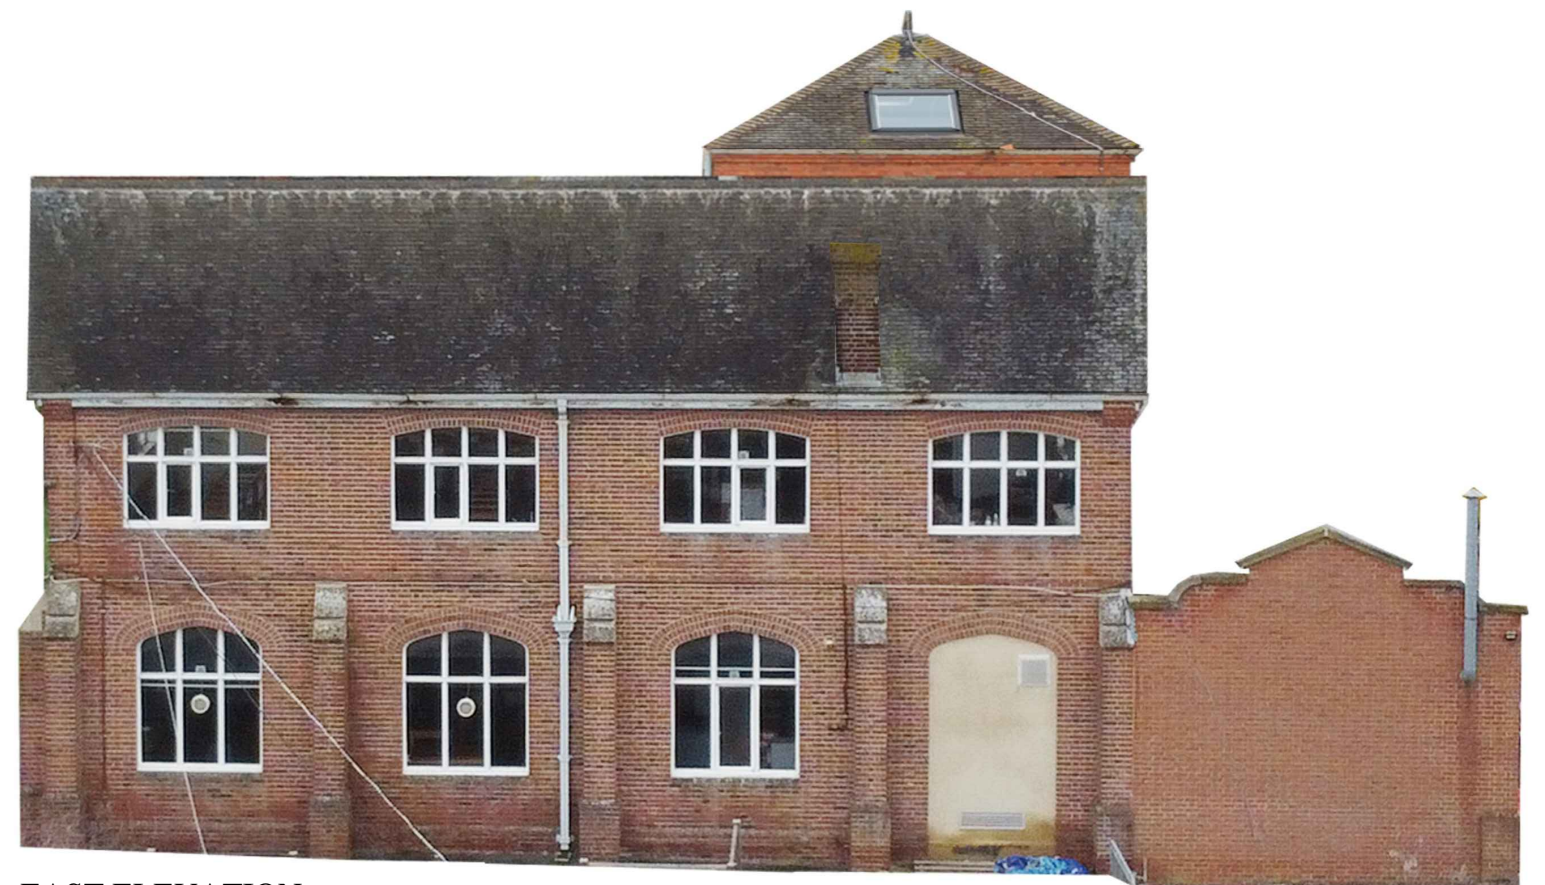
Figure 7d: Building 4 - South and east elevation

SOUTH ELEVATION

EAST ELEVATION
