WINDOW SURVEY AT 1-2 & 3-4 LIVESEY STREET, TESTON, KENT

1. SWAT Archaeology Partnership has been instructed by the owners of the above properties to carry out a full investigation of all the windows and provide a detailed written condition report based on the survey findings.

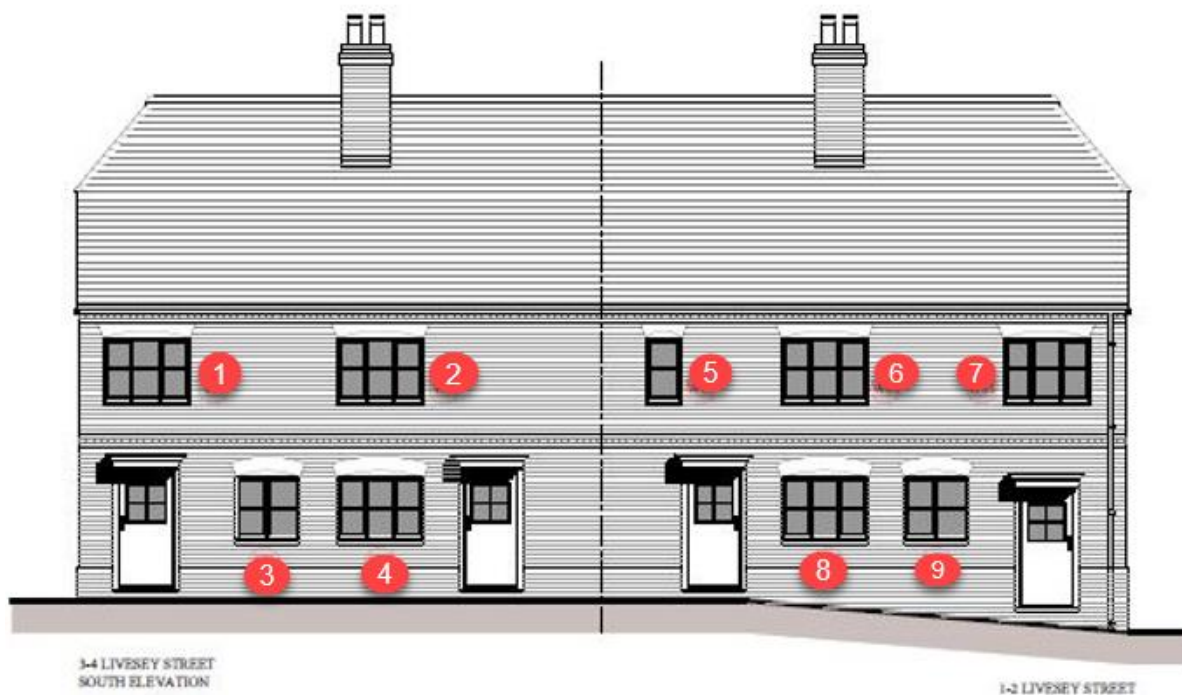
WINDOWS SOUTH ELEVATION

ITEM	WINDOW CONDITION	REPAIR OR REPLACE
Window 1 (Plate 2)	Cill, bottom rail, left jamb rotted	Replace
Window 2 (Plate 2)	Cill, bottom rail, right and left jamb rotted	Replace
Window 3 (Plates 2, 4)	Cill rotted	Replace
Window 4 (Plates 2, 6)	Poor replacement cill, left mullion rotted	Replace
Window 5 (Plate 1)	Cill and right jamb rotted	Replace
Window 6 (Plate 1)	Cill rotted	Replace

Window 7 (Plate 1)	Cill rotted	Replace
Window 8 (Plates 1, 5)	Cill, right and left bottom rail rotted	Replace
Window 9 (Plate 3)	Cill, left and right bottom rotted	Replace

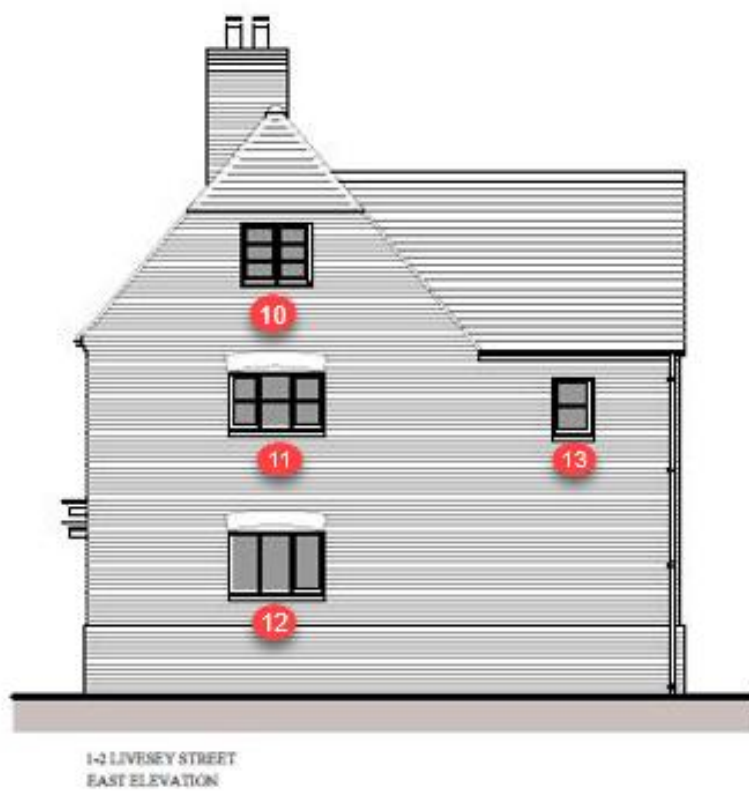
WINDOWS EAST ELEVATION

ITEM	WINDOW CONDITION	REPAIR OR REPLACE
Window 10 (Plate 7)	Cill, bottom rail, left jamb rotted	Replace
Window 11 (Plates 7, 9)	Cill and bottom rail rotted	Replace
Window 12 (Plate 7)	Cill, bottom rail, right and left jamb rotted	Replace
Window 13 (Plates 7, 8)	Bottom rail rotted	Replace

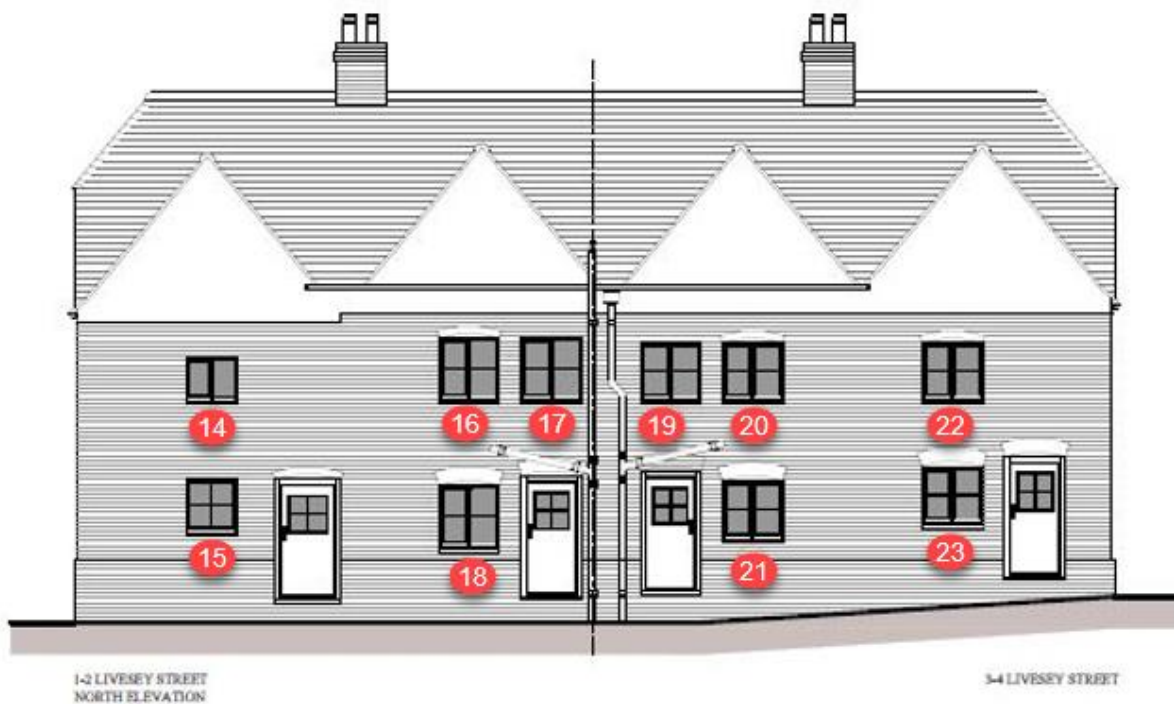
WINDOWS NORTH ELEVATION

ITEM	WINDOW CONDITION	REPAIR OR REPLACE
Window 14 (Plates 10, 15)	Cill, bottom rail, left jamb rotted	Replace
Window 15 (Plates 10, 12)	Cill, bottom rail, right and left frame rotted	Replace
Window 16 (Plate 10)	Cill, bottom rail, right and left jamb rotted	Replace
Window 17 (Plate 10)	Cill, bottom rail, right and left jamb rotted	Replace
Window 18 (Plates 10, 11)	Cill rotted	Replace

ITEM	WINDOW CONDITION	REPAIR OR REPLACE
Window 19 (Plates 10, 13)	Cill, bottom rail, left jamb rotted	Replace
Window 20 (Plates 10, 13)	Cill and bottom rail rotted	Replace
Window 21 (Plates 10, 13)	Cill rotted	Replace
Window 22 (Plates 10, 14)	Cill, right jamb rotted	Replace
Window 23 (Plates 10, 14)	Cill rotted	Replace

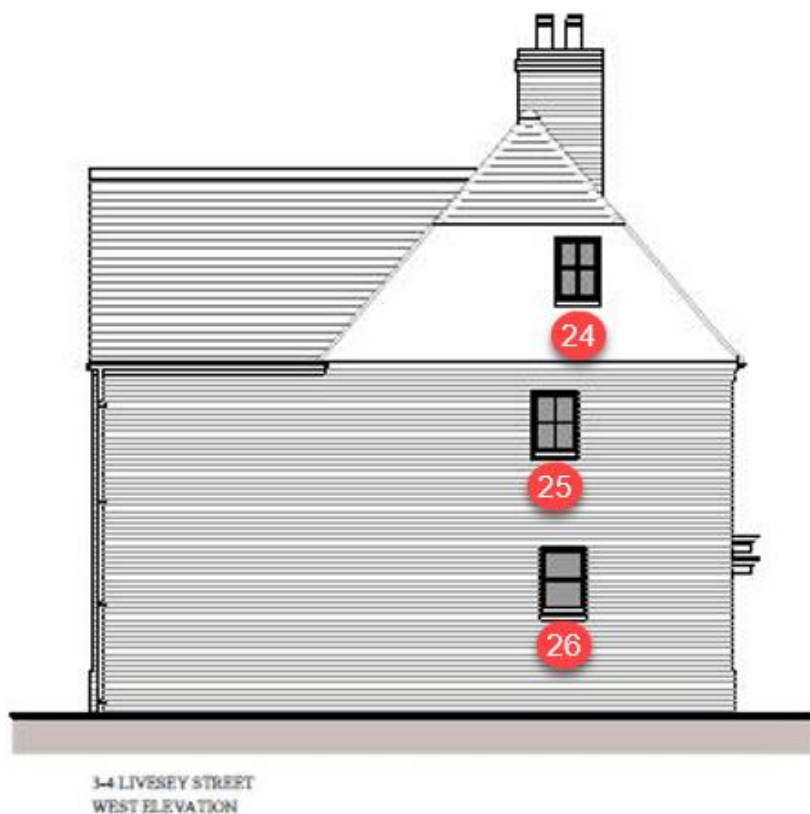
WEST ELEVATION

ITEM	WINDOW CONDITION	REPAIR OR REPLACE
Window 24 (Plate 16)	Cill, bottom rail, left jamb rotted	Replace
Window 25 (Plate 16)	Cill, bottom rail, right and left jamb rotted	Replace
Window 26 (Plate 16)	Cill, bottom rail, right and left frame rotted	Replace
