HISTORIC BUILDING RECORDING AT CLAYDENE FARM, HARTFIELD ROAD, COWDEN, KENT

Date of report 11^{th} June 2021

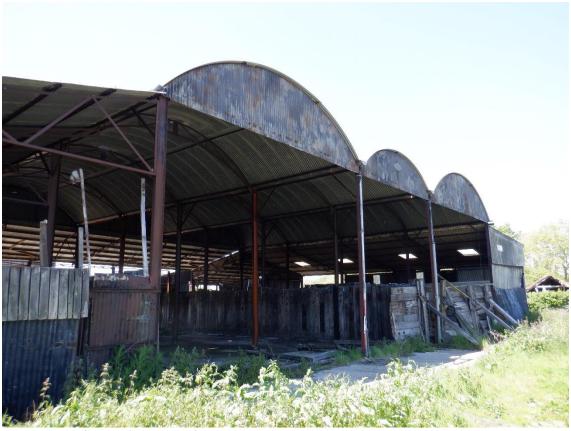
Plate 2. View of Barn 4 (looking NW)

3.4 Barn 4 The building (Figure 6) is a three bay Dutch barn with two additional extensions with sloping roofs (Plate 11) and is the largest building on the site (Plates 1, 2). Early barn types in the UK, such as aisled barns, were primarily used for the processing and temporary storage of grain. Processing comprised of hand-threshing (or later, machine threshing) the grain before removal to a granary for more permanent storage. The hay barn was developed

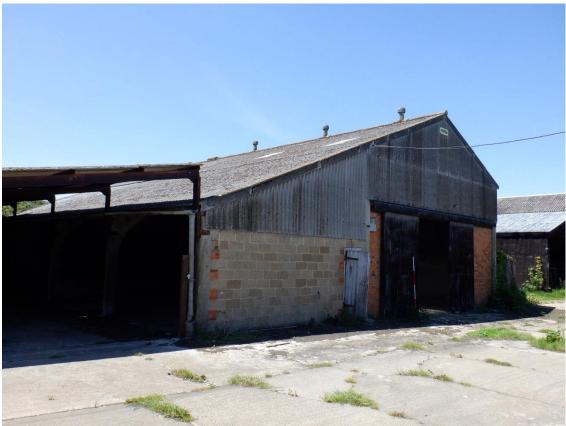
Plate 8. View of Barn 1 (looking NNW)

3.1 Barn 1 The building is located in the centre of the group of farm buildings and faces northeast. It is a ATCOST Building with the main building measuring 11m x 19.75m and the additional building to the south-east 13m in width (Plate 7. Figure 4). The main building has a brick facade with two large sliding double doors of corrugated metal painted black whilst the attached building is faced with concrete blocks and accessed through a single timber door (Plate 8). The roof is corrugated asbestos sheets as is the upper storey of the building (Plate 9). The interior has a concrete floor and a number of concrete settling tanks whilst the four roof spans are of ATCOST concrete with concrete purlins (Plate10).

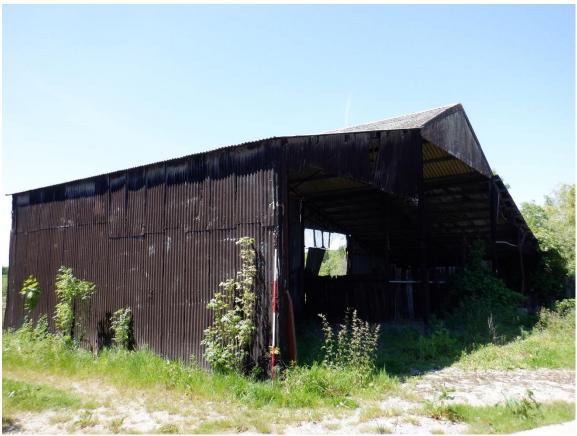
Plate 16. View of Barn 2 (looking W)

3.2 Barn 2 The building is located in the north-west area of the site and is timber framed and sheathed with vertical sheets of corrugated steel painted black. The pitched roof of the main building is of corrugated asbestos sheets whilst the extension with its sloping roof is corrugated metal sheeting (Plates 15, 16). The main area measures 27m x 9.75m and the extension to the south-west 8m x 10m. Access to the main area of the building is by double doors located on the south-west facade and through the north-east facade which is open. The internal floor is of concrete (Figure 5).

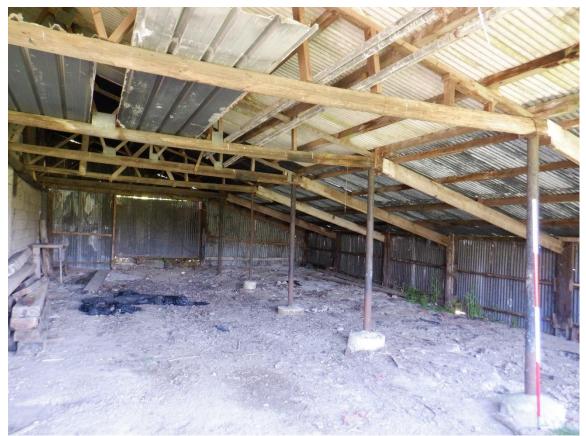
Plate 19. View of interior of Barn 5

3.5 Barn 5 The building (Figure 7) is a double height barn built of vertical corrugated sheets of asbestos cement secured to a metal frame with a large sliding double door faced with vertical corrugated metal sheets painted black (Plate 18). The building measures 14m x 22m including the extension with a sloping roof built of timber (Plate 19). The interior of the main barn shows the central pitched roof built of metal struts sat on vertical metal beams with the three side extensions divided by vertical railway sleepers. The internal floor surface is of tarmac road scrapes (Plate 20).
