# HISTORIC BUILDING RECORDING AT THE MEDWAY MARITIME HOSPITAL, WINDMILL ROAD, GILLINGHAM, KENT

Date of report 07.05.2020

In April 2020 SWAT Archaeology carried out a historic building recording at the Medway Maritime Hospital, Windmill Road, Gillingham in Kent (Figure 2). The buildings, Residences 14, 15 are presently unoccupied and are about to undergo stripping out and demolition.

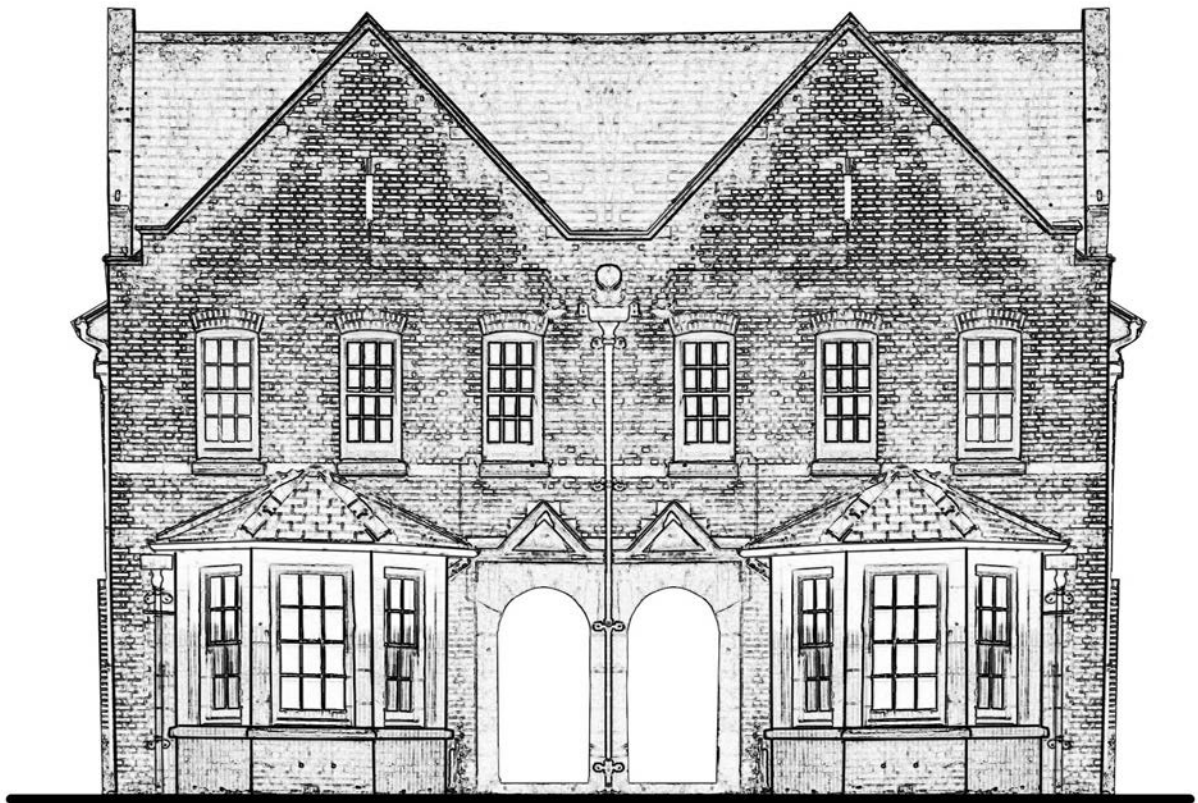
RESIDENCE 14 - NORTH EAST ELEVATION (Front)

RESIDENCE 14 - SOUTH EAST ELEVATION (Left)

Figure 6: Front and left side elevation of Residence 14

7.3 The NE front elevation shows that the building was designed as a pair of semi-detached houses and in the late Victorian practise has side by side doors in the middle of the building (Plate 4. Figure 6).

7.6 The upper storey is delineated by a stone string course and set above it each semi-detached house has three sash windows each divided into 12 panes of clear glass set with an arched lintel built of a double course of soldier bricks and the window frame sits on a stone cill (Plate 11). The roof is drained by a hidden lead lined gutter draining into an external cast iron- and painted black- hopper decorated with heraldic motifs and vertical cast iron drainpipes secured to the wall by decorative straps (Plate 11, Figure 6).

7.7 The two front doors are each individually recessed within a fine stone semi-elliptical arched doorway topped by an ogee curved stone cornice capped by a triangular pediment framed by a raking cornice. The front panelled doors are painted blue and hung within a white painted flat arched timber frame (Plate 8, Figure 6).

7.8 The rear (SW) elevation has two flat roofed bays pierced by modern UVPC windows and UVPC French doors with fanlight which lead to five stone steps. To the right is a toilet block addition with a slate sloping roof. The upper storey is pierced by four sash windows and the gabled roof is divided by a secret gutter leading to an external gutter box and vertical black painted cast iron drain pipe (Plate 6, Figure 6).

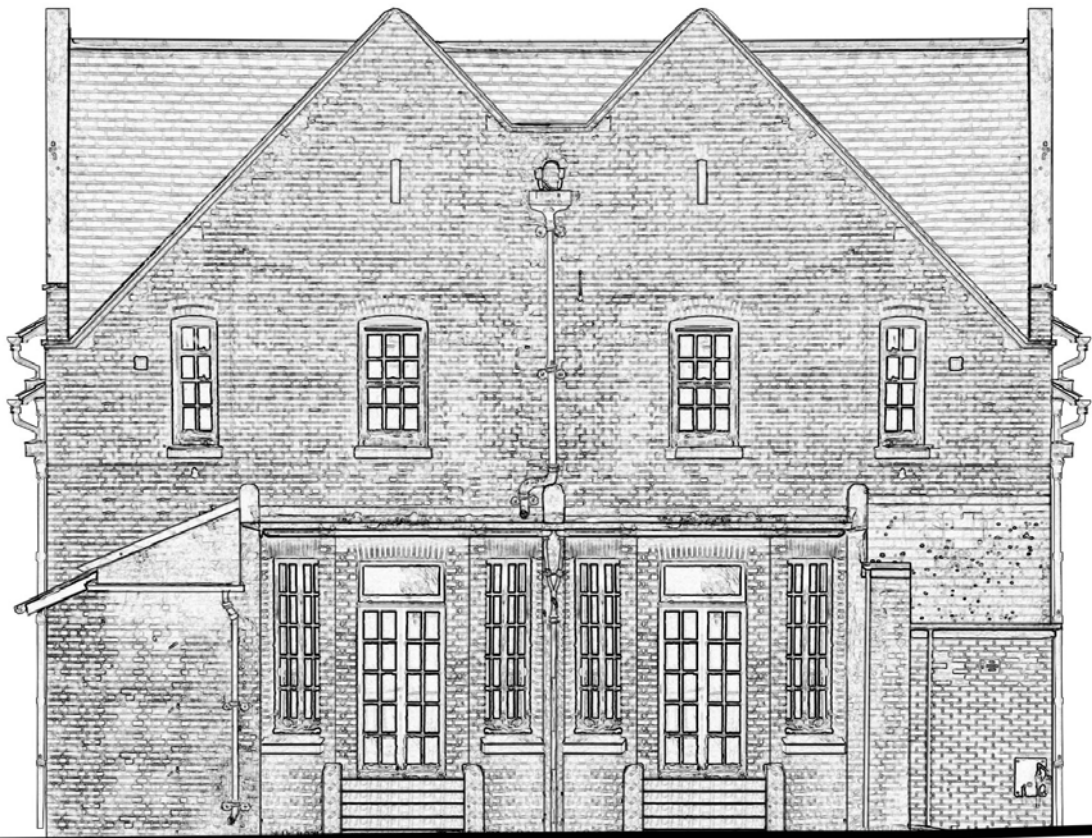
RESIDENCE 14 - SOUTH WEST ELEVATION (Rear)

RESIDENCE 14 - NORTH WEST ELEVATION (Right)

Figure 7: Rear and right side elevation of Residence 14

7.9 The side (SE) elevation has a hipped roof and three stories of window with five sash windows on the ground floor, four sash windows on the first floor and two sash windows on the second floor. There is a UVPC half glazed external door with side light just off of centre on the ground floor (Plate 5, Figure 7).

7.10 The side (NW) elevation has a hipped roof and three stories of windows with five sash windows and a UVPC external door on the ground floor, four sash windows on the first floor two sash windows on the second floor (Plate 7, Figure 7).

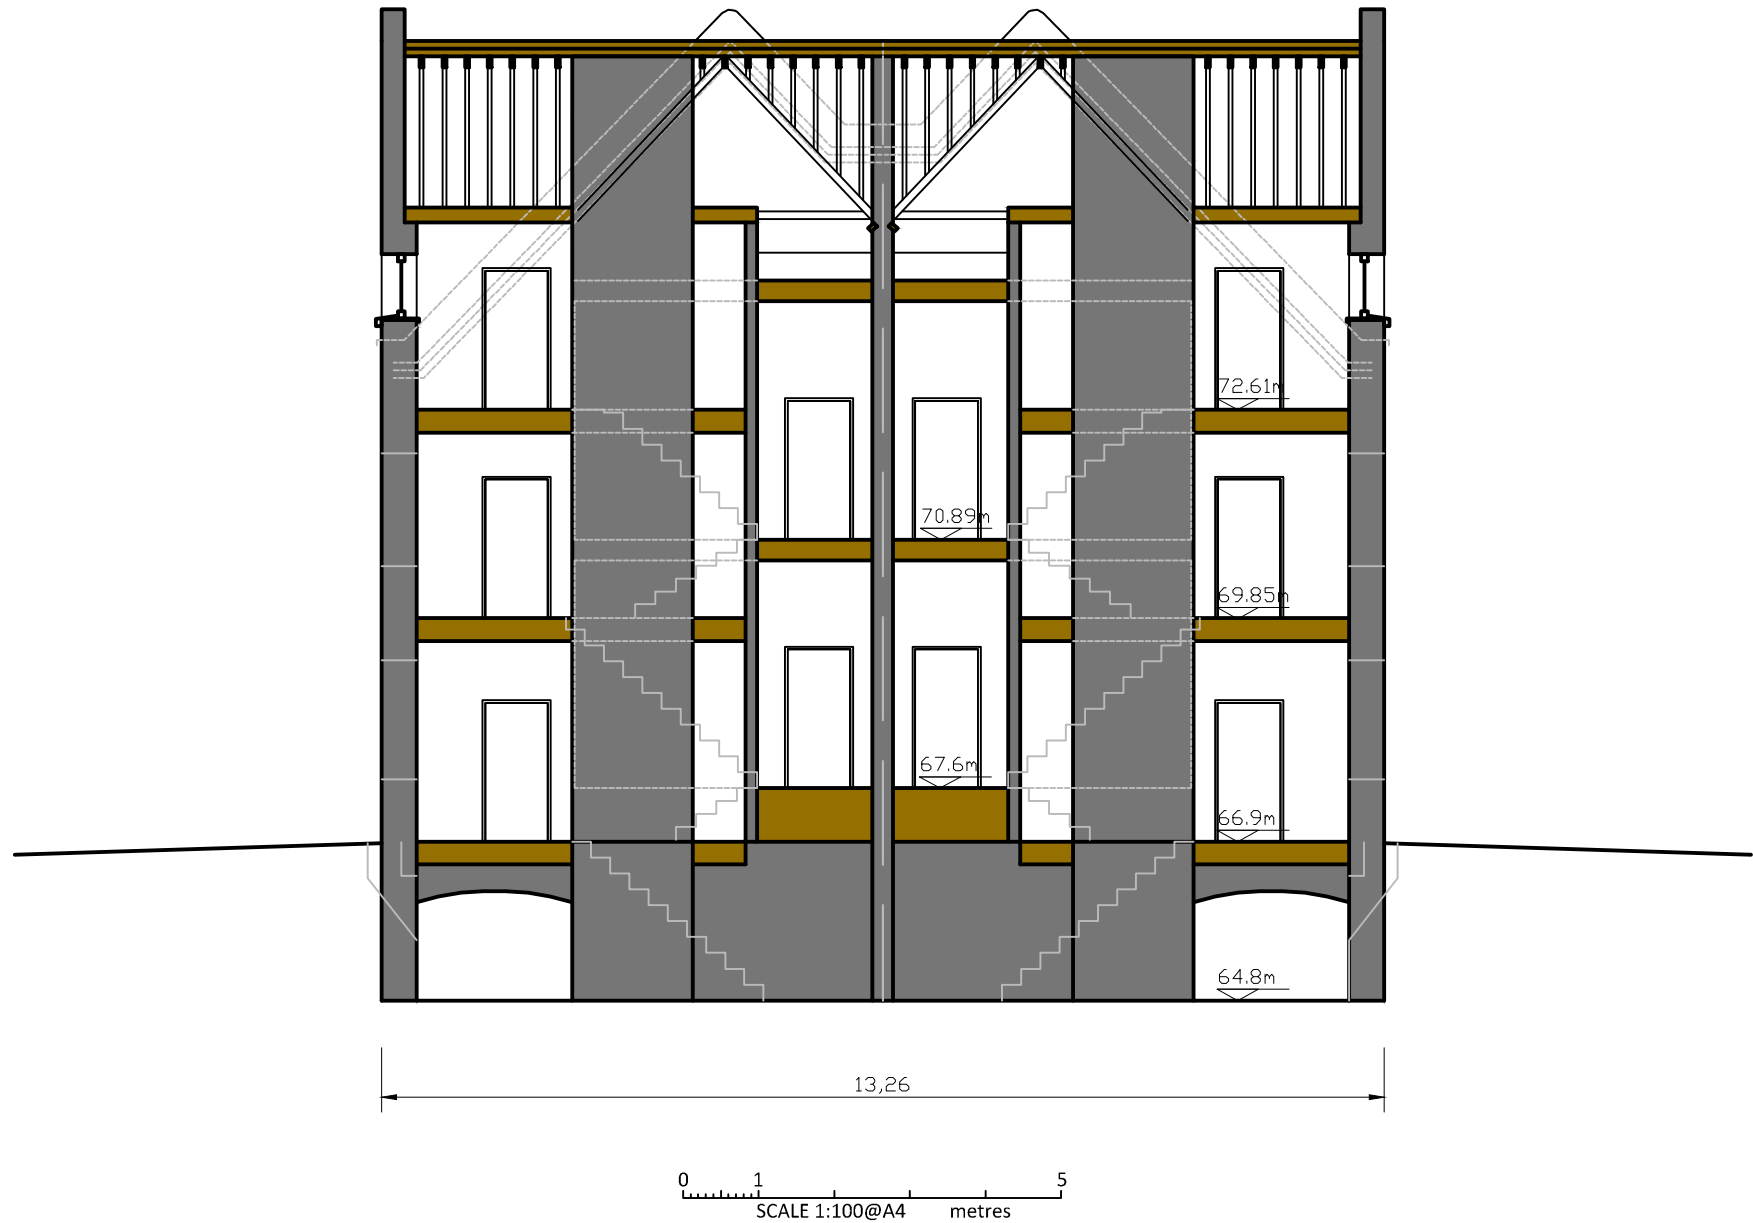
Figure 9: Cross-section of Residence 14

7.2 The main body of the building is on three floors and with four bays on the ground floor (Plate 3). The roof has four hipped ends and the roofing material is slate and with leaded roof gullies. There are no chimney stacks (Figures 8, 9).

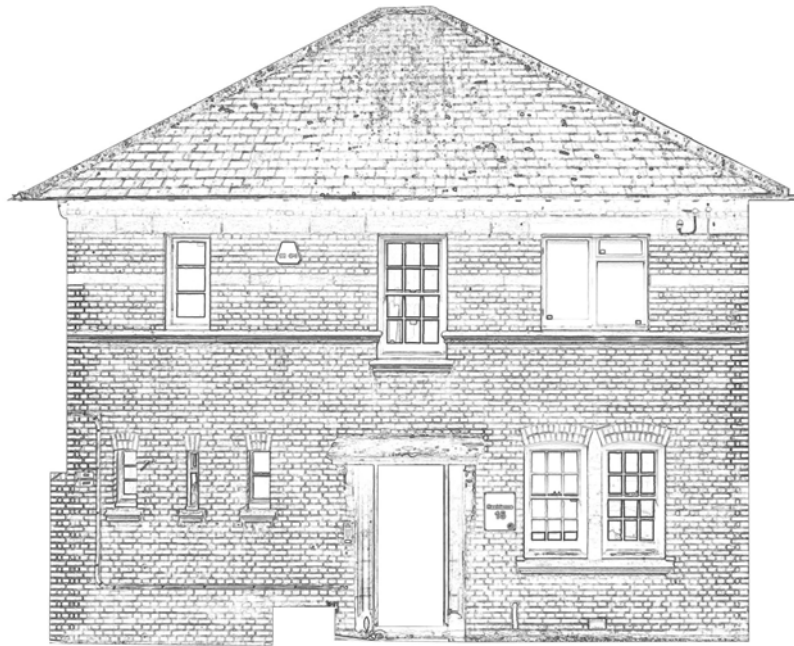
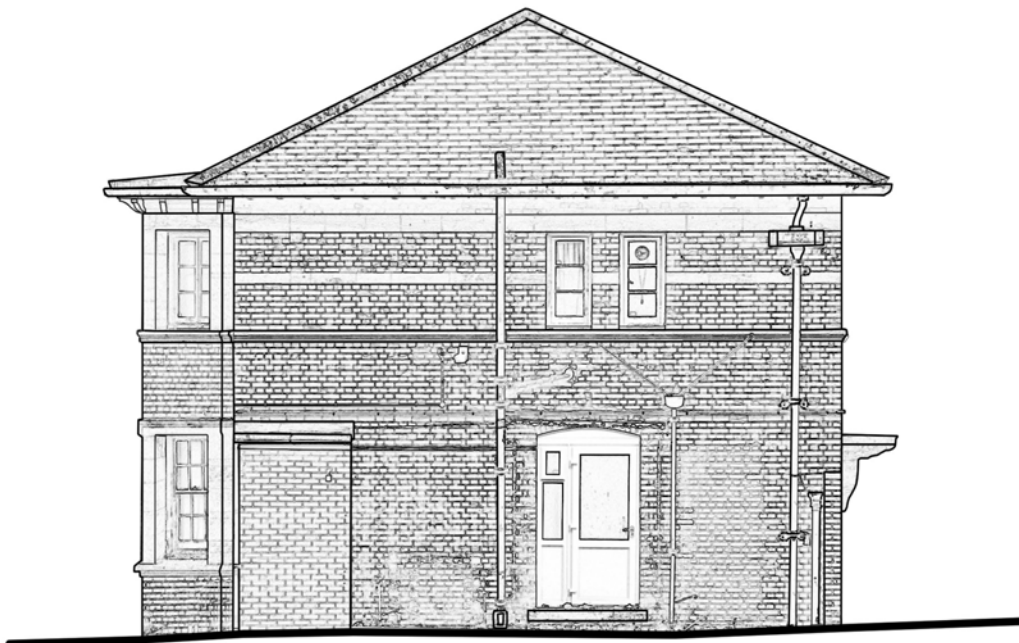
RESIDENCE 15 - EAST-NORTH-EAST ELEVATION (Front)

RESIDENCE 15 - SOUTH-SOUTH-EAST ELEVATION (Left)

Figure 11: Front and left side elevation of Residence 15

2.4 Residence 15 is a more 'under-stated' two storey building and is probably a replacement or underwent significant external changes in the 1930s. The brickwork does not have the same visual texture and grain as Residence 14, and the use of stone dressing on the front elevation is more muted. The single main entrance is retained on the front elevation. Residence 15 has a simpler roof form than Residence 14 (with a pitched roof leading to an apex). More recently, both buildings had been in use as offices, but are currently vacant (Figures 10, 11, 12, 13).

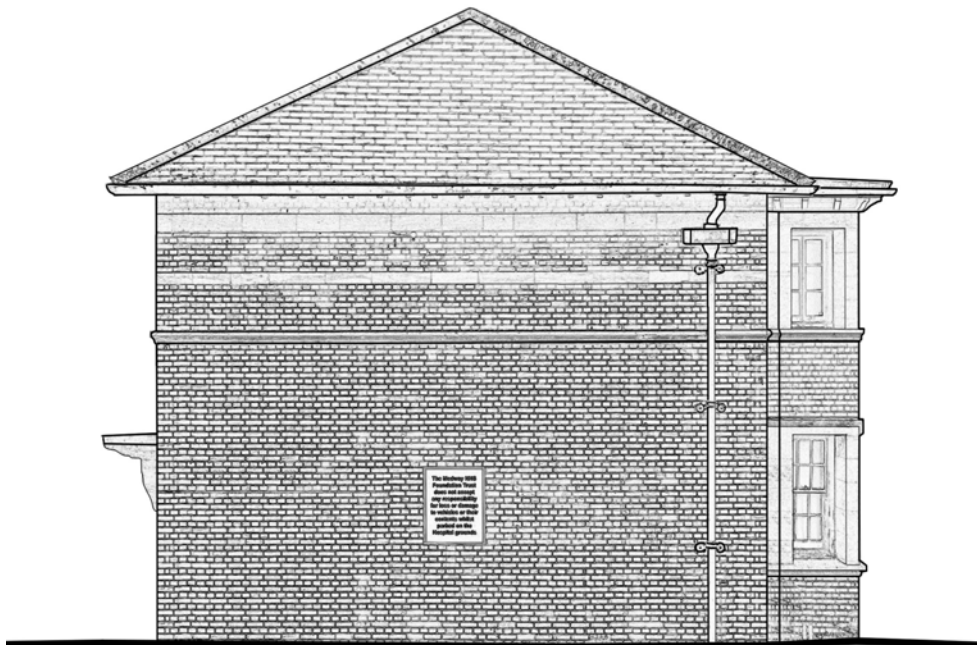
RESIDENCE 15 - WEST-SOUTH-WEST ELEVATION (Rear)

RESIDENCE 15 - NORTH-NORTH-WEST ELEVATION (Right)

Figure 12: Rear and right side elevation of Residence 15

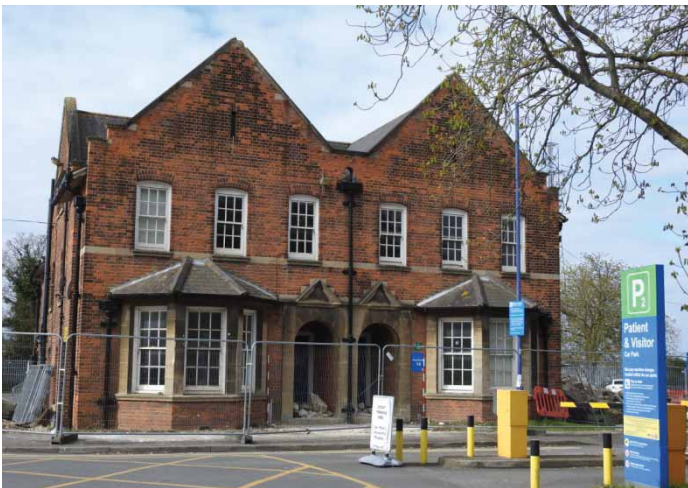
Plate 4: Residence 14; North-east elevation

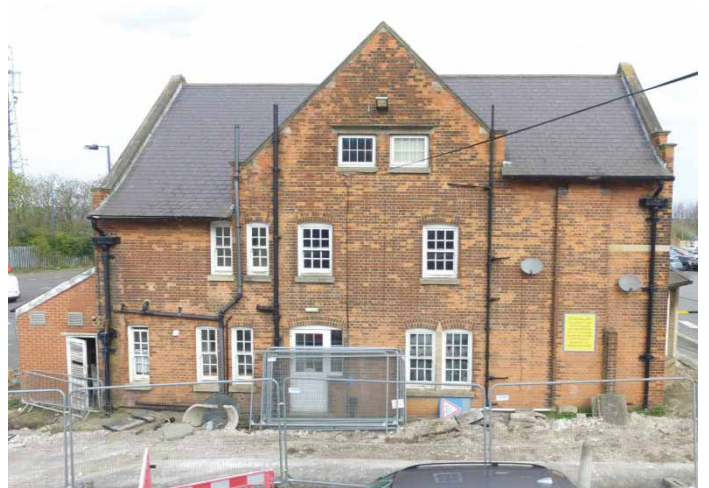
Plate 5: Residence 14; South-east elevation

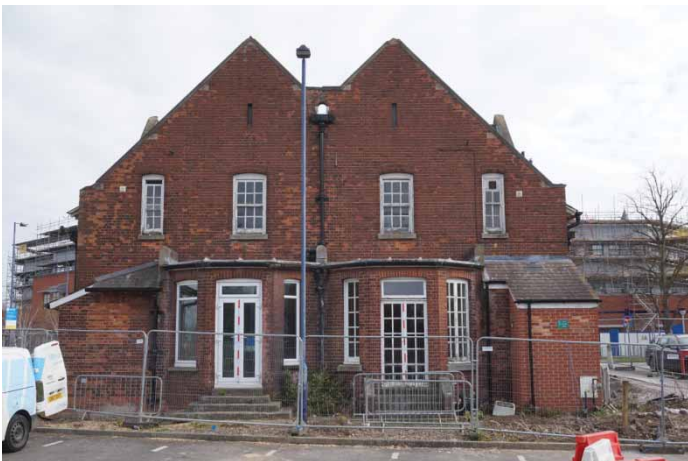
Plate 6: Residence 14; South-west elevation

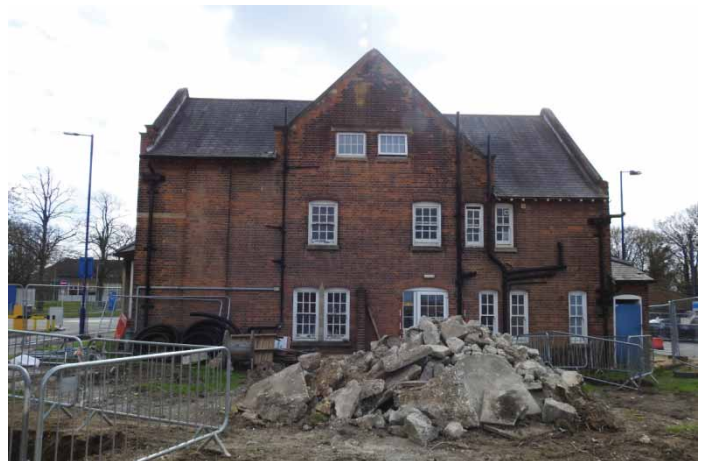
Plate 7: Residence 14; North-west elevation

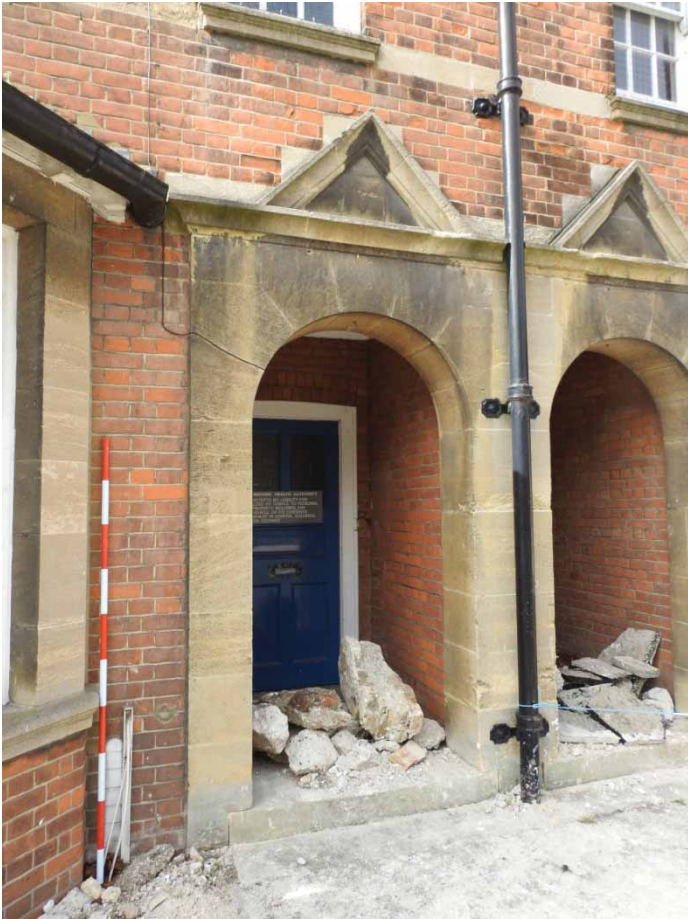
Plate 8: Residence 14; NE elevation; Portico entrance

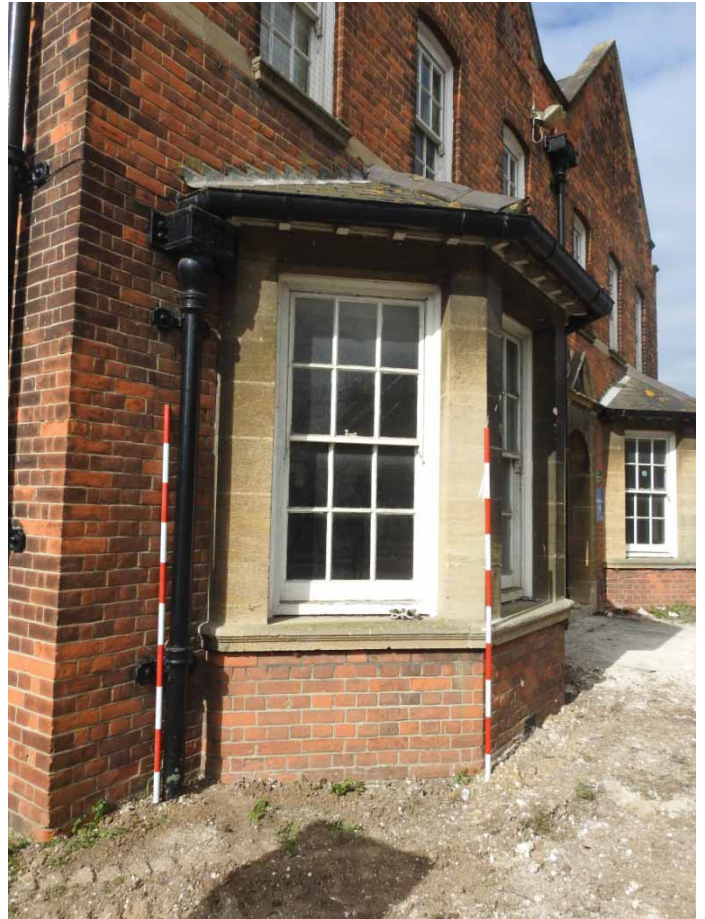
Plate 9: Residence 14; NE elevation; Looking west at bay window

7.4 The build is of red brick laid in a type of English Bond laid in lime mortar with a tuck pointing finish. Two protruding bay windows on the ground floor have a splayed slate roof set on a fine stone window frame with three sliding sash windows inserted but set behind the wall in keeping with building regulations of the time each with 12 panes of glass in each window (Plate 9).

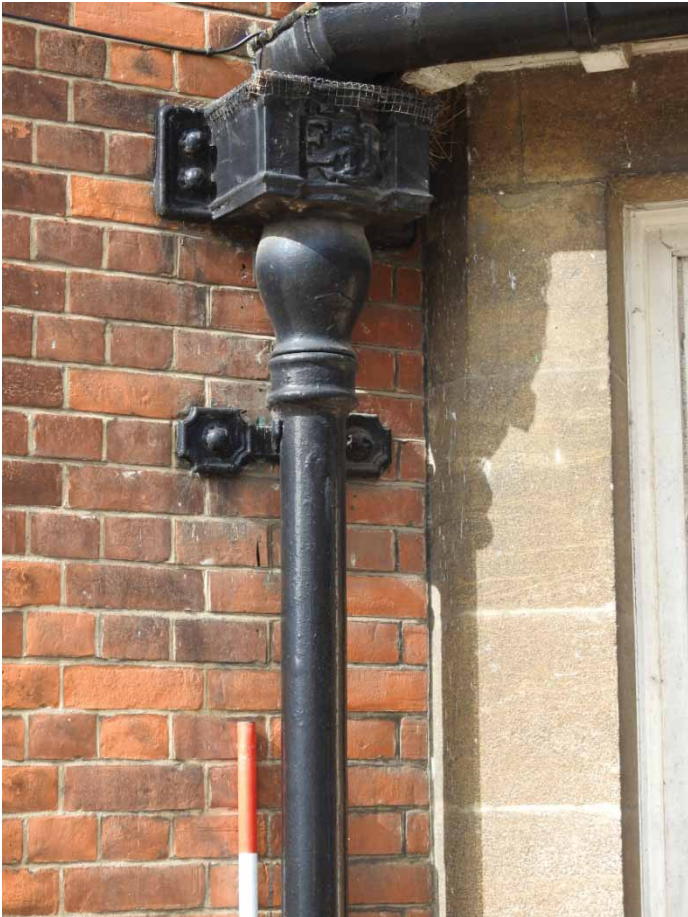
Plate 10: Residence 14; NE elevation; Looking west at bay window gutter box

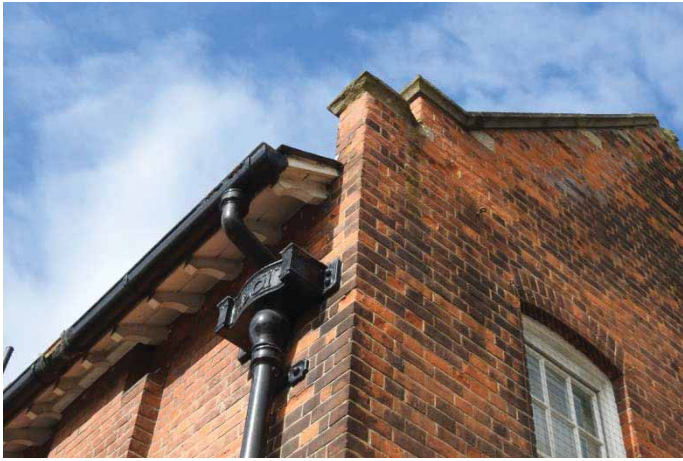
Plate 12: Residence 14; NE elevation; Looking west at roof eaves

7.5 The roof is a straight pitch with two gabled ends on the NE elevation and stepped in the Dutch tradition on the two external hip slopes (Plate 12).

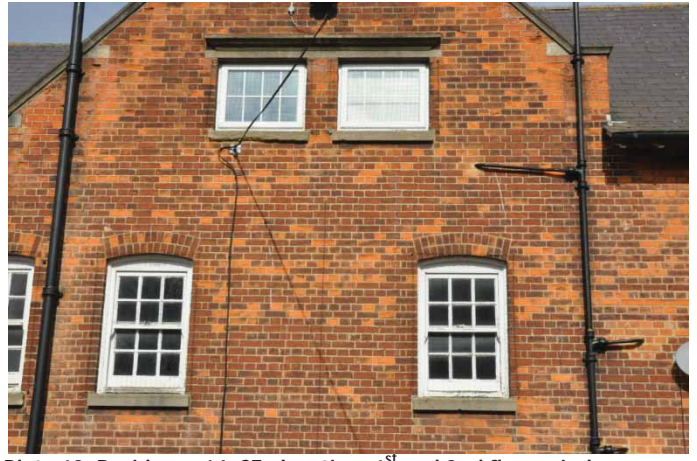
Plate 13: Residence 14; SE elevation; 1<sup>st</sup> and 2nd floor windows

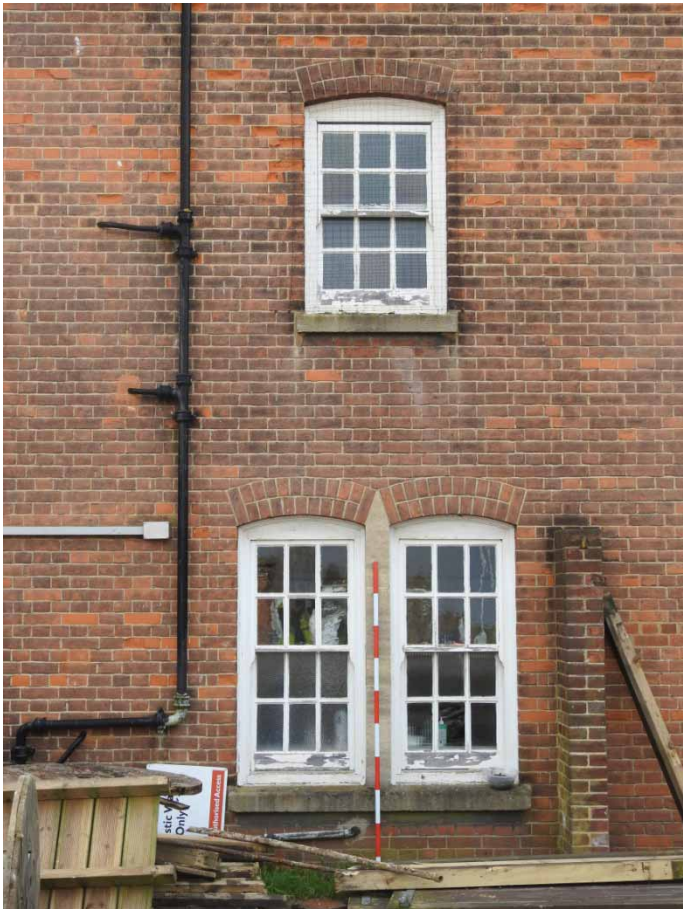
Plate 14: Residence 14; SE elevation; 1<sup>st</sup> and ground floor windows

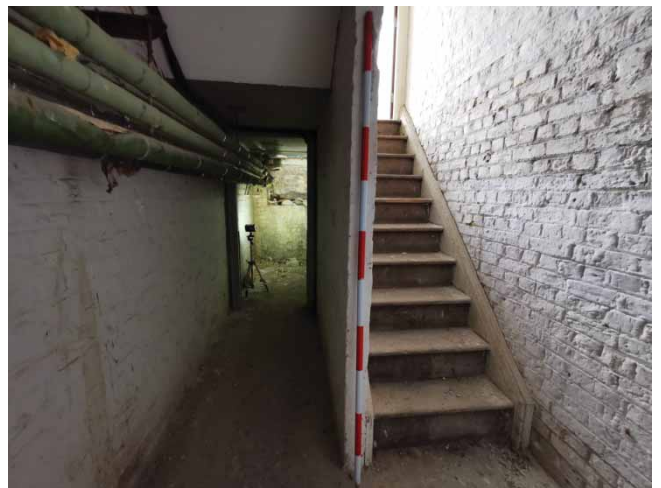
Plate 22: Residence 14; Basement

8.1 Residence 14 is on three floors with a basement (Plates 22, 23). The ground floor has been divided into eight rooms, with two corridors and two staircases. In addition to these rooms there is a shower room with toilet, two staircase lobbies and a walk-in electrical cupboard (Figure 3).

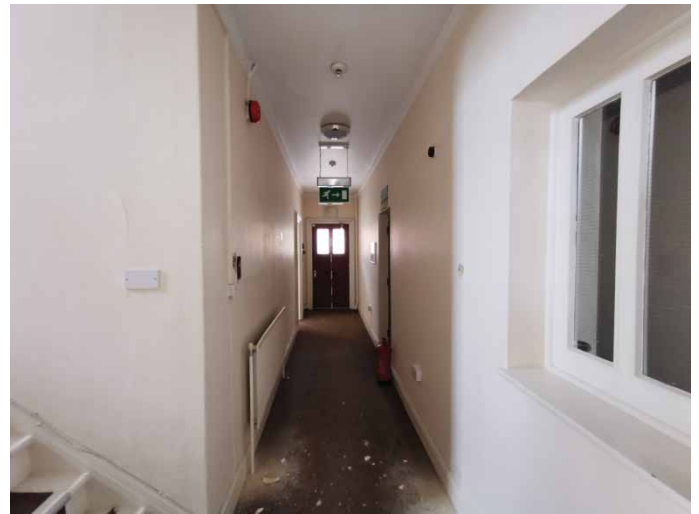
Plate 26: Residence 14; Upper ground floor - staircase

8.4 Two sets of stairs lead up to the First Floor (Plates 26, 34) with Bedsitting Rooms 13, 17, 18, 21, 22 and Lounge Room No.21 and Bathrooms (Plates 30, 31, 32, 33, Figures 3, 4).

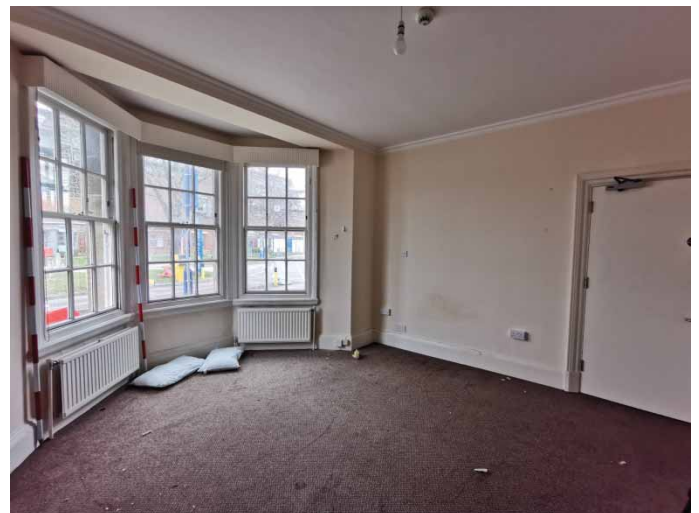
Plate 28: Residence 14; Upper ground floor – Common room

8.3 Corridors G002 and G016 are entered through the two front doors G001A and G0017A and access bedrooms No. 1 and No. 10 (Plate 29). Adjacent is Bedroom No. 3 with an attached kitchen and next door is Bedroom No.5 with the Common Room next door (Plate 28). Kitchen Diner and Shower are adjacent (Plates 24, 25, Figure 3)

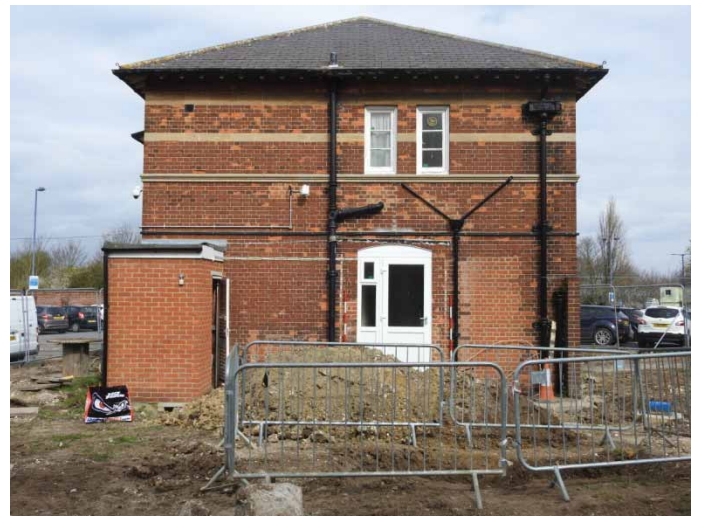
Plate 41: Residence 15; East-north-east elevation

lintel built of a double course of soldier bricks and the window frame sits on a stone cill. The other two windows on the ENE elevation are UVPC replacement windows (Plate 41, Figure 11).

9.5 The ENE elevation also houses the imposing front door set within a fine stone frame and topped by a horizontal stone canopy held up by two carved stone brackets (Plates 41, 45).

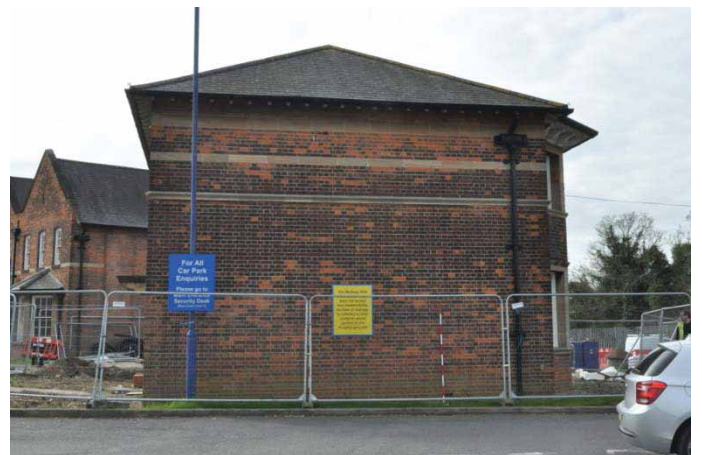
Plate 43: Residence 15; West-south-west elevation

9.2 The main body of the building is on two floors and with a two storey canted bay window located on the WSW elevation (Plate 43). The roof has a pitched roof with apex and the roofing material is slate. There are no chimney stacks (Figure 10).

9.3 The build is of red brick set in English Bond laid in lime mortar with a tuck pointing finish. The protruding canted bay window on the ground floor and first floor on the WSW elevation has a splayed leaded flat roof set on a fine stone window frame with three sliding sash windows on the ground and first floor inserted but set behind the wall in keeping with building regulations of the time each with 12 panes of glass in each window (Plate 50). However, the first floor bay windows are replacement UVPC windows (Plate 43, Figure 10).

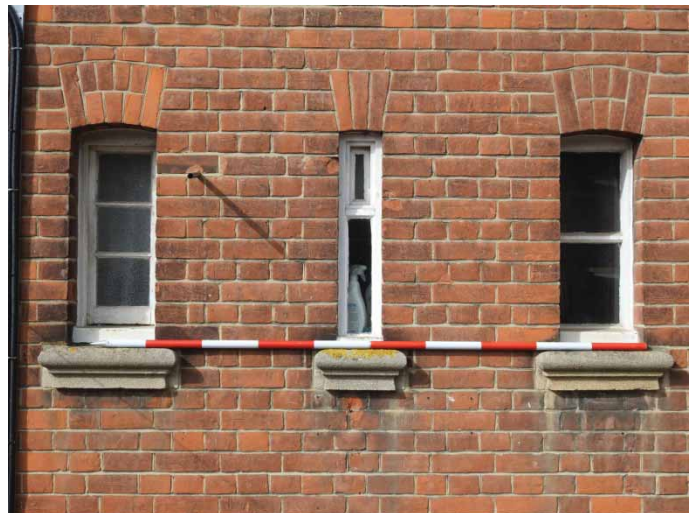
Plate 47: Residence 15; ENE elevation, windows

9.6 The windows on the ground floor ENE elevation are two sash windows to the right and three smaller narrow windows to the left all set on a moulded stone cill (Plates 47, 48)
